## 100/300 AREA UNIT MANAGER MEETING ATTENDANCE AND DISTRIBUTION

## 100 & 300 AREA UNIT MANAGER MEETING MINUTES

**Groundwater and Source Operable Units; Facility Deactivation, Decontamination, Decommission, and Demolition (D4); Interim Safe Storage (ISS); Field Remediation (FR); and Mission Completion**

**August 9, 2012**

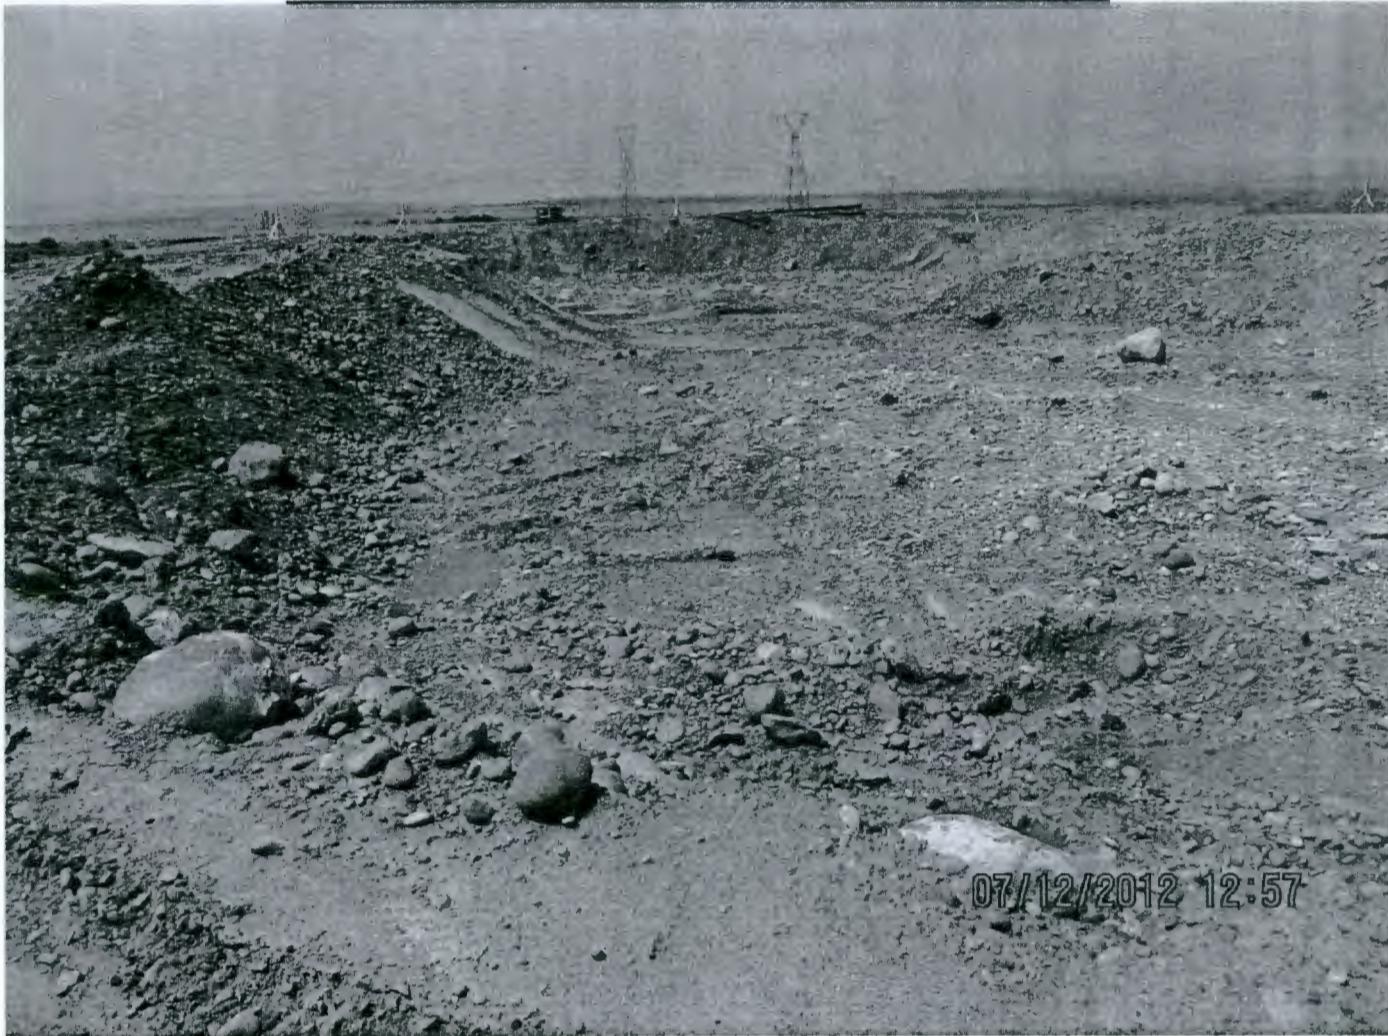
At approximately 1300 hours on 7/12/12, the soils of the excavation(s) for removal of the 1900-N Tank pads were visually inspected for signs of staining or anomalous items. The excavations were observed to be free of any stained soils or anomalies that would be indicative of chemical or petroleum contamination. The GPERS survey (Performed 7/17/2012) didn't identify contamination, nor was any expected since the structures were not radiologically contaminated. Please see the attached word file for photographs that were taken during the inspection and PDF file of the GPERS survey. I'll CHRON this e-mail and attachments for future use as reference for closure documentation. Feel free to contact me if you have any questions. Thanks.

**1900-N Excavation Looking West (view from Southeast tank ring excavation to Southwest excavation)**

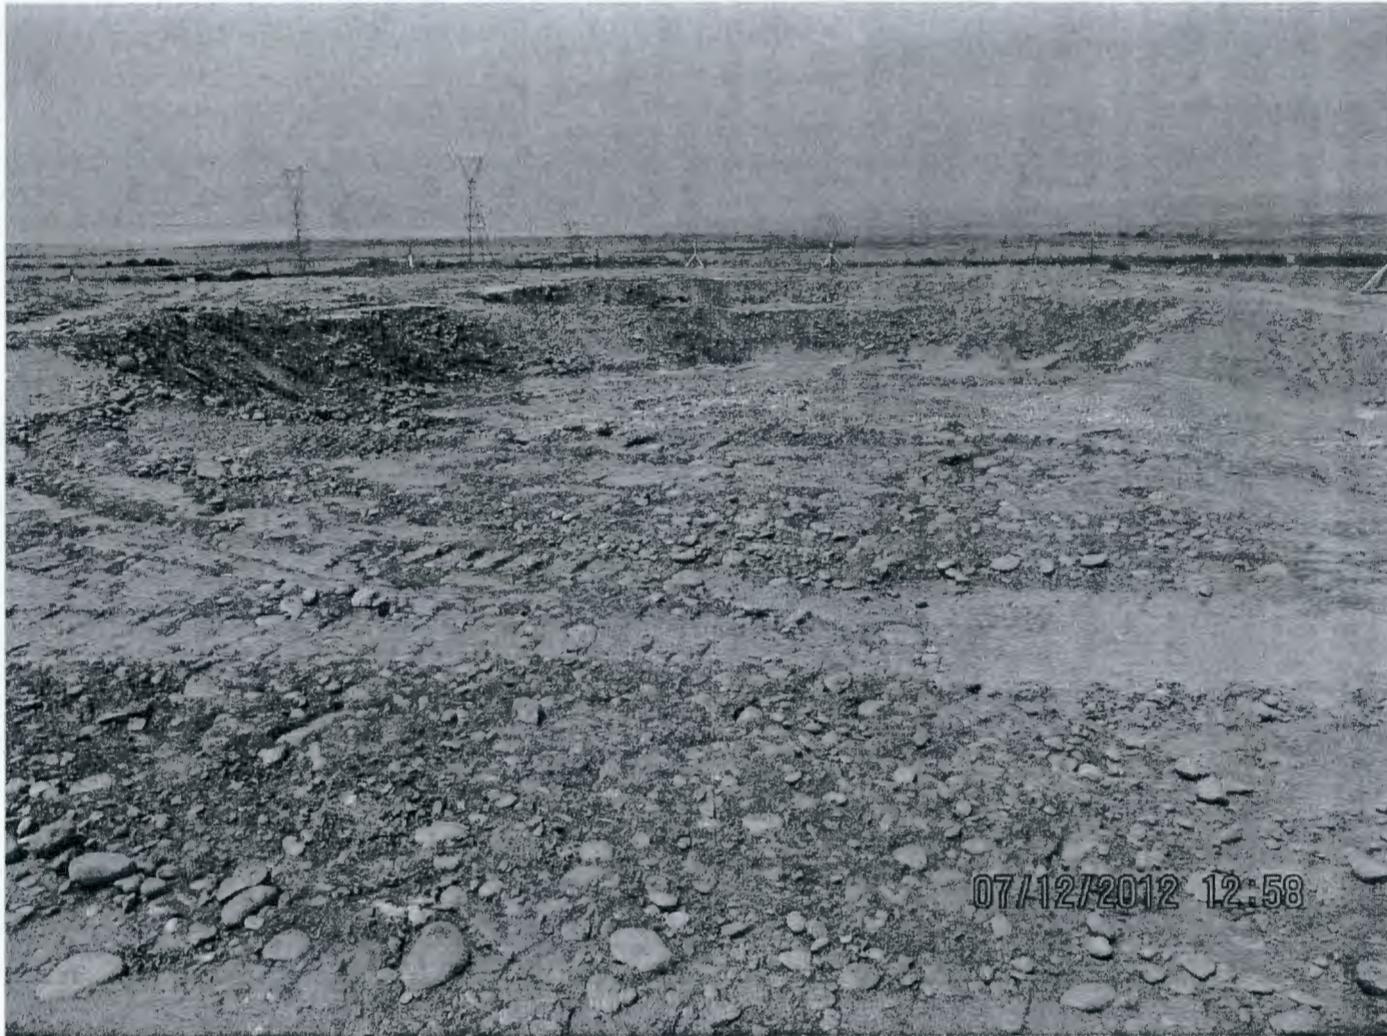
**1900-N Excavation Looking West (view from Northeast tank ring excavation to Northwest excavation)**

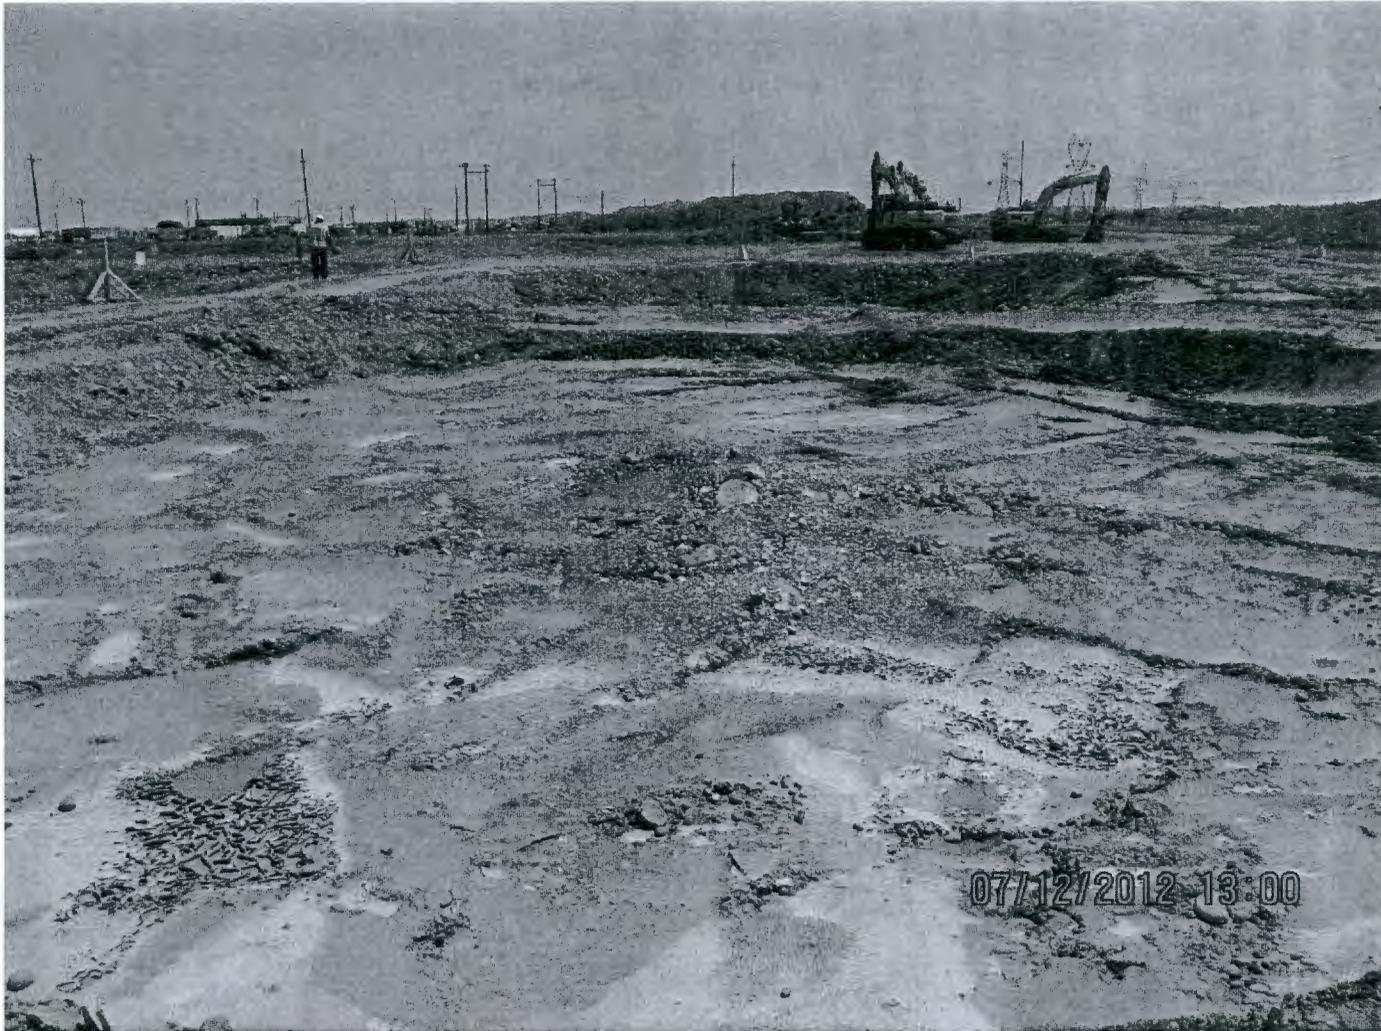
**1900-N Excavation Looking East (view from Northwest tank ring excavation to Northeast excavation)**

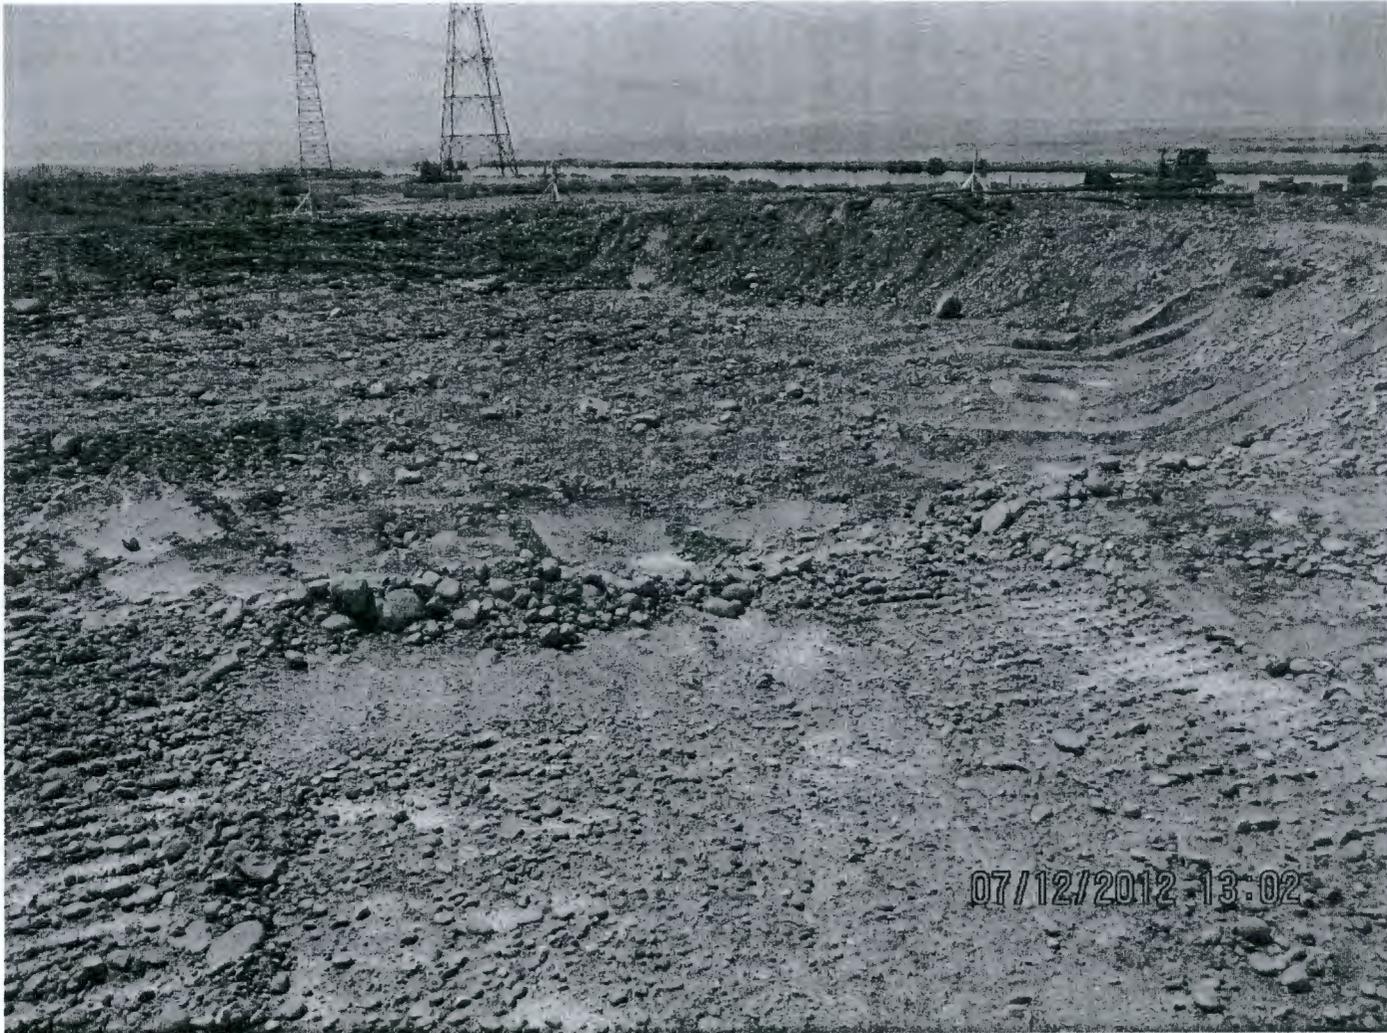
**1900-N Excavation Looking South-Southwest (view from Southwest tank ring excavation)**
