PNL-7611
UC-602

ENGINEERING-SCALE TEST 4:
IN SITU VITRIFICATION OF TOXIC METALS
AND VOLATILE ORGANICS BURIED IN INEL SOILS

June 1991

Pacific Northwest Laboratory
Richland, Washington 99352

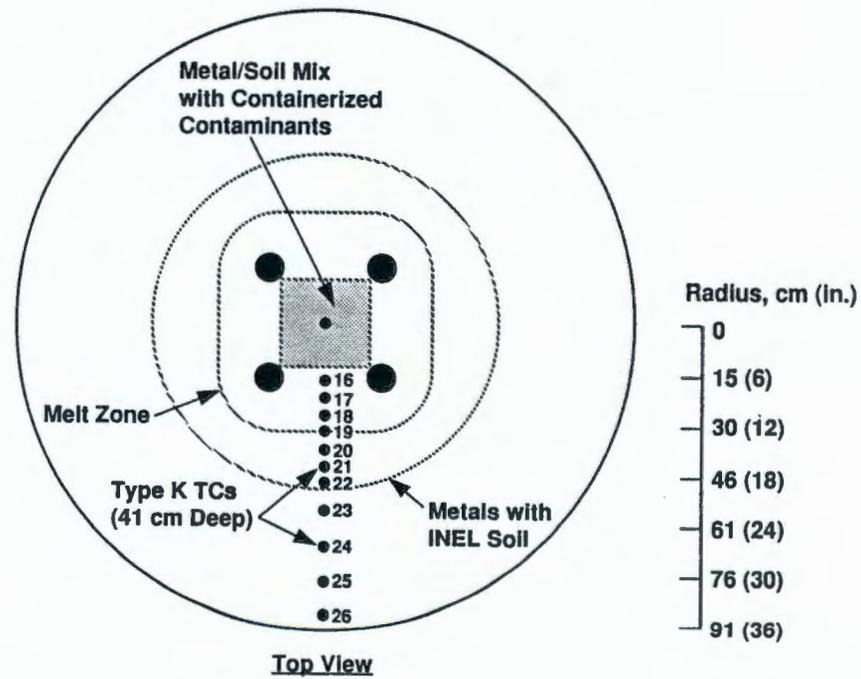
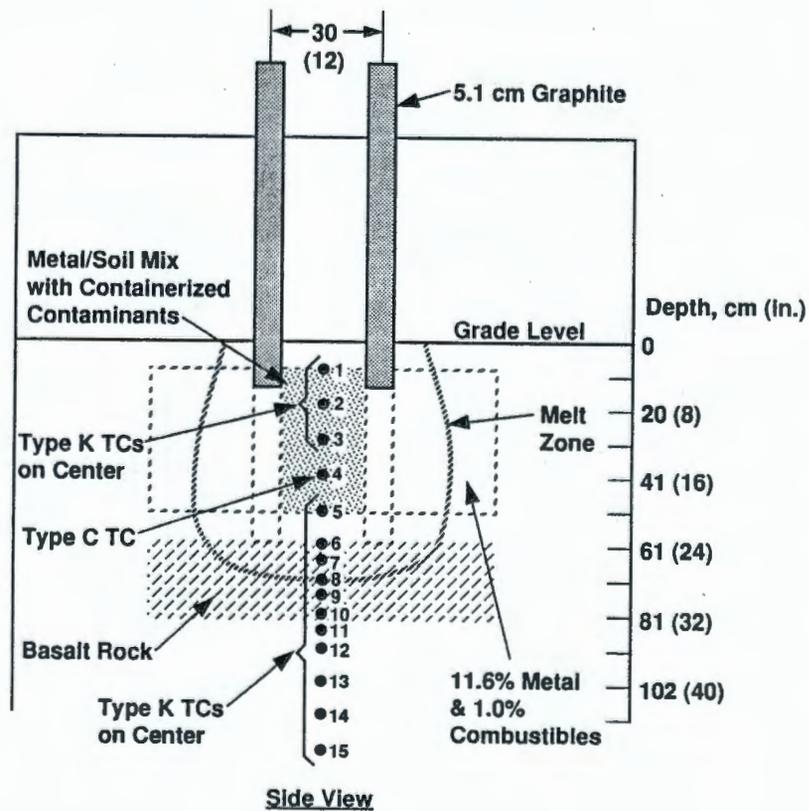
FIGURE 4.1. ES-INEL-4 Test Configuration

The test was setup as shown in Figure 4.1 and described in the ES-INEL-4 test plan. A parametric matrix was established to summarize key parameters and system constraints for the test. Testing contaminants, soil moisture content, off-gas flow requirements, and combustible content limits are provided in Table 4.1.

The basalt rock was placed such that its top surface was at a depth of 66 cm (26 in.), 15 cm (6 in.) below the bottom of the metal/soil mixture (see Figure 4.1). The eight inorganic EP Tox chemicals [barium carbonate, chrome (III) oxide, silver oxide, lead, cadmium oxide, arsenic trioxide, selenium dioxide, and mercury as listed in Table 4.3] were separately placed in the center of the metal/soil mixture at 5-cm (2 in.) intervals, with barium carbonate (a nonvolatile EP Tox chemical) placed at the 15-cm (6 in.) level, and mercury (the most volatile EP Tox metal) placed at the 51-cm (20 in.) level. All but the mercury were loosely placed in the metal/soil mixture. The mercury was placed in a small glass bottle that was expected to break before it came into contact with the ISV melt front.

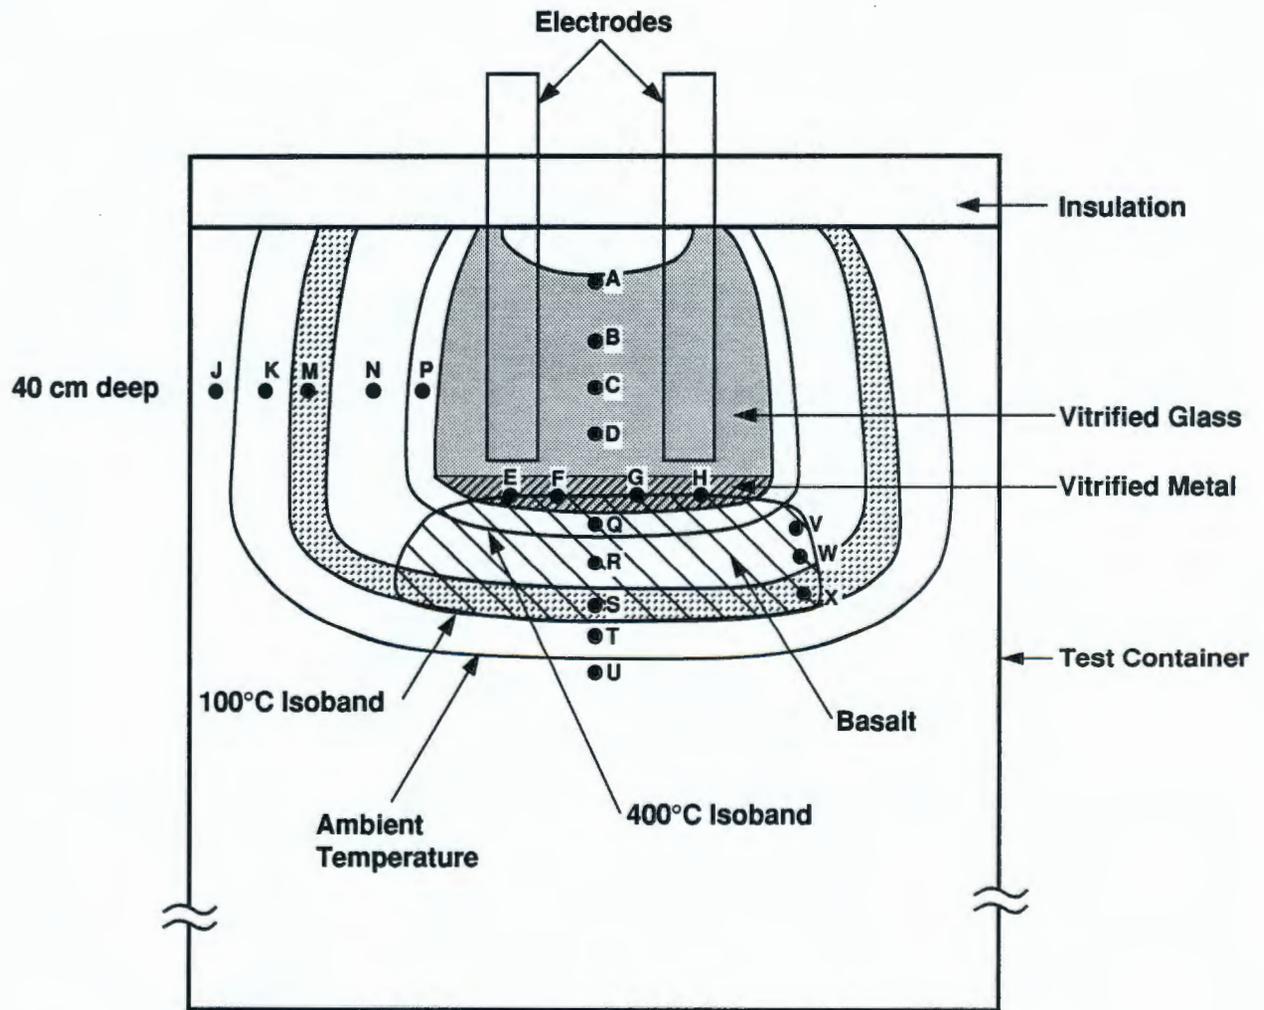
FIGURE 4.2. ES-INEL-4 Pretest and Posttest Sample Locations

Pretest soil samples were obtained during construction of the ISV system. These samples were taken from the same soil locations designated for the posttest sampling, as shown in Figure 4.2. The pretest soil was sampled to determine the background levels of the organics and EP Tox metals, as well as to determine the soil composition so as to further define the actual test conditions.

Sample locations shown as ●

Samples consist of a composite within the "band" of soil as indicated by the sample location. The soil sample below the ambient temperature band extends to 2° below the band.

The concentration of volatile test organics in soil samples surrounding the melt is given in Table 6.1. Samples labeled P through J (as shown in Figure 4.2) were taken at successively lower isotherms away from the melt; samples T and U were taken below the basalt block. The concentrations of organics in these samples are uniformly low. The maximum equivalent concentration (EC) and halogenated hydrocarbon (HH) calculations for these samples

The soil sample at zone M, which included the 100°C isotherm, yielded the highest TCLP values (see Figure 4.2). Samples beyond this zone were consistently lower suggesting that no outward migration of organics occurs outside of the 100°C soil isotherm. Since all but PCE are generally volatile below 100°C, this supports the theory of molecular diffusion of organics

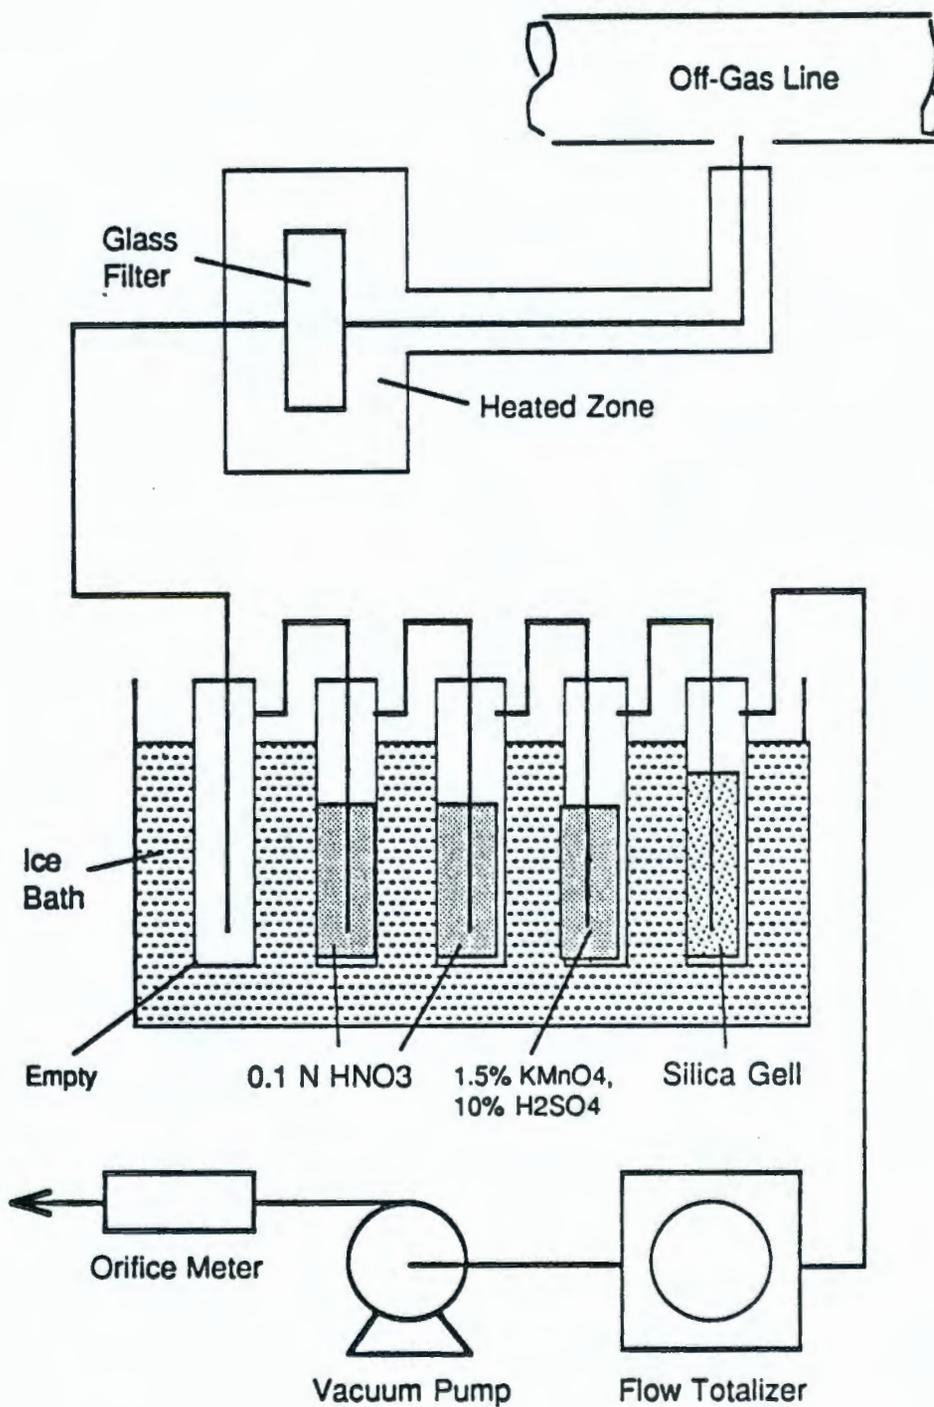
FIGURE 4.3. ES-INEL-4 Off-Gas MM5 Sample Train for Inorganics

Off gas from the vitrification zone was sampled continuously during the test. A fraction (13 L/min) of the total off-gas flow was drawn isokinetically into a Modified Method 5 (MM5) sampling train that was used for sampling the EP Tox metal effluents and entrained particulate that is sent to the off-gas system during ISV processing.

The inorganic and organic off-gas trains are depicted in Figures 4.3 and 4.4, respectively. Further information about the off-gas sampling is contained in SW-846 Test Method 0010.

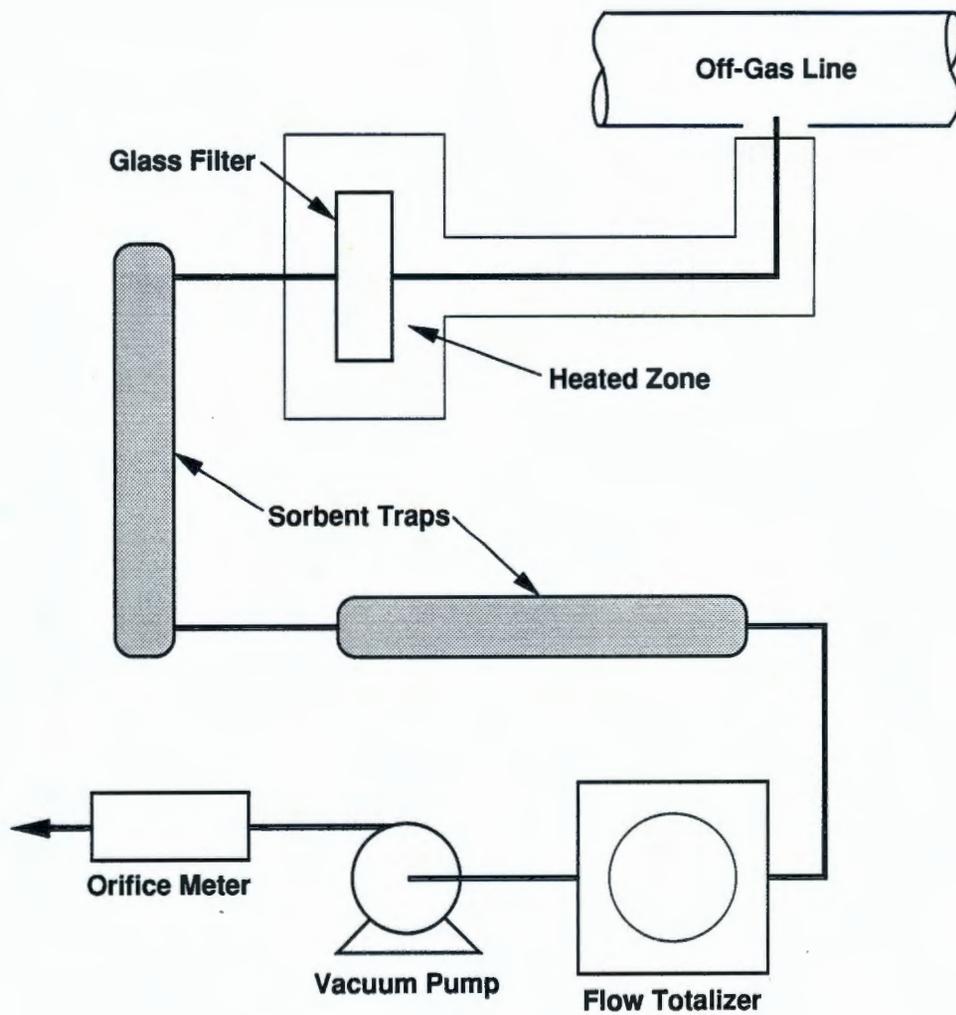
FIGURE 4.4. ES-INEL-4 Off-Gas MM5 Sample Train for Organics

The off-gas trains for sampling the organics consisted of two sorbent resin tubes of activated carbon, through which a small fraction (50 mL/min) of the total off-gas flow was drawn. The first tube was used to capture most of the organics, while the second tube was supposed to capture any residual organics.

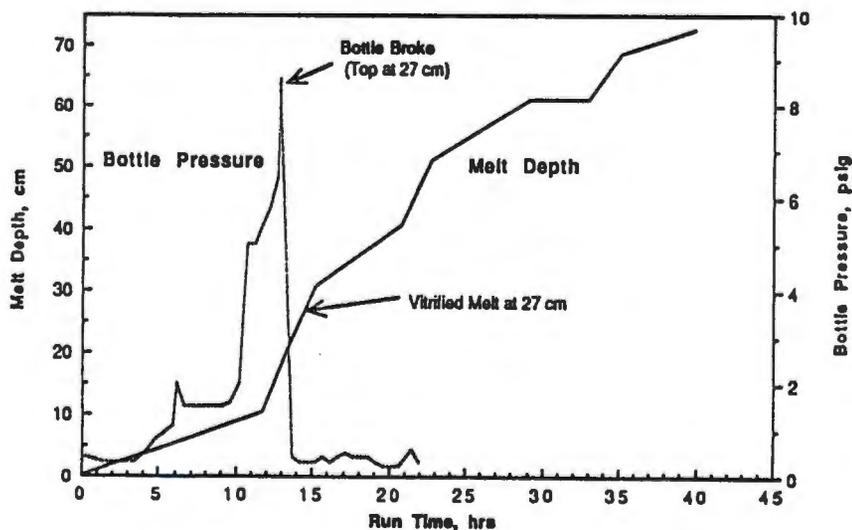
FIGURE 5.1. Glass Bottle Pressure Versus ISV Melt Depth

time, the ISV melt had reached a depth of approximately 20 cm (8 in.), and the temperature of the soil directly adjacent to the inverted bottom of the glass bottle was approximately 200°C (see Figures 5.1 and 5.2). This shows that the organic materials contained in the glass bottle were free to move prior to being contacted by the melt. Persistent flares, appearing to be pressurized gas venting, were observed at the melt surface during this time and may have resulted from the burning organic vapors.

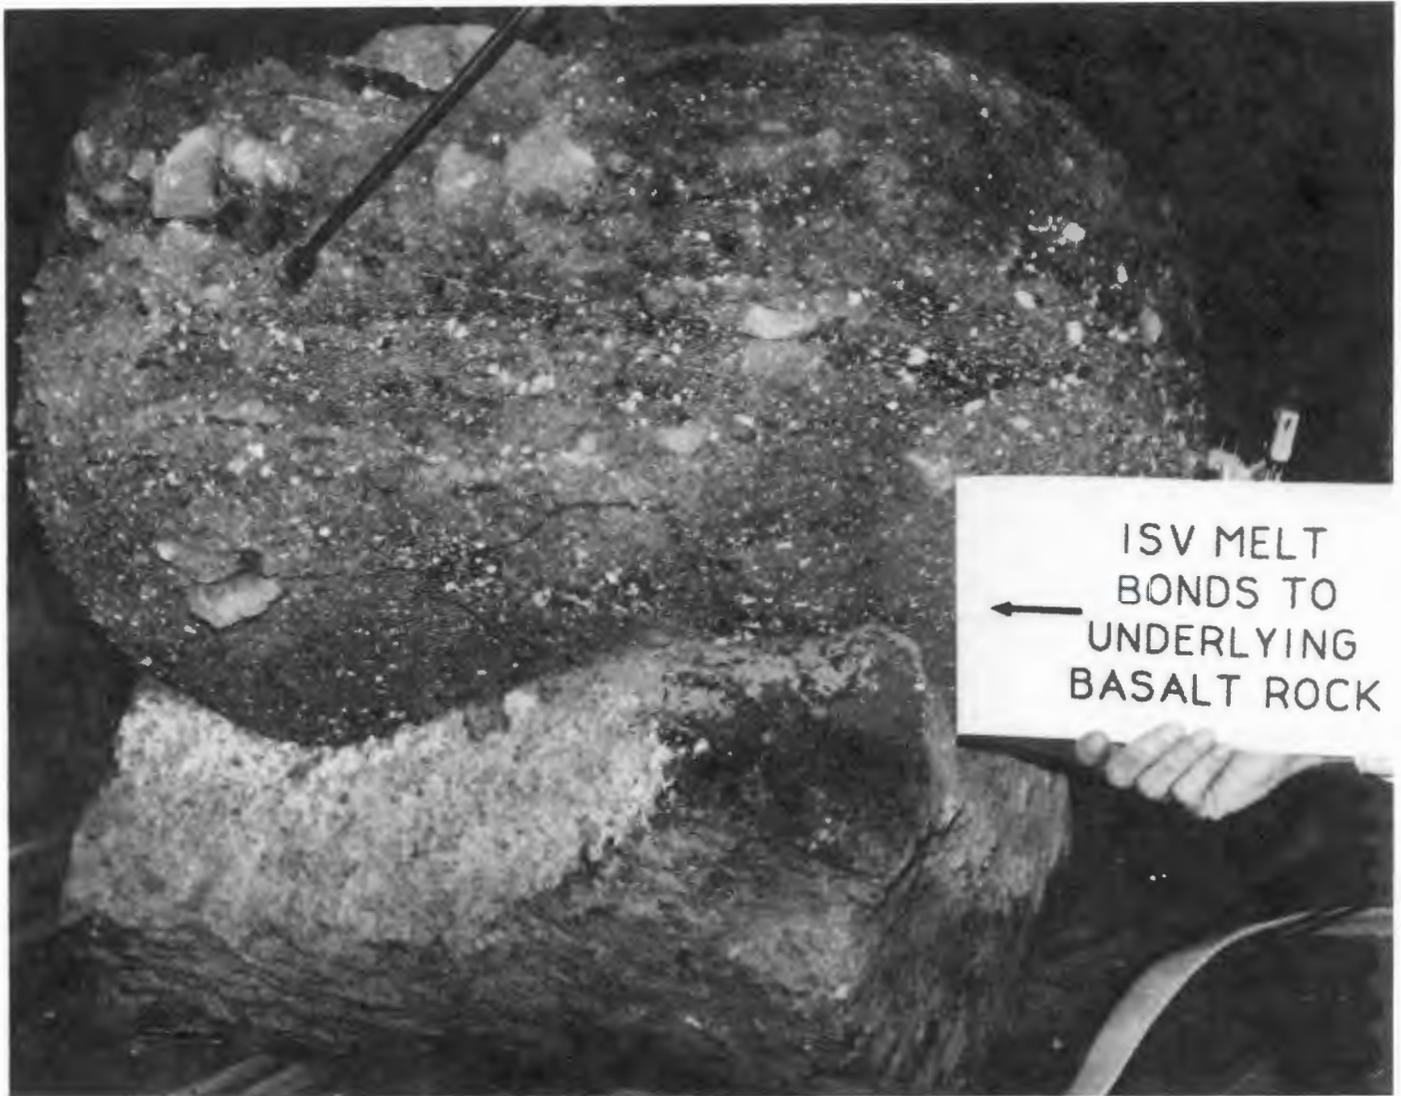
FIGURE 5.3. Vitrified Block Resulting from ES-INEL-4

A photograph of the vitrified block is shown in Figure 5.3. The vitrified block weighed approximately 407 kg (898 lb). During ISV processing, the block reached a depth of 79 cm (31 in.) and a width of 81 cm (32 in.), with

full surface subsidence to a depth of 38 cm (15 in.). Because of the hazardous nature of the melt, subsidence measurements of vitrified melt could not be taken during testing as originally planned. Instead, final melt subsidence was measured after the vitrified block had cooled. The amount of fused glass above the subsided surface was completely broken up by the removal of the four electrodes during this test. Assuming that none of the metal was oxidized and dissolved in the glass, mass balance of the metal remaining in the soil indicated that the vitrified block had a total steel concentration of 9.4%.

Four metal pools formed in the vitrified block between the glass and the basalt rock directly beneath where the graphite electrodes used to be. The presence of four metal pools instead of one was probably due to the lack of joule heating in the center bottom of the melt, relative to the high amount of joule heating that occurred between the electrodes and the metal pools. The metal pools appeared to be completely homogeneous.

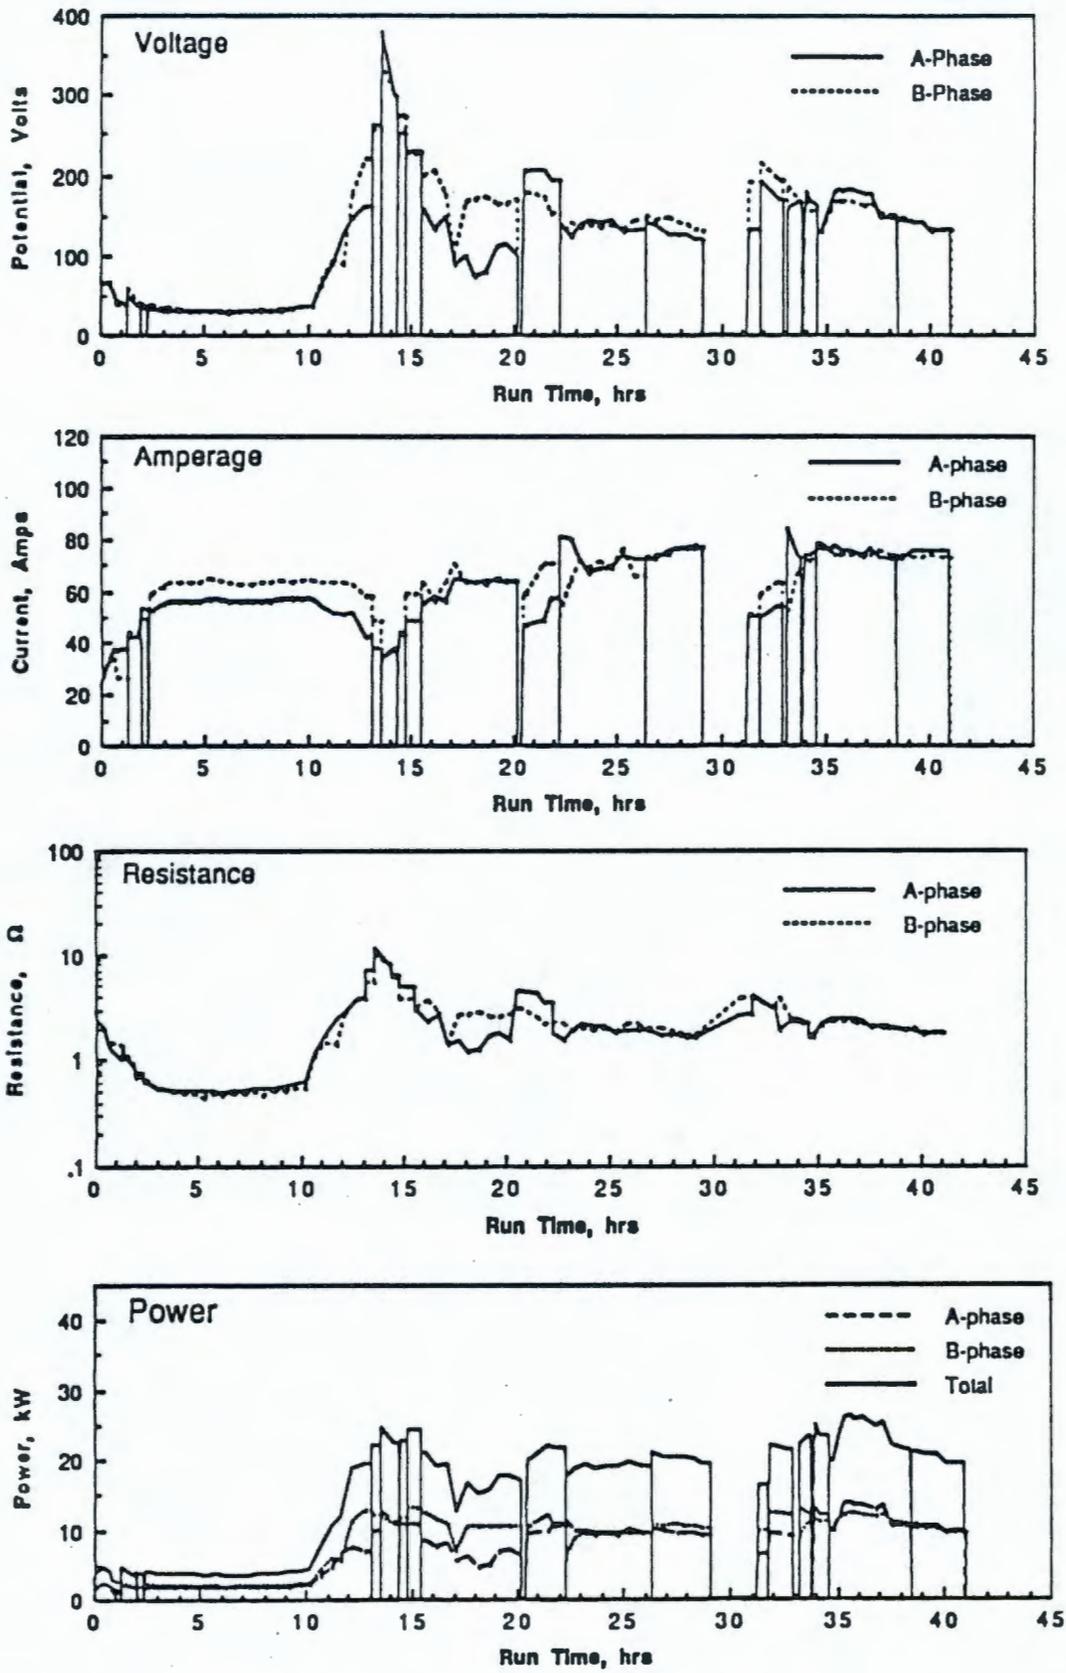
FIGURE 5.4. Electrical Test Data for ES-INEL-4

Electrical data for ES-INEL-4 are illustrated in Figure 5.4. As with ES-INEL-3, the measured voltages, amperages, and resistances were relatively balanced between electrical phases.

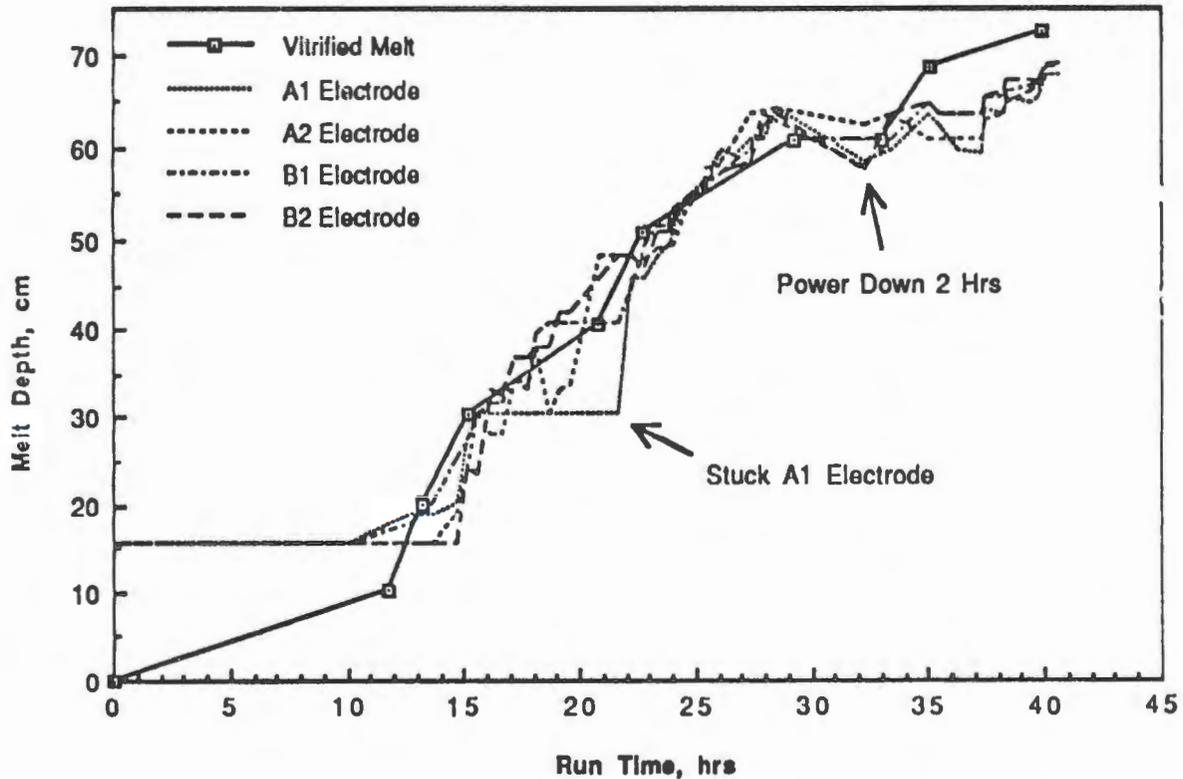
FIGURE 5.5. Melt Depth Versus Electrode Depth for ES-INEL-4

During testing, the electrode depth was determined based on the height of each electrode above the melt surface. The electrode depths were then plotted against the projected depth of the vitrified melt, based on the time at which each Type K thermocouple went off-scale. The plot of melt depth versus electrode depth is shown in Figure 5.5. As seen in Figure 5.5, the use of electrode feeding provides a relatively good estimate of melt depth in INEL soils.

Only in the last 8 h of testing did the vitrified melt depth drop significantly below the electrode depth. This occurred at the 60-cm depth, which corresponds with the top surface of the basalt block. It could have been due in part to the metal pooling in the basalt rock beneath each electrode, which limited electrode depth.

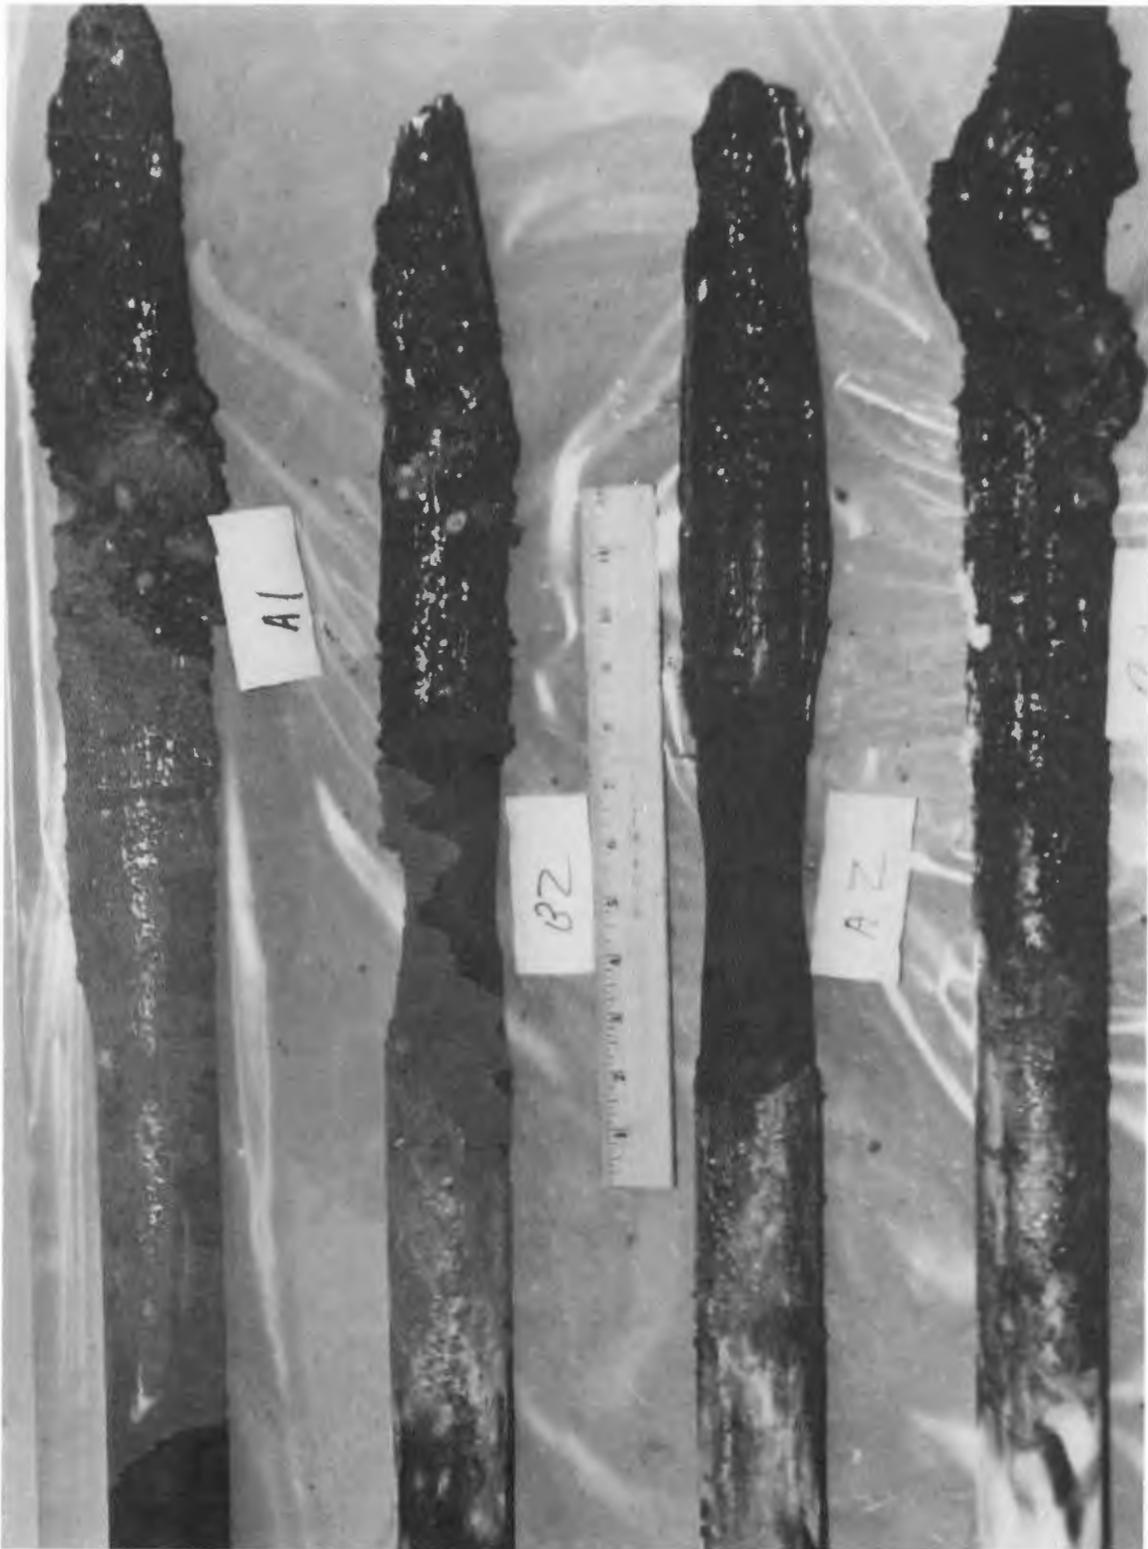
FIGURE 5.6. Posttest Observation of Electrode Corrosion from ES-INEL-4

A photograph of the four posttest electrodes is shown in Figure 5.6. The final lengths of the CVD-coated electrodes (A-1 and B-1) were 70 cm (27.5 in.), 2.5 cm (1 in.) shorter than the initial lengths. Each CVD-coated electrode began to taper off about 18 cm (7 in.) from the bottom, reaching a minimum diameter of 2.5 cm (1 in.) at the bottom.

For the Zyp SC-coated electrodes (A-2 and B-2), the final lengths were only 65 cm (25.5 in.), 7.5 cm (3 in.) shorter than the original lengths. The necking down started 47 cm (19 in.) from the bottom, but formed a point at the bottom of each electrode. In addition, a more corroded area, with a diameter of 3.8 cm (1.5 in.), was observed 35 cm (14 in.) from the bottom of each electrode.

With each electrode experiencing the same type of start-up environment, the differences provide a direct comparison between the CVD-coated and the Zyp SC-coated electrodes. On the basis of this test, it appears that the more expensive CVD coating would provide better corrosion resistance than the Zyp SC coating. Nevertheless, tests conducted subsequent to this test have shown that coated electrodes are not necessary with electrode feeding provided the start-up time for the melt is not significantly long.

All four of the electrodes were coated with a SiC coating to protect the graphite electrodes from air oxidation at temperatures up to 1000°C. However, the SiC coating on two of the electrodes was applied by carbon vapor deposition (CVD), while the other two electrodes were hand-painted with three coats of SC coating manufactured by the Zyp Coating Company of Oak Ridge, Tennessee. Because of the hazardous nature of the tests, the effect of these two coatings on preventing electrode corrosion rates was evaluated after the test rather than during the test as originally planned.

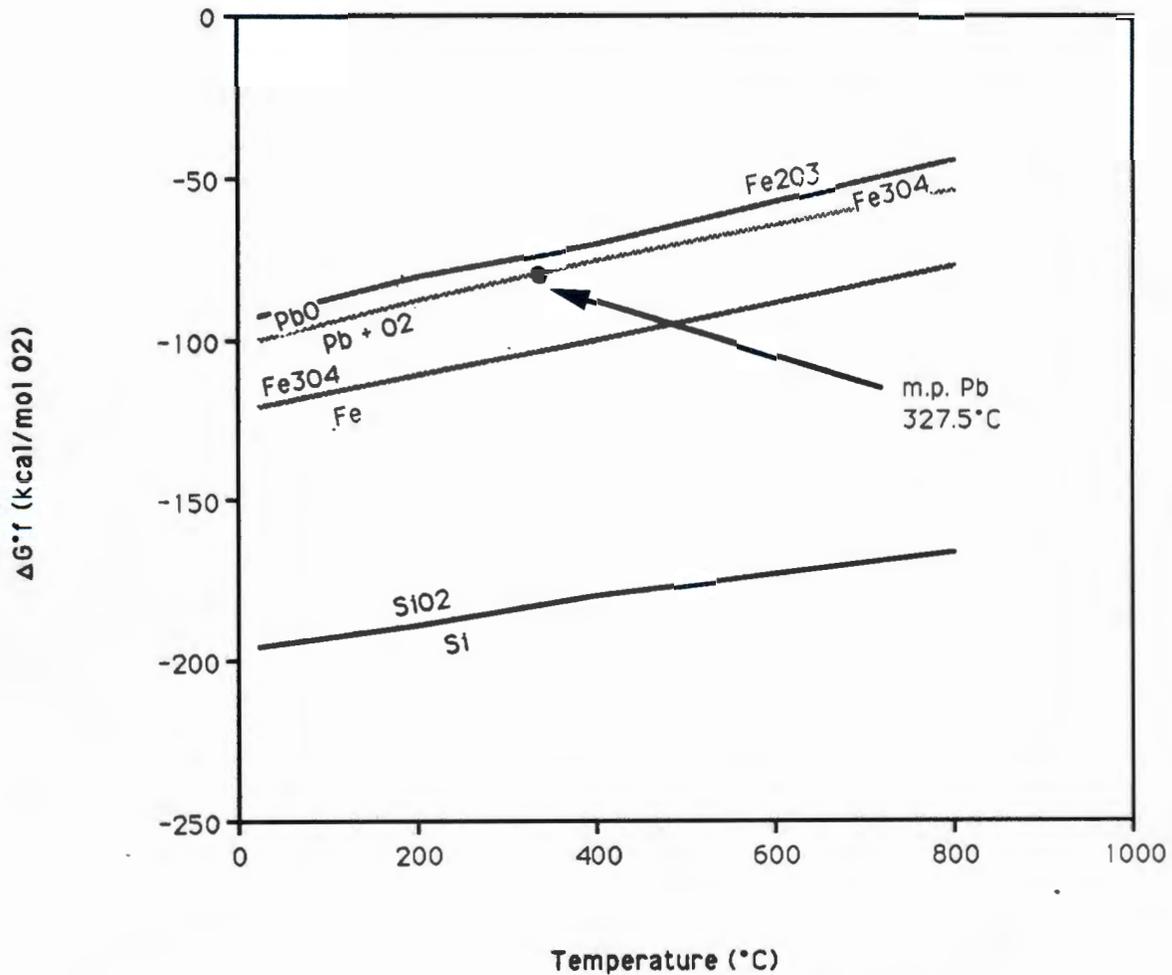
FIGURE 6.1. Comparison of Pb Oxidation with Fe Oxidation

the presence of metallic Fe, Pb will tend to be in the metallic form. In order for Pb to dissolve in the melt it must oxidize and if the redox state of the system prevents this, Pb will occur as a separate phase. Under nonequilibrium conditions or local oxidation, however, some Pb can dissolve in the melt. If a separate Pb phase becomes a problem in ISV applications, the possibility of preoxidation or incorporation of Pb into other glass phases such as phosphates may be considered. Larger scale ISV melts may also enhance oxidation and dissolution of Pb into the vitrified glass by allowing more time for oxidation and dissolution to occur.
