SUBJECT: Page changes for the 4843 AMSF Closure Plan, Revision 1

1
2
3
4
5
6
7
8
9
10
11
12
13
14
15
16
17
18
19
20
21
22
23
24
25
26
27
28
29
30
31
32
33
34
35
36
37
38
39
40
41
42
43
44
45
46
47
48
49
50
51
THE 4843 ALKALI METAL STORAGE FACILITY CLOSURE PLAN**1.0 INTRODUCTION**

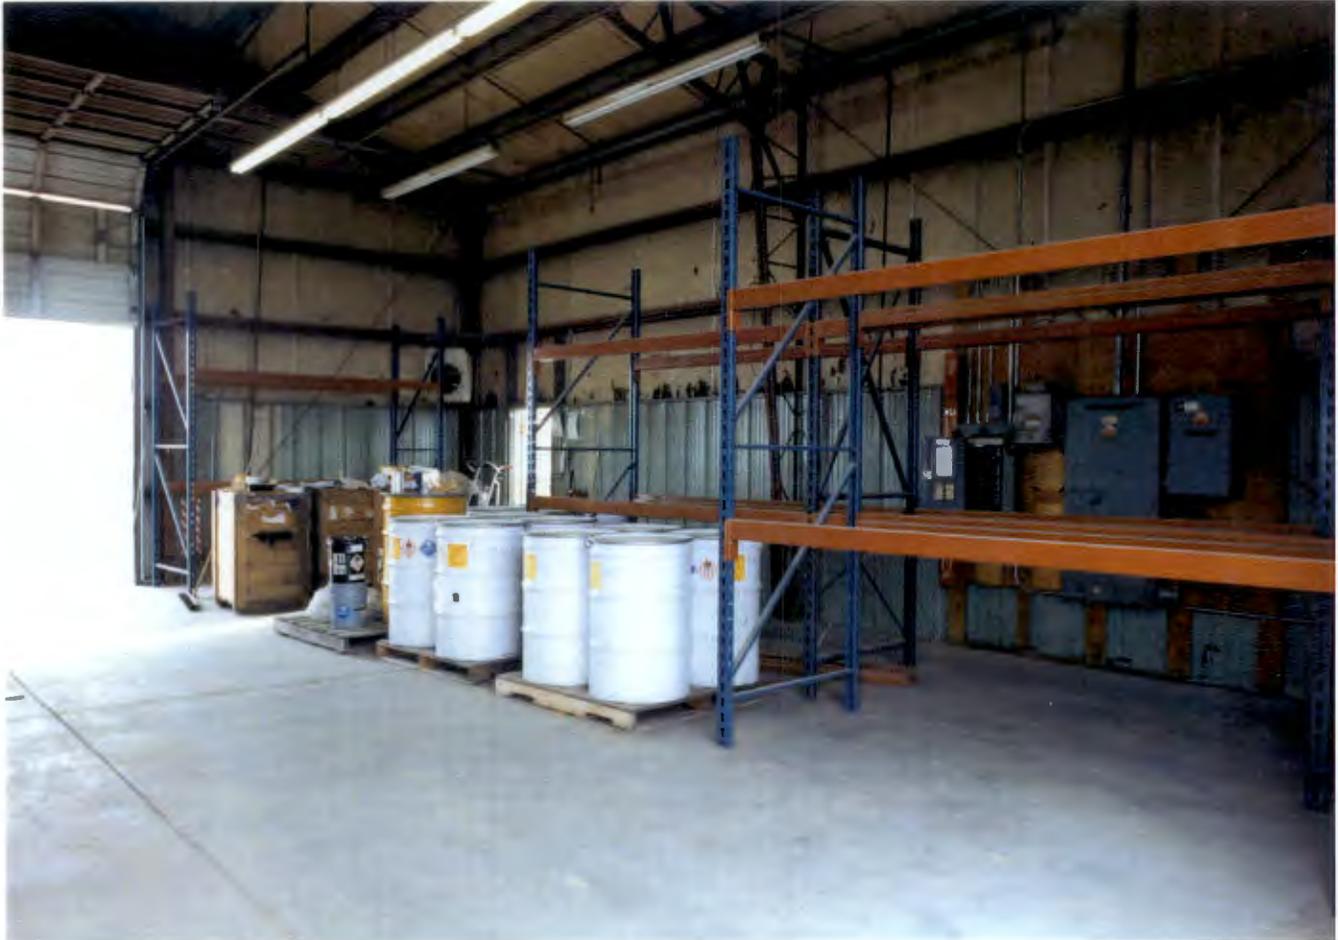
Figure E-3. Interior of the 4843 AMSF. Past configuration showing containers of dangerous waste. Photograph taken December 1990.

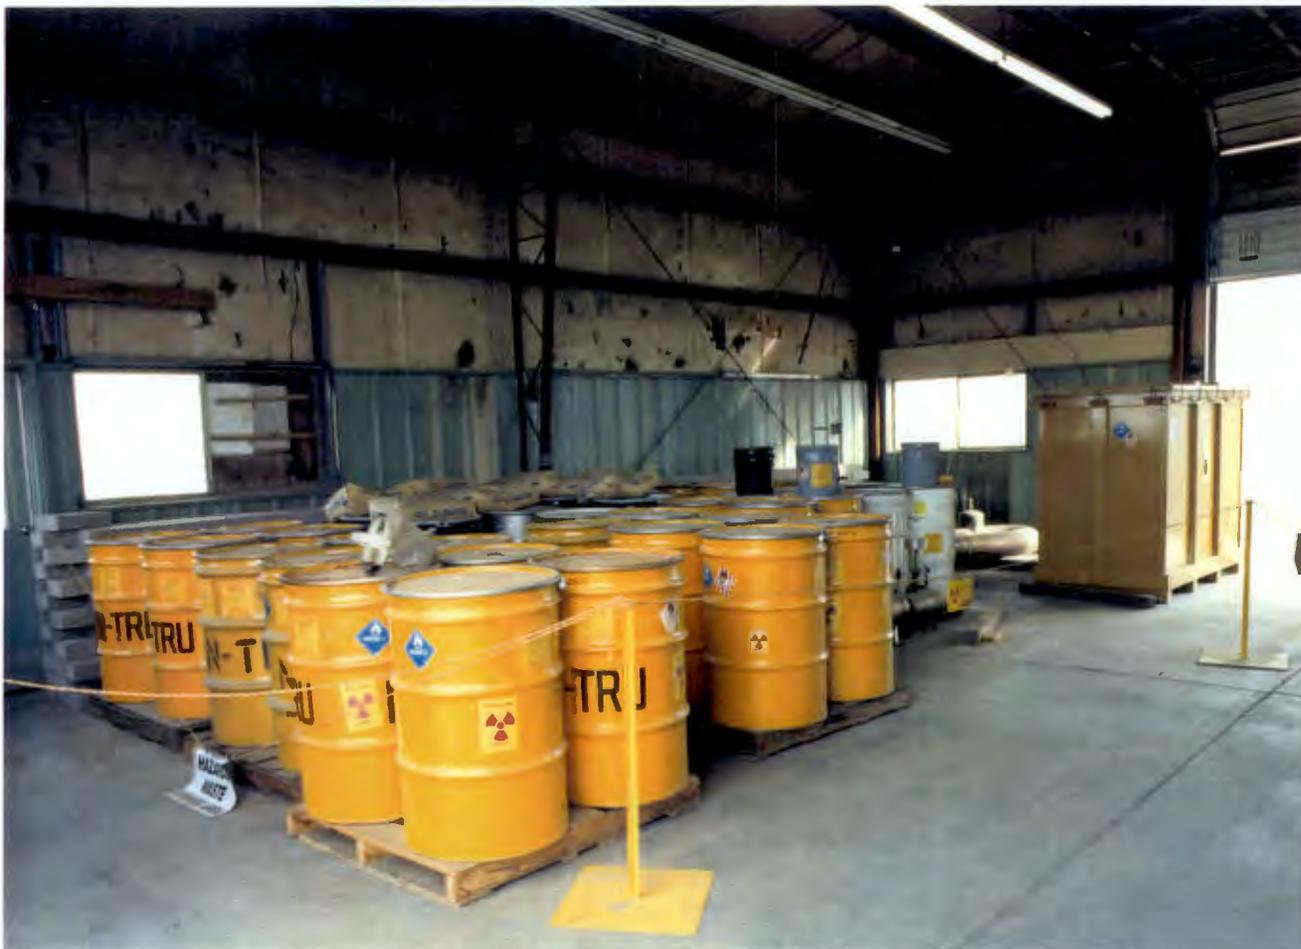
Figure E-4. Interior of the 4843 AMSF. Past configuration showing containers of mixed alkali metal waste. Photograph taken December 1990.
