FACILITY STATUS CHANGE FORM

Date Submitted: February 7, 2013 Originator: Chris Strand Phone: 554-2720	Area: 300 Area Facility ID: 329 Action Memorandum: Action Memorandum #3	Control #: D4-300-080
---	---	---------------------------------

END-STATE PROPOSAL FOR THE 329 BUILDING

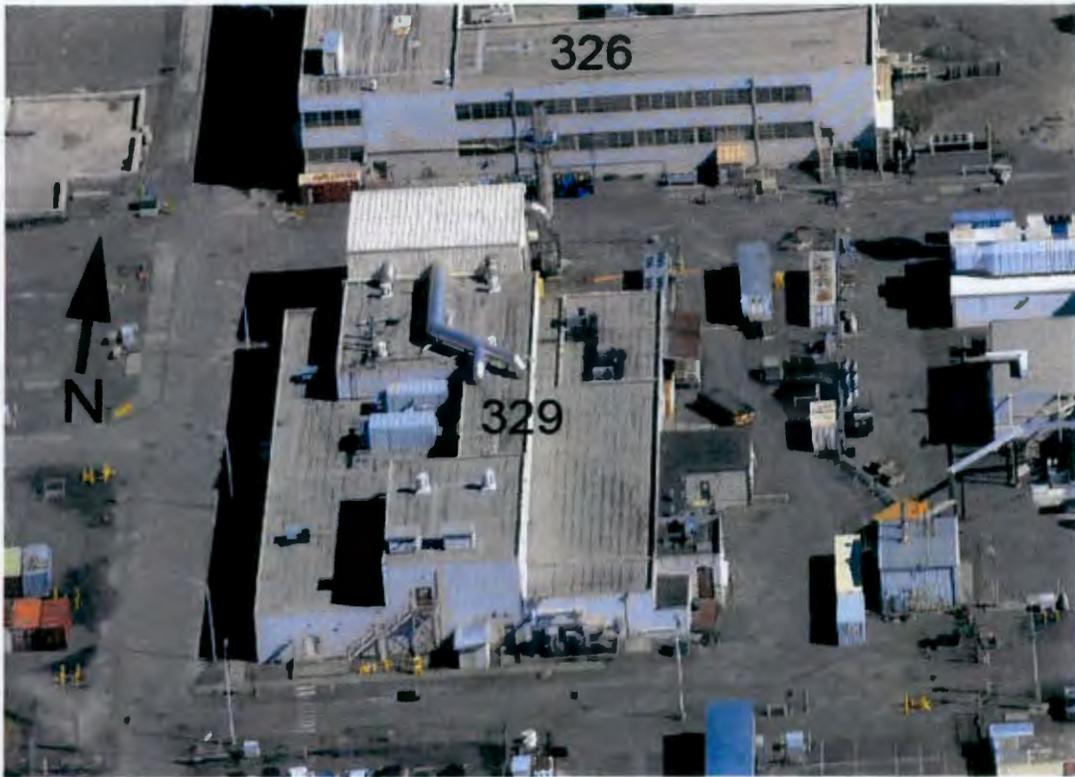
Photograph 1: Looking north at the 329 Chemical Sciences Laboratory in July 2012.

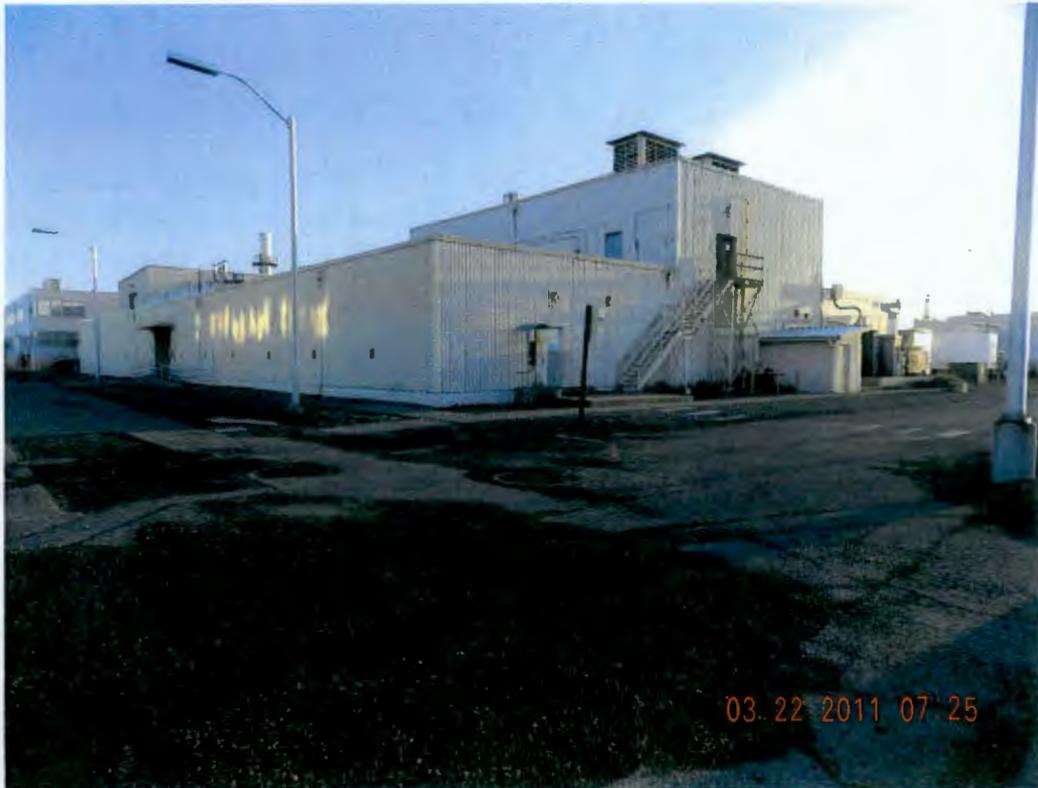
Photograph 2: 329 exterior looking northeast on March 22, 2011.

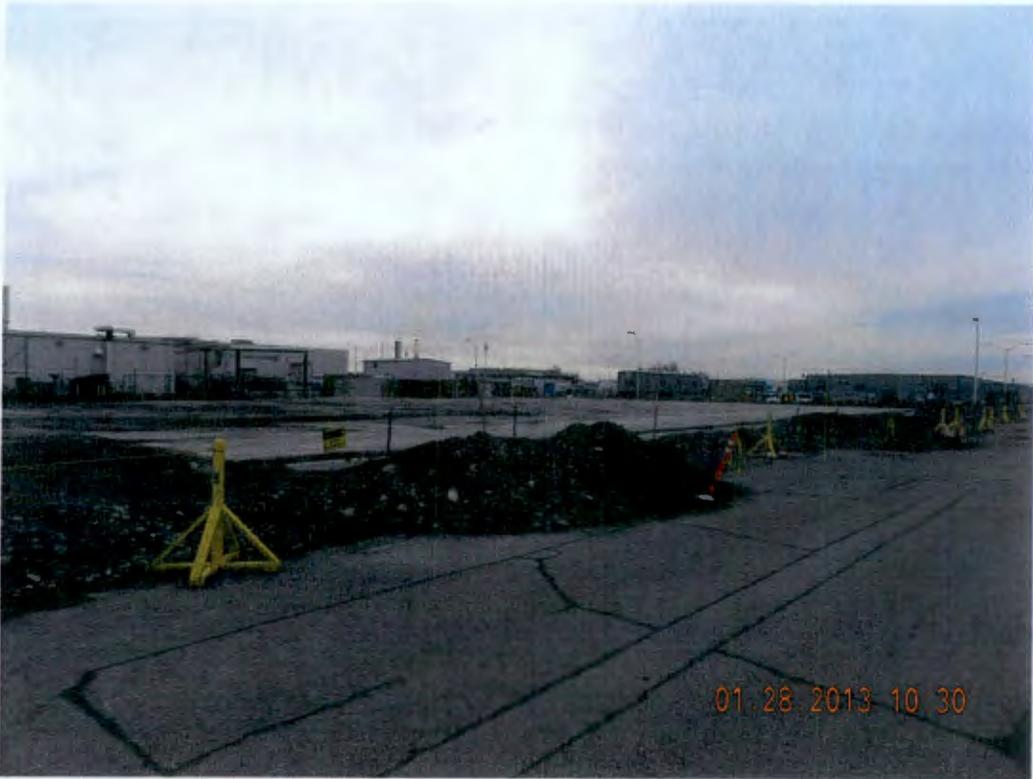
**Photograph 3: 329 slab following above-grade demolition,
looking southeast on January 28, 2013.**

Demolition: Above-grade demolition of the the 329 Building was completed in January 2013. The at-grade slab, partial basement, and neutron monitoring and ion exchange pits remain in place. Removal of these portions of the facility are interfered with by long-term retained utilities that support ongoing operation of the adjacent 325 Building. The building debris from above-grade demolition was removed and disposed of at ERDF. The demolition was performed under Radiological and Industrial Hygiene controls.

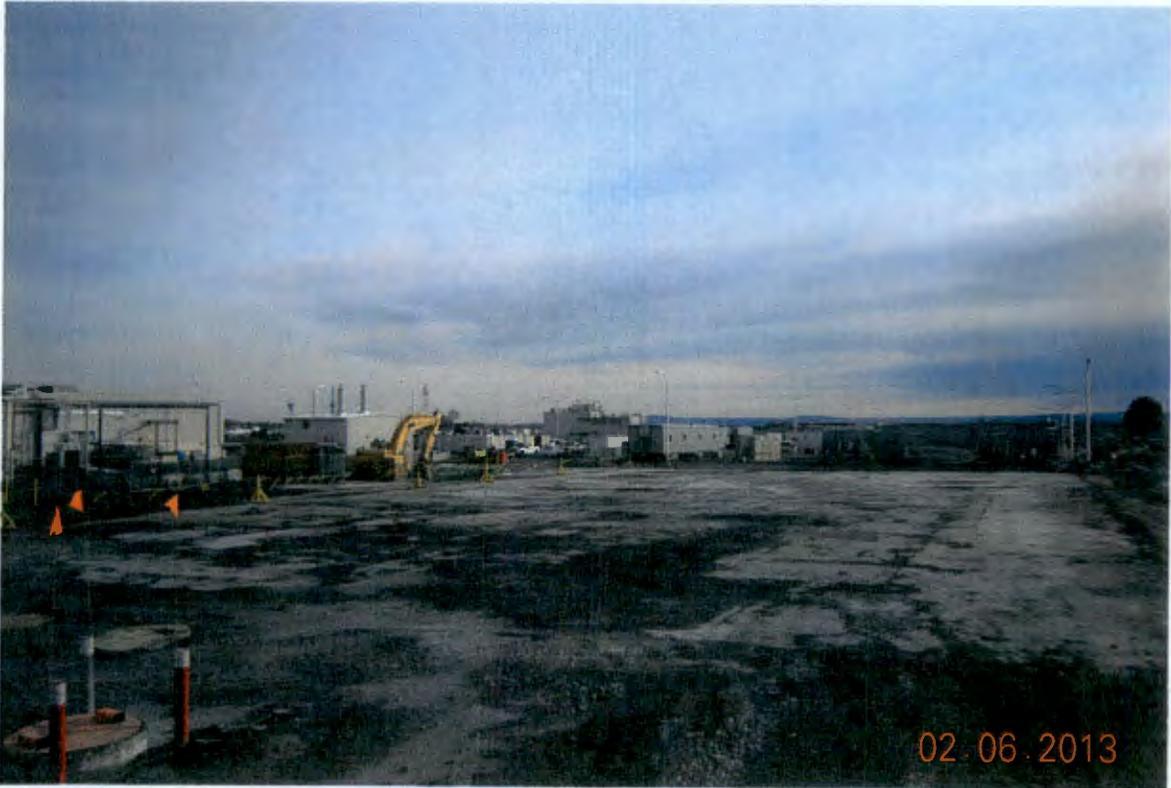
**Photograph 4: 329 slab following final grading and down-posting,
looking southeast on February 6, 2013.**

The 329 at-grade slab and grout-filled basement and pits remain. IH and radiological down-posting of the area is complete. A final GPERS survey of the slab was performed, no postings remain.

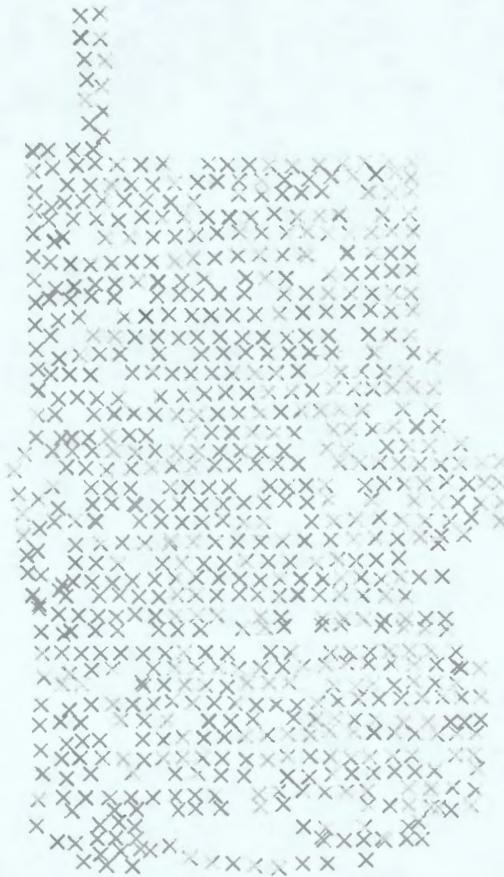
300 D4 329 Slab Area GPERS Radiological Survey Beta Track Map

Bkg Location ↗
190 meters NE
353 cpm

Coverage File: D4_028,A
Number of Data Pnts: 777
Type of Survey: beta
Max GCPM: 854
Avg Bkg CPM: 353
Survey Date: 1/28/2013
Area Surveyed: 3,060 m²
Project File: ESRFRM130013B
Pdf File: ESRFRM130013BC

No anomalies were observed during the demolition of the 329 Building. GPERS surveys of the remaining slab surface identified no contamination.
