## FACILITY STATUS CHANGE FORM

<b>Date Submitted:</b> Jul 11, 2012	<b>Area:</b> 300 Area	<b>Control #:</b> D4-300-063
<b>Originator:</b> John Harrie	<b>Facility ID:</b> 3719	
<b>Phone:</b> 509.308.9935	<b>Action Memorandum:</b> Action Memorandum #1

## Attachment 1: Facility Information

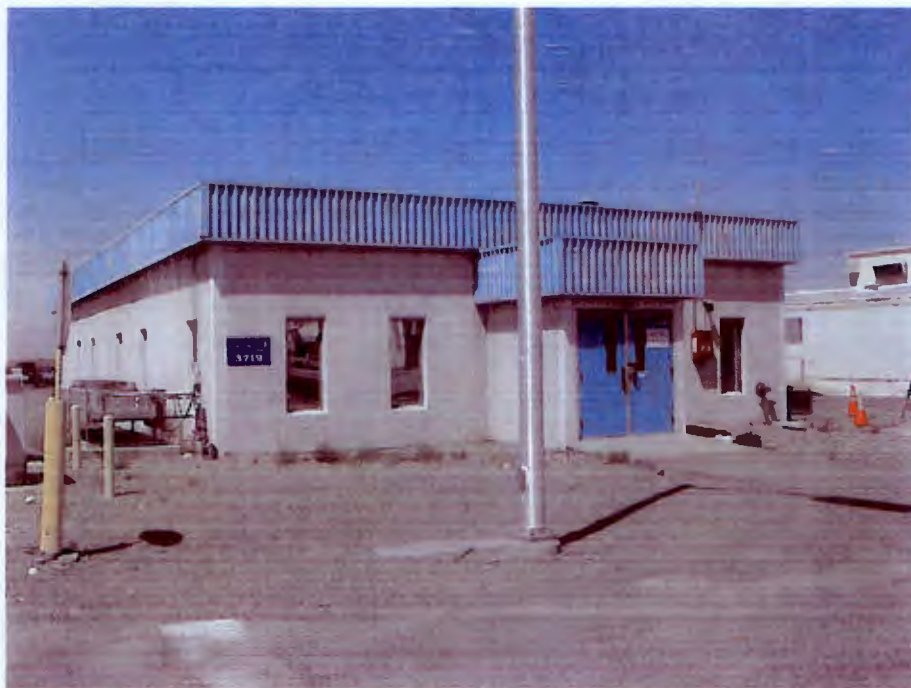
**Figure 1: Looking north at the 3719 Building in July of 2004.**

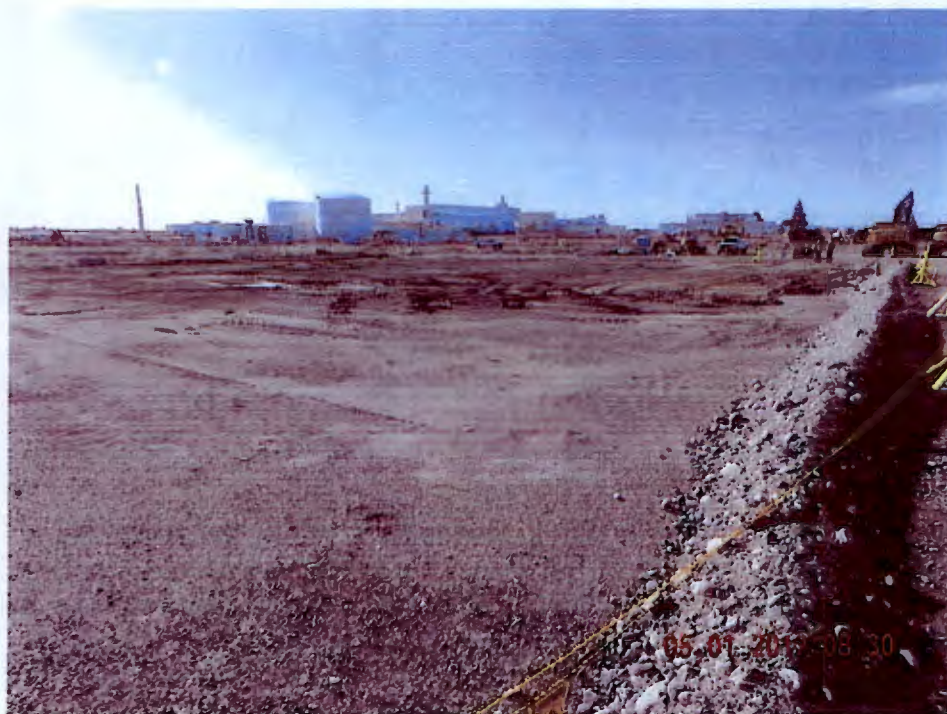
**Figure 2. Looking southeast at 3719 following slab removal on May 1, 2012.**

**Demolition:** Above-grade demolition of the 3719 facility was completed in June of 2007. Below-grade demolition of the 3719 foundation slab was completed in April of 2012. Approximately 2-feet of soil was removed during slab demolition and the excavation backfilled with clean fill. The building debris were removed and disposed of at ERDF. The demolition was performed with Radiological and Industrial Hygiene controls.

No anomalies were observed during the demolition of the 3719 Building. Soil beneath the slab displayed no visual evidence of staining or discoloration.

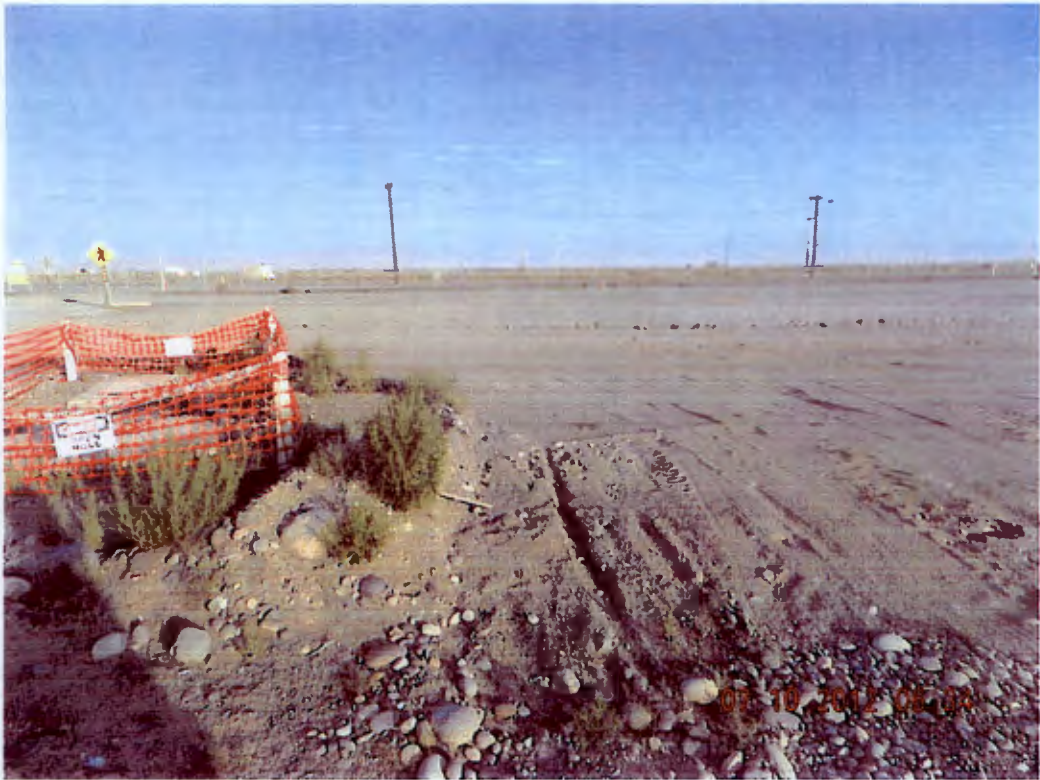
**Figure 4. Looking west at 3719 following backfill in July of 2012.**

The building debris and slab foundation was removed and disposed of at EDRF. A GPERS survey is included as Attachment 3. Excavation was backfilled to grade with clean fill.

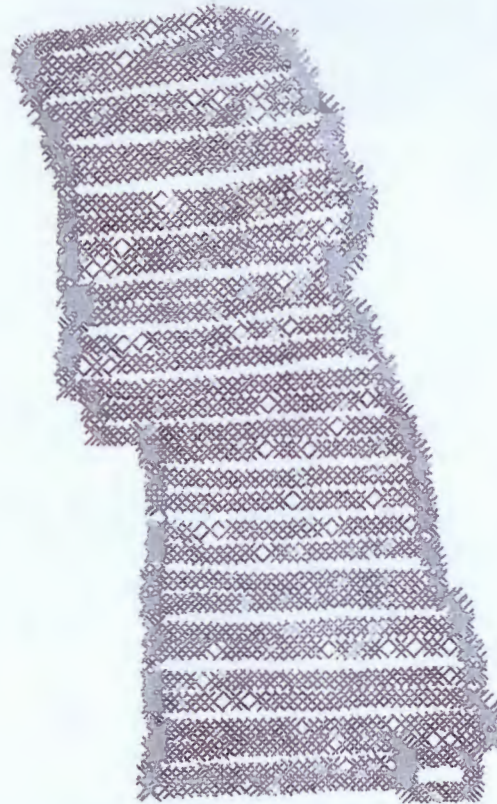
**300 D4**  
**3705, 3705BA, 3719**  
**GPERS Radiological Survey**  
**Gamma Track Map**

↗  
Bkg Location  
394 meters NE  
1217 cpm

Coverage File: D4\_93  
Number of Data Pnts: 1733  
Type of Survey: gamma  
Max GCPM: 1747  
Avg Bkg CPM: 1217  
Survey Date: 4/2/2012  
Area Surveyed: 2411 m<sup>2</sup>  
Project File: ESRFRM120043  
Pdf File: ESRFRM120043C
