18-AMRP-0068  
REISSUE

**REISSUE - REQUEST FOR WAIVER OF SECURITY ADDENDA REQUIREMENTS FOR THE 216-A-29 DITCH, 216-A-36B CRIB, 216-A-37-1 CRIB, 216-B-3 MAIN POND, 216-B-63 TRENCH AND 216-S-10 POND AND DITCH**

## Information and Justification of the Security Waiver for 216-A-29 Ditch in the 200 East Area

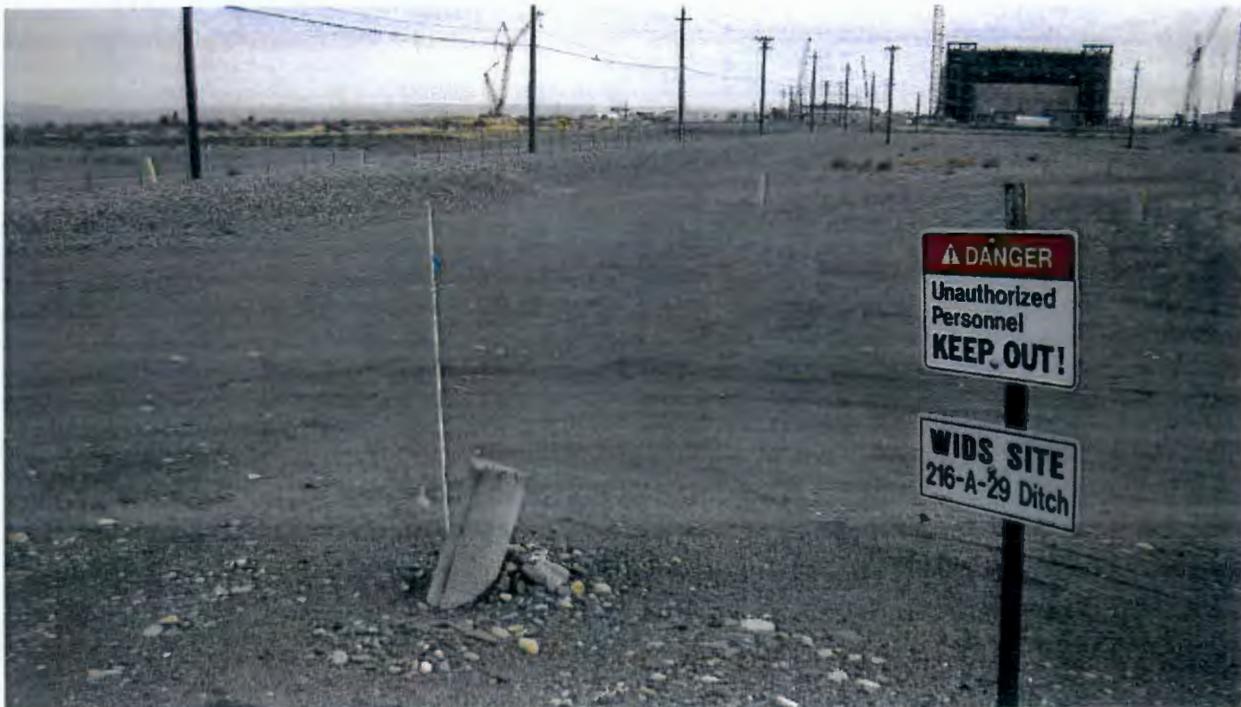
November 2017. Head end of the 216-A-29 Ditch. Photo was taken facing east.

The ditch was backfilled and the surface stabilized in 1991. Part of the area has been revegetated. Therefore, physical contact and disturbance of the waste is not possible for persons or livestock which may enter the ditch area. The Dangerous Waste Management Unit (DWMU) does not contain structures or equipment above ground.

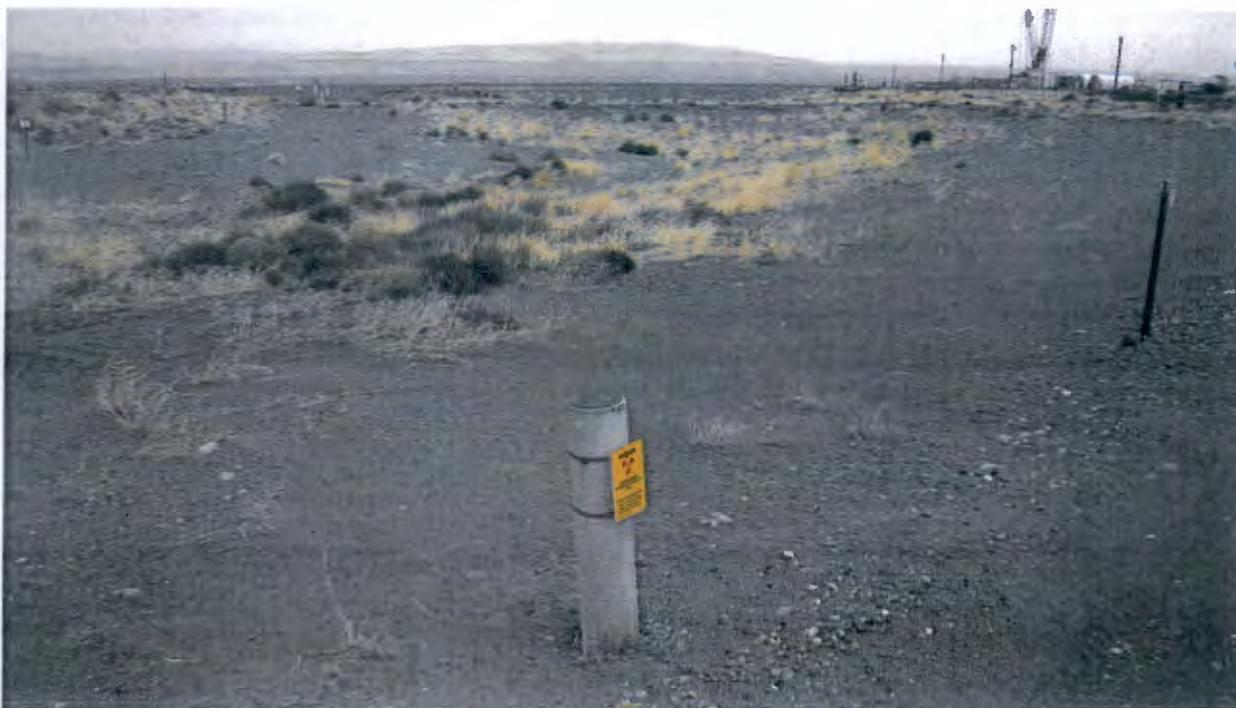
November 2017. Upper part of 216-A-29 Ditch, east of 4<sup>th</sup> Street and south of WTP Loop Road.

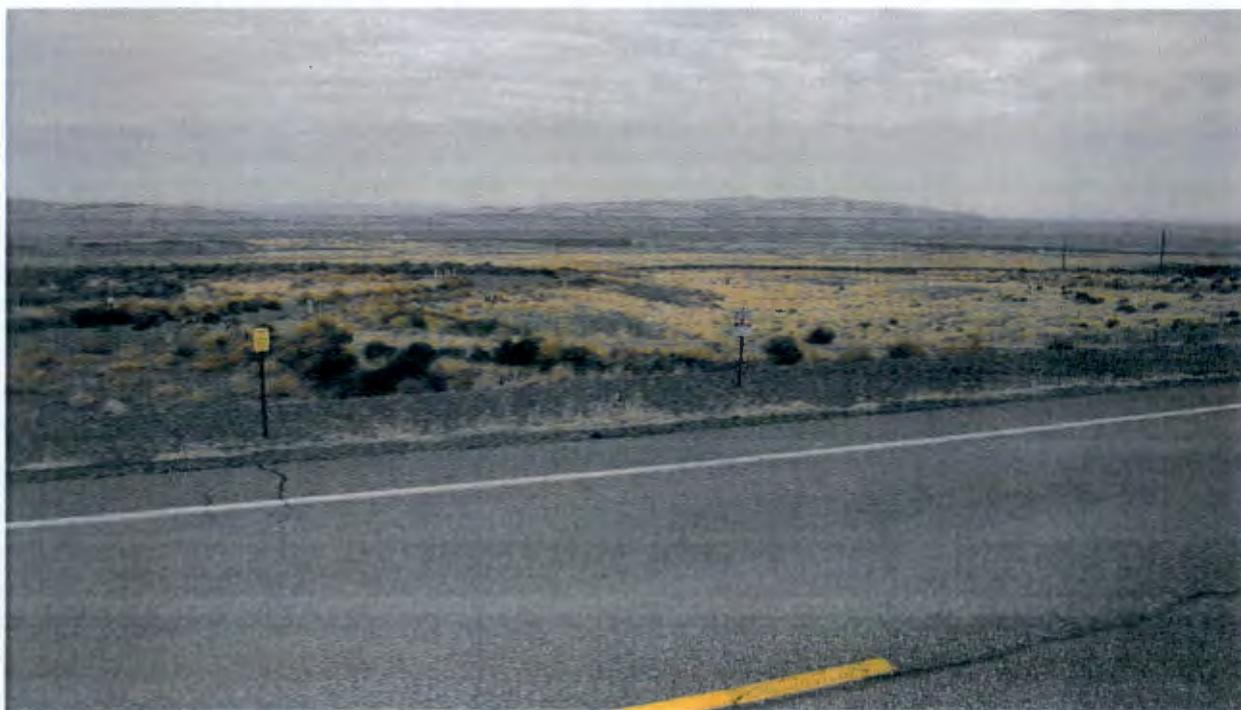
November 2017. Lower part of 216-A-29 Ditch. Photo taken from WTP Loop Road that crosses the 216-A-29 Ditch. Photo was taken facing north.

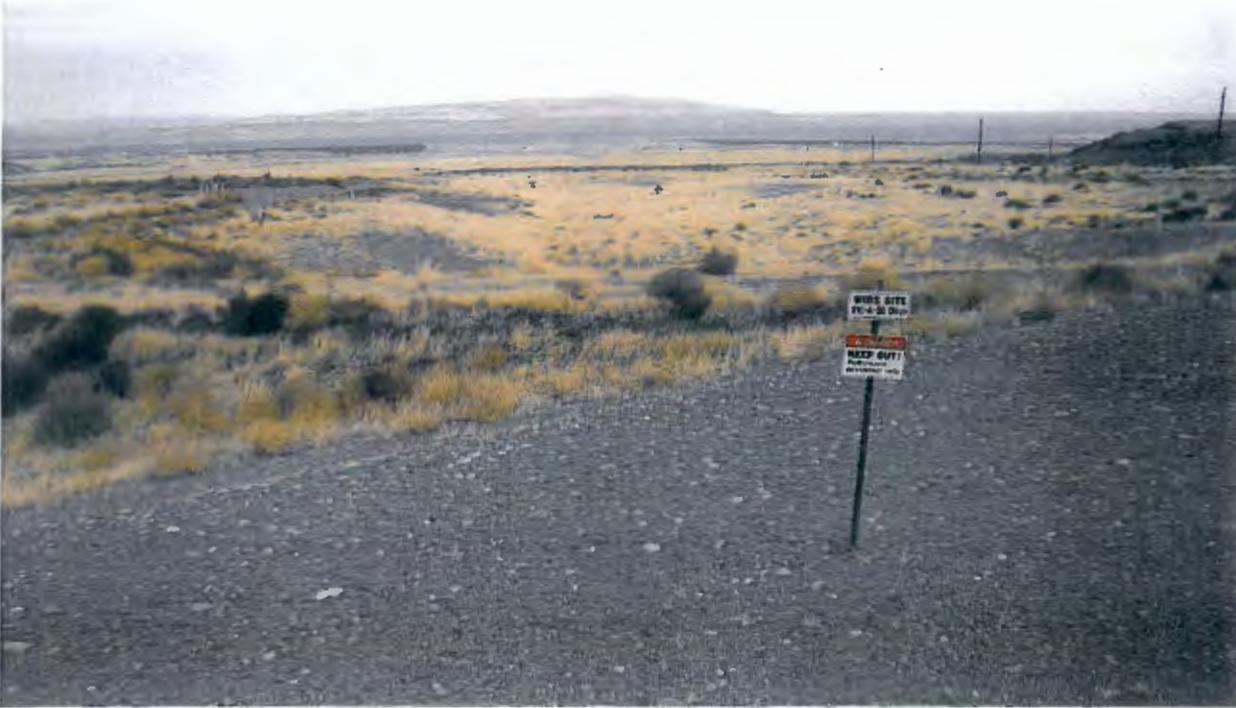
November 2017. Lower part of 216-A-29 Ditch. Photo taken from WTP Loop Road that crosses the 216-A-29 Ditch. Photo was taken facing north.

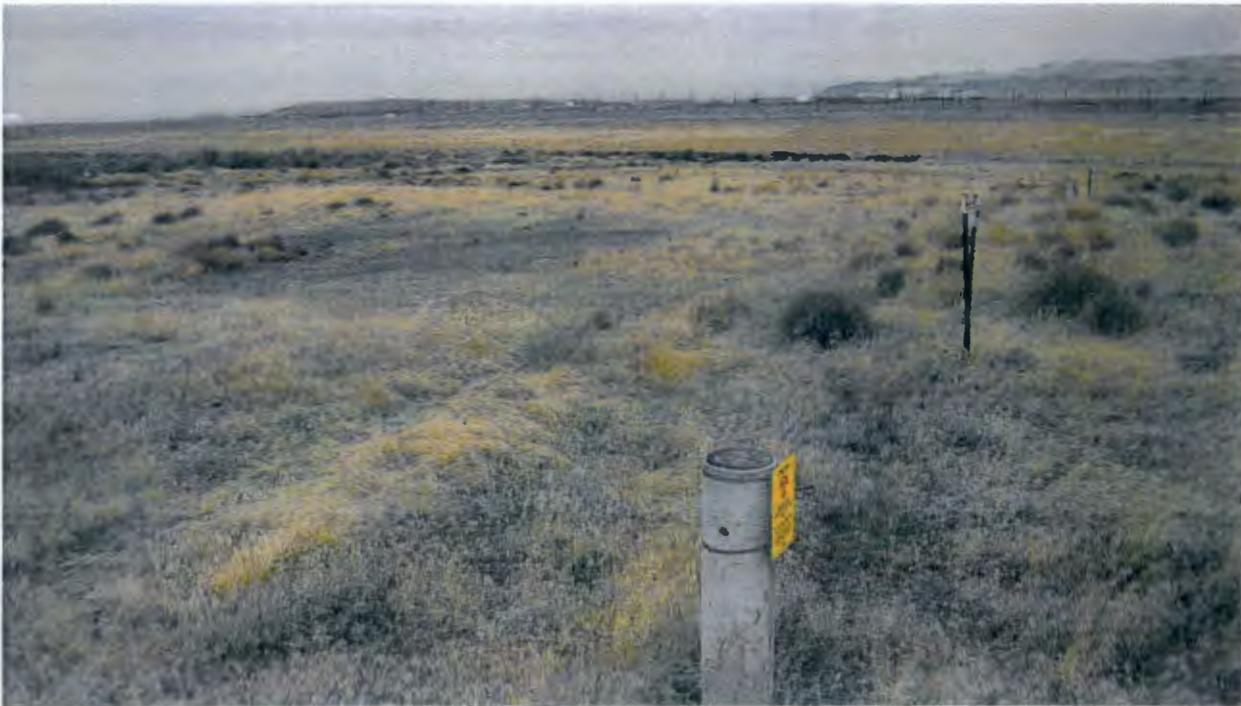
November 2017. Lower part of 216-A-29 Ditch where the 216-A-29 Ditch meets the 216-B-3-3 Ditch. Photo was taken facing north.

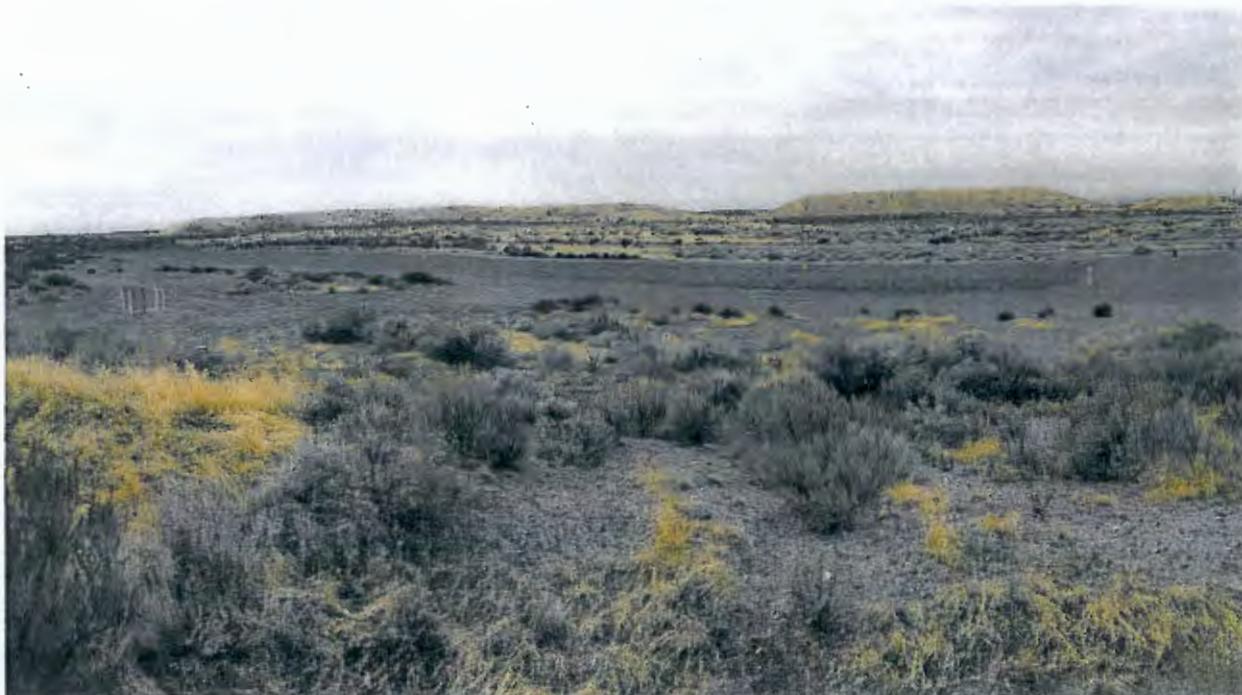
November 2017. Photo of the 216-A-36B Crib. Photo was taken facing southwest.

The waste percolation area in the crib was located between 22 and 24 feet underground. The Crib has been backfilled and surface stabilized with gravel. Therefore, physical contact with the waste is not possible for unknowing or unauthorized persons or livestock which may enter the crib area. The crib does not contain structures or equipment above ground.

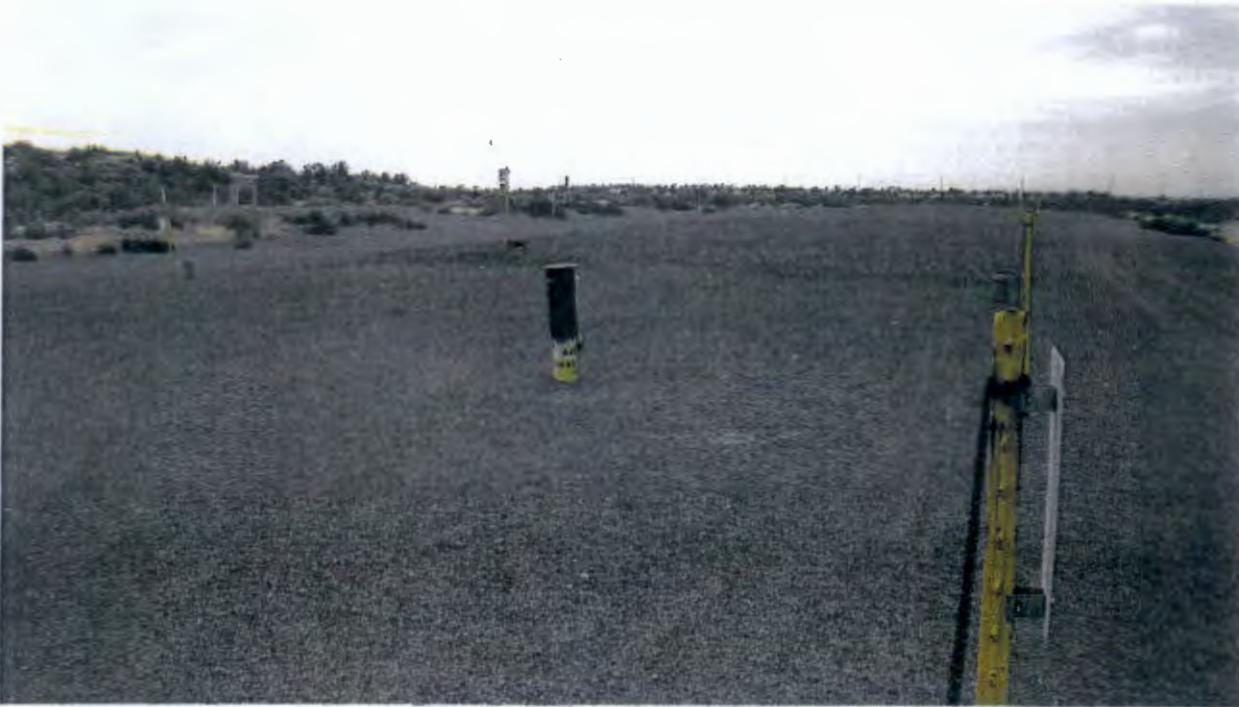
November 2017. Head end of the 216-A-36B Crib. The crib area starts at the sign beyond groundwater monitoring well 299-E17-9.

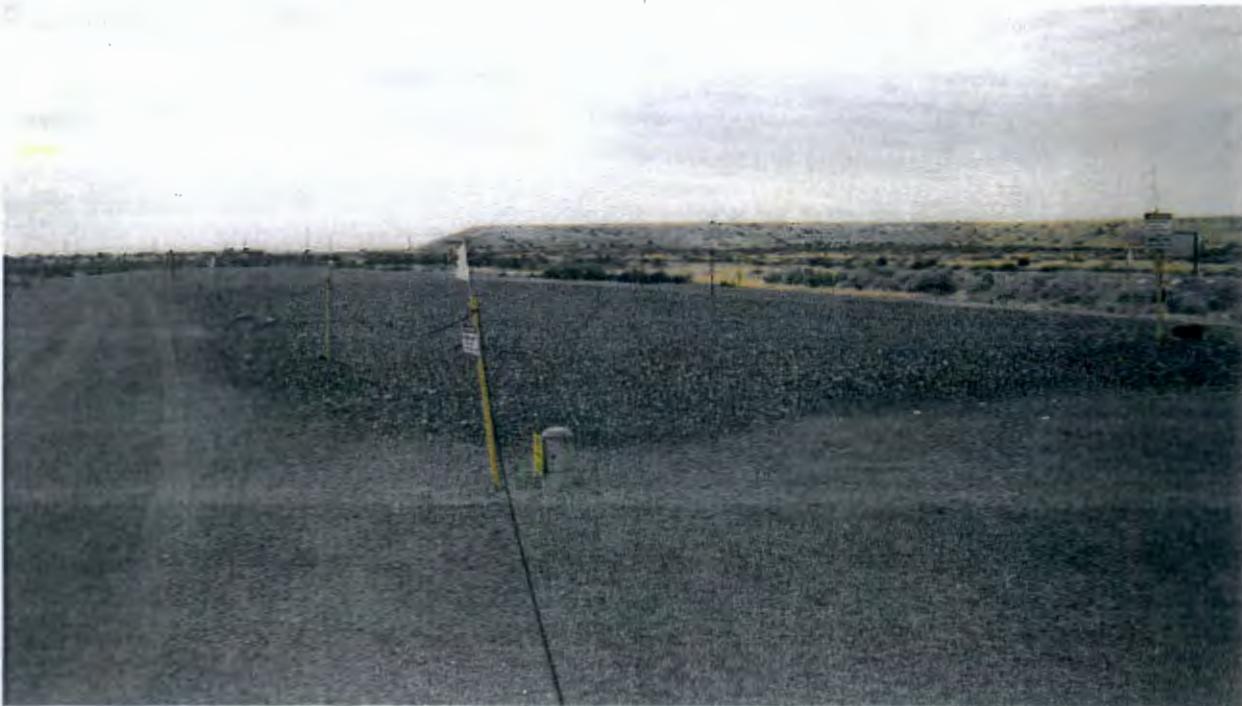
November 2017. Head end of the 216-A-36B Crib. The crib area starts at the sign at the right side of the photo.

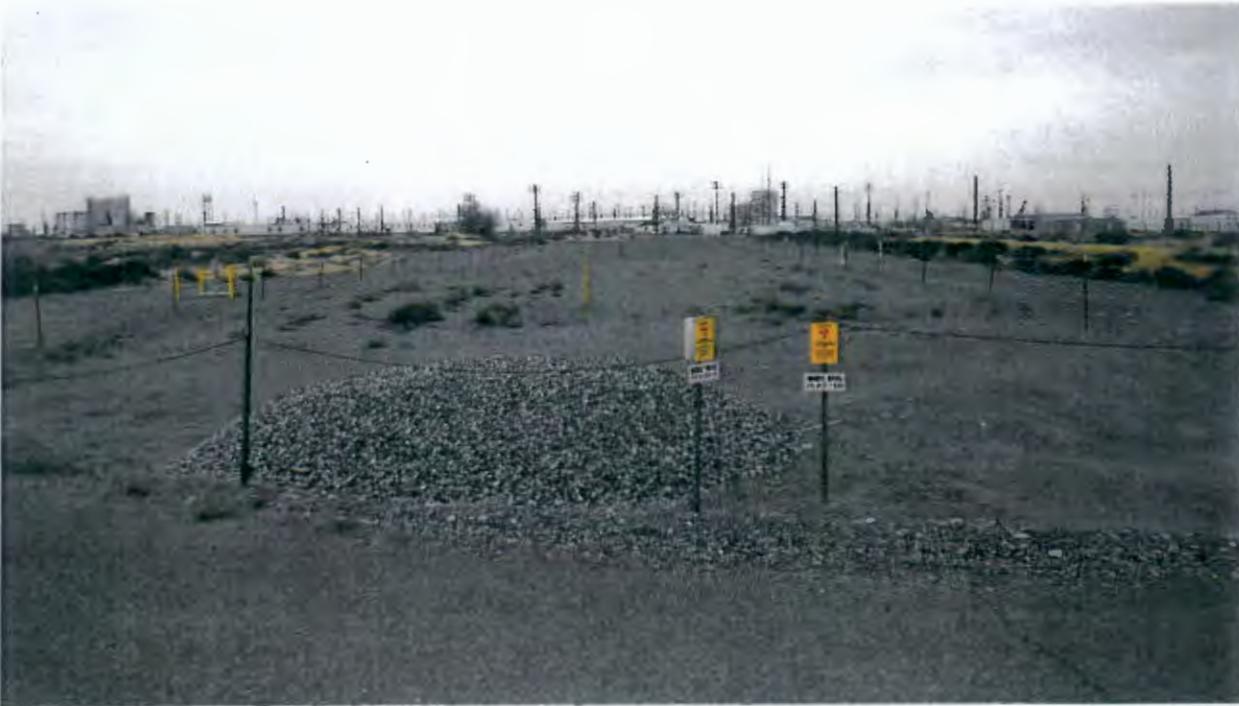
November 2017. Southeastern end of the 216-A-37-1 Crib.

The waste percolation area in the crib was located between 7 and 11 feet underground. Therefore, physical contact with the waste is not possible for unknowing or unauthorized persons or livestock which may enter the crib area.

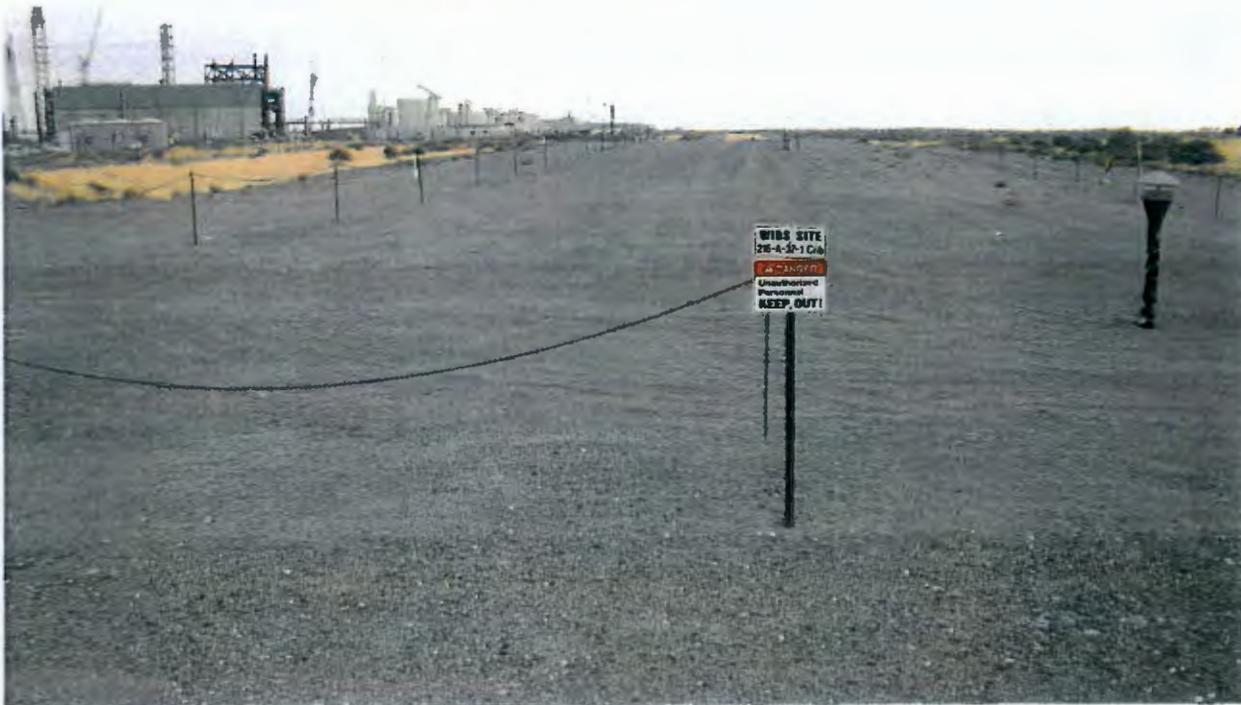
November 2017. Northwestern end of the 216-A-37-1 Crib. The surface feature seen on the right side of the photograph is a vent riser which was sealed in 2000 as a preventative measure for potential passive radioactive emissions.

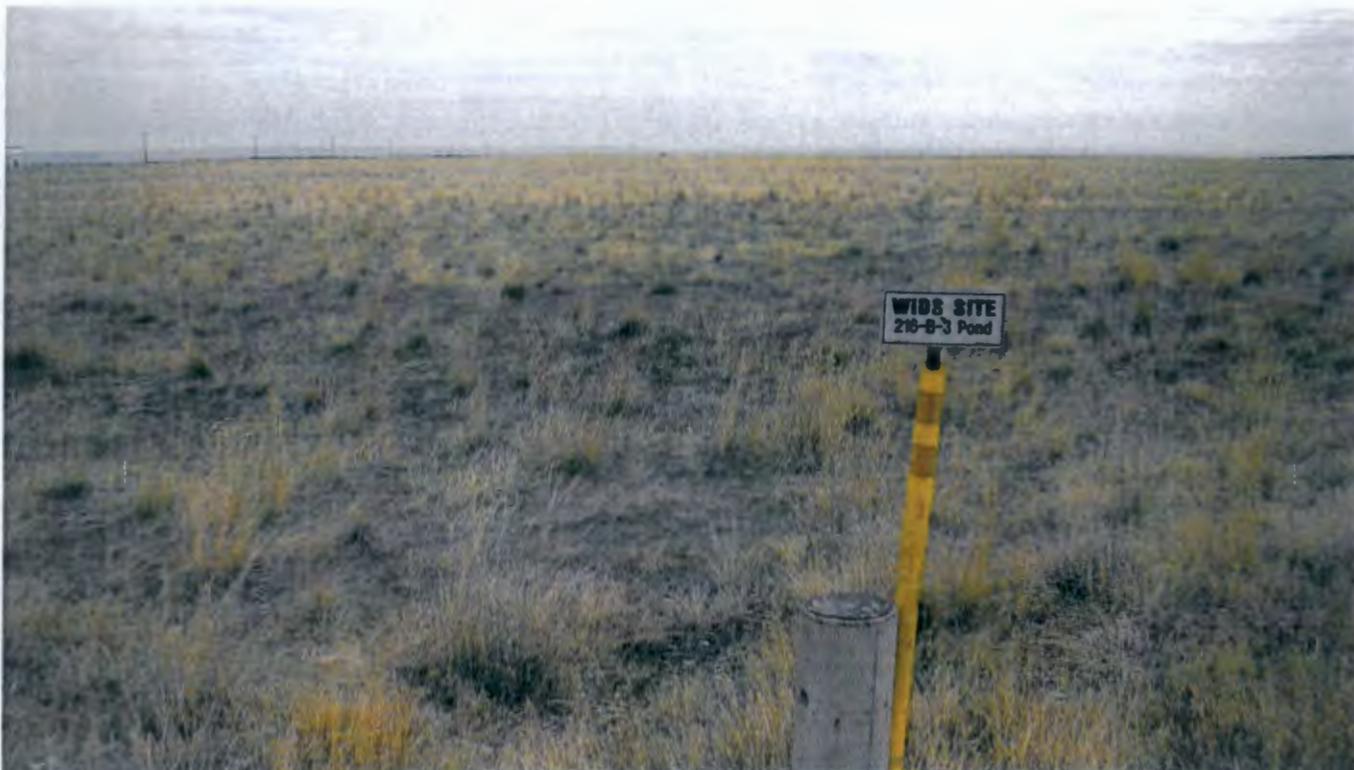
November 2017. West part of the 216-B-3 Main Pond. Photo was taken facing east.

The 216-B-3 Main Pond and the 216-B-3-3 Ditch were decommissioned, backfilled with 3 to 7 feet of fill and interim stabilized in 1994. The area has been re-vegetated. Therefore, physical contact with the waste is not possible for unknowing or unauthorized persons or livestock which may enter the pond and ditch areas. The pond and ditch have no structures nor equipment above ground.

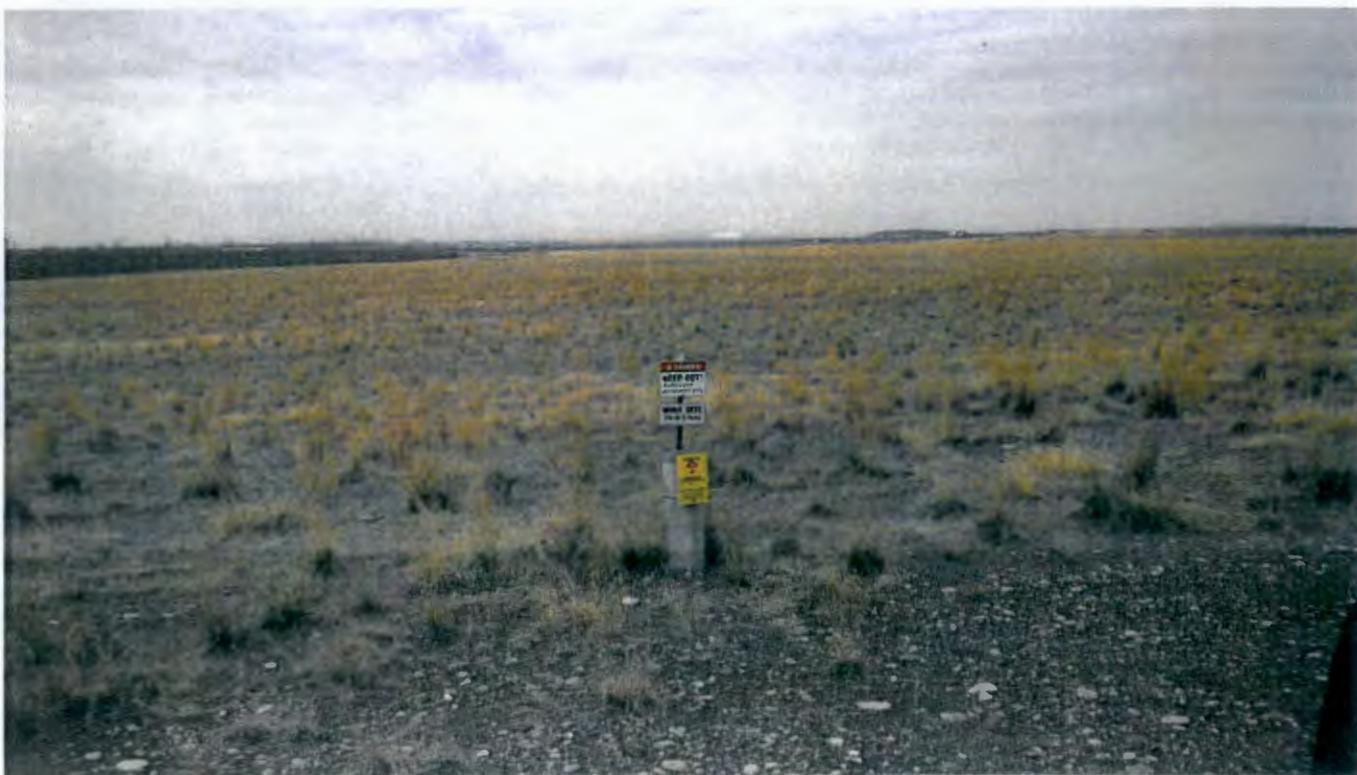
November 2017. East part of the 216-B-3 Main Pond. Photo was taken facing west.

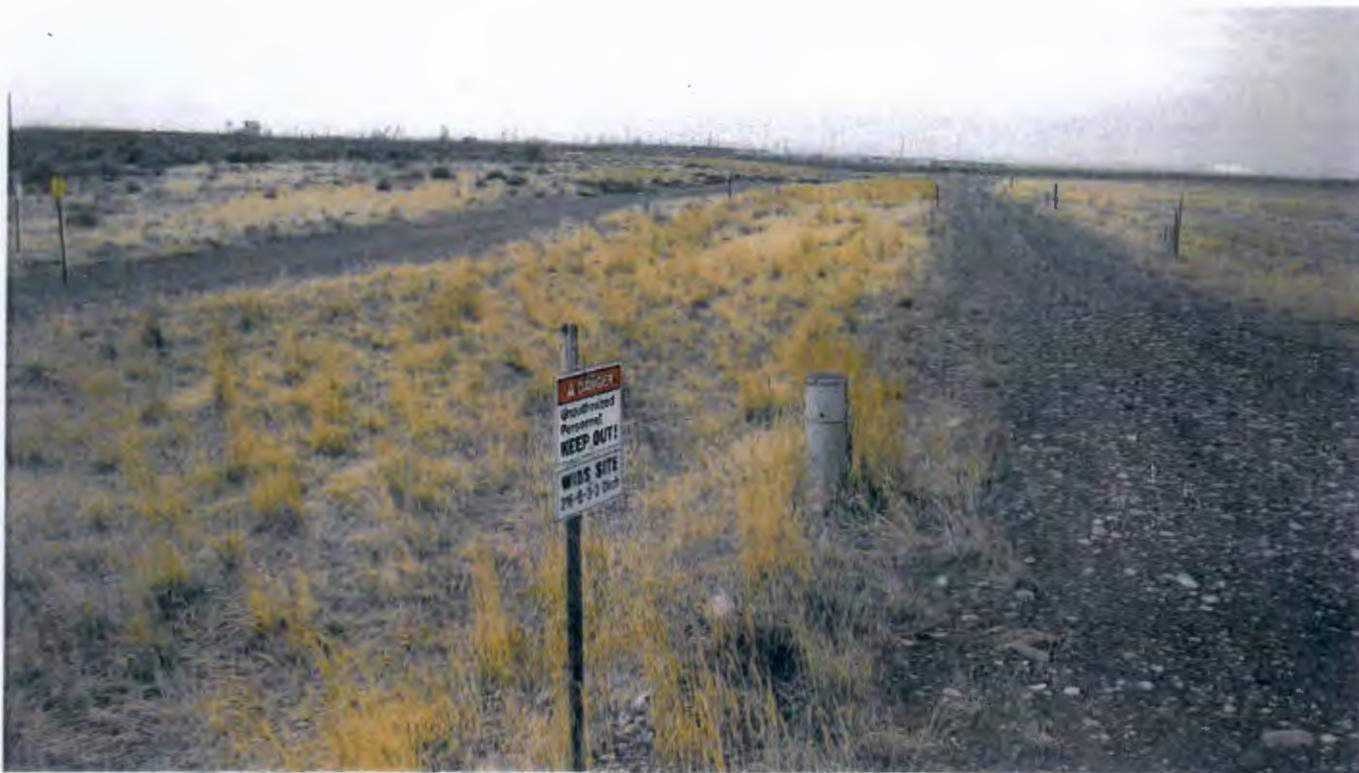
November 2017. 216-B-3-3 Ditch was located between the roads. Photo was taken facing west.

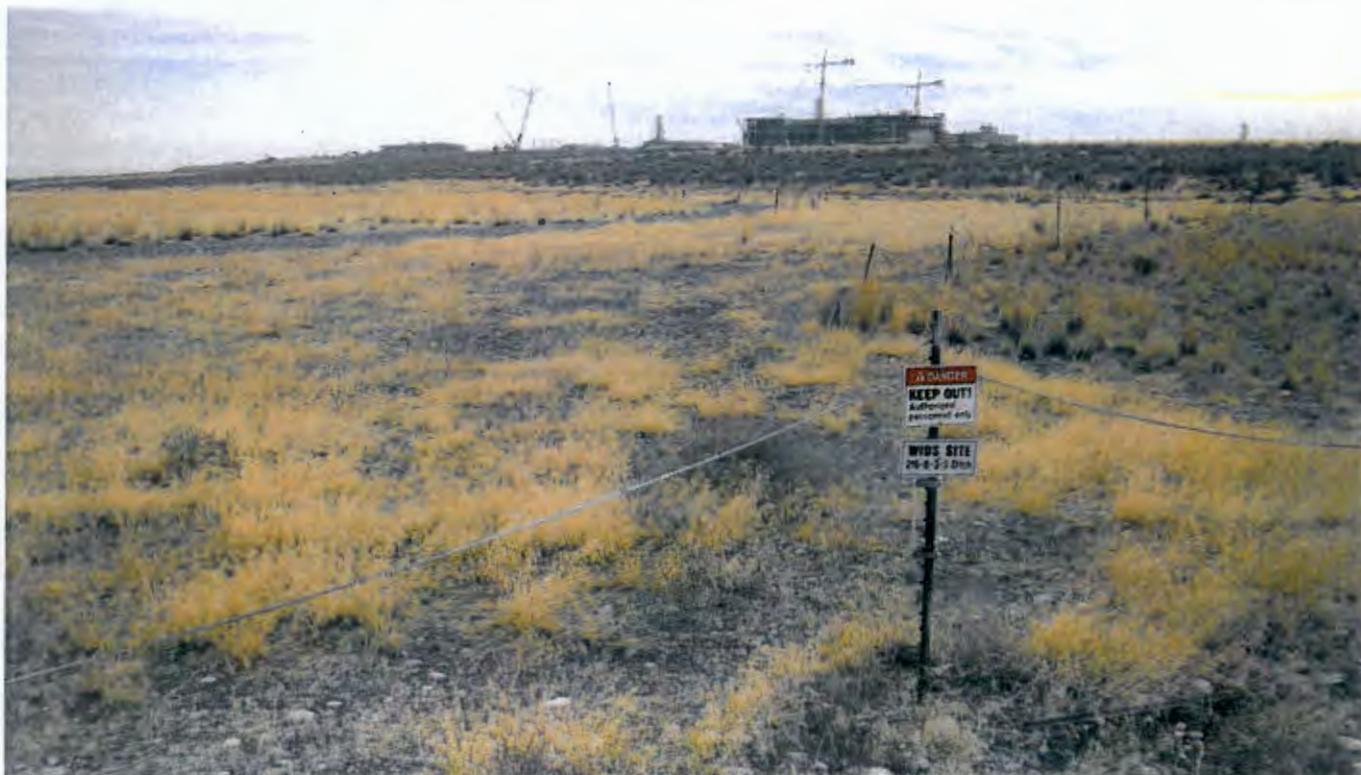
November 2017. West end of 216-B-3-3 Ditch. Photo was taken facing southeast.

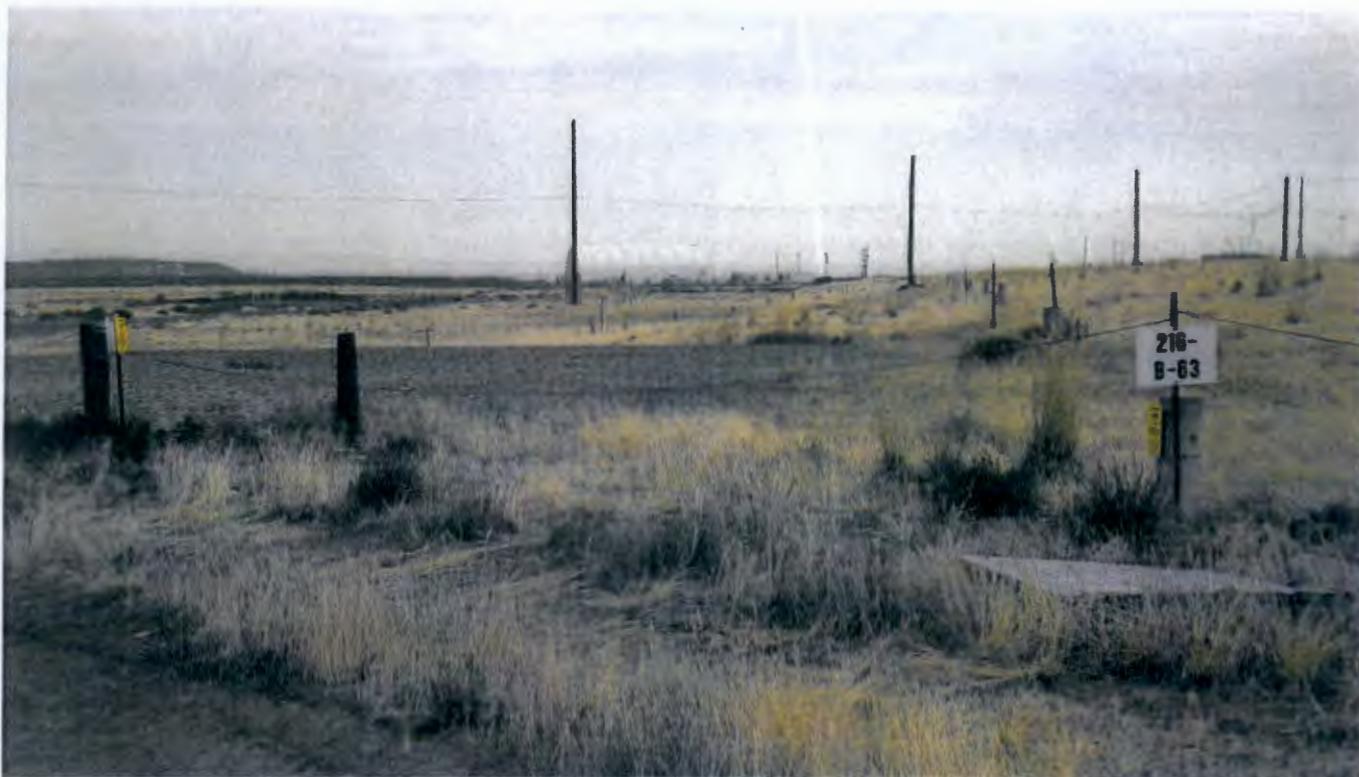
November 2017. Head end of the 216-B-63 Trench with weir box. Photo was taken facing east.

The trench was backfilled with clean soil in November 1994. The weir box at the end of the pipeline was filled with cement in December 1994. The area has been re-vegetated. Therefore, physical contact with the waste is not possible for unknowing or unauthorized persons or livestock which may enter the trench area.

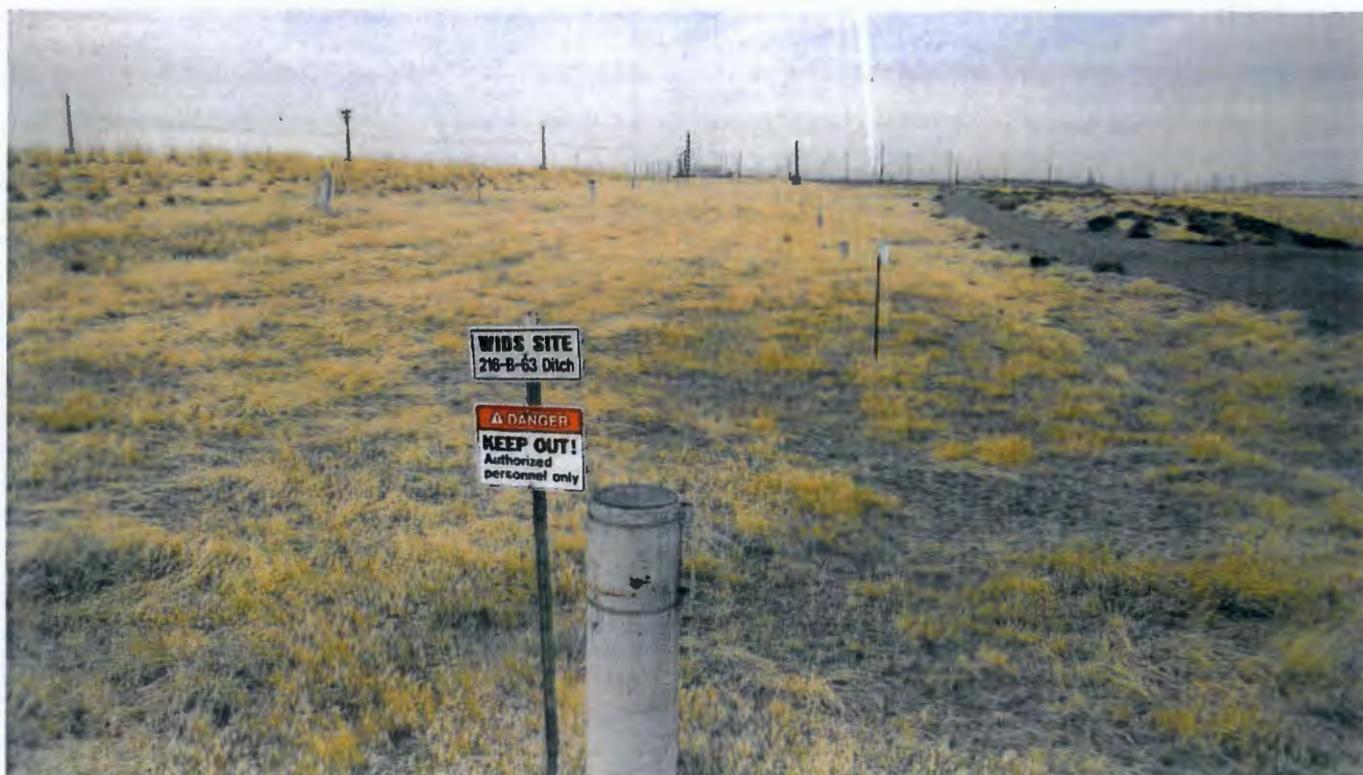
November 2017. East end of the 216-B-63 Trench. Photo was taken facing west.

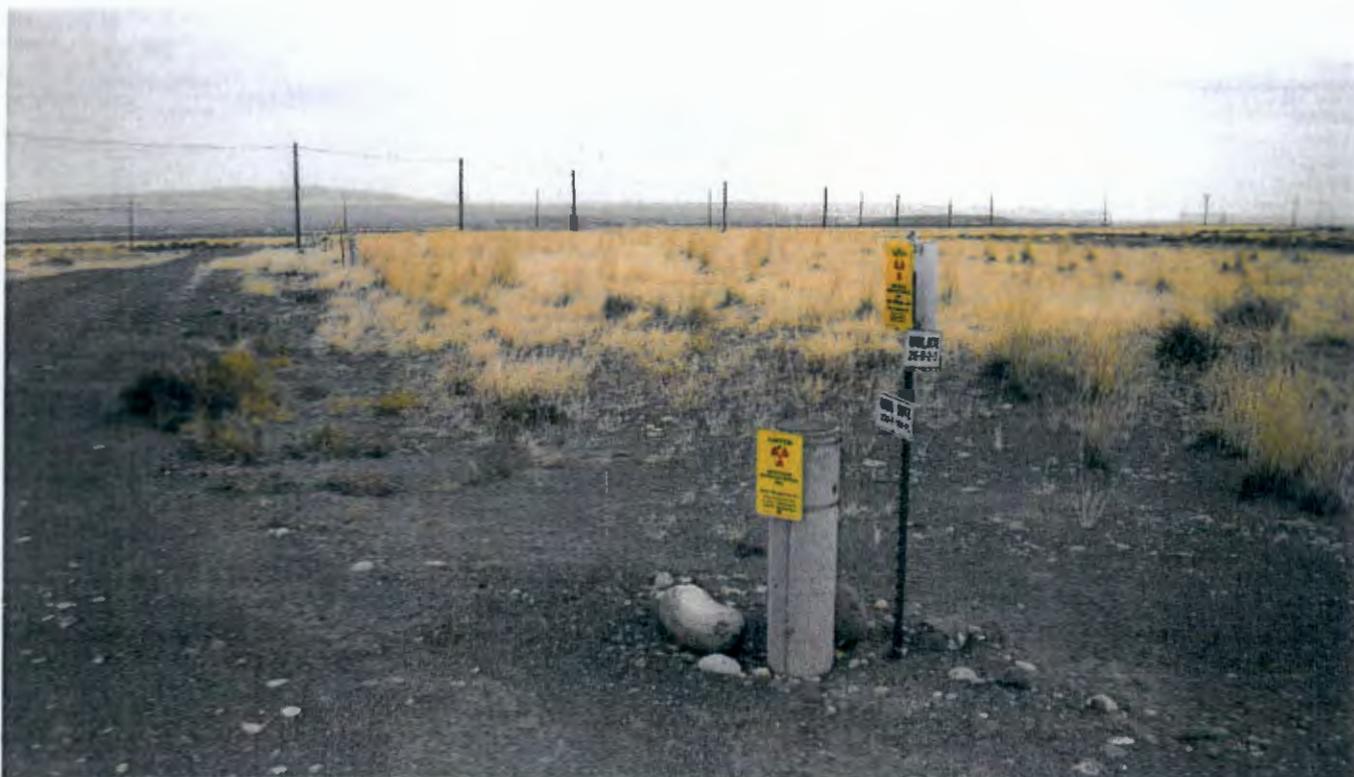
November 2017. 200-E-191-PL pipeline is located under the row of posts along the road. Photo was taken facing northeast.

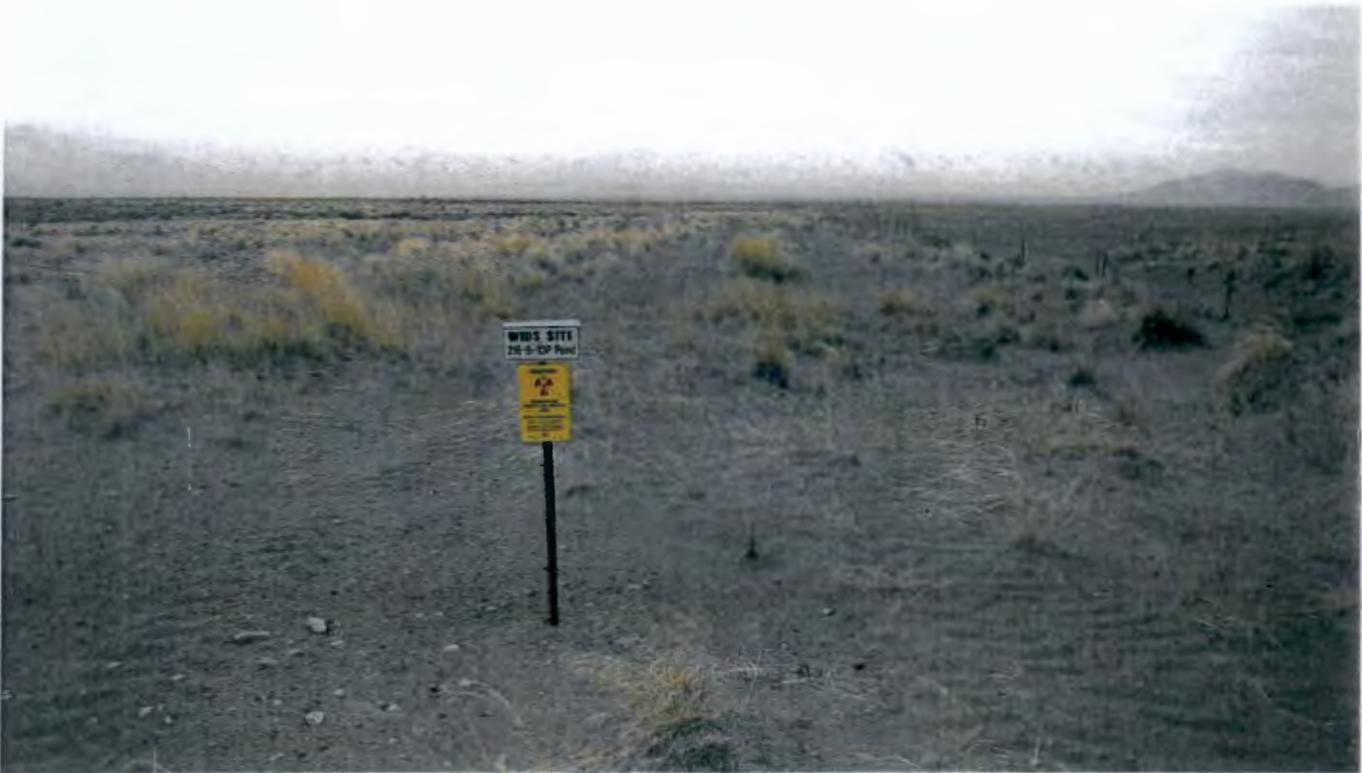
November 2017. Northeast end of the 216-S-10 Pond. Photo was taken facing southwest.

The pond and the southwestern part of the ditch was backfilled and stabilized in 1984. These areas have been re-vegetated. The remaining portion of the ditch remained active and received the last wastewater discharge in October 1991. The manhole at the outfall of the supply pipeline was filled with concrete in 1994. Therefore, physical contact with the waste is not possible for unknowing or unauthorized persons or livestock which may enter the pond and ditch area. The grouted manhole is the only physical structure.

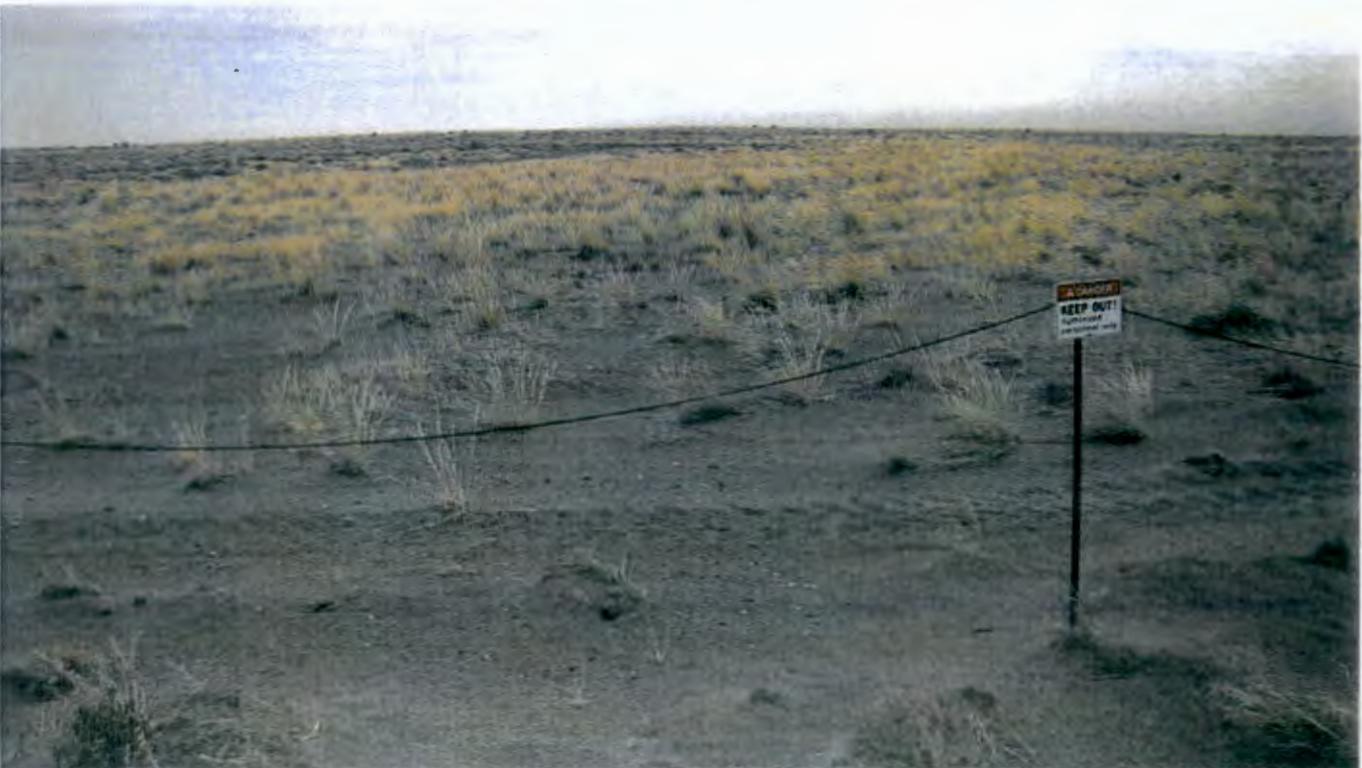
November 2017. The finger area part of the 216-S-10 Pond. Photo was taken facing south.

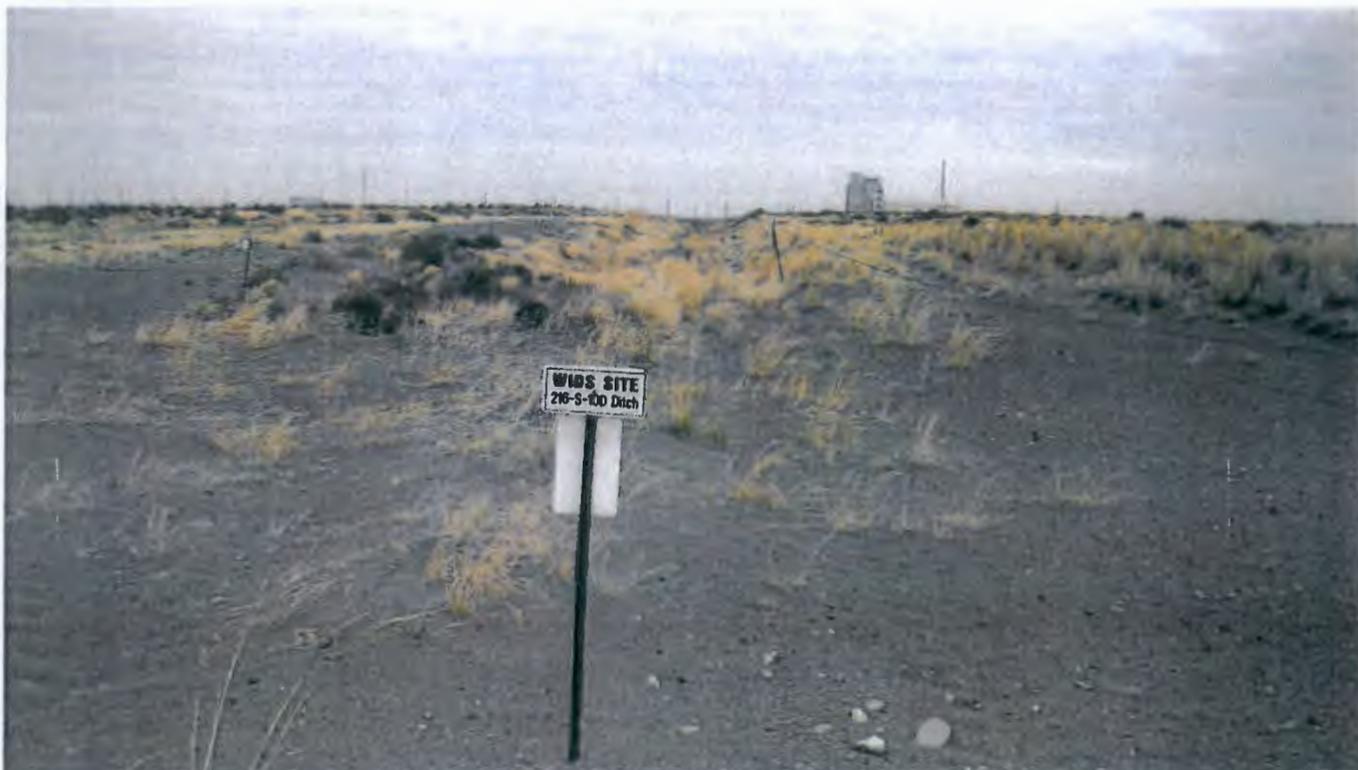
November 2017. Southwestern end of 216-S-10 Ditch at the 216-S-10 Pond. Photo was taken facing northeast.

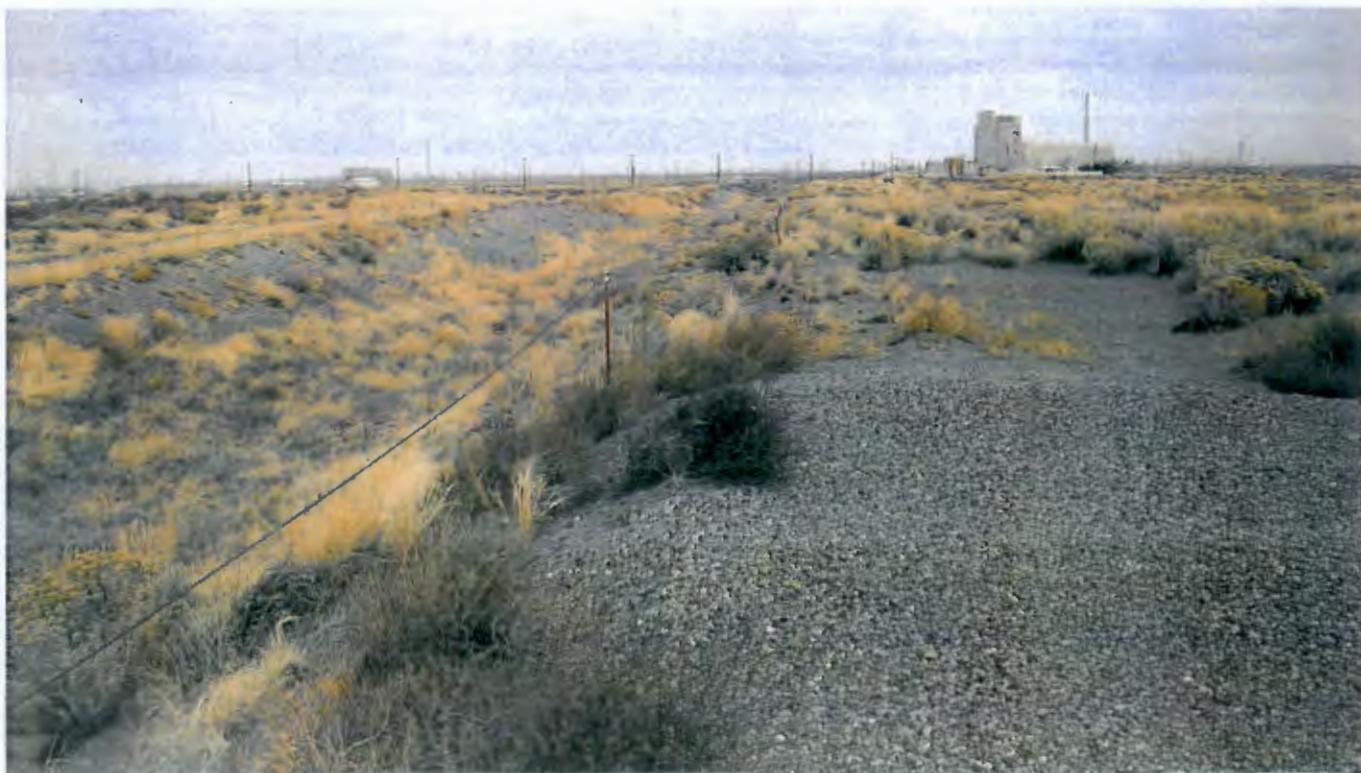
November 2017. 216-S-10 Ditch. Photo was taken facing north.
