ENGINEERING EVALUATION/COST ANALYSIS FOR THE 200-MG-1 OPERABLE UNIT
WASTE SITES, DOE/RL-2008-44, DRAFT A

Engineering Evaluation/Cost Analysis for the 200-MG-1 Operable Unit Waste Sites

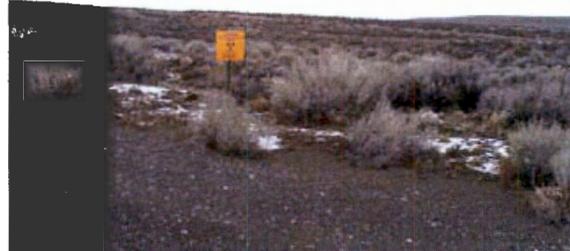
200-E-139

**Site Name:** 200-E-139, Contamination Area North of C Farm**Site Type:** Unplanned Release**Current OU:** 200-MG-1**Facility:** WTP/A Farm Area**Former OU:** 200-UR-1**Waste Site Description:**

A large posted URM area is located on the north side of 8th St. It contains growing vegetation (rabbit brush and tumbleweeds). A small posted URM area is located on the south side of 8th St. The area on the south side of 8th St has been covered with a biobarrier and gravel. The two areas have been radiologically posted for many years. The areas were surveyed with Global Positioning equipment and mapped in 12/97. No radiological survey can be found to provide any radiological condition information. As of 2/2002, it is not known which Hanford organization erected the posts and chain or when the areas were posted.
