# River Corridor Closure Contract

## 100 Area D4 Project Building Completion Report

January 1, 2014, to  
September 30, 2014

WCH-603  
Rev. 0

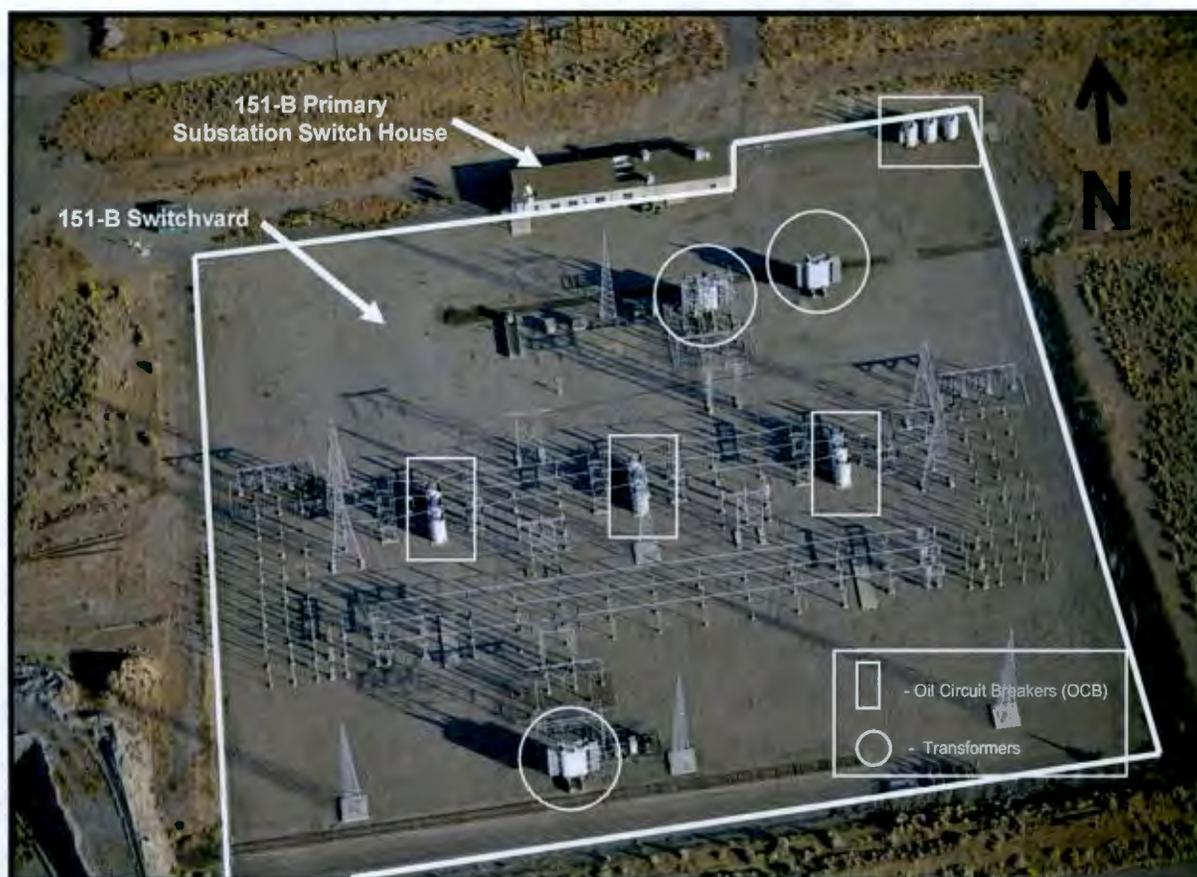
Figure 1. 151-B-A2 Electrical Substation Switchyard.

The 151-B-A2 Electrical Substation Switchyard (151-B Switchyard) was located in the 100-B/C Area, approximately 1,000 ft southwest of the 105-B Reactor at Washington State plane coordinates N144238, E5650618. Energized in June 1944, the 151-B Switchyard received 230-kV power from the Midway Substation and served as the primary source of electrical power for all facilities in the 100-B/C Area (Figure 1). The 151-B Switchyard transmitted power from 3 main transformers to 13 secondary substations and 9 distribution substations located throughout the 100-B/C Area via underground cables. One 27.5-kV transformer, located adjacent to the 151-B Substation Switch House, provided service for the building. Five oil circuit breakers (OCBs) were also in service to support the switchyard operations.

The 151-B Switchyard originally included a fenced, gravel-surfaced area with wooden-framed bus structures, two main 15,000-kV transformers, three OCBs, and terminal structures. Served by a rail spur, the 151-B Switchyard contained several underground ducts that connected the 151-B Switchyard to the 151-B Substation Switch House. The 151-B Switchyard equipment rested on two types of foundations (i.e., reinforced concrete slabs and reinforced concrete piers with spread footings).

In 1952, the 151-B Switchyard was expanded to support the new facilities associated with the 105-C Reactor Building. The expansion included the installation of a new 18,750-kV transformer, OCBs, disconnect switches, bus, and conductor. Below-grade oil transfer lines were installed within the 151-B Switchyard to fill the OCBs. Oil containing polychlorinated biphenyls (PCBs) was transferred from a rail tanker through above-ground and underground piping to the transformers and OCBs in the 151-B Switchyard.

Final D4 documentation is contained in CCN 175434, "Post-Demolition Summary Report for 151-B-A2 Electrical Substation Switchyard."

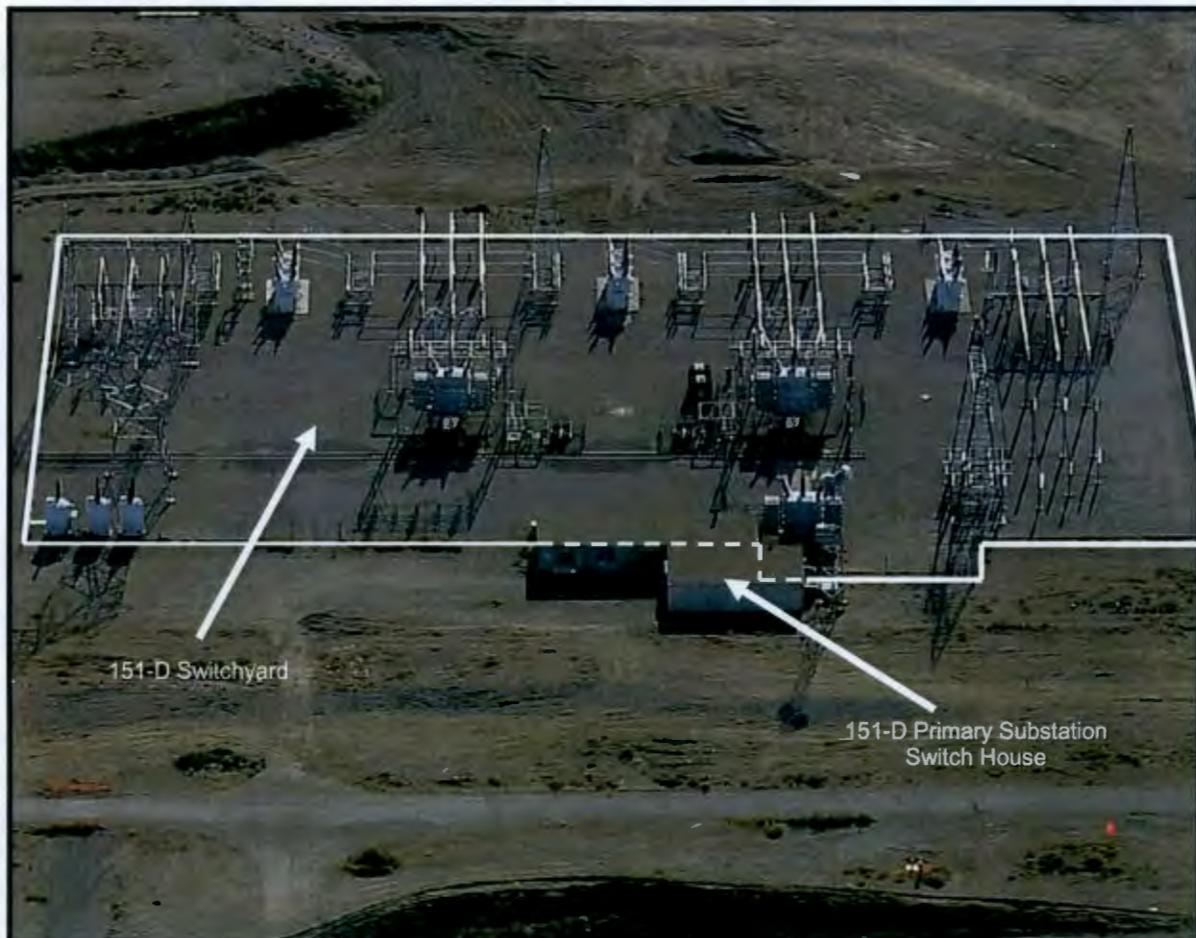
**Figure 2. 151-D-A4 Electrical Substation Switchyard.**

The 151-D-A4 Electrical Substation Switchyard (151-D Switchyard) was used as the primary source of electrical power for all facilities in the 100-D Area. It was first energized in August 1944 and received 230 kV of power from the Midway Substation. From the three main transformers in the 151-D Switchyard, power was transmitted primarily via underground cables to 13 secondary substations and 9 distribution substations located throughout the 100-D Area. One 27.5-kV transformer, located adjacent to the 151-D Substation Switch House, provided service for the building. Three OCBs were also in service to support the 151-D Switchyard operations.

The 151-D Switchyard included a fenced, gravel-surfaced area originally 430 by 303 ft and contained wooden-framed bus structures, two main 15,000-kV transformers, three OCBs, and terminal structures. The area was served by rail spur and contained several underground ducts

that connected the 151-D Switchyard to the 151-D Substation Switch House. Two types of foundations were used for 151-D Switchyard equipment (i.e., reinforced concrete slabs and reinforced concrete piers with spread footings).

The 151-D Switchyard was modified in 1949 to support the new 105-DR Reactor Building, including the addition of two 13.8-kV refrigeration feeders. A 13.8-kV crosstie line was installed between the 100-D and 100-H Areas. In 1956, the 151-D facility was expanded to meet the power requirements for the increased production under the project CG-558. A new 230-kV/13.8-kV transformer was installed in the 151-D Switchyard with a capacity of 18,750/31,250 kV (Figure 2).

Final D4 documentation is contained in CCN 174858, "Post-Demolition Summary Report for 151-D-A4 Electrical Substation Switchyard."

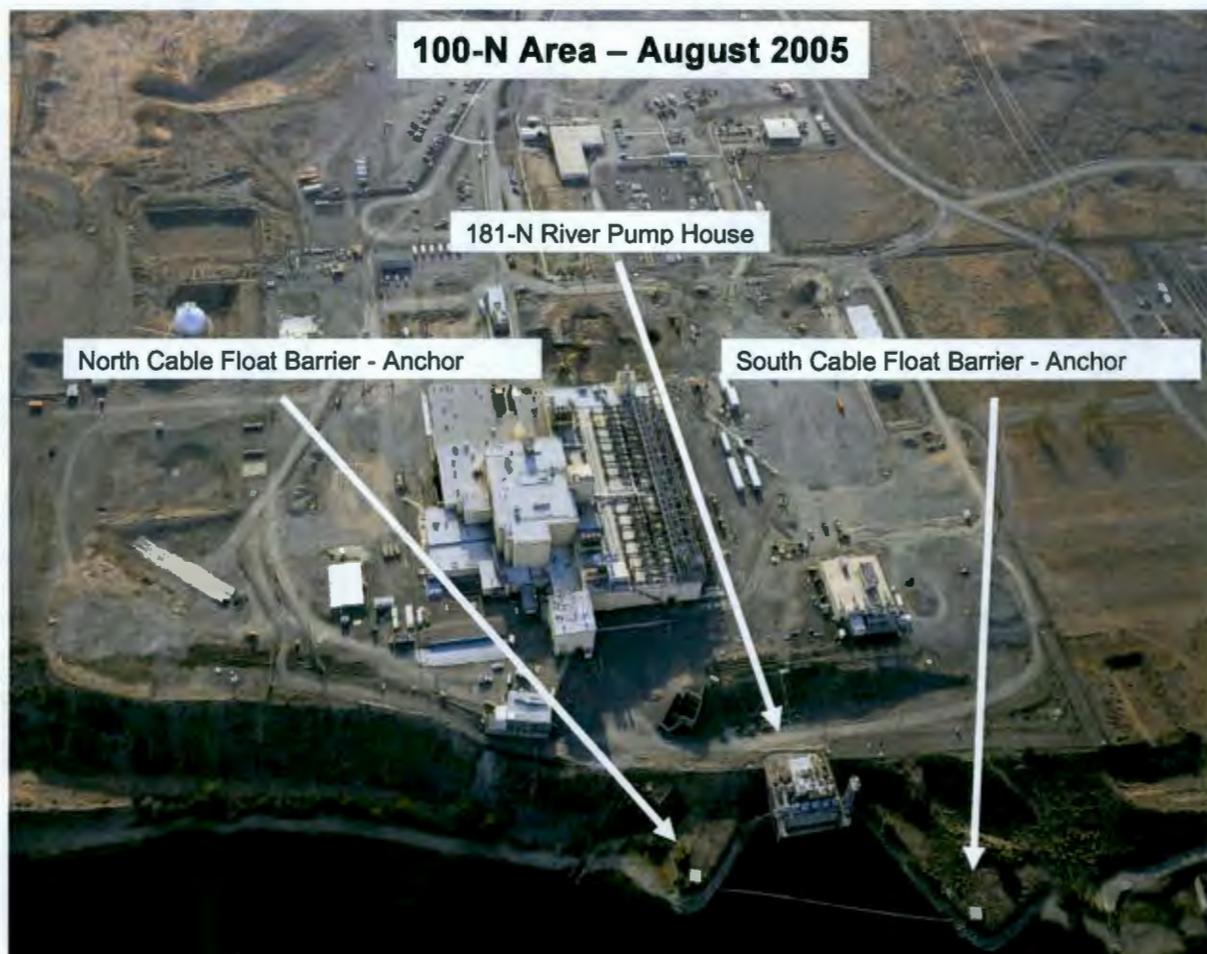
**Figure 3. 181-N River Pump House Cable Float Anchor Blocks.**

The 181-N River Pump House Cable Float Barrier Anchor Blocks were constructed in 1983, upstream and downstream of the 181-N River Pump House inlet (Figure 3). The 181-N Anchor Blocks restrained a 0.75-in. steel aircraft cable with foam-filled floats. The cable served as a safety barrier for the 181-N structure.

The solid concrete anchor blocks measured 16 ft wide, 16 ft long, and were 8 ft tall. They were reinforced around the perimeter with #5 rebar. The blocks were designed with a soil bearing pressure of 3,000 psf, and were able to withstand 80-mph winds and a 25-year flood. Although design drawings indicated the anchor blocks were recessed below grade, they were constructed on grade as noted during demolition.

Final D4 documentation includes a post-demolition global positioning system (GPS) survey. This data and other information are available in CCN 175461, "Post-Demolition Summary Report for the 181-N River Pump House Cable Float Barrier Anchor Blocks."

- 181-N Anchor Blocks – During wire saw cutting in freezing conditions, remove the diamond wire at the end of the work shift. While wire saw cutting the 181-N Anchor Blocks the wire was left in the cut over night during freezing conditions. The wire became frozen within the cut line and operations could not resume until weather conditions improved.

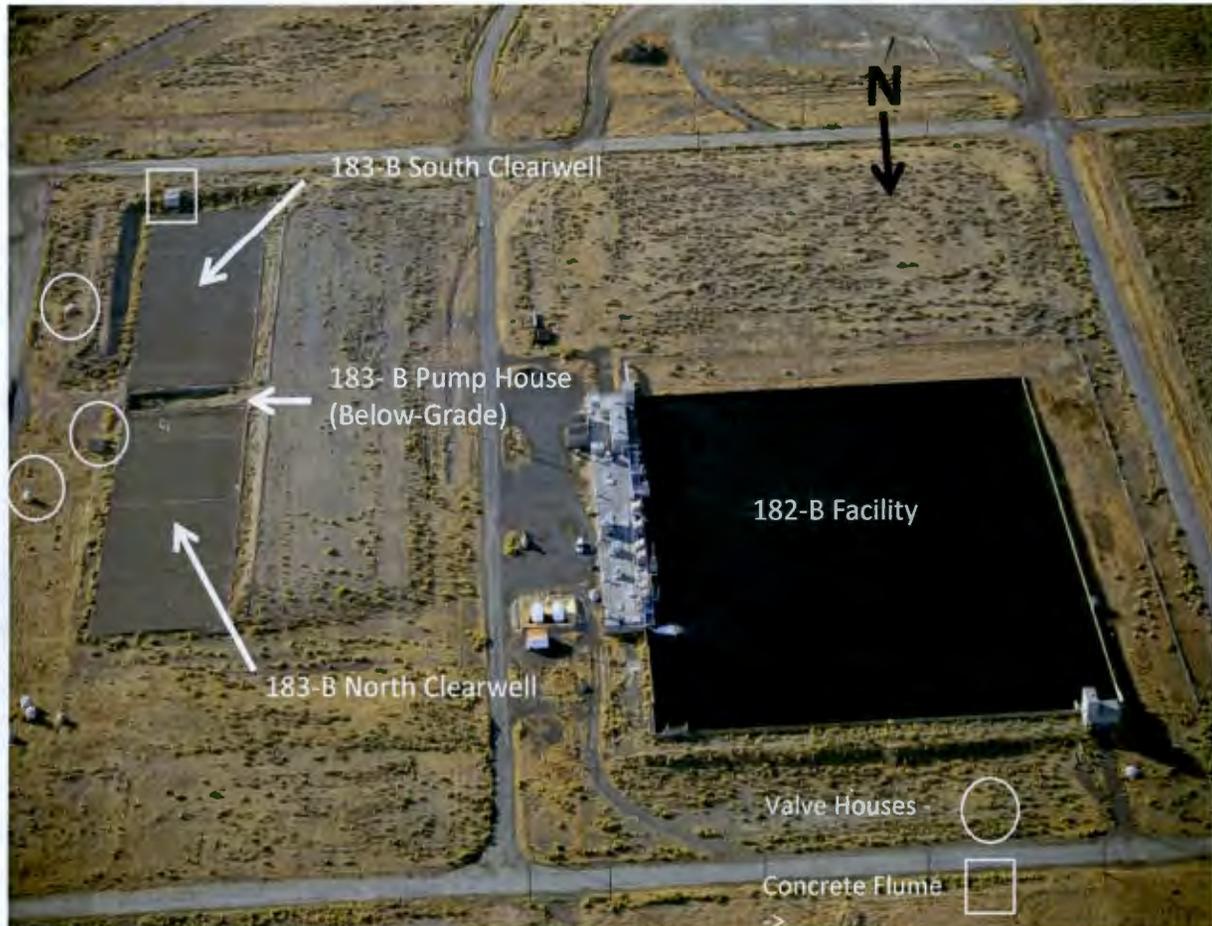
**Figure 4. 183-B Water Treatment Plant Clearwells and Pump House.**

The 183-B Water Treatment Plant Clearwells were located 1,300 ft west of the 105-B Reactor Building. The Clearwells and Pump House are described separately below and the spatial relationship of the facilities is depicted in Figure 4.

Most of the 183-B Water Treatment Plant was demolished in 1987 including the Headhouse, Flocculation Basins, Sedimentation Basins, above-grade Filter Building, and the Pump House down to 3 ft above grade.

The 183-B Clearwells (Clear Water Reservoirs) consisted of two below-grade, 5M-gal reinforced concrete enclosed reservoirs. Each Clearwell measured approximately 135 ft wide, 750 ft long, and 20 ft deep. Each reservoir had a reinforced concrete slab roof that was supported by reinforced concrete pillars. A tar and gravel surface covered the roof. The Pump House was located between the north and south Clearwells (Figure 4).

Water within the Clearwells gravity fed two suction wells located 5 ft below the Clearwell floors one on either side of the Pump House. Water within the Suction Wells was pumped to the B Reactor utilizing pumps located in the Pump Room.

Three valve houses on the east side of the Clearwells and a concrete over-flow flume on the south side of the south Clearwell were used to distribute water for operations and to maintain the reservoir level. The two-valve houses furthest from the Clearwells were constructed of 8-ft-diameter vertical corrugated galvanized steel culvert material with steel roofs. The valve house nearest the north Clearwell consisted of a small wooden structure (approximately 10 by 10 ft) with an asphalt shingle roof. The concrete over-flow flume (approximately 20 by 20 ft) had both a reinforced concrete roof and walls, and resided on the south end of the south Clearwell.

The 183-B Pump House, located between the north Clearwell and the south Clearwell, measured approximately 45 by 135 ft. The remaining Pump House consisted of the reinforced concrete walls, which were 3 ft above grade and extended 20 ft below grade. The Pump House above-grade structure, including the above-grade and below-grade equipment, had been previously removed.

The Pump House originally contained 10 electric pumps and 6 steam turbine pumps. Two of these pumps were used for backwashing the filter beds and four pumps were connected to the combined sanitary and fire protection system. The remaining 10 pumps handled the distribution of filtered water.

Overflow trenches of 20,000-gpm capacity ran along both walls of the Pump Room below floor level, paralleling the two Clearwells.

The 183-B Clearwell and Pump House excavation backfill was completed on May 30, 2014, under the River Corridor Closure Contract (RCCC) using excavation permit DAN13-0120. An Ecological and Cultural Resources Review aided the preparation of the excavation permit.

Final D4 documentation includes a post-demolition GPS survey. This data and other information are available in CCN 176390, "Post-Demolition Summary Report for the 183-B Water Treatment Plant Clearwells and Pump House."

- 183-B Water Treatment Plant Demolition – Prepare for Ecological Impacts by Migratory Birds. Demolition of structures creates habitat for migratory birds. During the planning phase there were no mud swallow nests on the 183-B facility. During building demolition, mud swallows built nests on the structure when convenient nesting locations and ample water and mud were made available from dust-suppression water application. Where possible, conduct demolition activities in a manner that does not create opportunities for nesting. Remove nests prior to the birds laying their eggs (swallow nests need to be removed three to four times daily; once established, as many as three sets of eggs may be laid by one bird). Additionally, apply dust-suppression water conservatively.

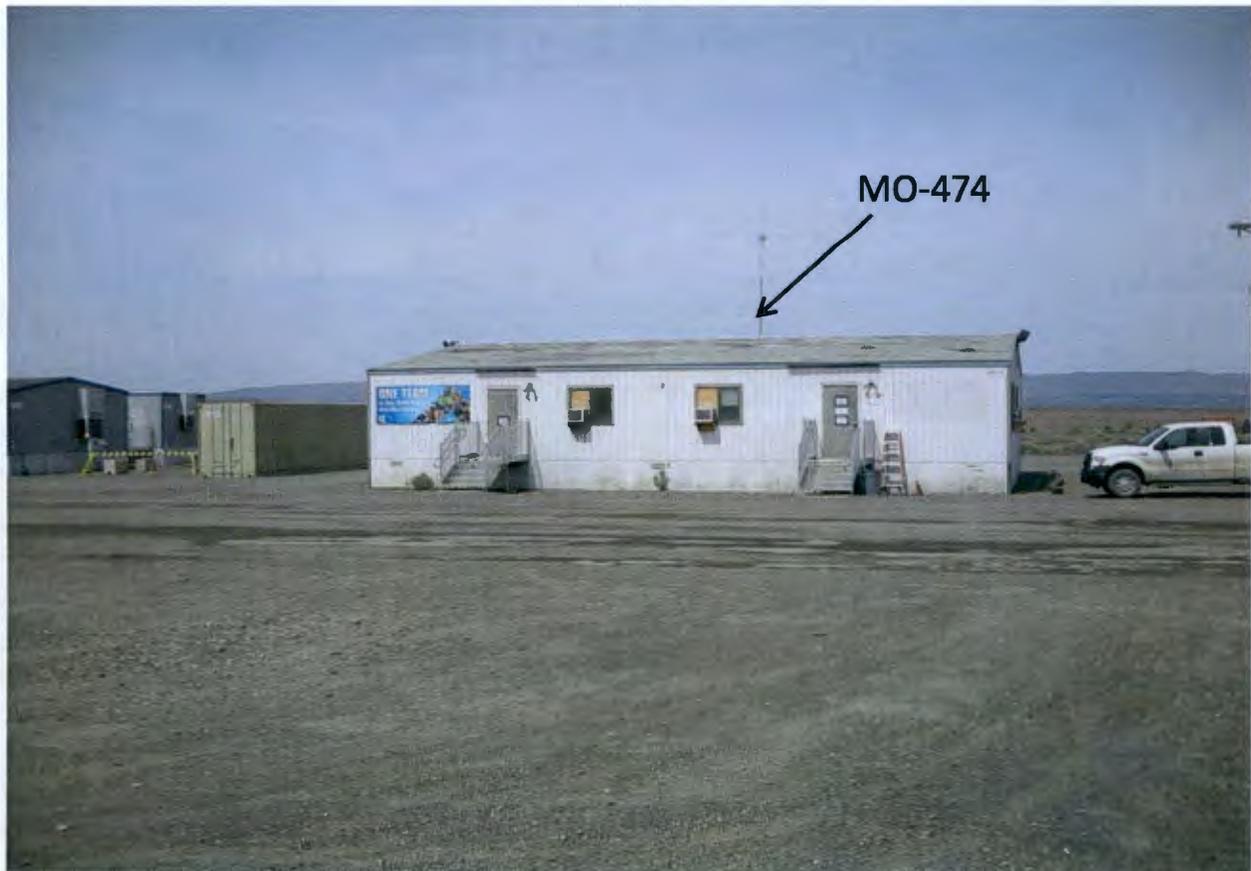
**Figure 5. MO-474 Mobile Office.**

Mobile office MO-474 was a triple-wide transportable office trailer. The 2,470-ft<sup>2</sup> structure was installed in the 100-B/C Area in 1996. Typical mobile office construction consisted of sheet metal, wood walls, and a roof on a steel frame. MO-474 was located approximately 885 ft northwest of the 105-B Reactor Building (Stewardship Information System) and served as the primary field office for WCH D4 and Field Remediation personnel (Figure 5).

Hazardous waste material was removed from MO-474 in June 2014. The trailer was split into three sections and transported to the ERDF on June 26, 2014, by George A Grant Construction (a subcontractor to WCH) and demolished at ERDF. This workscope was completed under the RCCC.

Final D4 documentation includes a post-demolition GPS survey. This data and other information are available in CCN 176967, "Post-Demolition Summary Report for 100-B Area Mobile Office MO-474."

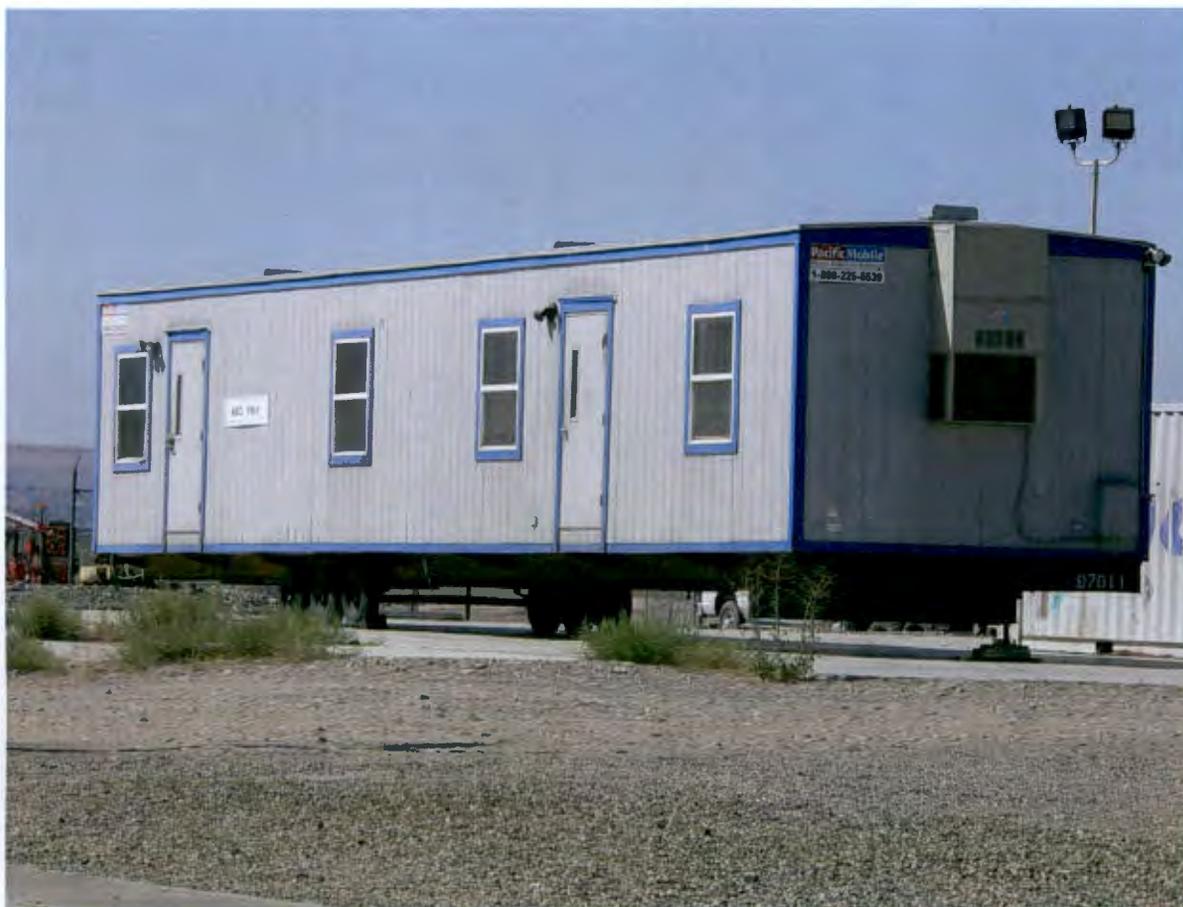
**Figure 6. MO-767 Mobile Office.**

Mobile office MO-767 was a 620-ft<sup>2</sup> single-wide transportable facility that was originally located at the 100-N Area and later moved to the 300 Area. The trailer was of typical mobile office construction, sheet metal, wood walls, and a roof on a steel frame (Figure 6). It originally provided office space for 100-N personnel and later 300 Area personnel.

Hazardous waste material was removed from MO-767 in June 2014. The trailer was transported to the ERDF in June 2014 by George A Grant Construction (a subcontractor to WCH) and demolished at ERDF. This workscope was completed under the RCCC.

Final D4 documentation is available in CCN 176535, "Post-Demolition Summary Report for Mobile Offices MO-767 and MO-827."

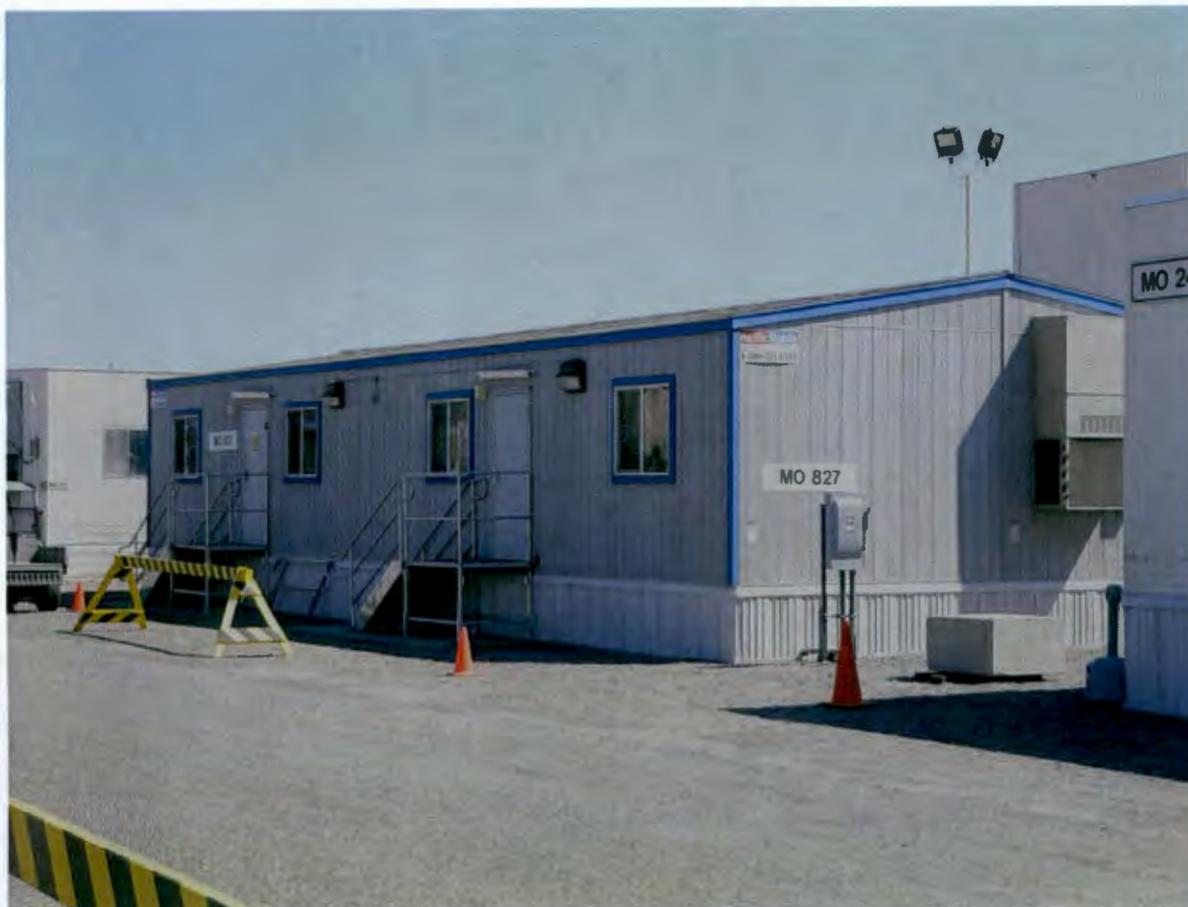
Figure 7. MO-827 Mobile Office.

Mobile office MO-827 was a 1,370-ft<sup>2</sup> double-wide transportable facility that originally was located at the 100-N Area and later moved to the 300 Area. The trailer was of typical mobile office construction, sheet metal, wood walls, and a roof on a steel frame (Figure 7). It originally provided office space for 100-N personnel and later 300 Area personnel.

Hazardous waste material was removed from MO-767 in June 2014. The trailer was split into two sections and transported to the ERDF in June 2014 by George A Grant Construction (a subcontractor to WCH) and demolished at ERDF. This workscope was completed under the RCCC.

Final D4 documentation is available in CCN 176535, "Post-Demolition Summary Report for Mobile Offices MO-767 and MO-827."
