**OWNER/OPERATOR
CLOSURE CERTIFICATION
FOR
1325-N LIQUID WASTE DISPOSAL FACILITY**

**PROFESSIONAL ENGINEER'S CERTIFICATION OF THE
CLOSURE STATEMENT OF THE 1325-N (116-N) TREATMENT,
STORAGE, AND DISPOSAL UNIT**

**Independent Registered Professional Engineer's
Closure Certification Report
for 1325-N (116-N-3)**

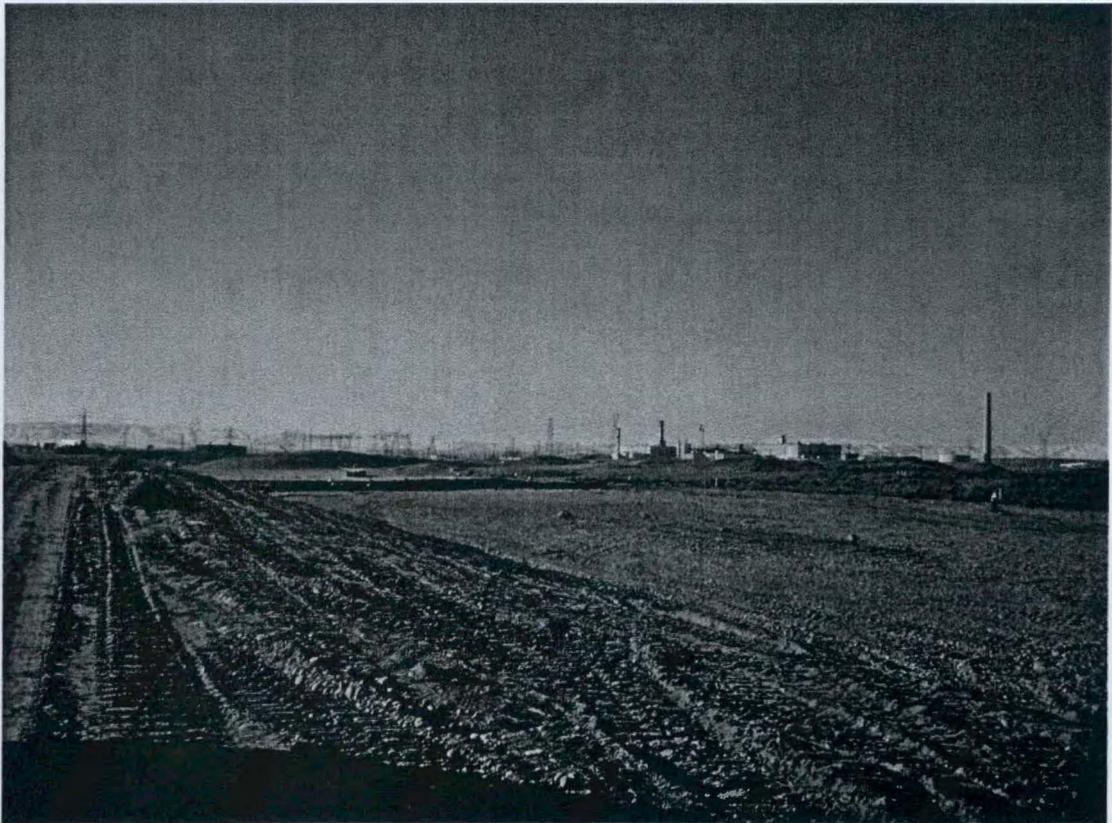
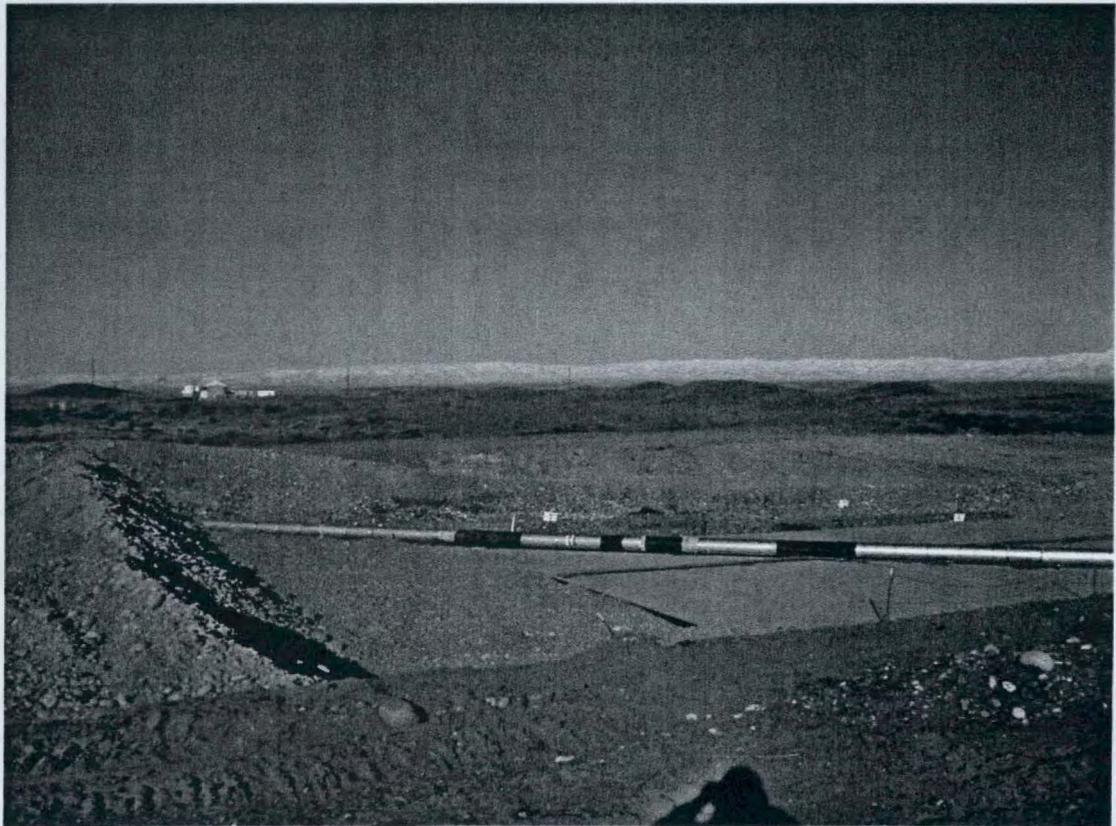
January 5, 2005 – Backfill and re grading of 1325-N is complete. Subcontractor has issued as-built topography to the ERC. The export water line remains in place, supported by clean concrete cover panels. This portion of the trench remains unbackfilled. Bales of straw are staged at various locations in preparation for reseeded, planned to start in early 2005. Photos of completed site are attached.
