FACILITY STATUS CHANGE FORM

Date Submitted: Jul 9, 2012	Area: 300 Area	Control #: D4-300-055
Originator: John Harrie	Facility ID: 3746 & 3746A	
Phone: 509.308.9935	Action Memorandum: Action Memorandum #3

300-FF-2

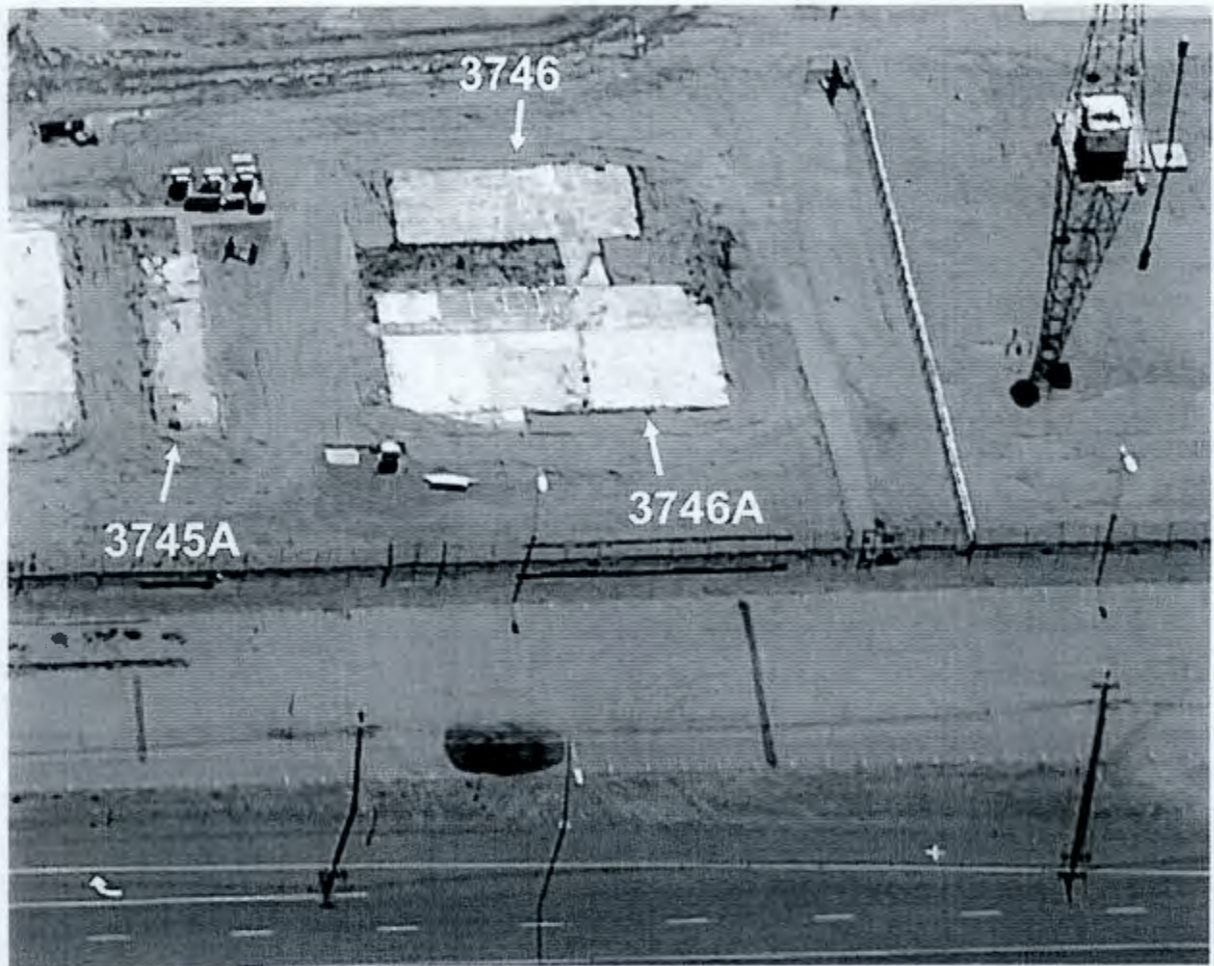
Figure 4. 3746 and 3746A after above-grade demolition on July 16, 2008

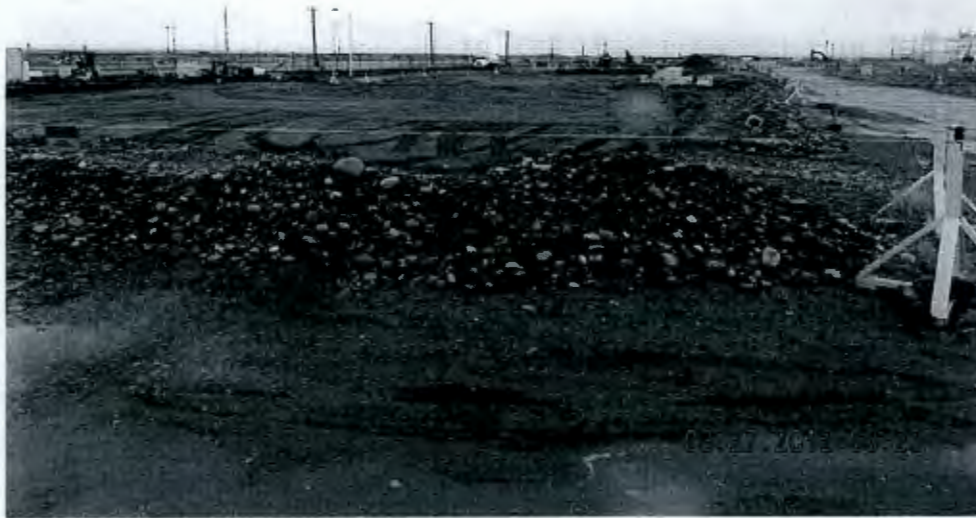
No anomalies were discovered during the demolition of 3746 and 3746A. Soil beneath the slabs displayed no visual evidence of staining or discoloration.

Figure 5. Looking north at 3746 and 3746A following below-grade demolition on March 27, 2012.

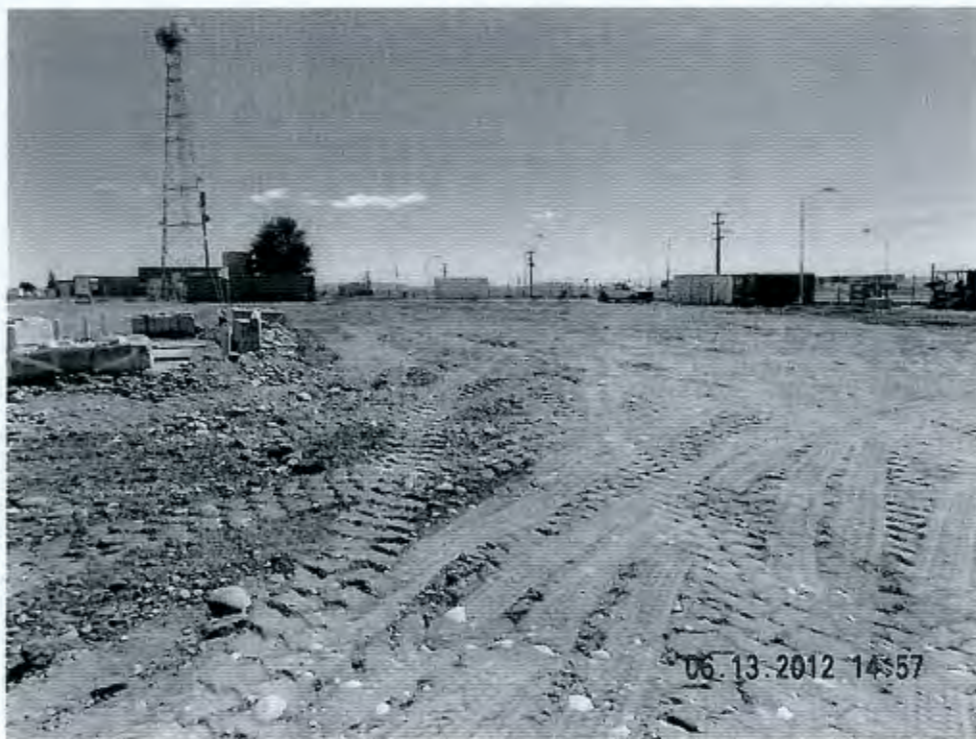
Figure 6. Looking south at 3746 and 3746A following backfill on June 13, 2012.

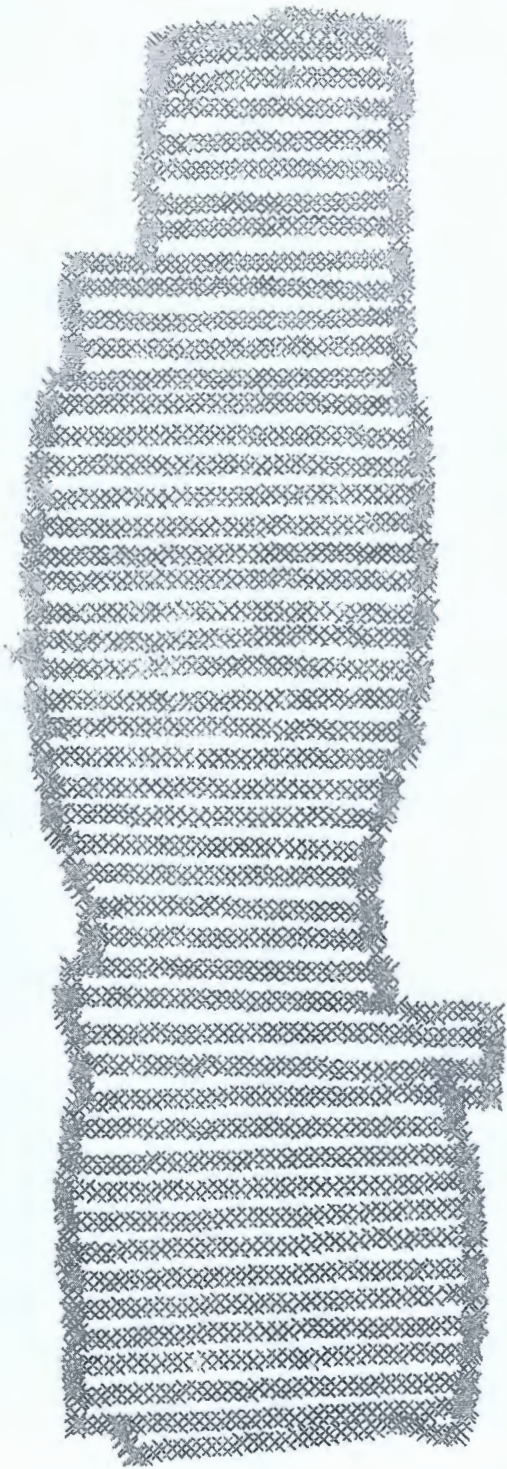
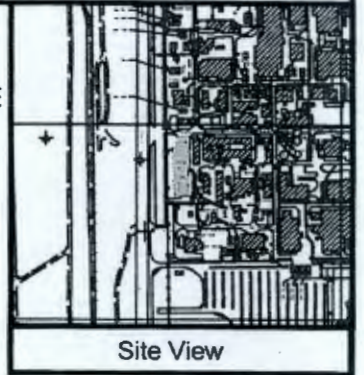
300 D4 - 3709, 3745A/B, 3746/A
GPERS Radiological Survey - Gamma Track Map

Bkg Location
465 meters NNE
1290 cpm

Coverage File: D075
Number of Data Pnts: 2519
Type of Survey: gamma
Max GCPM: 2062
Avg Bkg CPM: 1290
Survey Date: 3/15/2012
Area Surveyed: 3646 m²
Project File: ESRFRM120040
Pdf File: ESRFRM120040C
