WASTE SITE RECLASSIFICATION FORM

Operable Unit: 100-NR-1

Waste Site Code(s)/Subsite Code(s): 1908-N, 1908-N Outfall

**1908-N, 1908-N REACTOR OUTFALL FACILITY
STATUS CHANGE FORM**

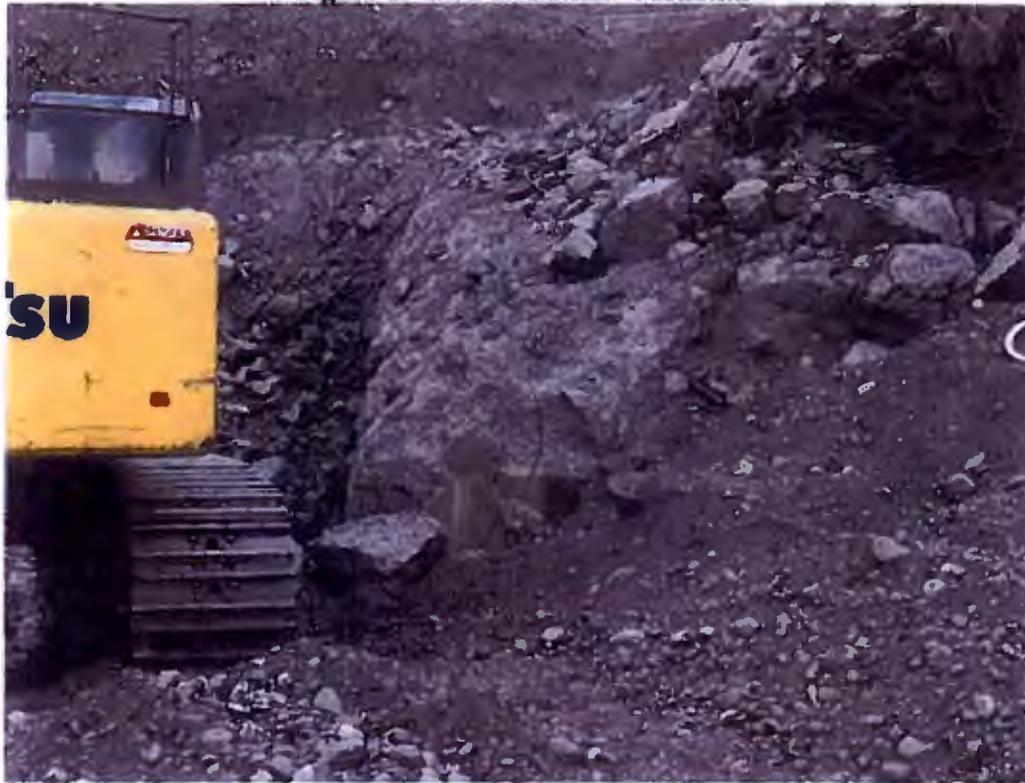
Figure 1. 1908-N Outfall - Monolith

On April 26, 2002, a sample of concrete was collected from the 1908-N concrete monolith that remains after demolition of the 1908-N Outfall structure (Figure 1). The sample was chipped from the monolith and submitted for laboratory analysis to evaluate potential contaminant concentrations and make a decision concerning whether or not this material may remain in place or requires removal as provided in the *Removal Action Work Plan for 100-N Area Ancillary Facilities* (DOE-RL 2012). The concrete sample was collected in accordance with ENV-1, *Environmental Monitoring & Management*, to fulfill the requirements of the *100-N Area Remedial Action Sampling and Analysis Plan for CERCLA Waste Sites* (SAP) (DOE-RL 2006a).

Evaluation of the results provided in Table 3 indicate that all COPCs were either undetected or were quantified below remedial action goals (RAGs) and soil lookup values with the exception of copper and zinc which were detected above the soil RAGs for protection of the Columbia River. However, based on RESRAD modeling discussed in Appendix C of the 100-N Area RDR/RAWP (DOE-RL 2006b), residual concentrations of copper and zinc are not predicted to migrate more than 3 m (9.8 ft) in 1,000 years, based on copper, having the lowest partitioning coefficient, 22 mL/g. The vadose zone underlying the concrete monolith at the 1908-N outfall is approximately 4.4 m (14.5 ft) thick. Therefore, residual concentrations of copper and zinc are predicted to be protective of groundwater, and thus, the Columbia River.

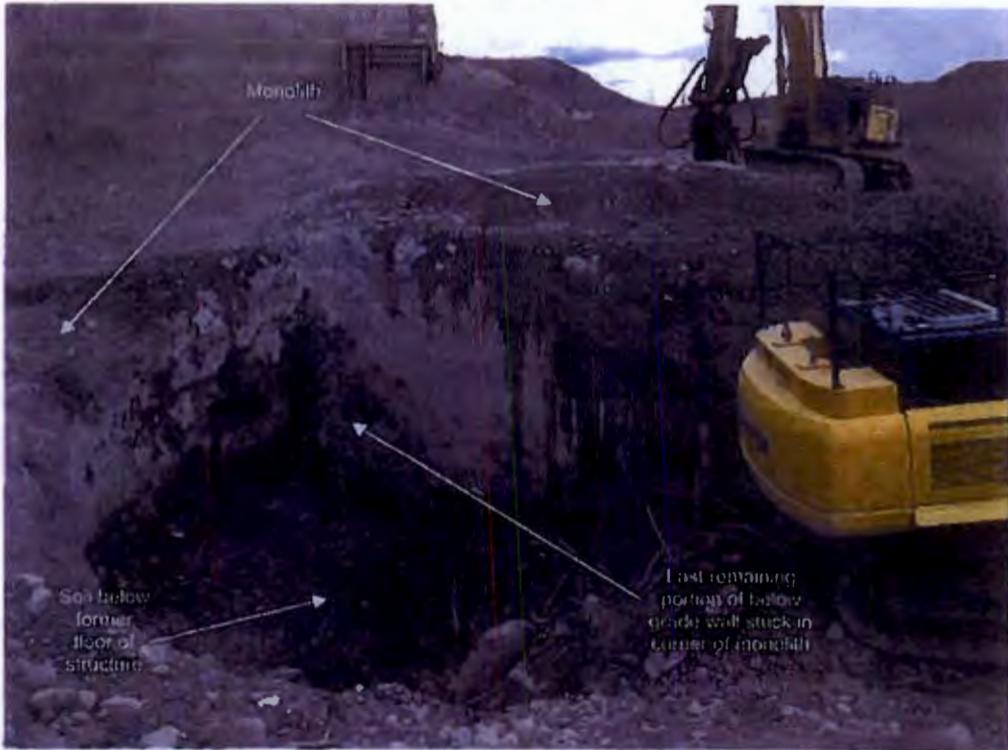
View of monolith below grade (facing east).

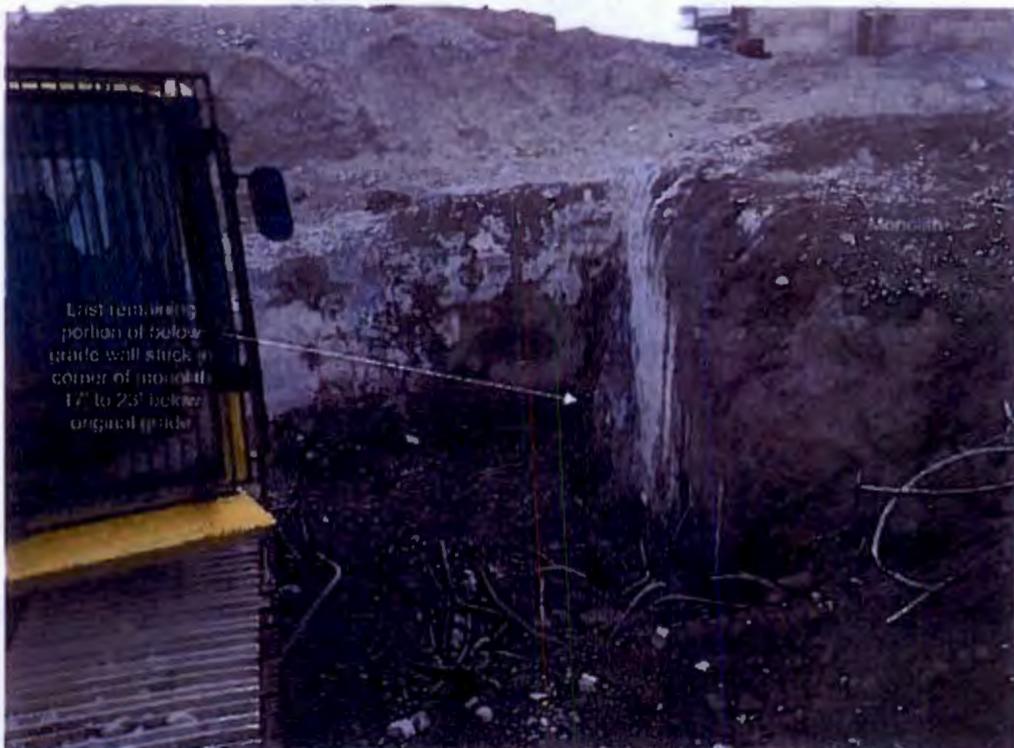
View of monolith below grade (facing north).
