HNF-EP-0182
Revision 366

Waste Tank Summary Report for Month Ending June 30, 2018

Prepared for the U.S. Department of Energy
Assistant Secretary for Environmental Management

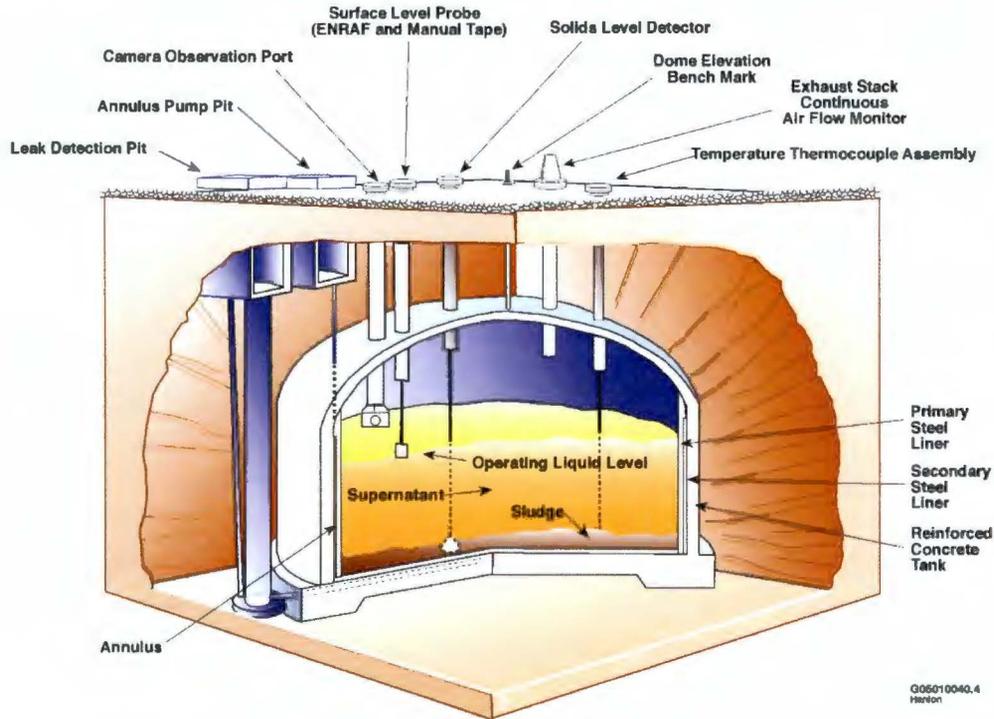
Figure 1-1. Double-Shell Tank Configuration

Illustrations of the double-shell tank (DST) and single-shell tank (SST) configurations are shown in Figure 1-1 and Figure 1-2, respectively. Figure 1-3 and Figure 1-4 summarize the 200 East Area and 200 West Area tank contents by tank farm.
