Document No.  
UNI-3807

Title  
UNCONDITIONAL RELEASE OF THE 115-D/DR GAS  
RECIRCULATION FACILITY SUPERSTRUCTURE

UNCONDITIONAL RELEASE OF THE  
115-D/DR GAS RECIRCULATION FACILITY SUPERSTRUCTURE

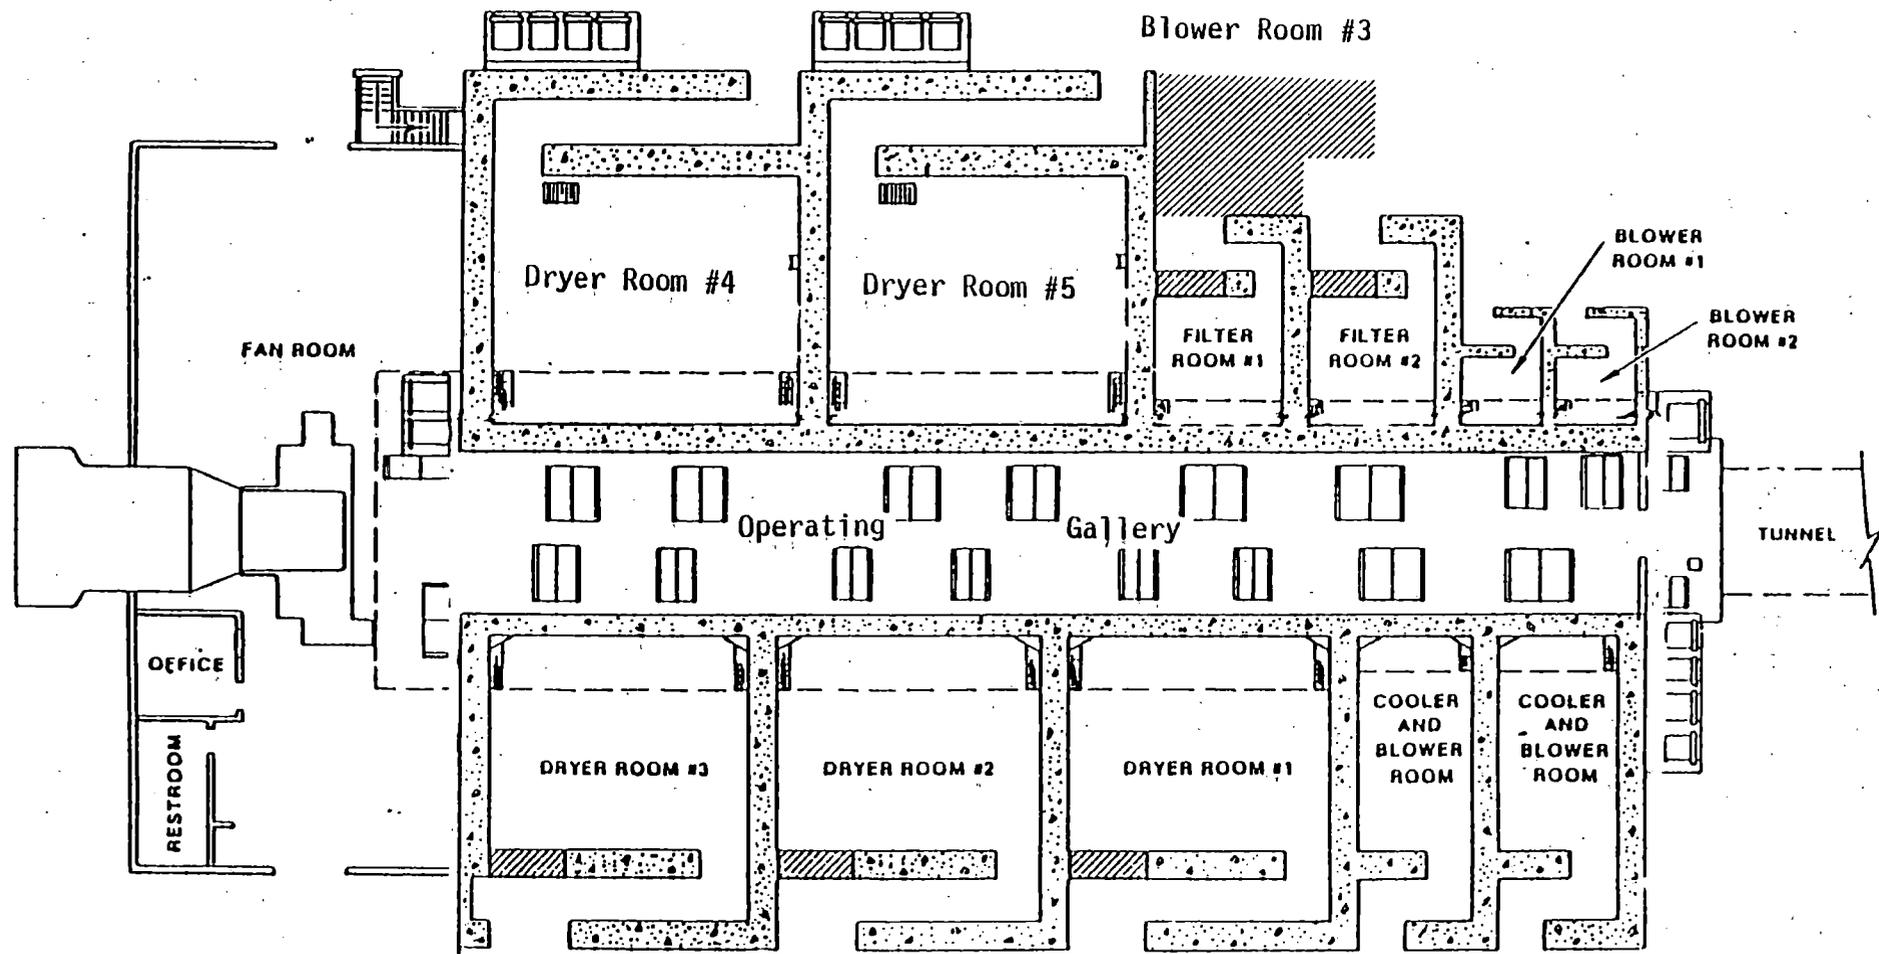
Figure 3. Plan View of 115-D/DR Gas Recirculation Building.

The 115 Buildings are composed of operating galleries, process cells, fan rooms, and support facilities. The Operating Gallery extends through the center of the building north and south and is flanked by the process cells. There is no access to the process cells from the operating gallery. Located at the south end of the operating gallery is the fan room containing the building air supply equipment, compressors, gas analyzers, office, and restroom. The process cells include the following: five dryer rooms, two cooler and blower rooms, two filter rooms, and three blower rooms (Figure 3).

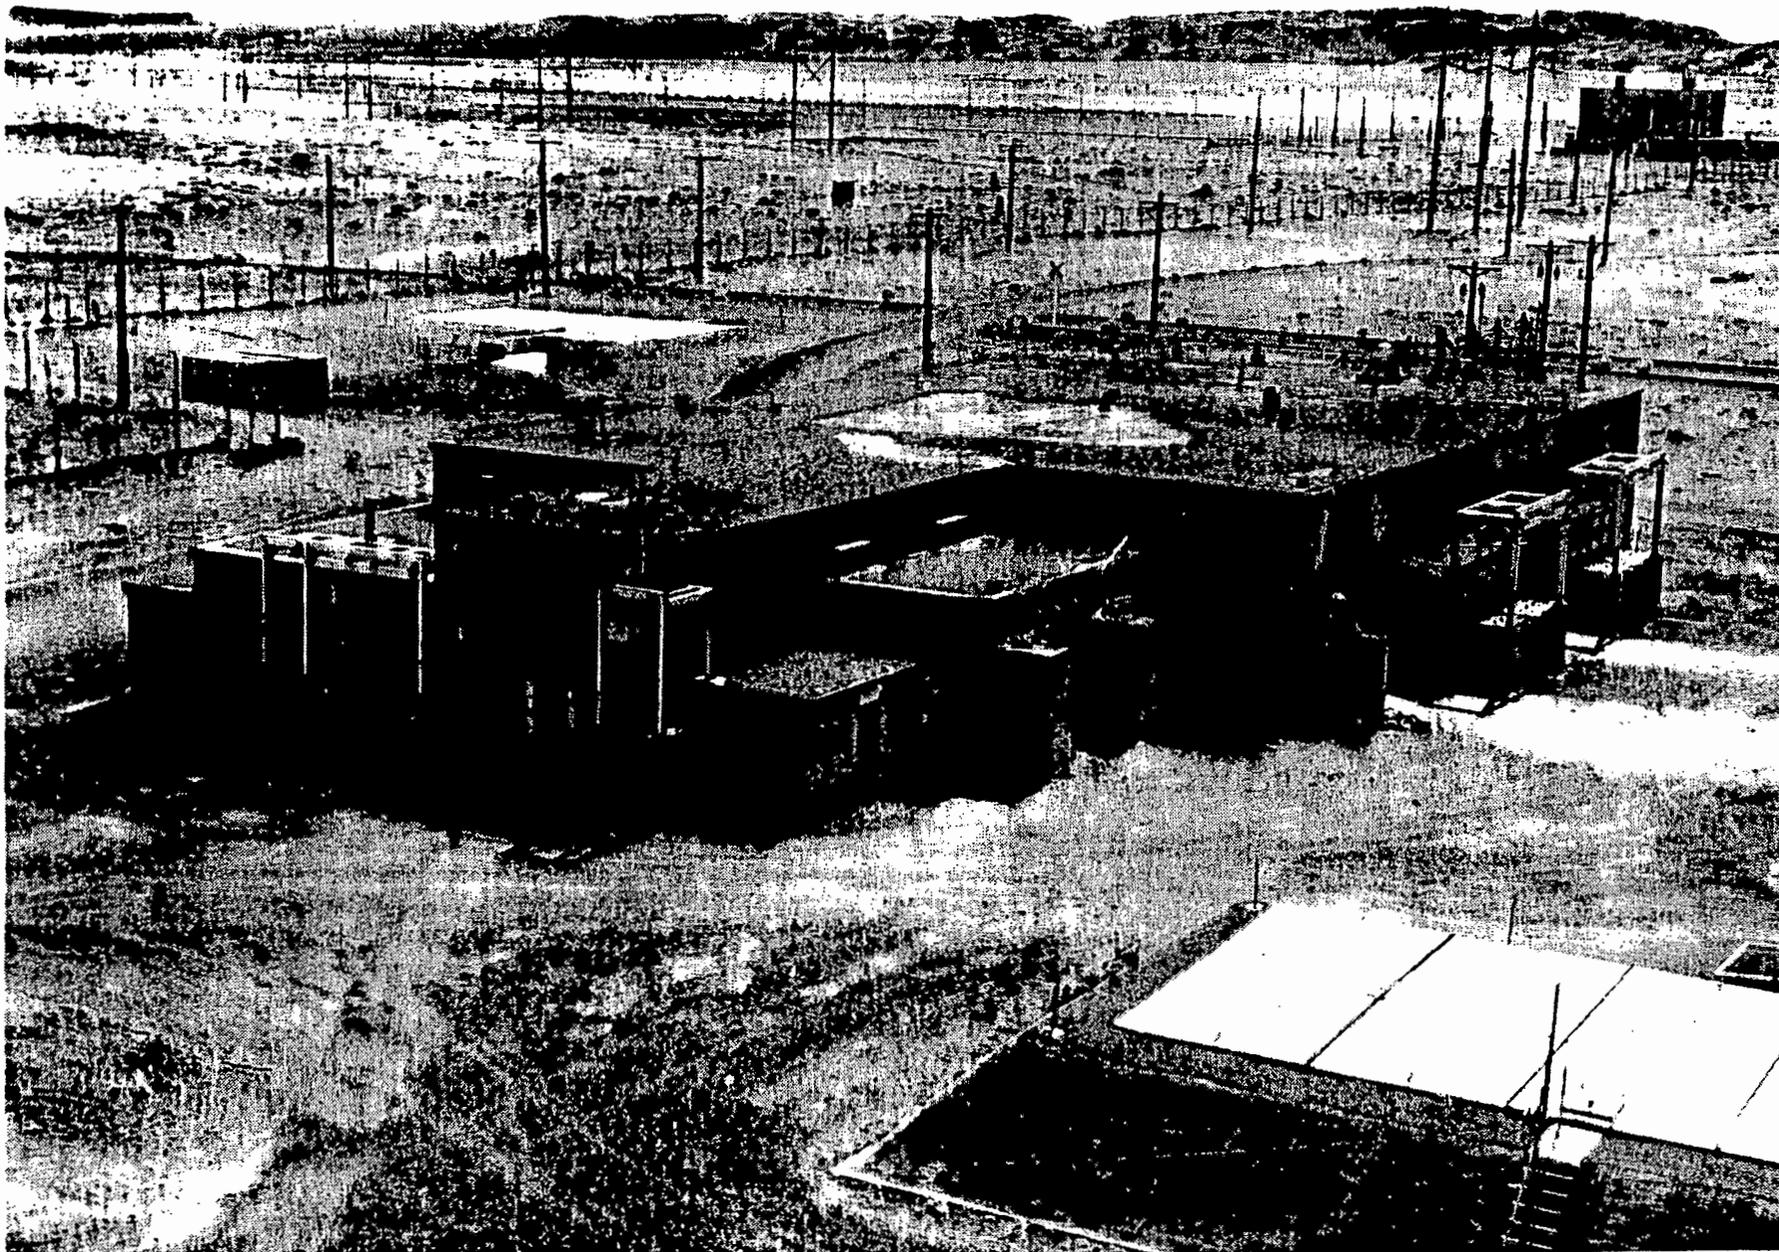
Figure 4. 115-D/DR with Openings Enlarged to Remove Equipment.

The 115-D/DR Project Decommissioning Work Procedure (DWP) required removal of equipment from the process cells; therefore, it was necessary to open and enlarge the sealed equipment hatches (Figure 4). The equipment hatches were originally sealed with concrete block and mortar.

All contaminated equipment was removed from the process cells. The cooler blowers, filters, and other bulky equipment were unbolted or cut free of the process piping; all openings were sealed either with blank wooden flanges or quadruple layers of plastic and tape. The equipment was properly packaged and transported to the disposal facility located at the Hanford 200 West Area.

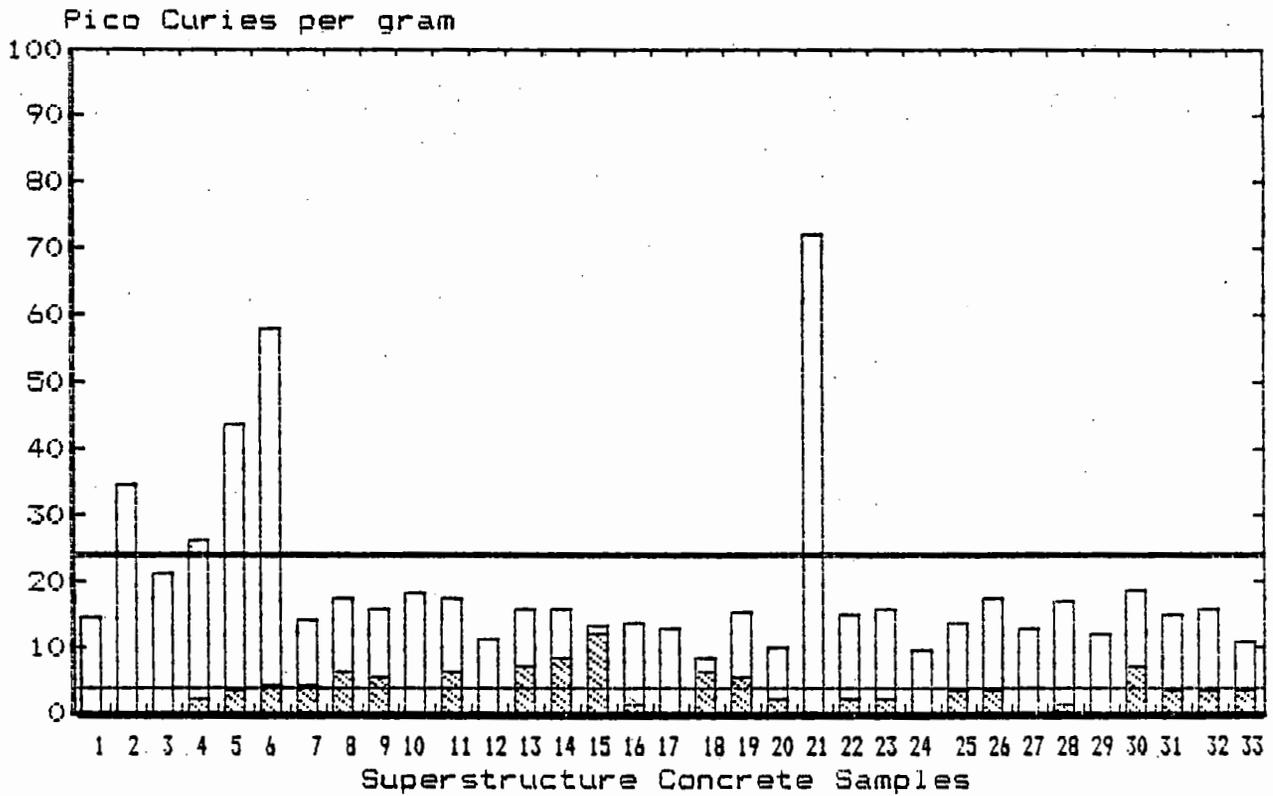
FIGURE 7. 115-D/DR DISPERSED ACTIVITY

Background for dispersed beta and alpha activity in concrete was established by the analyses of four concrete samples from the sidewalk outside the 183-KE facility, 100-K Area. These samples were counted for total alpha and beta activity. The results of the 115-D/DR concrete samples and background concrete samples are presented in Figures 7 and 8, respectively.

The upper confidence limits (UL) of the estimated means, for the 115-D/DR and 183-KE background samples' alpha and beta activities were calculated at the 95% confidence level and are presented below. For complete sample data results and statistical calculations see Appendix C.

A comparison of the 115-D/DR UL dispersed activity values (Figure 7) and the 183-KE background (Figure 8) clearly indicate that the alpha and beta activity of the 115-D/DR superstructure is at background levels. As a result, the intent of Table 11-1 dispersed activity limits have been satisfied since the activity of the superstructure appears to be indistinguishable from the activity levels that could be expected due to normal background.

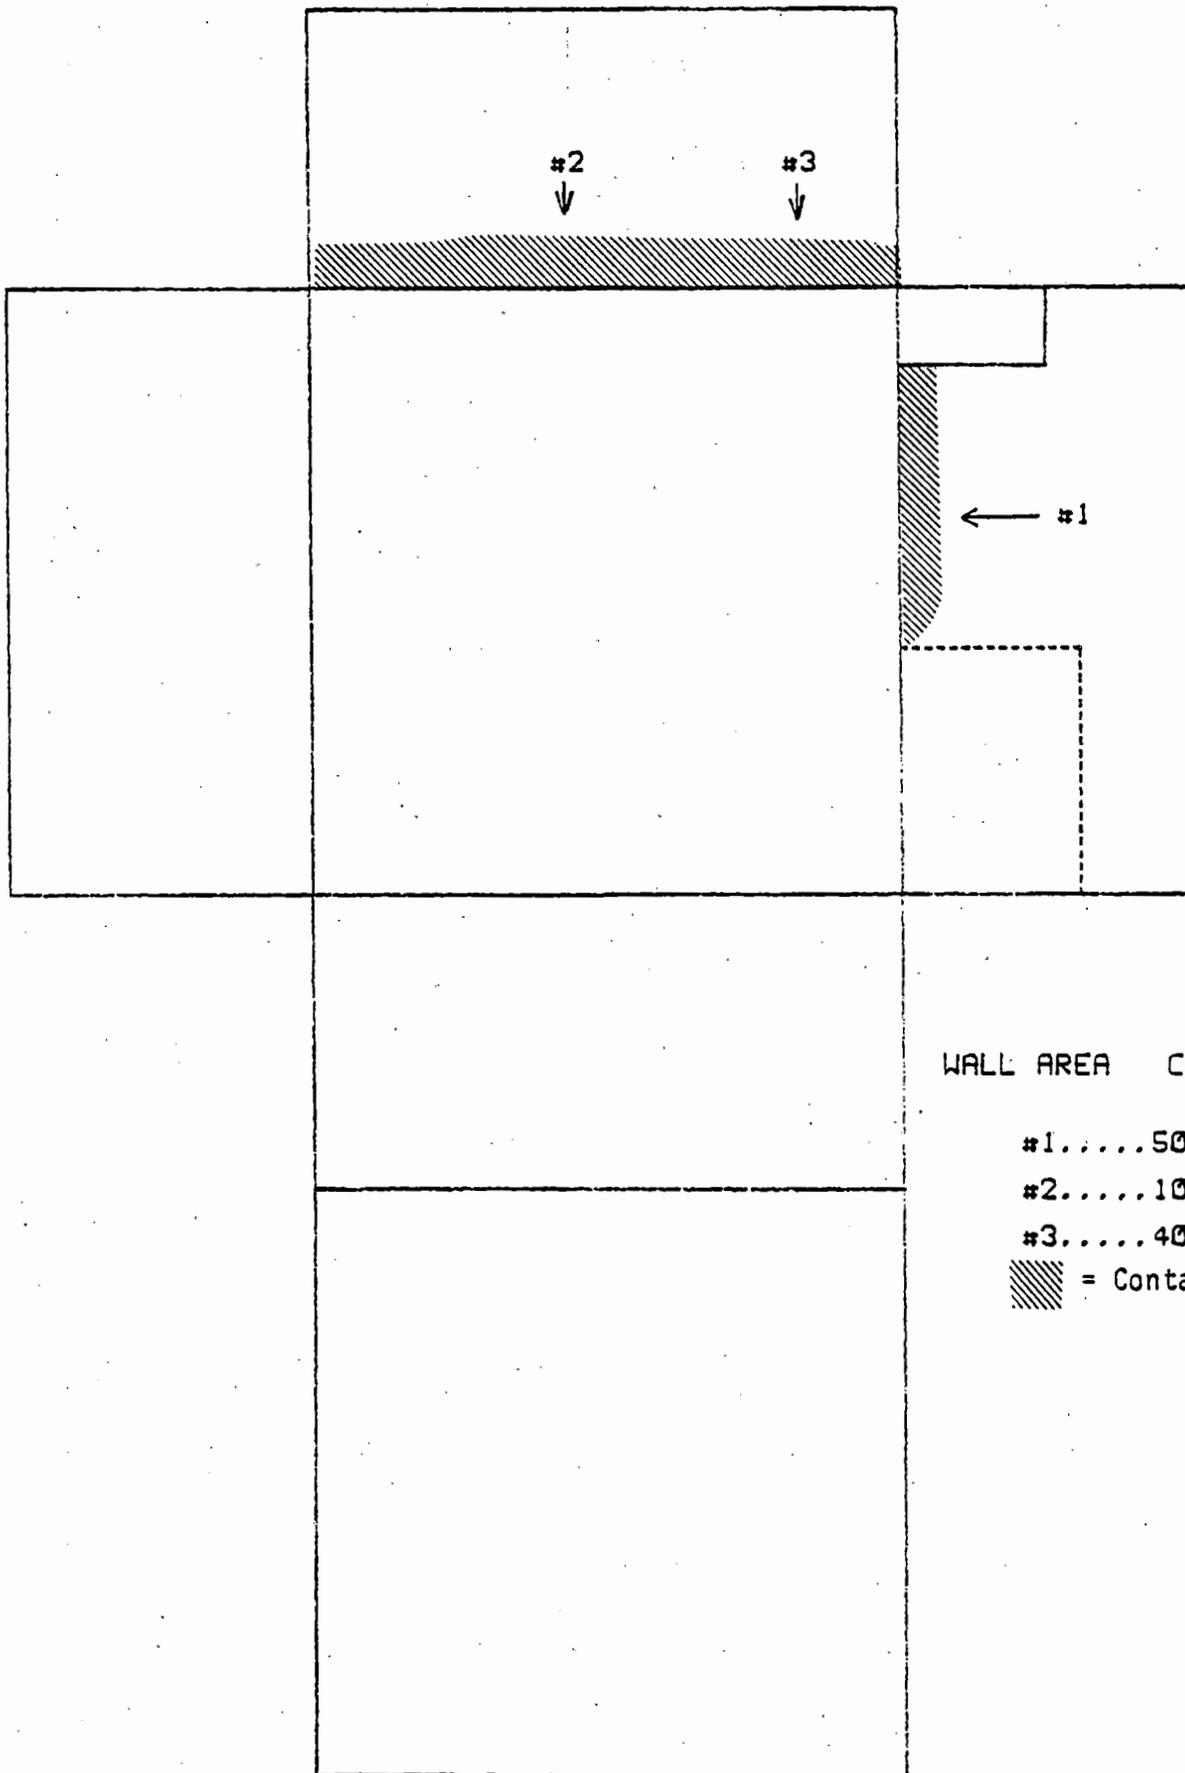
115 D/DR DRIER ROOM #2

WALL AREA CONTAM.

- #1.....5000 C/M
- #2.....1000 C/M
- #3.....40000 C/M
-

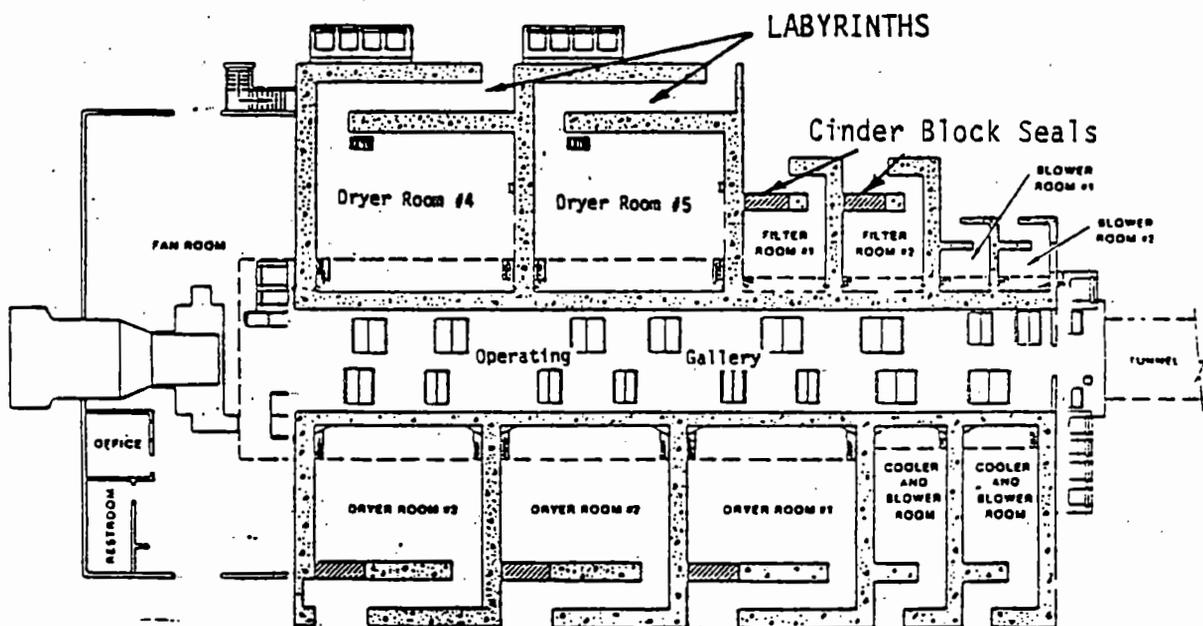
Overall Plan of 115-D/DR Layout

Each cell, room, or area is depicted as a separate drawing for clarity. There are drawings to show the approximate locations where concrete samples were taken. These drawings use the technique of unfolding the walls and overhead to lie in the same plane with the floor.

Room openings are either labeled or marked as indicated in the symbol table on the individual sheets. Each grid area is indicated with a dashed line at one or more of its boundaries. Openings in the walls that were made by removal of bricks and mortar are indicated by a fine dashed line. Portions of the walls that were demolished to allow equipment removal are shown with a wave-like line. The general layout of the building is shown below for reference.
