Five-Year Surveillance Report for the 105-C, 105-D, 105-H, 105-F and 105-N/109-N Safe Storage Enclosures

Document Type: RPT

D. G. Ranade
Mission Support Alliance

Date Published
March 2016

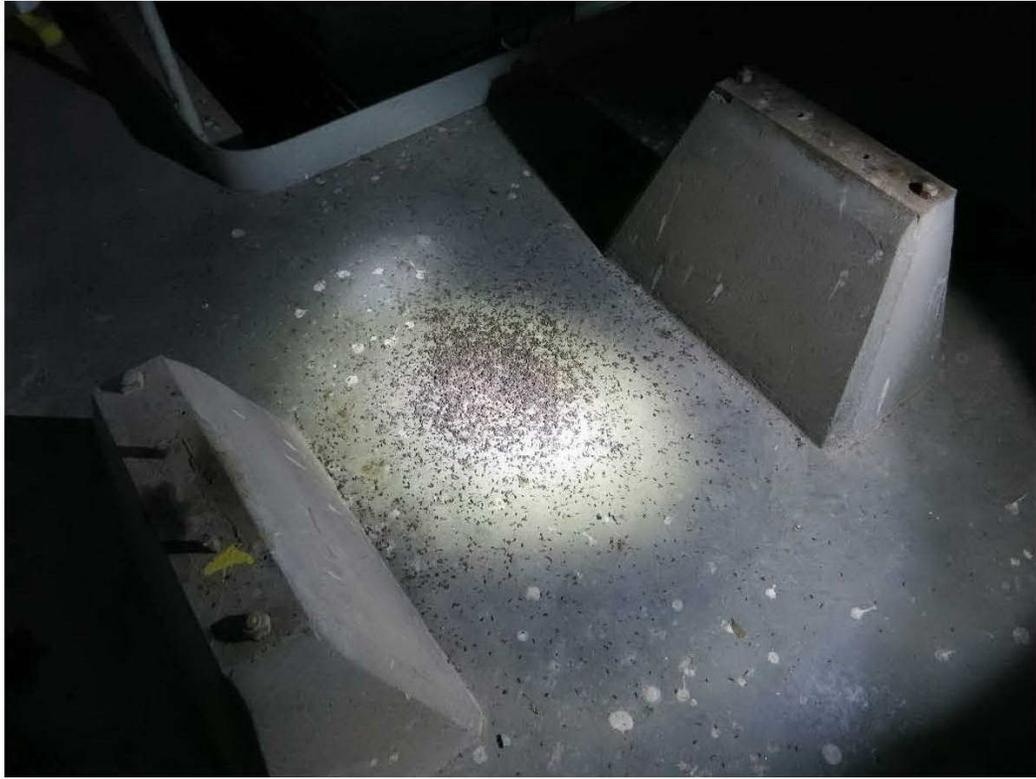
Biologists surveyed the routes for dead or live animals, such as snakes, spiders, or other biological hazards. Bat guano was present in the 105-C, 105-D, 105-F, and 105-H SSEs. Fecal droppings from other animals also were present. The live bats observed in the SSEs were not on the routes. The routes were cleared for walking. The biological surveys are addressed in Appendix F.

Figure 1. Accumulation of Bat Guano on floors during reactor entry

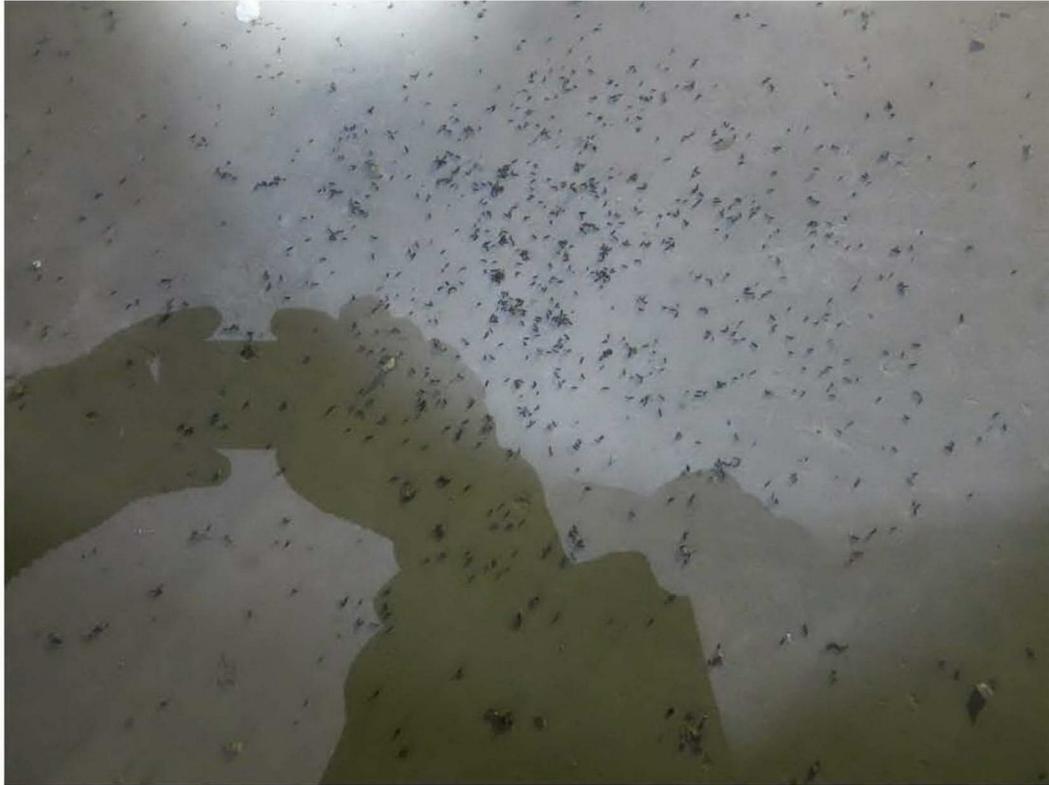
Figure 1. Accumulation of Bat Guano below a Light Fixture in the 105-F Reactor SSE

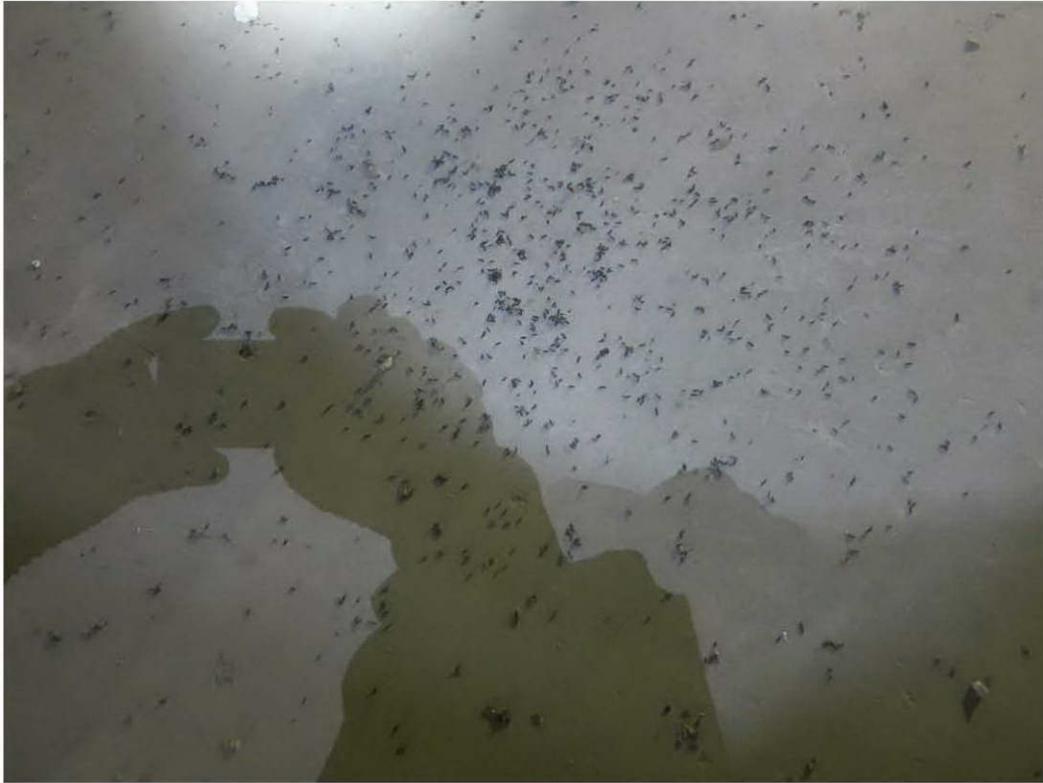
Figure 1. Accumulation of Bat Guano below a Light Fixture in the 105-F Reactor SSE

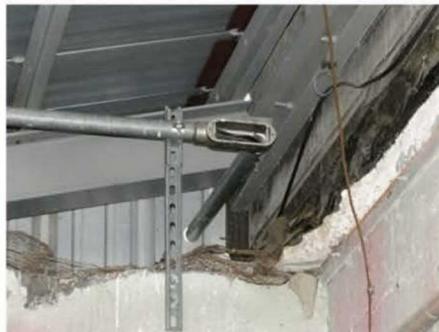
3579 Open junction box in vestibule

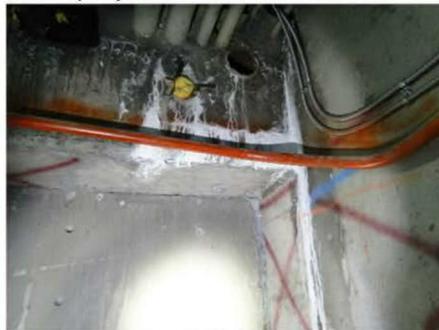
3581 When chipped off, a small chunk of this white deposit had a water drop inside. Somehow from recent water (rain). Also found some of this deposit on outside of bldg at same location

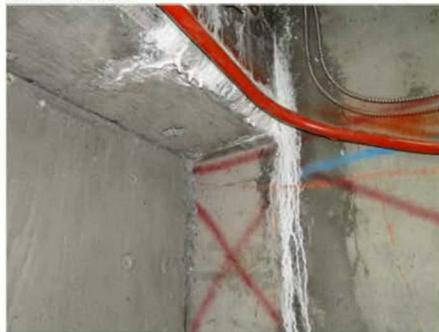
3582 white deposit on building interior

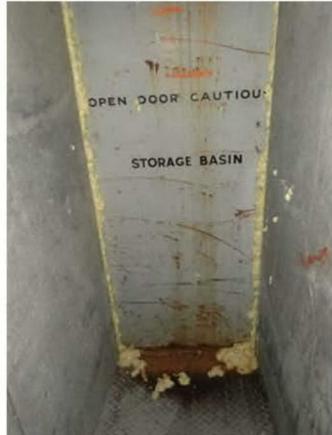
3594 Match THIS PICTURE WITH #3646
Evidence of water/rust at bottom of door

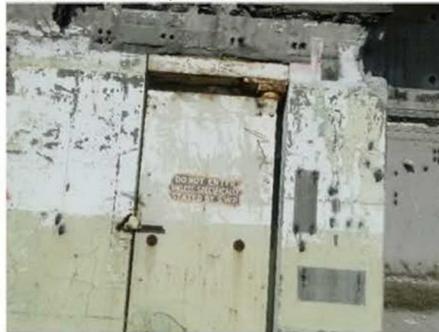
3646 Rear face shield door.. Evidence of rusting inside Possible weather protection issue

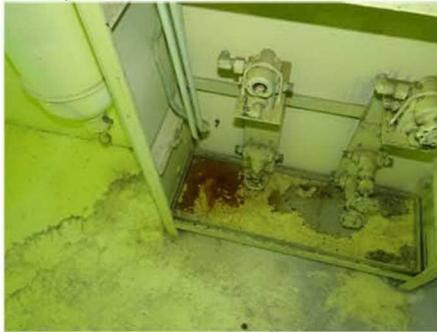
7. Hydraulic fluid is present in the equipment pan and on the floor (Appendix B, Photos 3601 and 3605).

3605 Hydraulic fluid is staying well within the equipment pan. Entire area 2' x 3'

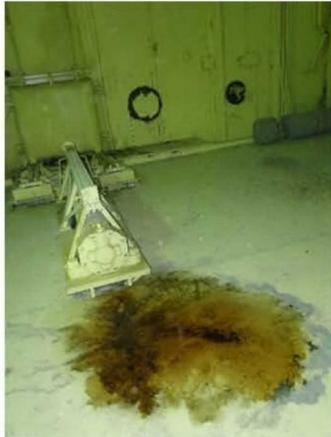
3601 Fluid on floor from overhead winch

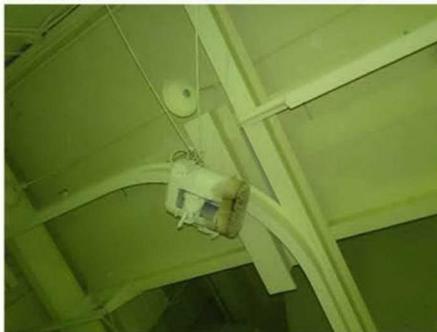
3602 Overhead winch

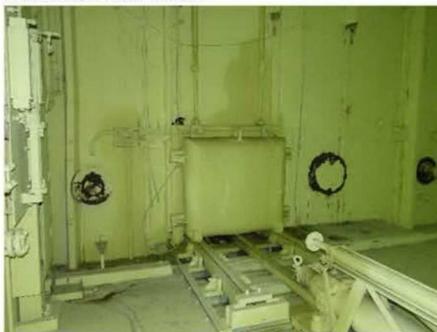
3607 Hydraulic fluid from this op system for this shield door dripping in pic 3605

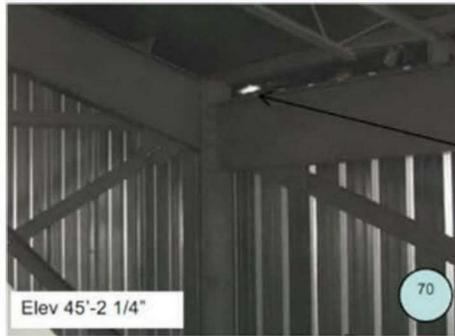
5. Observation of SSE metal sheathing at the 45' and 59' levels showed multiple openings at junction points where outside light could be seen – evidence of a possible access point for small birds, bats, insects, spiders, etc. While not every pinpoint of outside light is big enough for bird or bat access, there is ample evidence of a number of bats being in the structure in the past and reports of one or two seen during the inspection on April 20th. If any closure of these openings is considered, timing is an issue with the biological team, but a program of maintenance may be recommended to close off the identifiable openings with a wire mesh or metal fabric from the outside. Adhesive or self-tapping screws with a non-corrosive metal mesh or metal fabric would seem to provide an effective and fast way to inhibit further entries, this approach would presumably use an articulated man-lift of significant size. Additionally, consideration for galvanic corrosion with the galvalum roof / siding materials must be accounted for when selecting a material for closure. The area shown in Attachment C-3, Item 70 and Attachment C-4, photo 3622 are a few typical instances. If or when a maintenance program is planned, the timing noted in the 105-C SSE ecological reviews must be considered. Further, it is recommended that this maintenance be completed prior to significantly extending the SSE surveillance periodicity.

Areas where light can be seen from the interior

Item 70 – 2008 Detail SS Details, Soffit area between wall and roof, Elev. 45'-2 1/4", visible light thru gaps,

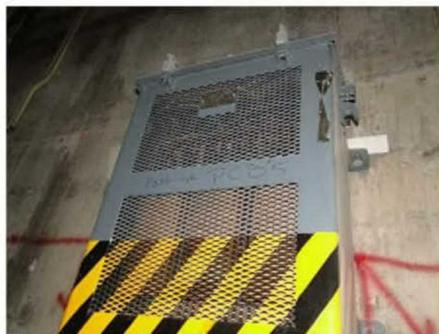
8. Two dry transformers observed at 45 ft 2¼ in. (Appendix B, Photos 3628 and 3629)

3628 Possible PCB in transformer

Two dry transformers were observed in 105-C SSE. A work package will be prepared to remove the transformers. The removal work will be completed in FY 2016.

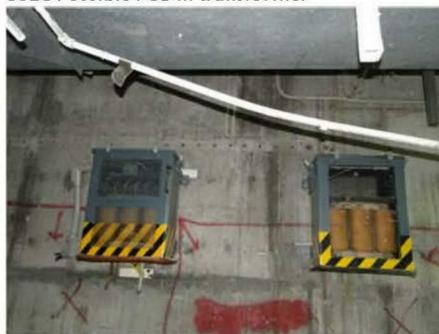
3629 Possible PCB in transformer

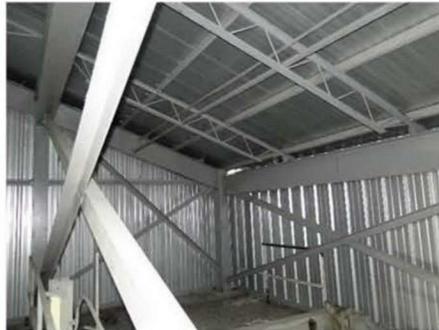
#	New Photo #	Description	Area / Location	Recommendation	Notes
	3622	General ISS Roofing structure	Elev. 59'-4"	Close corner openings. Continued observation to assure no change	Other than openings at corners, structure in very good condition. See pic # 70 on Elev. 45' for another example

3622 Other than openings at corners—structure in very good condition.

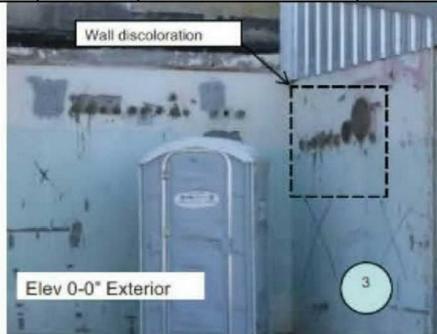
Item 3 –2008 Detail Exposed ISS Closure Details SW Wall of Building Exterior minor corrosion

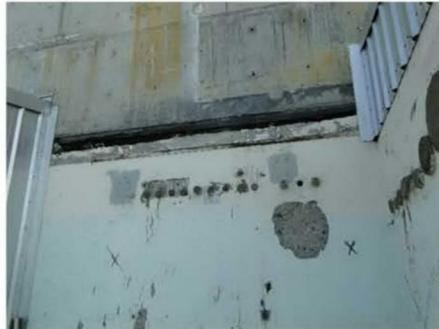
#	New Photo #	Description	Area / Location	Recommendation	Notes
Item # 3	3655	Exposed ISS Closure Details SW Wall of Building	Exterior, Elev. 0'-0"	Recommend plugging conduit opening on exterior	Open conduit

3655 Open Conduit

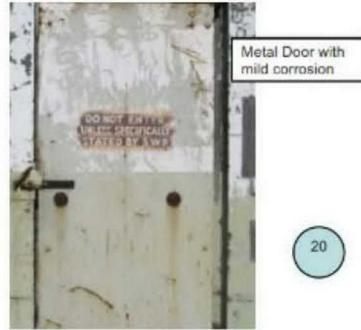
Item # 20 2008 Detail – Existing Metal door @ SE of Exterior building Elevation 0'0"

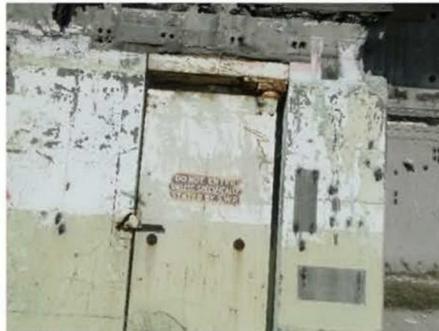
4. Attachment C-1; photo 3594 and 3646, and item 21 from 2008, show the interior and exterior of a steel door on the rear face that exhibit a good deal of corrosion on the outside at its base and some dampness and corrosion on the inside at this location.

3646 Rear face shield door. See picture # 3594. Possible WEATHER Protection issue
See pic # 3594 @ 0' level interior

1. SSE Structure – investigate the slow water in-leakage at the 0'0" pourback and corrosion at the 0'0" rear face door.
2. SSE Electrical – install a cover on the open J-box in the vestibule.
3. Update the contact information on the vestibule door.
4. Future use of surveillance routes and S&M Plan revision should be considered to reflect actual conditions / maps in the SSE and to provide guidance when and how Routes 3 to the Inner Rod Room at grade elevation shown in the S&M Plan Figure 2-1 should be used.

Item # 20	3646 3647	Existing Metal Door at SE of Exterior Building, Rear face shield door	Exterior, Elev. 0'-0"	Continue to observe, repair or replace with a pourback or plate if significant corrosion continues	See #3594 at 0" interior, minor corrosion

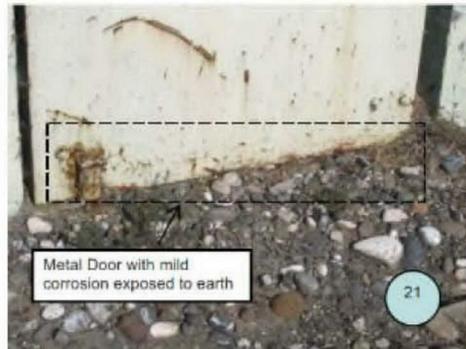
Item 21 – 2008 Detail Existing Reactor Metal Door at SE of Exterior Building Area , Elev. 0'-0", minor corrosion, soil removal recommended

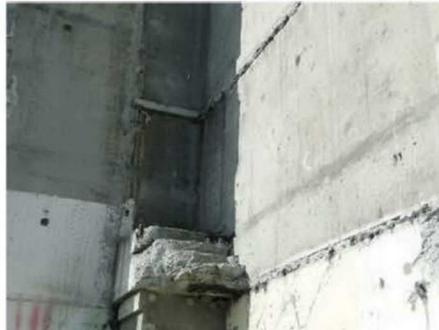
3642 Grass growing on ledge

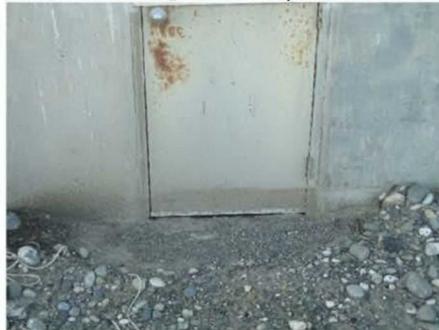
3641 Area of soil removal needs to be more of a gradual slope rather than a hole funneling rain water to the bottom of door jam.

Item # 33	3640 3641	Metal Door at N Wall of Building Exterior	Exterior, Elev. 0'-0"	Area of soil removal needs to be more of a gradual slope rather than a hole funneling right to the bottom of the door jam	Mild corrosion

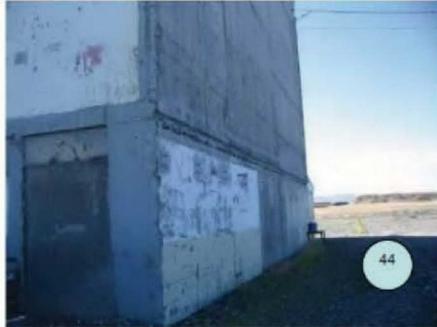
Item 44 – 2008 detail View of NW Wall of Building Exterior, from Elev. 0'-0"

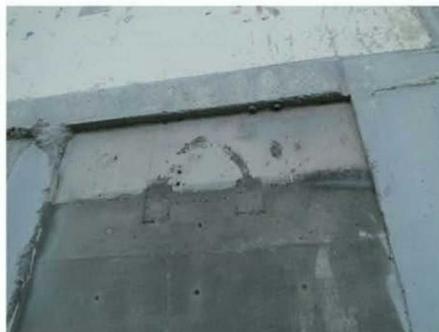
3631 Concrete pourback has cracks across top...Not an issue but should be watched for changes.

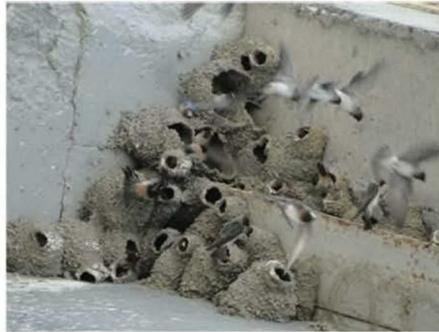
3638 swallows nesting

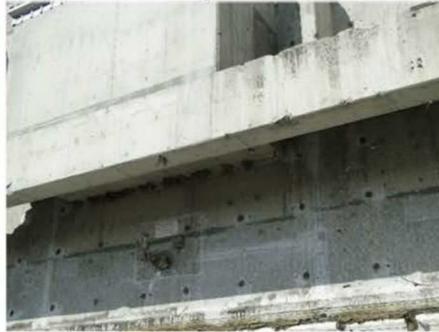
3644 swallow nests under ledge

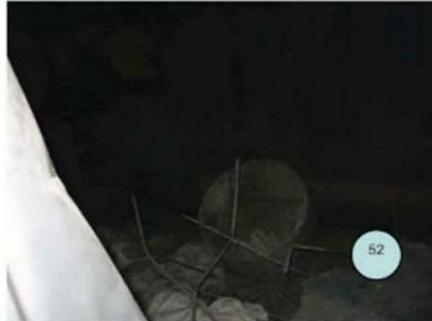
Item 52 2008 detail ISS Details rebar and pour back, no visible structural defects

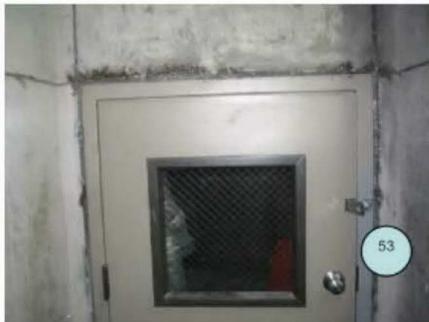
Item # 53 2008 Detail ISS Door Detail, Elev. -17'-6", no visible structural degradation

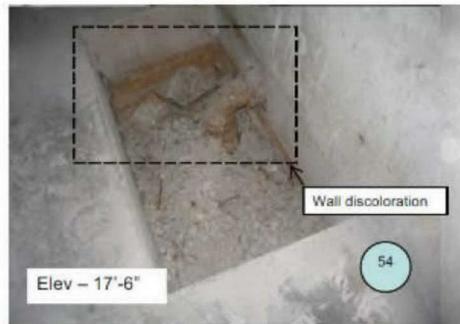
Item # 54 2008 Original Building Structure Floor Detail, Elev. -17'-6", moderate corrosion

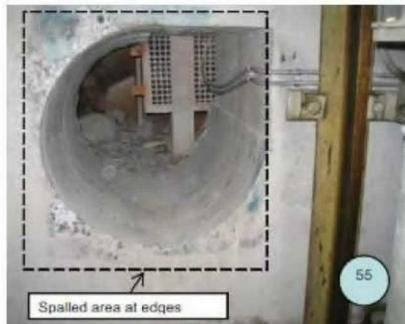
Item # 55 2008 detail spalling

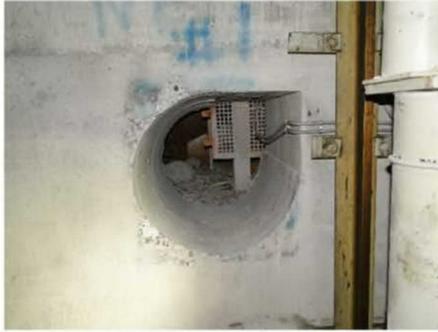
3584 View into water tunnel... Dry

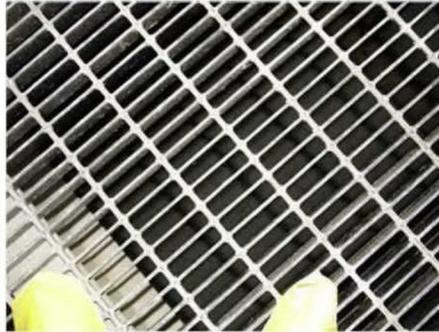
3590 -10' level Dried mud several feet below grating floor (@ -17' grade). Mud dried like tile pattern...cracked mud floor..very dry for a long time.

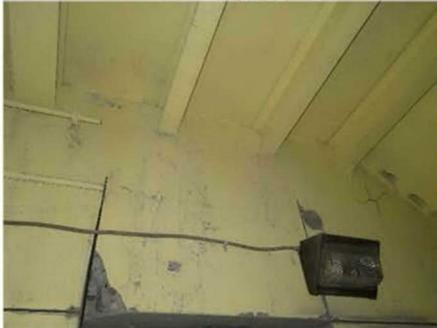
3591 No spalling—piece came out during saw cut of doorway

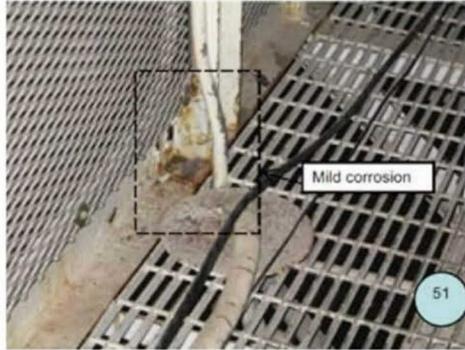
Item # 51 2008 Original Building Structural details @ building interior moderate corrosion

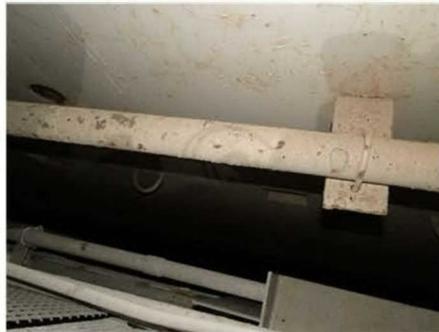
3596 D elevator pit Dry

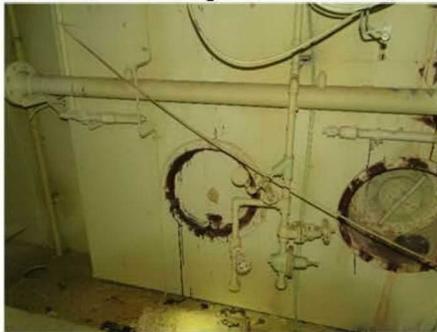
3598 No visible change

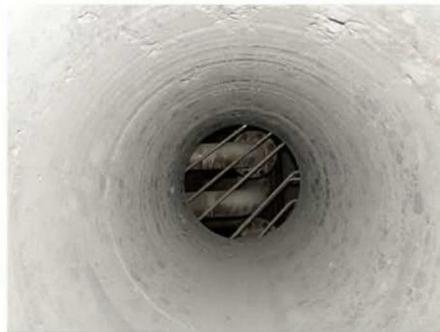
3599 Cutout to rear face

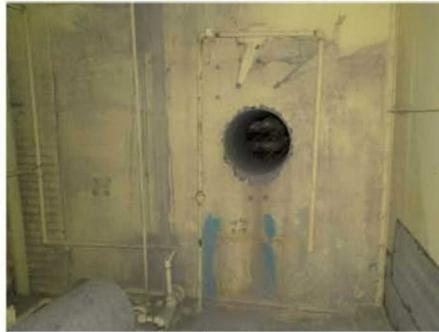
3600 Cut out to rear face

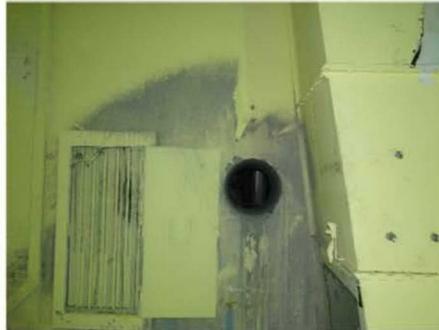
3603 Cut out to rear face

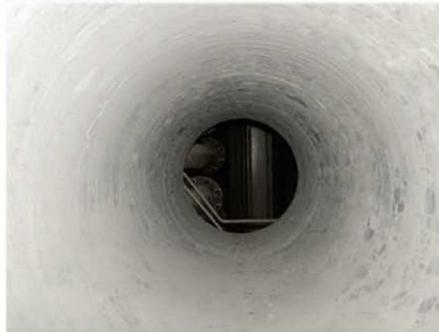
3604 Cut out to rear face

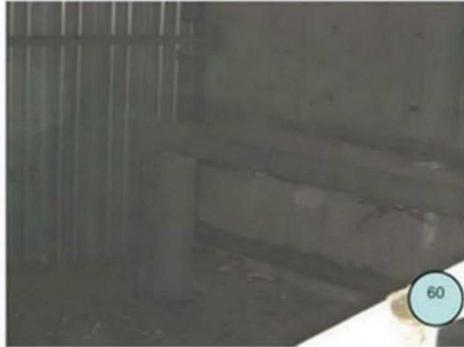
Item 60 –2008 Detail ISS Details, walls & girts, Elev. 45'-2 1/4", no visible structural defects

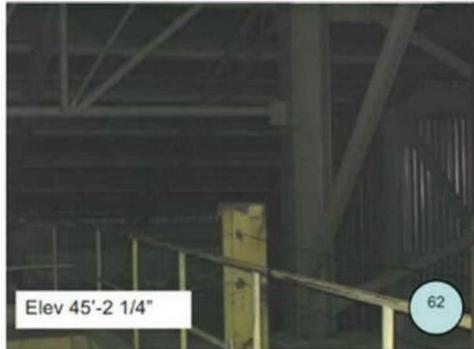
Item 62 2008 Detail – ISS Details, Columns & Beams, Elev. 45'-2 1/4", no visible structural defects

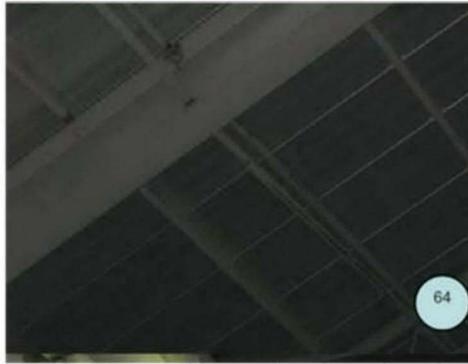
Item 64 – 2008 Detail SS Details, rafters, Elev. 45'-2 1/4", no visible structural defects

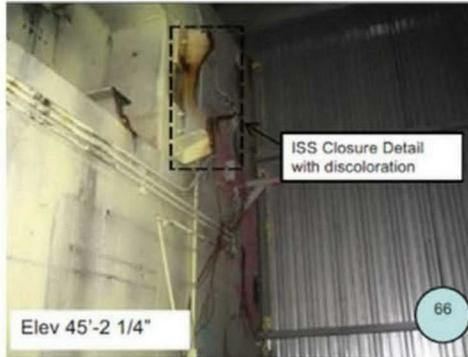
Item 66 – 2008 Detail ISS Details, Original Beam, Elev. 45'-2 1/4", no further structural degradation

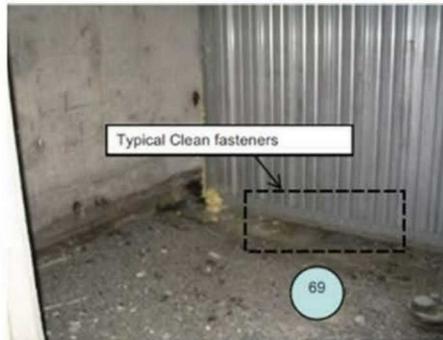
Item 69 – 2008 Detail ISS Details, fasteners, Elev. 45'- 2 1/4", no visible structural defects

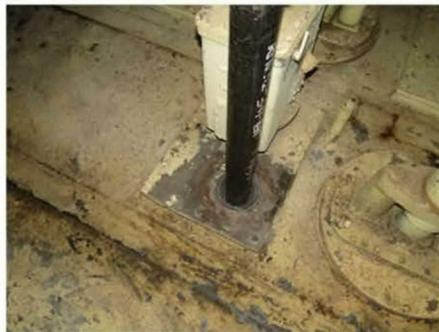
3611 vent penetration to top of reactor block / below HEPA filter housing

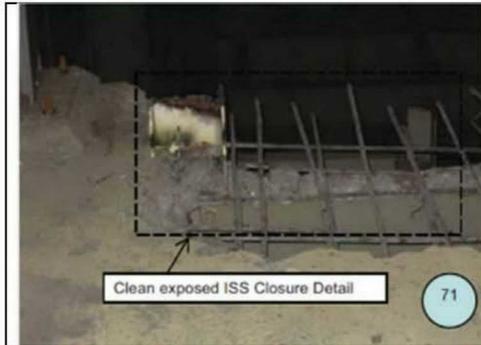
Item 71 –2008 Detail ISS Details, removed original structure, Elev. 59'-4", no further structural damage

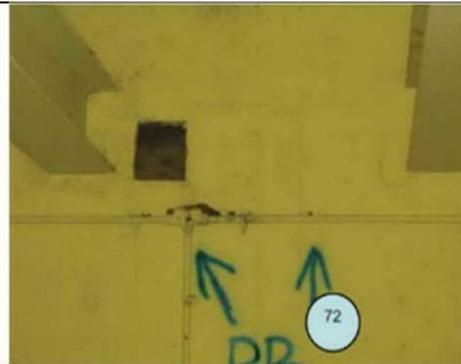
Item 72 – 2008 Detail ISS Details, pourbacks, Elev. 59'- 4", no visible structural defects

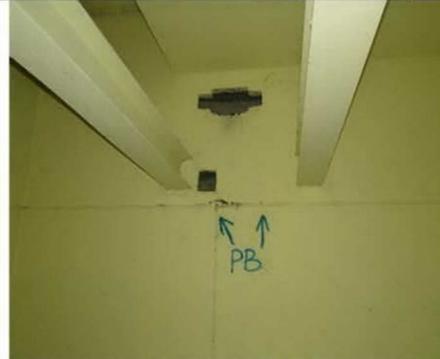
3624 No change to condition

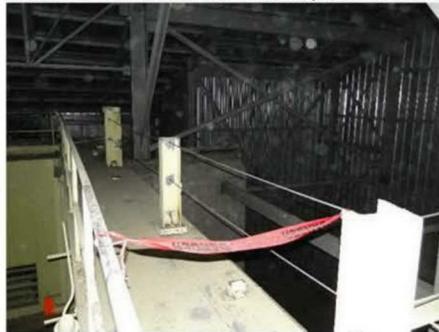
3619 Demolition beyond access boundary

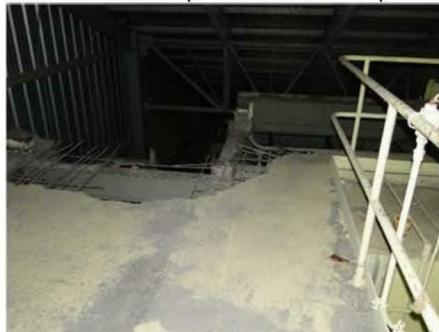
3620 Demolition beyond access boundary

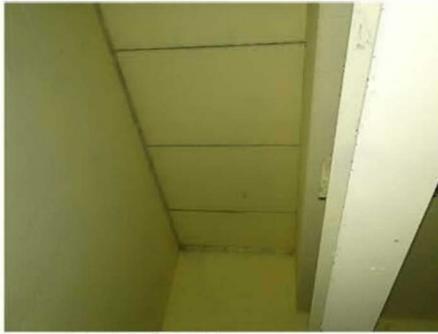
3625 old ceiling/roof plugs

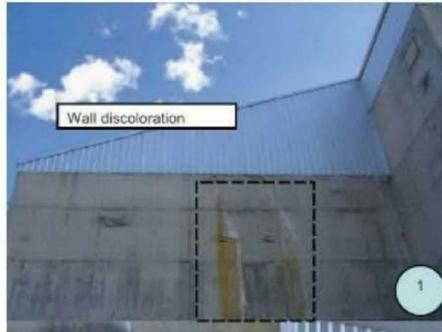
Item 1 – 2008 Detail Wall Discoloration at SW Wall of Building Exterior, Elev. 0'-0", minor corrosion

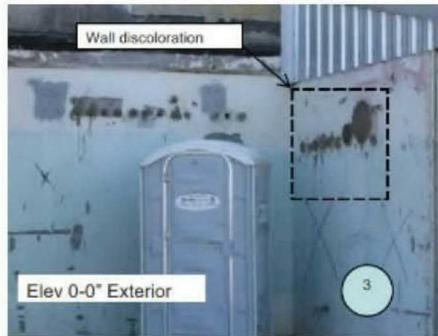
Item 3 –2008 Detail Exposed ISS Closure Details SW Wall of Building Exterior minor corrosion

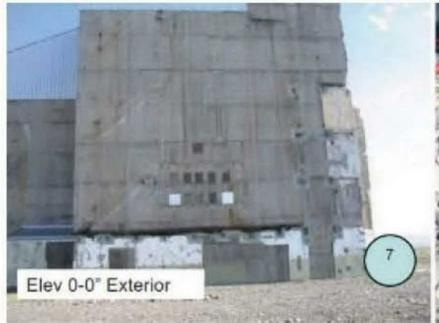
Item 7 – 2008 Detail View of South Wall, Elevation 0'-0"

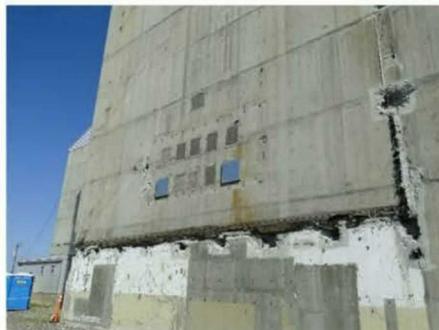
3652 HEPA Filter covers on south side of building, HEPA filter noted on interior +15' Experimental Room

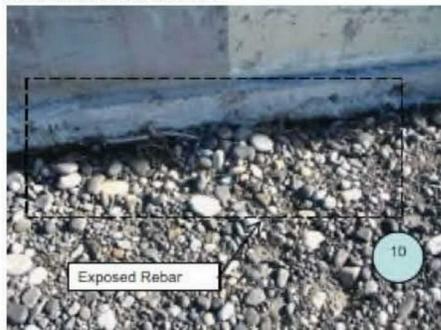
Item 10 –2008 Detail Exposed Foundation/Floor Rebar at S Wall of Building Exterior, Elev. 0'-0", recommend soil removal

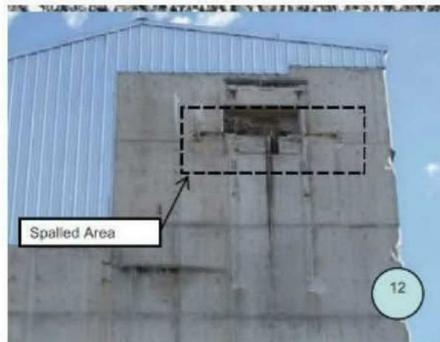
Item 12 – 2008 Detail Exposed Aggregate Detail at S Wall of Building Exterior, as seen from Elev. 0'-0", no visible defect

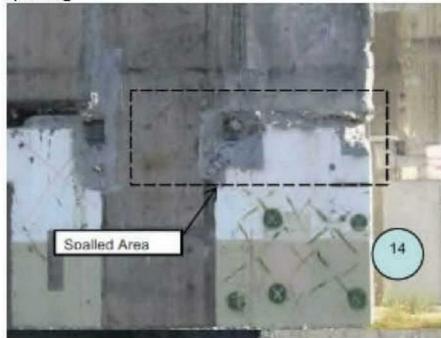
Item 14 2008 Detail- Exposed Aggregate at SE Wall Corner of Building Exterior, Elev. 0'-0", spalling

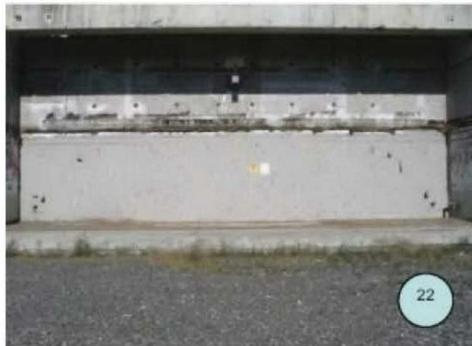
Item 22 – 2008 Detail ISS Closure Detail , Elev. 0'-0", no visible defect

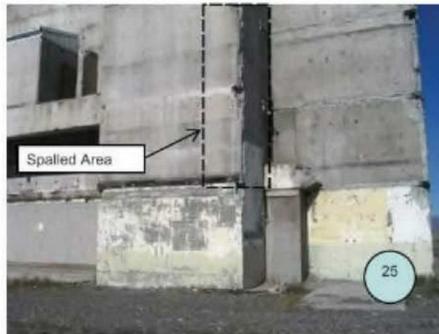
Item 25 –2008 Detail Exposed Aggregate at E Corner Wall of Building Area , Elev. 0'-0", spalling

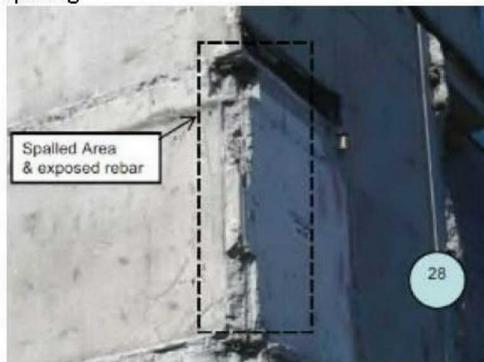
Item 28 –2008 Detail Exposed Aggregate at E Corner Wall of Building Area , Elev. 0'-0", spalling

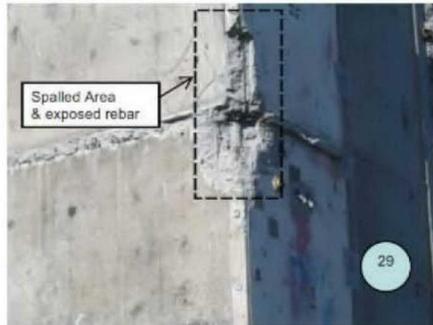
Item 29 –2008 Detail Exposed Aggregate at NE Corner Wall of Building Exterior, Elev. 0'-0", spalling

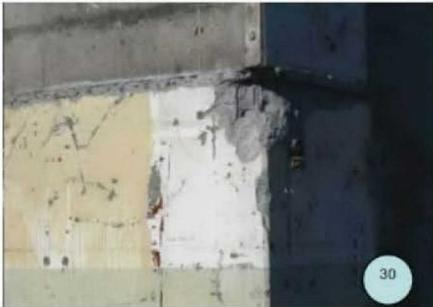
Item 30 – 2008 Detail Exposed Aggregate at NE Corner Wall of Building Exterior, Elev. 0'-0", spalling

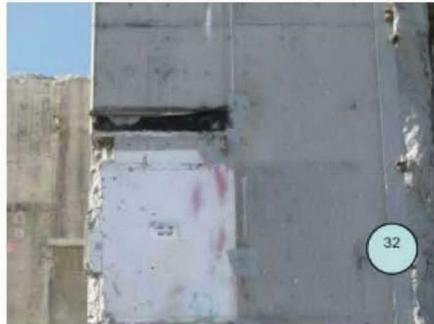
Item 32 2008 Detail Exposed Aggregate from ISS detail at Wall of Building Exterior, as seen from Elev. 0'-0", no further visible defect

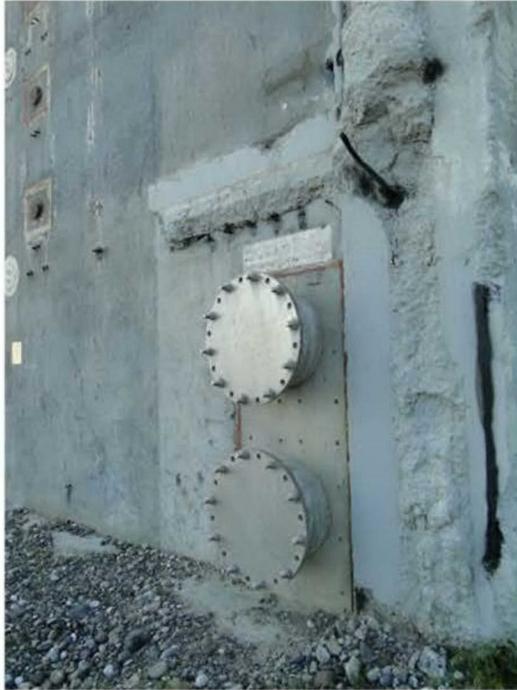
38 – Pourback ISS Detail at N Wall of Building Exterior, Elev. 0'-0", no visible defect

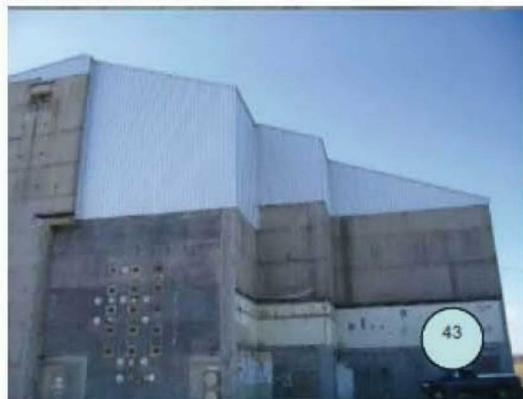
Item # 43 2008 Details Pourback ISS details @ NW wall of bldg. exterior

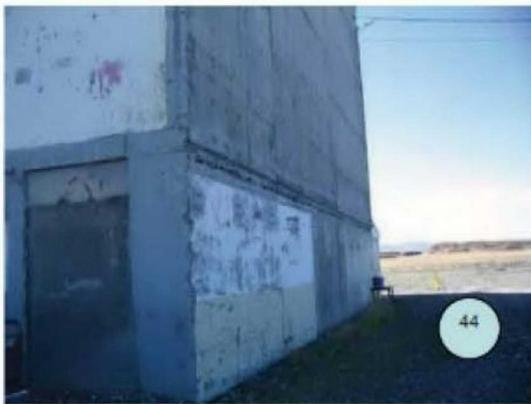
Item 44 – 2008 detail View of NW Wall of Building Exterior, from Elev. 0'-0"

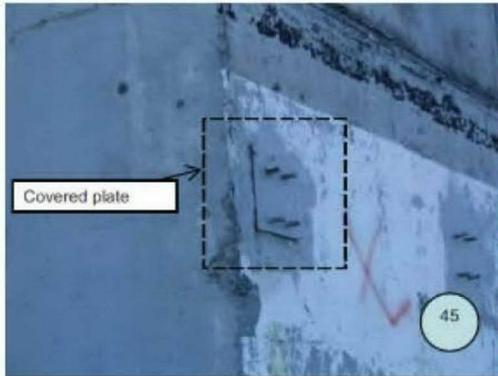
Item 45 –2008 detail Exposed ISS detail at NW Wall of Exterior Building, from Elev. 0'-0", no visible

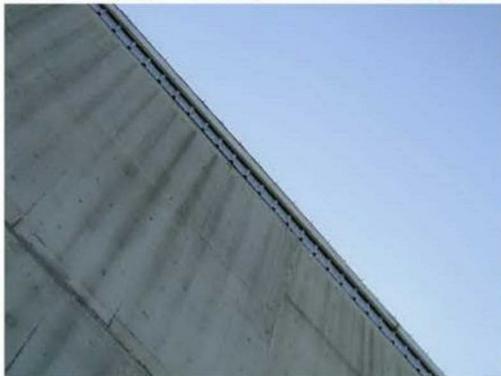
3630 general building exterior discoloration

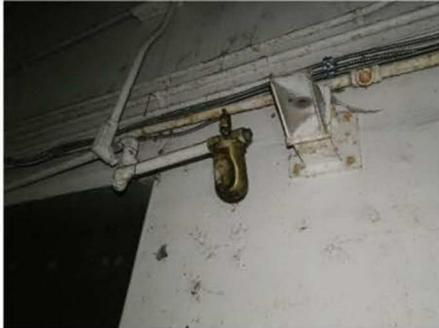
3538 Air line filter has residual fluid dripping from it

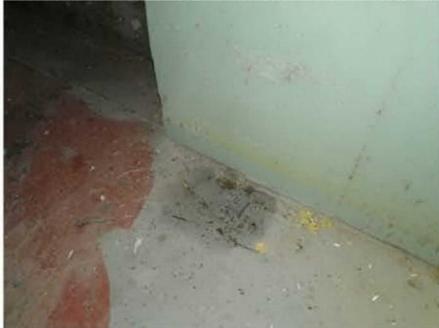
3539 floor below air line filter

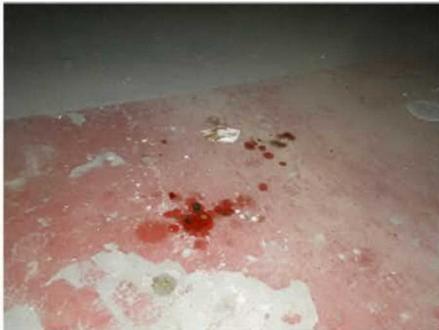
3540 under dripping winch from 40' level

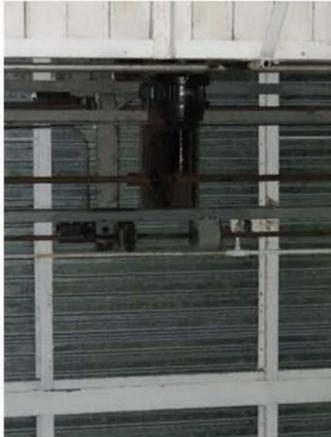
3542 looking up from 0' level up to 40' level above drip on floor..front face

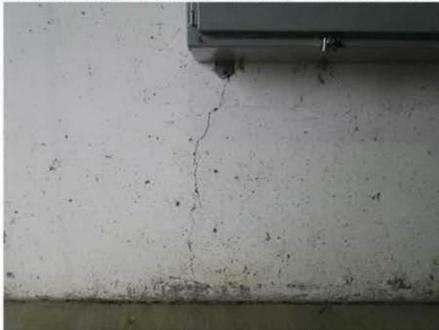
3543 inside vestibule crack on wall under electrical box

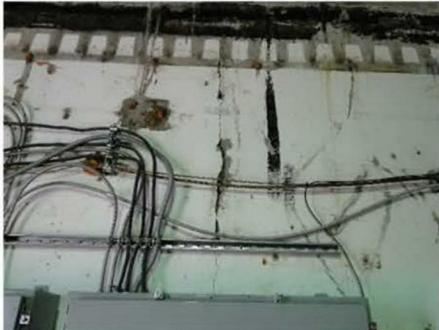
3544 vestibule crack

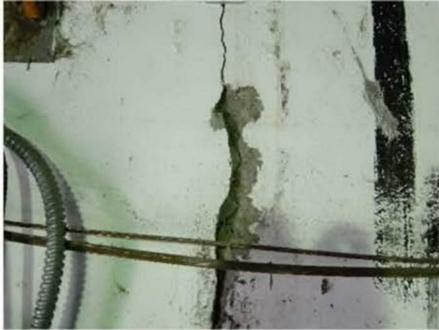
3545 vestibule crack

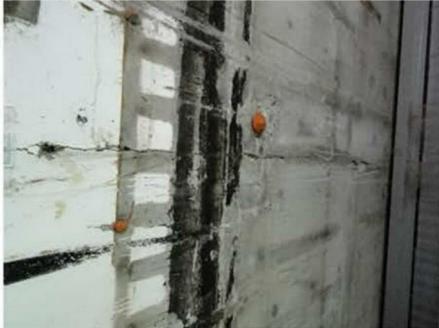
3546 vestibule crack

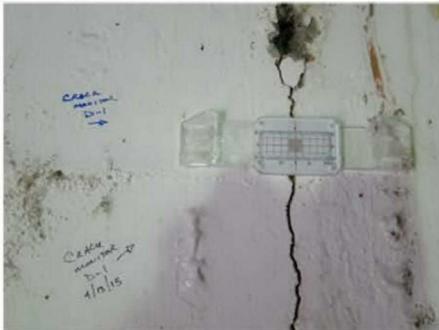
3561 crack monitor installed in vestibule on concrete wall crack

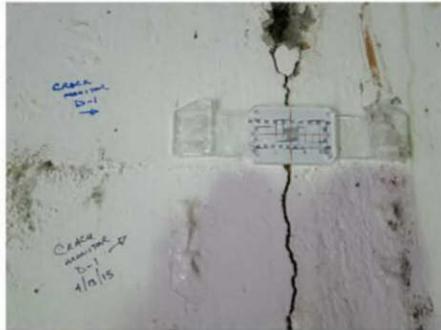
3562 Crack monitor installed in vestibule on concrete wall crack

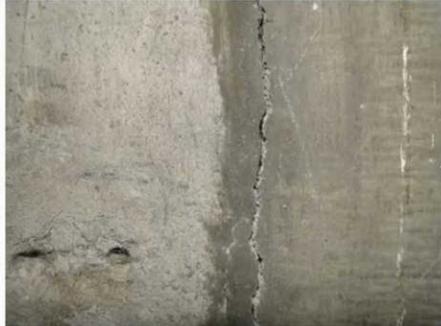
3659 Wall crack inside facility other side of vestibule wall

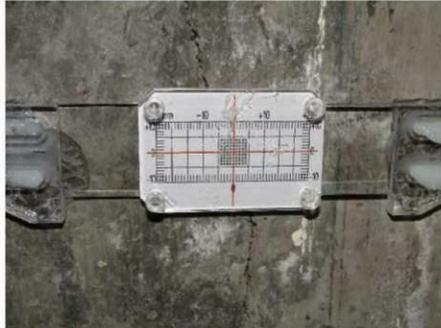
3669 Wall crack with crack monitor installed. Other side of vestibule wall

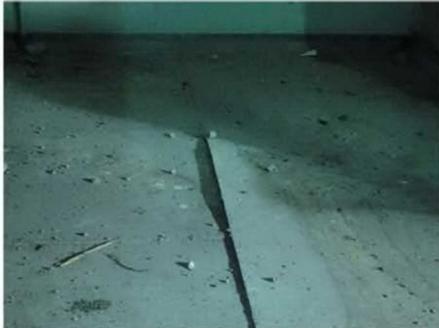
Item #	New Photo #	Description	Area / Location	Future Inspection/Maintenance Recommendations
14, 14A	3 505 3 506 3 507	Floor	Interior – Elev. 13'-0"	Floor panel previously just discolored, now seems to be lifting at edge Recommend continuing observation

3507 floor panel lifting at edge

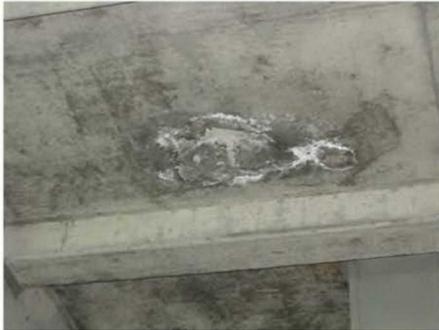
3509 White discoloration on surface of concrete looking up at ceiling in multiple locations

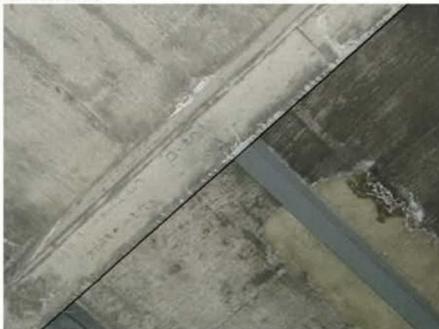
3508 White discoloration on surface of concrete looking up at ceiling in multiple locations

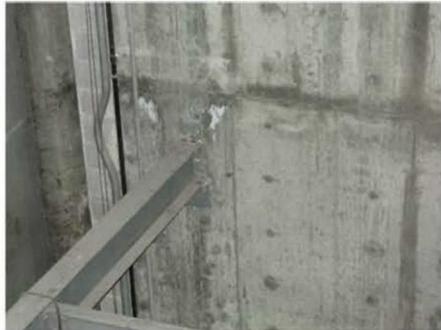
3510 White discoloration on surface of concrete looking up at ceiling in multiple locations

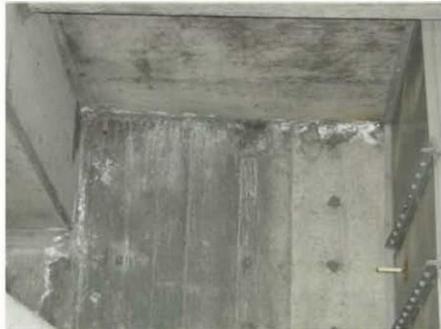
3511 White discoloration on surface of concrete looking up at ceiling in multiple locations

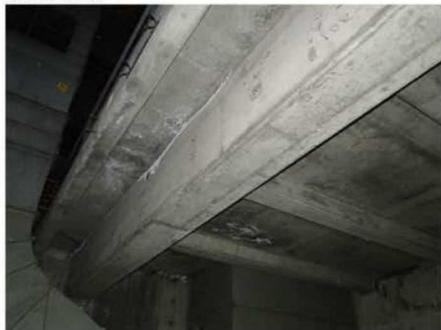
3512 White discoloration on surface of concrete looking up at ceiling in multiple locations

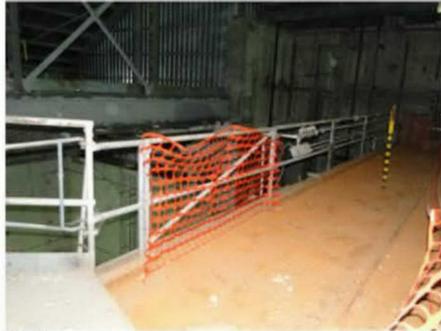
Item #	New Photo #	Description	Area / Location	Future Inspection/Maintenance Recommendations
19, 19A	3513	Guard Rails	42' 4 5/8"	Fall Hazard
	3516	Mechanical equipment blocking Surveillance path	42' 4 5/8"	S & M plan needs to be revised to show proper path. Unable to get all around top hat
	3530	Under side of floor above	42' 4 5/8"	42' elevation looking up under 56' elevation...several "holes" in floor with darkness around them... Same type of "holes" on other side of bldg. at exact same place....previous equipment used these penetrations Recommend continuing observation

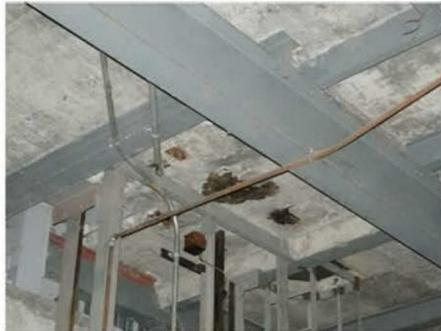
3530 at stairwell @ 42' elevation looking up under 56' elevation...several "holes" in floor with darkness around them... Same type of "holes" on other side of bldg. at exact same place....previous equipment used these penetrations

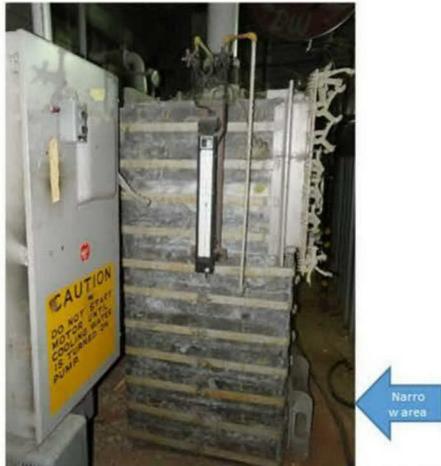
3516 On the current surveillance route behind the top hat on the west side... route should be revised so as not to walk "behind" the top hat. Very narrow area.

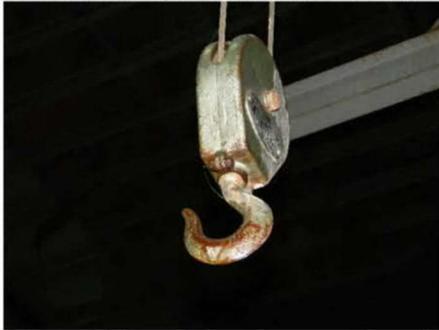
3515 Winch located above the reactor above the 80' elevation is leaking soil/grease. Oil/grease is dripping down chain/hood and floor below chain/hood which can be seen while standing in northwest portion of 56'4" level looking up.

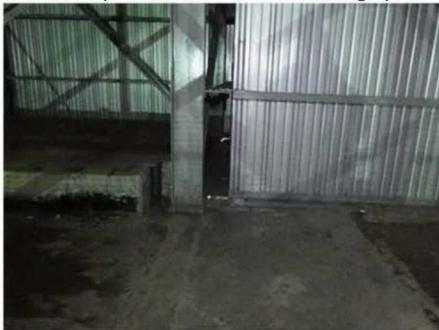
3519 On ease side of structure, various locations were observed in which light from the outside could be seen through gaps

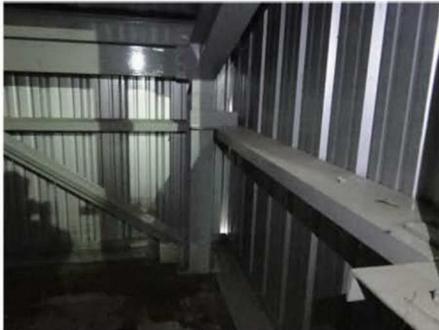
3520 On ease side of structure, various locations were observed in which light from the outside could be seen through gaps

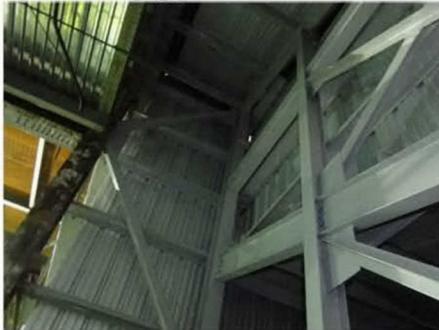
3521 On ease side of structure, various locations were observed in which light from the outside could be seen through gaps

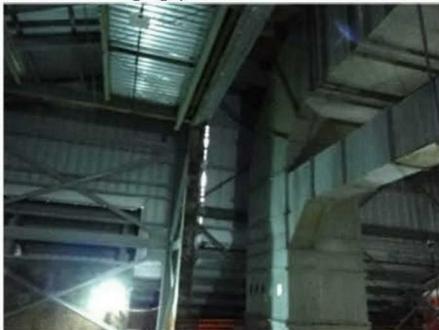
3522 On ease side of structure, various locations were observed in which light from the outside could be seen through gaps

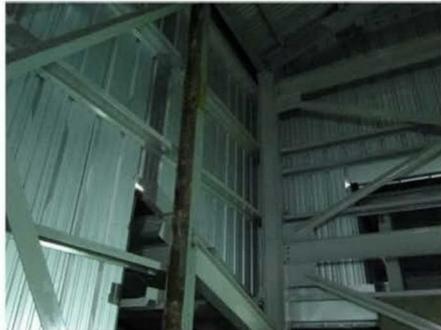
3523 On ease side of structure, various locations were observed in which light from the outside could be seen through gaps

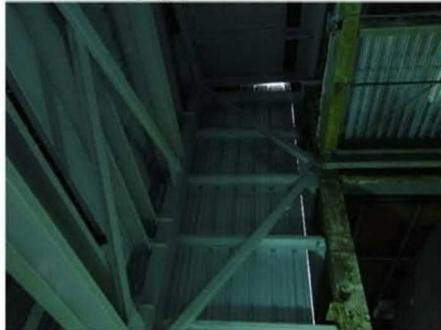
3524 On ease side of structure, various locations were observed in which light from the outside could be seen through gaps

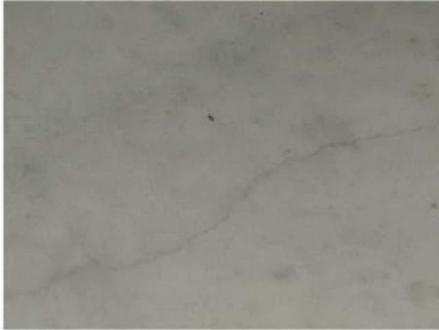
3526	Concrete "catwalk" area around top hat		Several hairline cracks in concrete in an area only a few feet long. Recommend continuing observation

3526 Same explanation as 3525—all cracks within a few feet of each other.

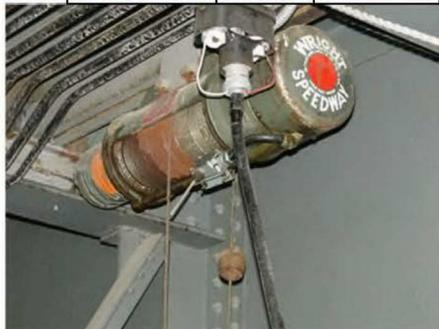
Item #	New Photo #	Description	Area / Location	Future Inspection/Maintenance Recommendations
	3527	Fluid dripping Winch	Elev. 80'-5 1/4"	Recommend continuing observation

3527 Winch located above the reactor above 80' elevation is leaking oil/grease. Oil/grease is dripping down chain/hook and floor below chain/hook which can be seen while standing in northwest portion of 56' elevation looking up

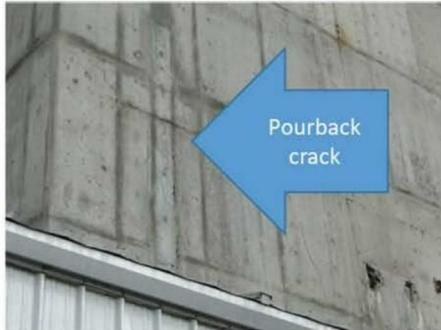
Item #	New Photo #	Description	Area / Location	Future Inspection/Maintenance Recommendations
	3547, 3548	Pourback above vestibule	Exterior Elev. 0'	Pourback appears to have begun to crack. No notations or pictures to show previous condition Recommend continuing observation
	3550, 3551	Metal roofline	Exterior Elev. 0'	Missing foam insert (both pics same location) West side of front face Recommend continuing observation
	3674	Pourback wall crack	Exterior Elev. 0'	See evaluation in Attachment A
	3676	Pourback wall crack	Exterior Elev. 0'	See evaluation in Attachment A

3547 outside above vestibule concrete pourback leading to crack in vestibule wall

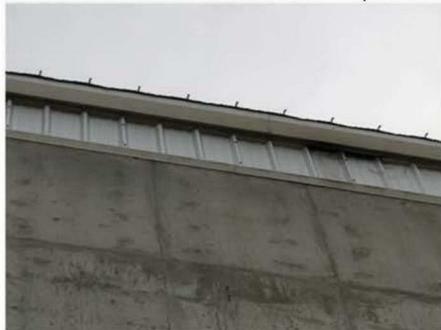
3550 Missing foam insert on west side of front face

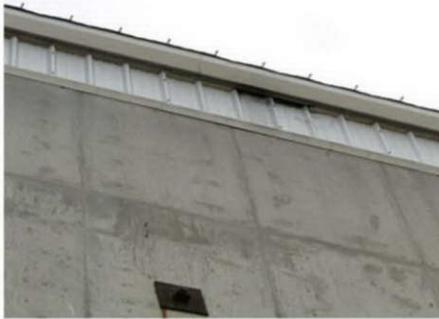
3551 Same spot as pic 3550 Missing foam insert on east side of front face

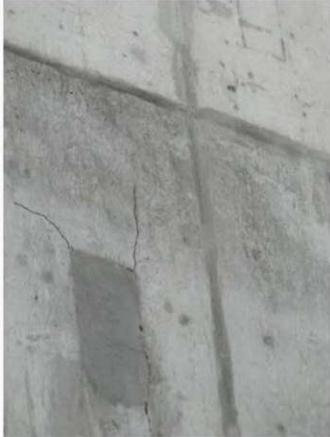
3674 Upper portion of cracked wall at pourback location

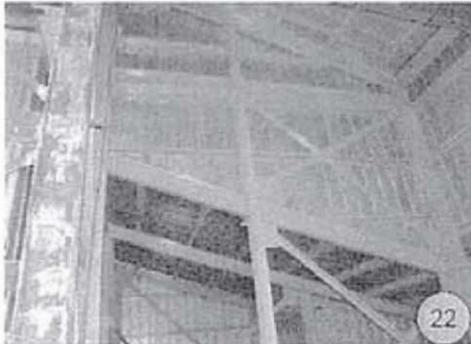
22 2009 Detail - Elev 56'-4", ISS Steel Beams, Gins. Braces & Columns, No Visible Issues No change to condition.

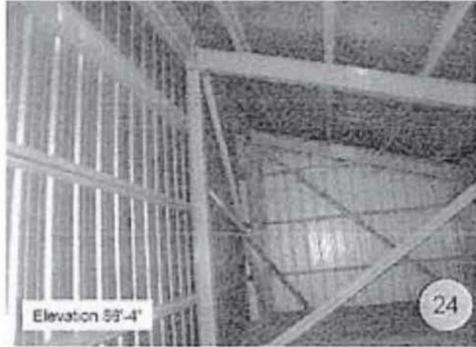
24 – 2009 Detail - Elev 56'-4", ISS Steel Beams, Girts, Braces & Columns, No Visible Issues

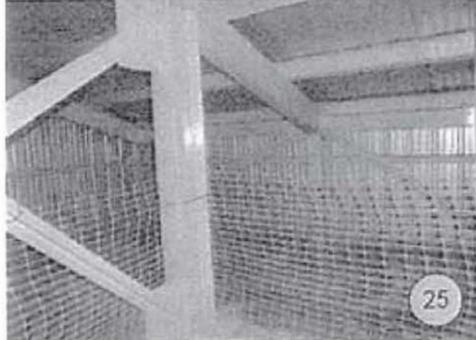
25 2009 Detail - Elev 56'-4", ISS Steel Beams, Girts, Braces & Columns, No Visible Issues

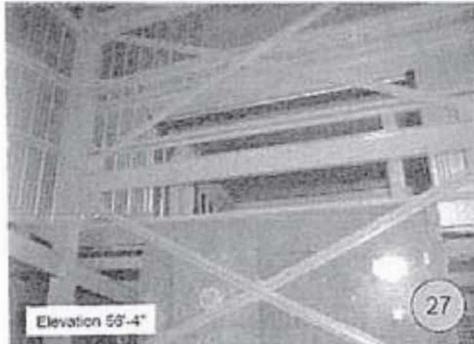
27 2009 Detail - Elev 56'-4", ISS Steel Beams, Girts, Braces & Columns, No Visible Issues No change to condition

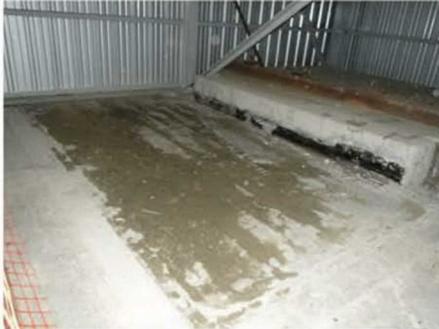
3517 Possible old roofing area with residual adhesive from previous roofing material (asphalt)???
