Five-Year Surveillance Report for the 105-C, 105-D, 105-H, 105-F and 105-N/109-N Safe Storage Enclosures

Document Type: RPT

D. G. Ranade
Mission Support Alliance

Date Published
March 2016

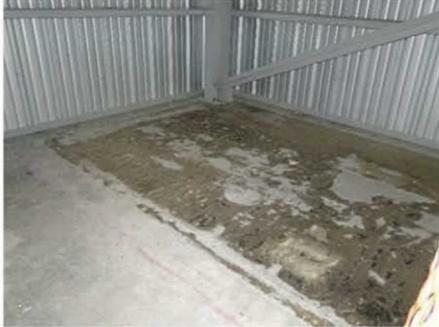
3518 same detail as 3517

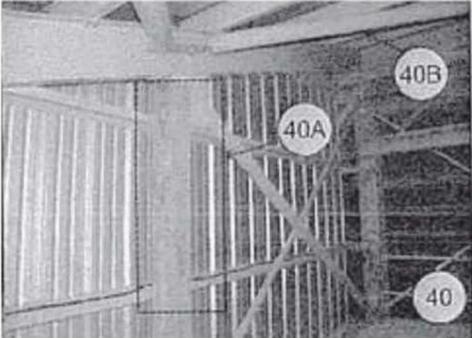
40A 2009 Detail - Elev 801-5 1/4", Column, Discoloration

40B 2009 Detail - Elev 80'-5 1/4", ISS Cross Brace, No Visible Issues No change to area condition

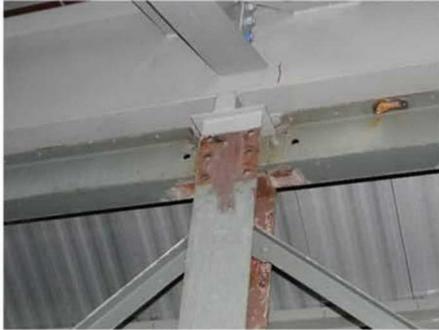
3528 Old pics 41, 41A, 42a 42b 42c Series of beams missing bolts.. appear to be unused structurally. Have been replaced with larger beam above and taken out of service

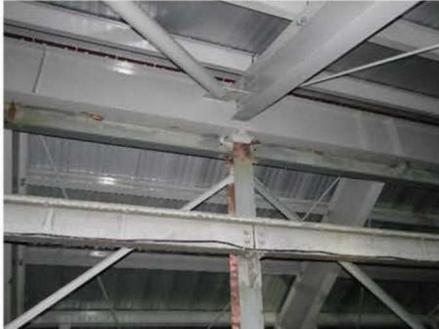
3529 Series of beams missing bolts.. appear to be unused structurally. Have been replaced with larger beam above and taken out of service 41 2015 Detail

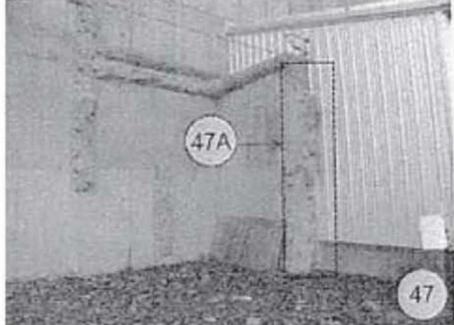
47A 2009 Detail - Elev 01-0", Concrete Wall, Existing Exposed Aggregate No change to area condition

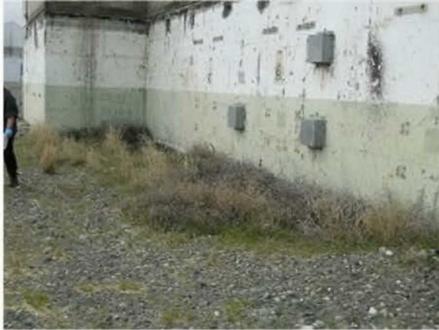
3555 tumbleweed accumulation and exposed rebar at dirt level on east side of SSE Old pic 48

- B. Exterior Conditions
 - i. Swallow nests were noted at various locations on the exterior of the facility. Locations of the nests don't appear to be a current problem. Photos are shown in Attachment D, Photos 3497, 3549, 3552, 3553, 3554, 3558, and 3559.
ASSESSMENT / RECOMMENDED ACTION: If recommended actions for Item in Section A, vi, suggest removal of nests.
 - ii. Foam insert appeared to be missing on the west side of the SSE (outside of front face) located on the bottom edge of the siding. Photo is shown in Attachment C, Photo 3550.
ASSESSMENT / RECOMMENDED ACTION: Same recommended action as Section A, vi.
 - iii. Tumbleweed accumulation on east side of SSE. Photos are shown in Attachment D, Photos 3556 and 3557.
ASSESSMENT / RECOMMENDED ACTION: Periodic removal of tumbleweeds is suggested.

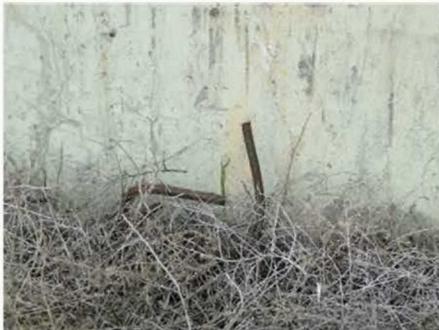
3556 same rebar as pic 3555 on east side of facility.

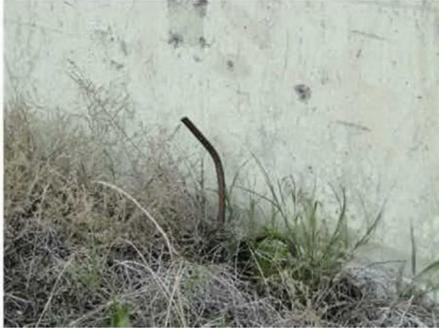
3557 same rebar as pic 3555 on east side of facility

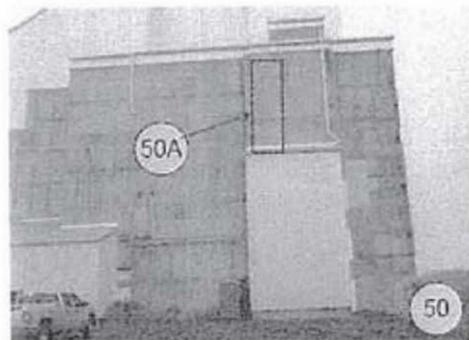
50A – 2009 Detail Exterior, Concrete Wall, Minor Corrosion No change to condition See pics 3547 3548 for vicinity area of concern...

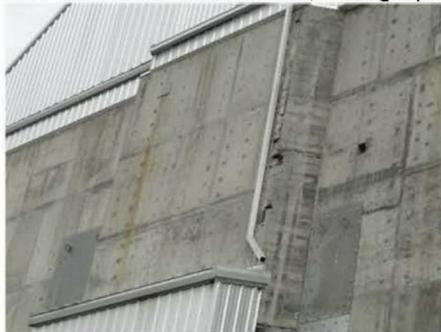
3560 Rust discoloration on south side of SSE

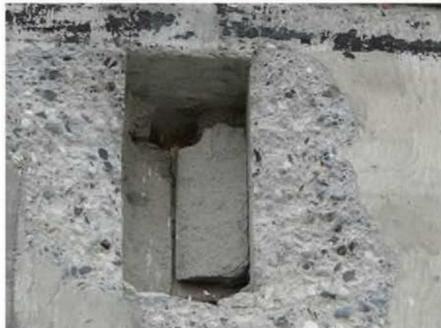
3497 Swallow nest inside beam cavit. On west side of front face wall.

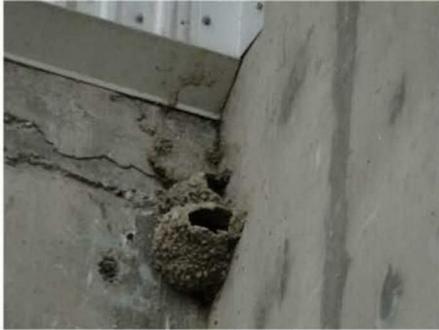
3552 bird nests

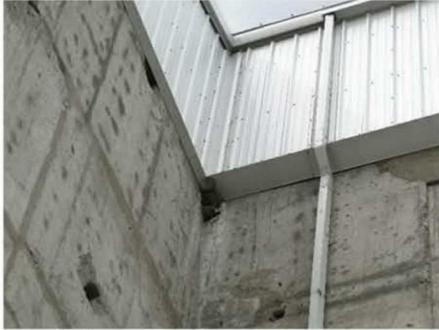
3553 bird nests

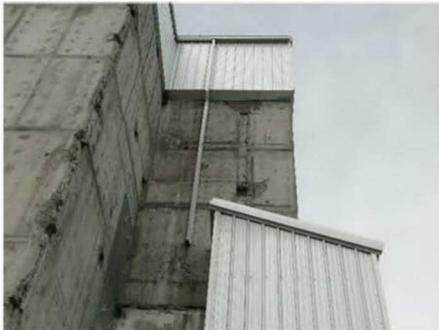
3554 bird nests

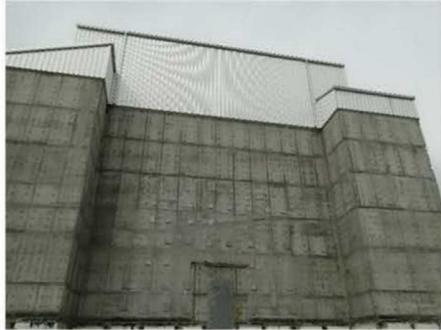
3558 bird nests

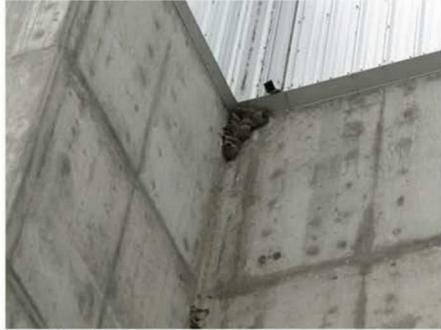
3559 bird nests

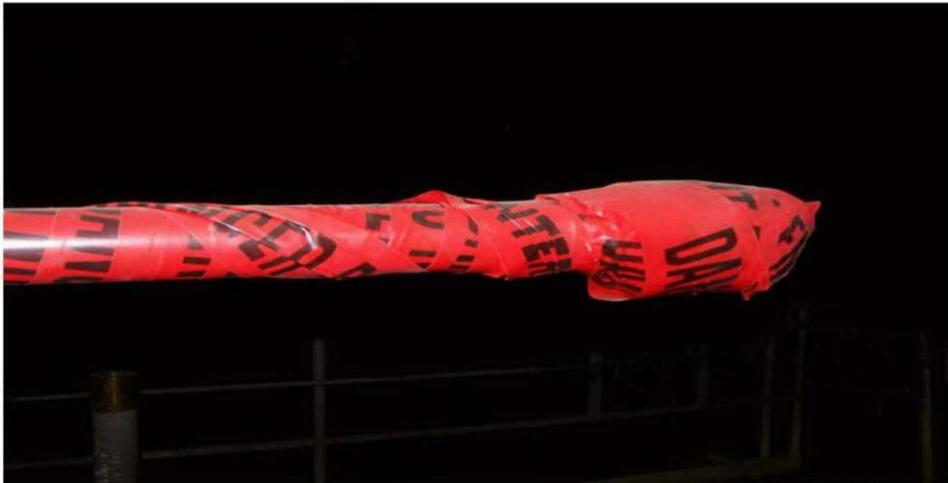
Photo 3

- Rise on top steps of bridge are taller than normal making this small stair case ununiformed.
- Speed rail extends out past bridge when crossing onto the "top hat" area. Rail padded and covered in Red "Danger" tape. (Photo 3)
- "Top hat" floor has approx. 1" rib at seam posing a tripping hazard (Painted Orange). (Photo 4)

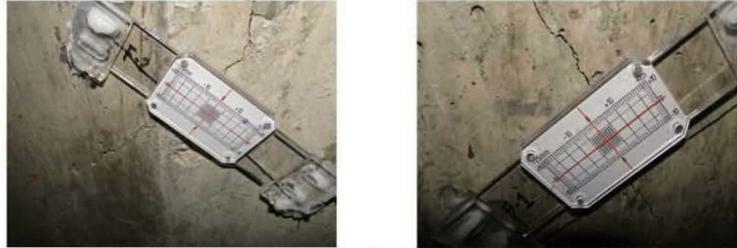
ASSESSMENT / ACTION – The fact similar infills / patches appear at all three original production reactor buildings indicates a common purpose (unknown) and design of the infill at some previous point in the facilities life span. This fact also eliminates any concern these cracks were caused by demolition of portions of the reactor building and or construction loading from the SSE.

To confirm that no significant movement is still occurring (or to quantify any future movement) a crack monitoring gauge was affixed on each crack as part of this inspection effort. Initial readings on both gauges (F-1 on the north side and F-2 on the south as shown in Figure 1 above and Attachment C-2 photos 3119, 3124, 3125) was 0-0 as shown. These readings are documented on the close-up photos of F-1 and F-2 shown in Figure 2 following affixing the crack monitors to the concrete wall with epoxy. Photos of the exterior area above the vestibule (similar to Attachment C-6, item 57 and photo 3015) are recommended on the annual inspection and it is strongly recommended that on every subsequent interior surveillance inspection collect and record the readings on these monitors to ensure that this is a stable situation or to quantify any current movement.

Figure 2 – Affixed Crack Monitors F-2 and F-1 (some parallax is evident in the photos, but straight on flash photos are unusable because of the glare of the flash on smooth plastic surfaces)

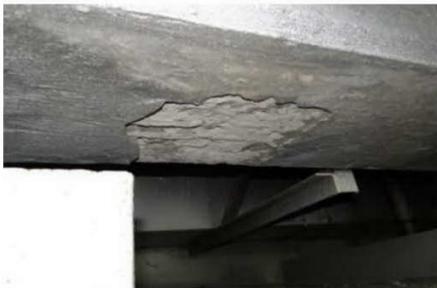
3020 Originally pictured crack in beam unverifiable. Evidence of spalling on underside of beam. Beam to ceiling joint intact. No indication of sagging of beam

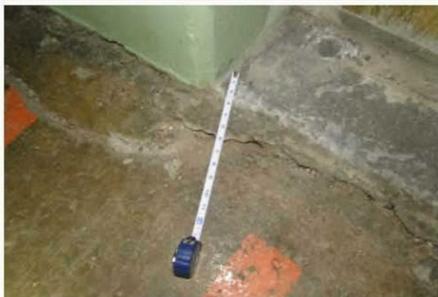
3032 No significant change since 2008

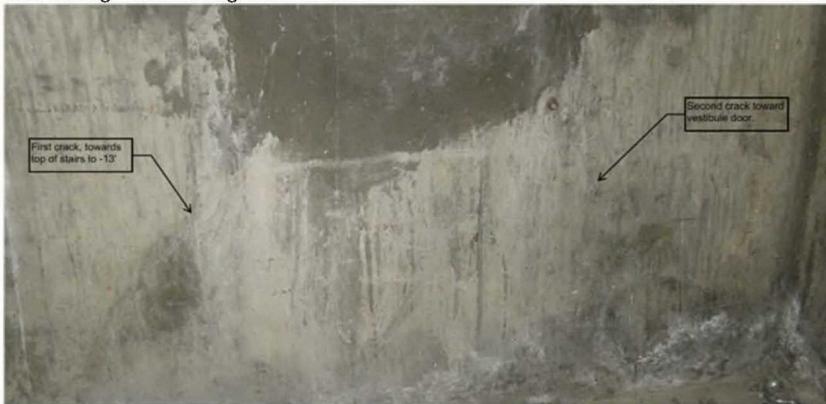
3031 No significant change since 2008.

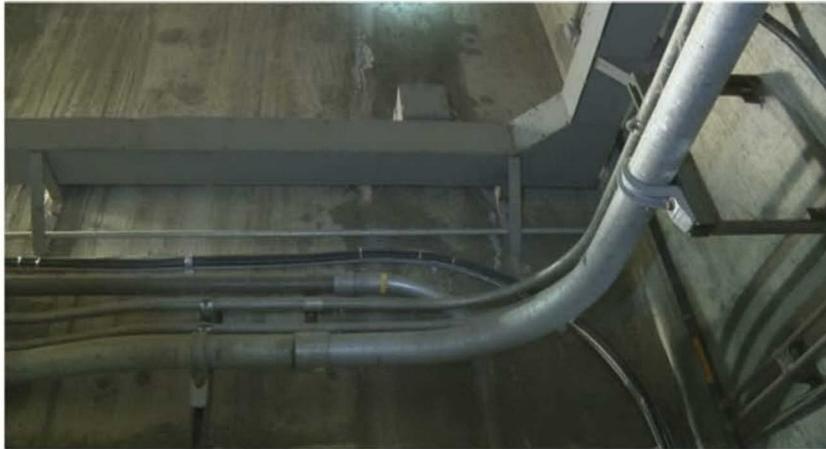
2982 Crack about 8 ft off floor

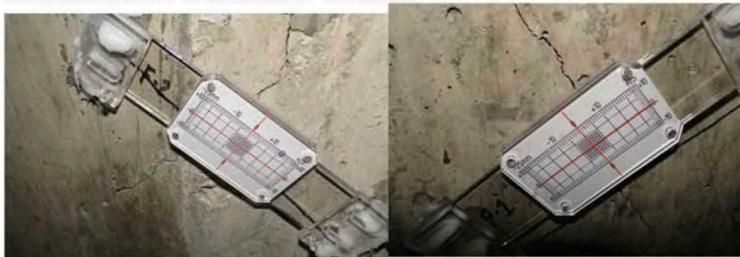
2014 Photo # 2984 Crack about 12 ft off floor

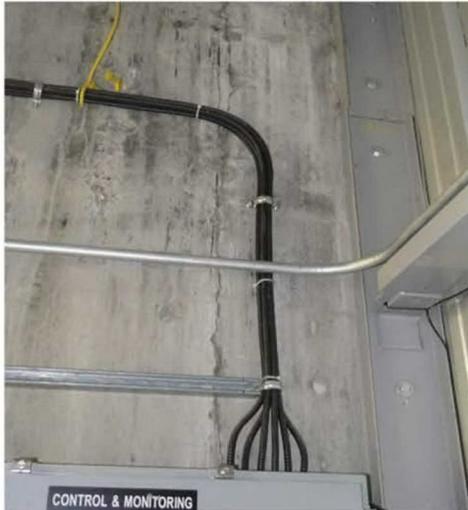
2014 Photos # 3124, 3125, 3119 As installed Crack Monitors at interior bottom corners of the infill

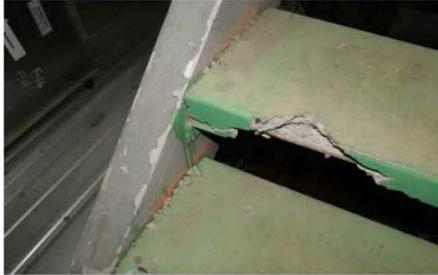
3050 No change since 2008. Safety and structural inspection concur stair is acceptable. Tread measures 10 ½ x 29 ½ x 2 ½ if tread replacement is ever planned.

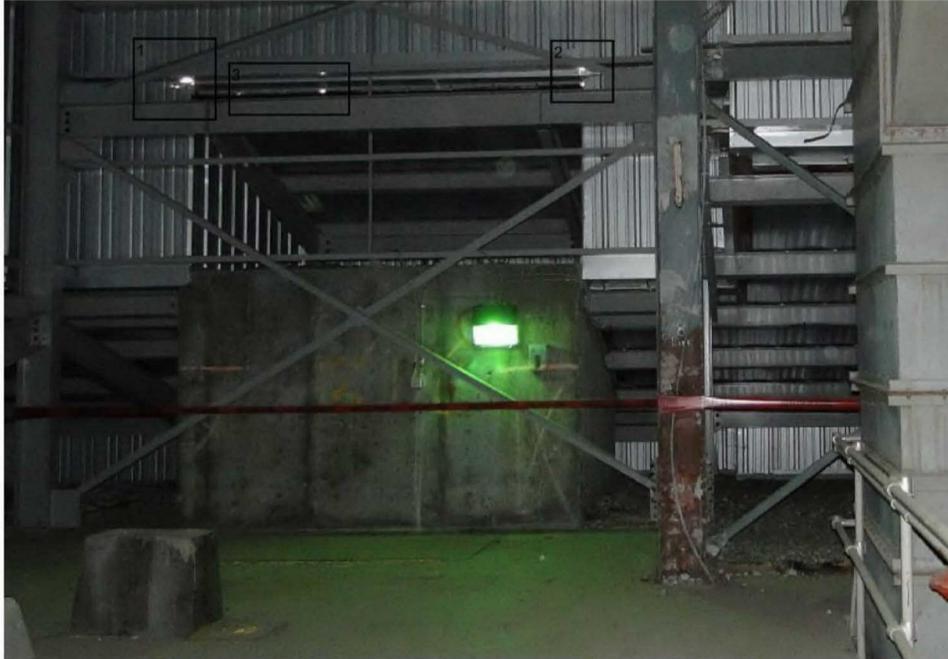
2014 Photo # 3087

2. Observation of SSE metal sheathing at the 56' and 80' levels showed multiple openings at junction points where outside light could be seen – evidence of a possible access point for small birds, bats, insects, spiders, etc. While not every pinpoint of outside light is big enough for bird or bat access, there is ample evidence of some bats being in the structure. If any closure of these openings is considered, timing is an issue with the biological team, but a program of maintenance may be recommended to close off the identifiable openings with a wire mesh or metal fabric from the outside. Adhesive or self-tapping screws with a non-corrosive metal mesh or metal fabric would seem to provide an effective and fast way to inhibit further entries, this approach would presumably use an articulated man-lift of significant size. Additionally, consideration for galvanic corrosion with the galvalum roof / siding materials must be accounted for when selecting a material for closure. The area shown in Attachment C-5, Items 31-34 and photo 3087 are typical instances. Scheduling of any maintenance program should be considered based on the Ref 4 input, and is recommended to be completed prior to extending the SSE surveillance periodicity.

Markup of photo 3087 showing 6 bright spots (outside light in 1 – large, 2- medium and 3-small spots) which are SSE openings to the outside for bat intrusion along one vertical to sloped siding junction. This photo is from the D Elevator area, 56' elevation, and looking west. This particular location shows a bit higher density of openings, but is somewhat typical of various sizes of openings that were observed at the 56' and 80' elevations.

1. SSE Structure – address numerous small openings in the steel siding prior to extending the time between inspections.
2. SSE Structure – annually visually monitor the crack above the vestibule and compare to earlier photos.
3. SSE Structure – record crack monitor quantitative information with each SSE entry in the future and evaluate building movement if any reading other than 0 – 0 is observed.
4. Include annual visual monitoring and quantitative record crack monitor readings (items 2 and 3 above) in the S&M Plan requirements when revised.
5. Future use of surveillance routes and S&M Plan revision should be considered to reflect actual conditions / maps in the SSE and to provide guidance when and how Routes 4 and 5 shown in the S&M Plan should be used.

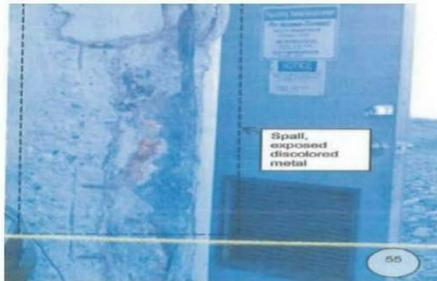
3012 Repair completed between surveillances. Concrete repair not holding up. Patch chipping away in places

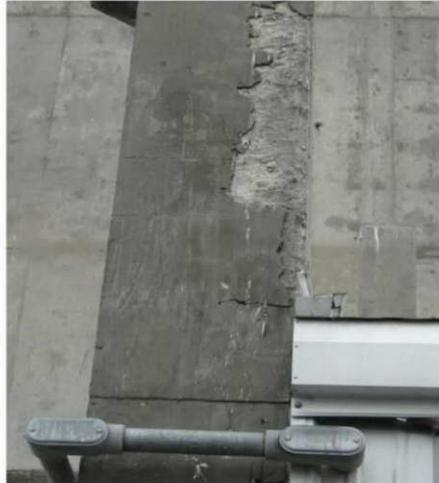
3014 2nd example of same patch failing, just above vestibule door.

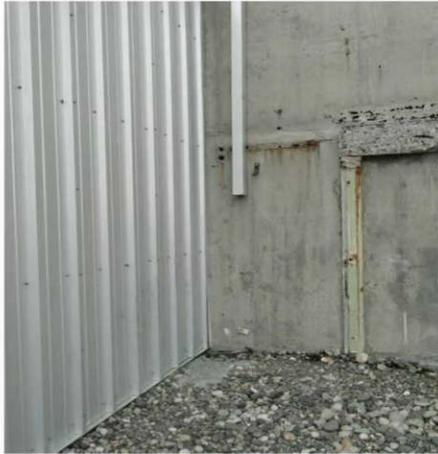
3016 Downspout at corner of building. Interior is dry.

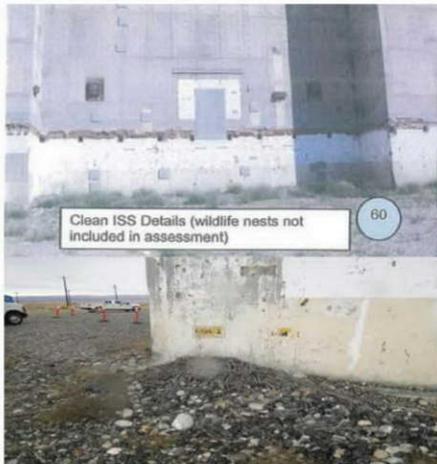
2995 No changes to building condition. Downspouts drain immediately adjacent to building from approx. 75'.

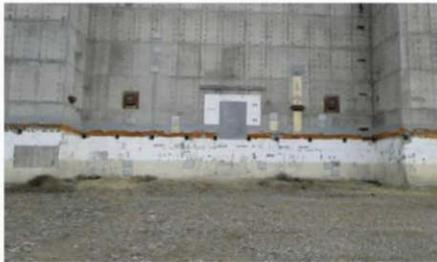
2996 No changes to building condition. Downspouts drain immediately adjacent to building from approx. 75'. Wildlife nests not included in assessments.

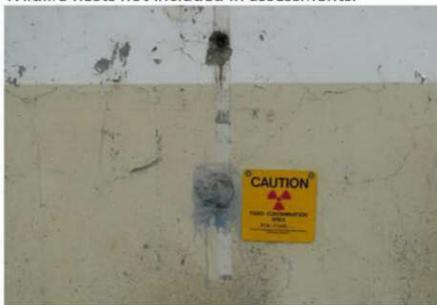
3019 Contamination spot (FCA-F-0001) on south wall. E of fuel discharge area.

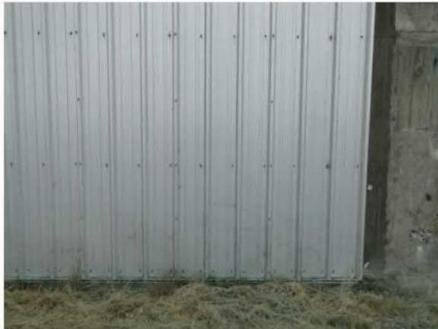
2991 Structural Steel around Route 4 access point was inspected for pattern suggest that "Man Door Knock Out" shown on 0105FDCC0005 / H187254 SHT01

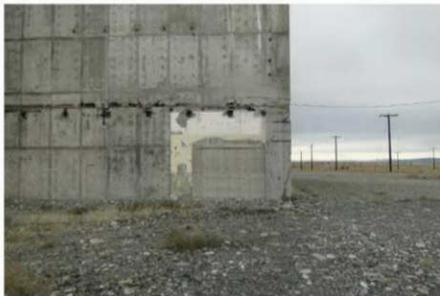
3004 Verified corner inside front face dry inside . Beam pockets no change

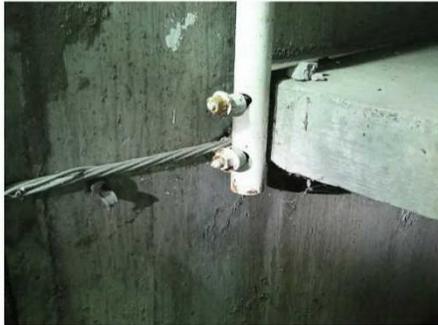
3025 No change. Remove from surveillance.

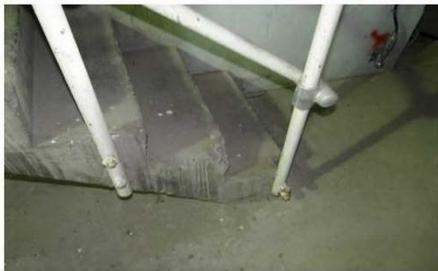
3026 No change since 2008. Remove from surveillance.

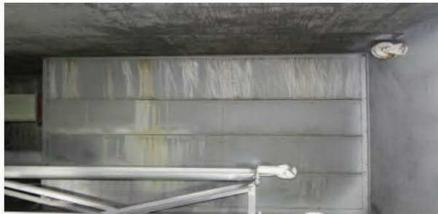
3027 No change since 2008. Remove from surveillance.

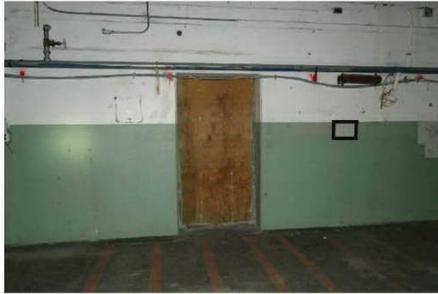
3029 No change since 2008.

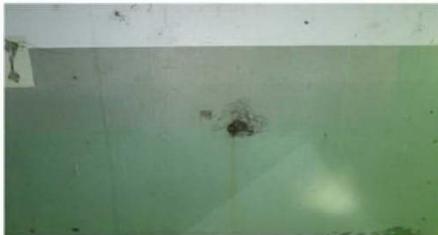
3034 No change since 2008. Remove from surveillance

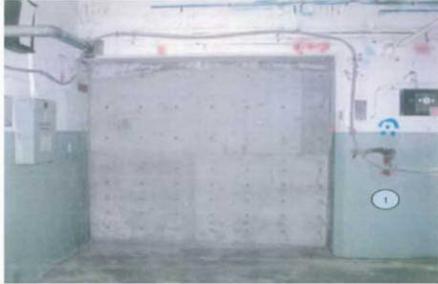
2008 Item mislabeled as 1, really 10

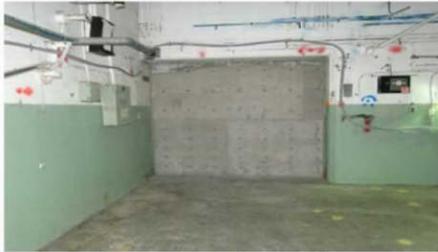
3035 No change since 2008. Dry all around and in corner.

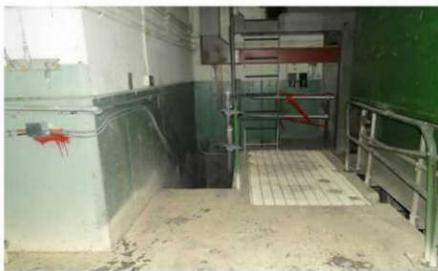
3037 No changes since 2008.

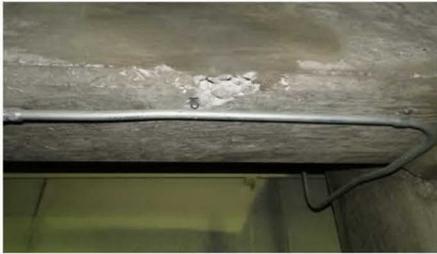
New Item 11A

3038 New spalling location to add to surveillance. No evidence this is new condition. Was not on surveillance route prior to 2014.

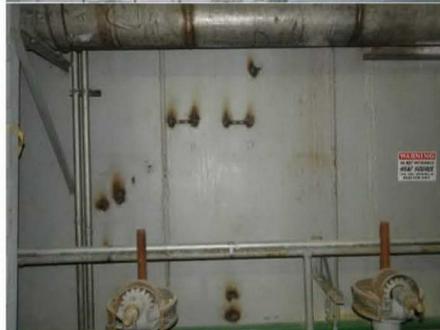
3040 No change since 2008.

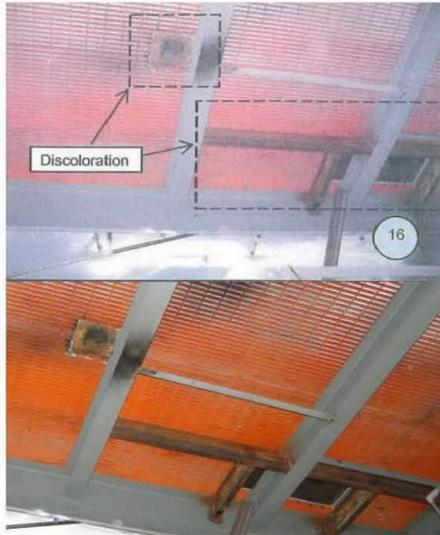
3031 No change since 2008

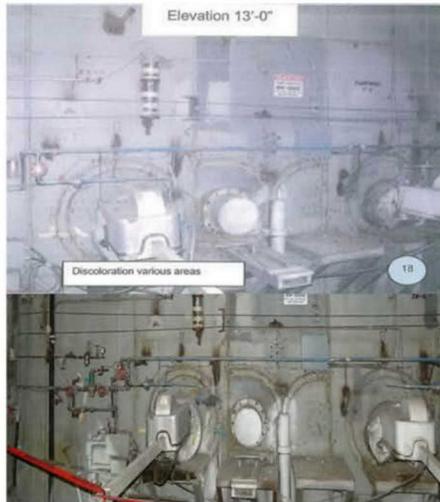
3043 No change since 2008.

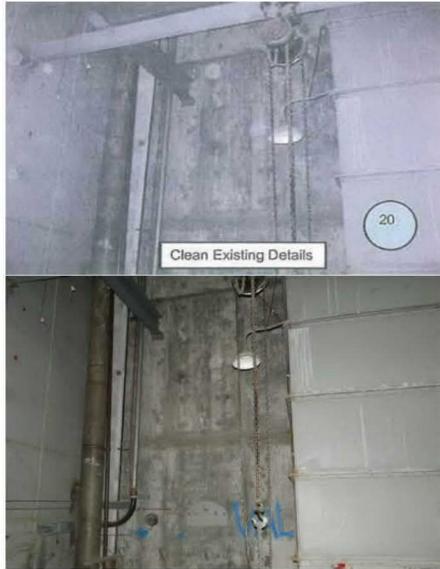
3044 No changes since 2008. Remove from surveillance.

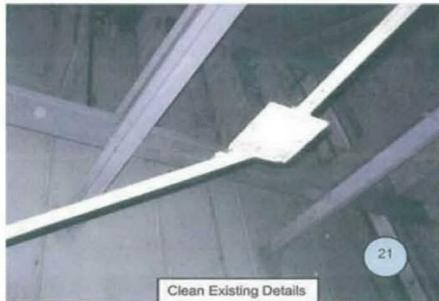
3045 No changes since 2008. Remove from surveillance.

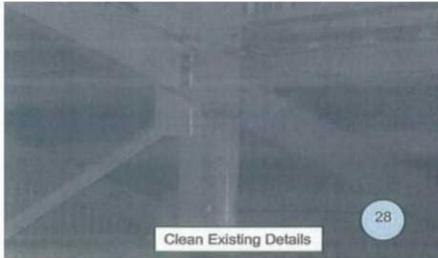
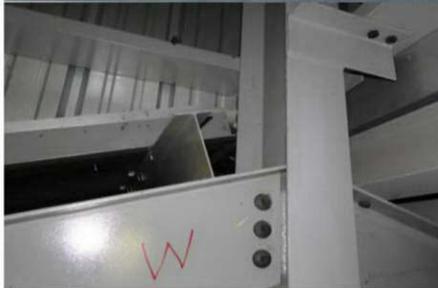
3053 No change since 2008. Opening to exterior

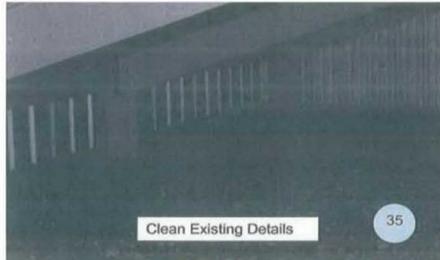
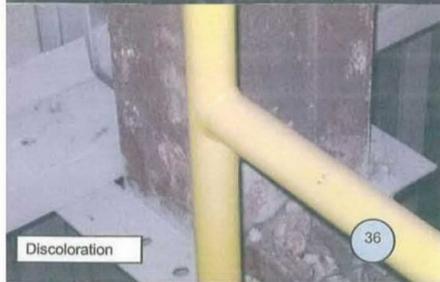
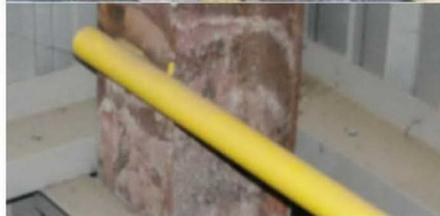
3058 Discoloration is determined to be grout stains from CMU infills. No change since 2008. Remove from surveillance.

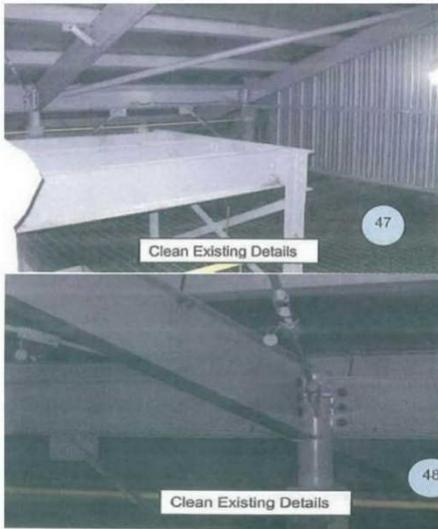
3066 no change since 2008. Discoloration confirmed to be grout stains from original CMU infill or Aged Red Lead coating. Remove from future surveillance.

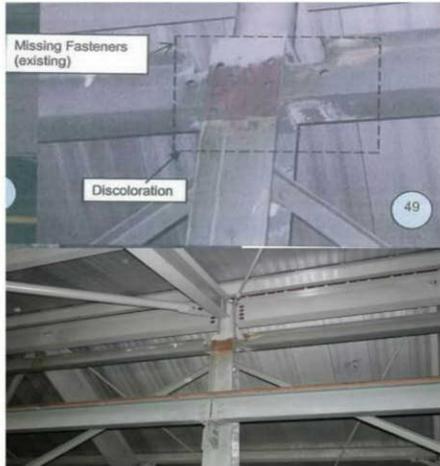
3067 Rivots removed as part of SSE Construction. No change since 2008

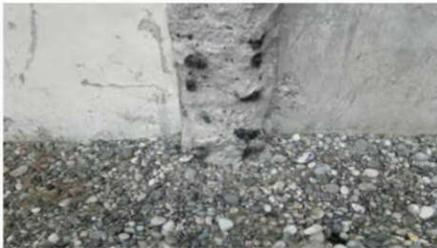
3008 Sometime between surveillances work was completed to cut rebar ends and paint the ends

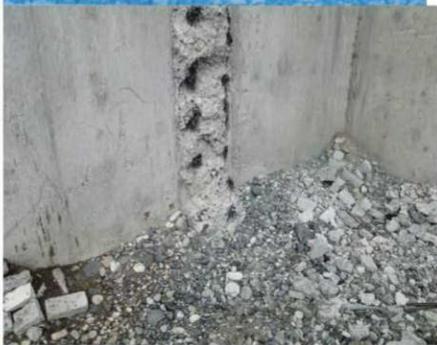
3009 Sometime between surveillances work was completed to cut rebar ends and paint the ends

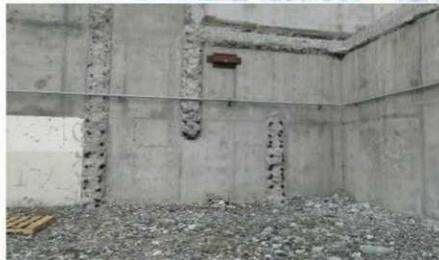
3010 Picture shows location better than previous... Work completed between surveillances buried rebar under concrete debris and guano from bat habitat.

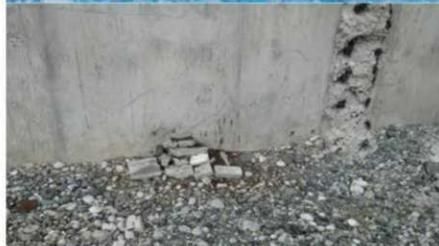
3011 Picture shows location better than previous... Work completed between surveillances buried rebar under concrete debris and guano from bat habitat.

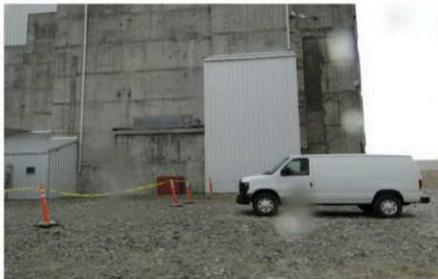
2993 No change in building condition. No reason to continue future surveillance. Birds nest on SW corner of building.

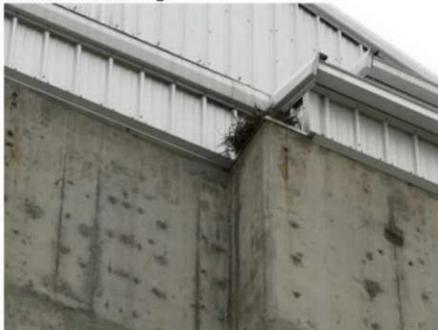
3018 No change in building condition. No reason to continue future surveillance. Birds nest on SW corner of building.

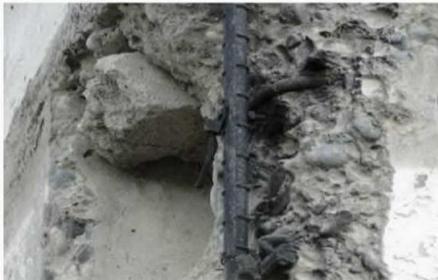
2014 Photo # 2999

3008 No change to spalling at beam pockets. Rebar exposed at corner in very good condition painted black.

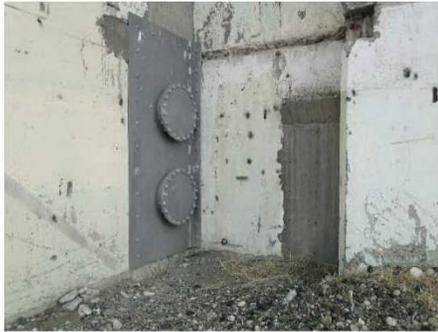
3001 Rt 5 Access very good shape.

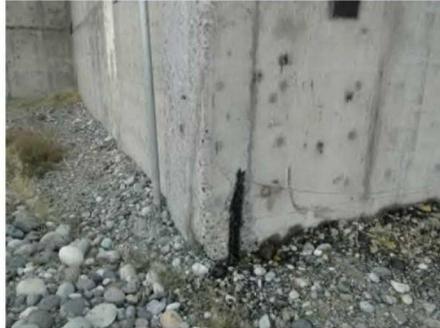
3006 No change since 2008. Verified corner inside front face was dry. Beam pockets.

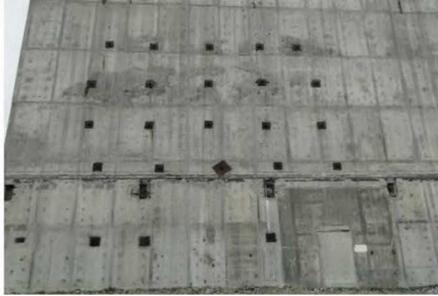
3007 No changes since 2008

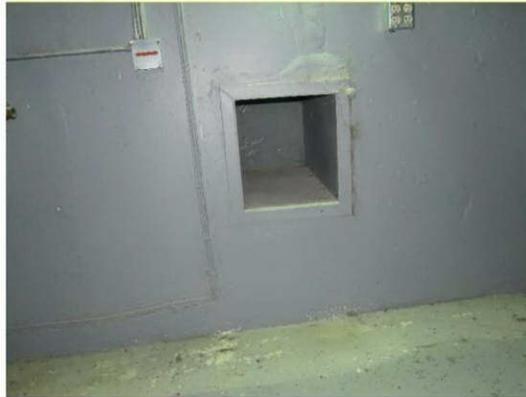
- Attachment A Figure A-1 and Attachment C-1 photo 3464 shows a 24" by 24" opening in the concrete west wall of the front face that is only closed by a bolted plate (just N of the vestibule). With a wrench or ratchet, the plate could be removed in a very short time and access to the interior of the SSE could be gained. Per Section 2.1.5 of Ref 4, any remaining entrances will be welded shut. It is recommended that this item be addressed in the near term.

construction did not remember any reason for or approval of a deviation to plate this opening versus a pour-back that would have met the SSE design criteria listed in Ref 4 for an opening of that size within 10' of outside grade elevation. This area was photographed in the previous WCH inspection report – with no record of concern for this item. It may be that the previous inspection team had good reactor and structural knowledge, they lacked the historic background and security basis for the pourback versus plate decision making used during design and construction of the SSE.

Figure A-1 – Front Face opening interior

ASSESSMENT / RECOMMENDED ACTION – While there is a risk of unauthorized access introduced by this item, and regulator and public confidence issues would result from an authorized entry, significant public safety risk (real health and industrial / radiological safety harm) is minimal given the very good conditions inside the SSE. However, there are easy actions to remove the risk completely short of installing a concrete pourback per the original design. Polestar recommends that when the SSE is closed, the same weld material used for the doors in

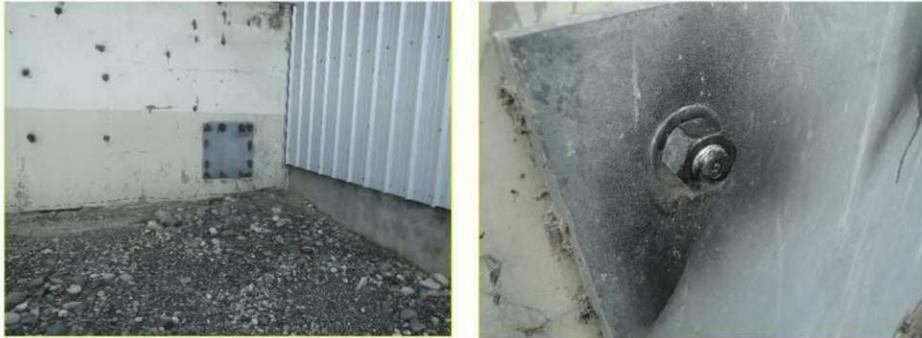
Figure A-2 – Front Face opening exterior (with close up of one bolt closure)

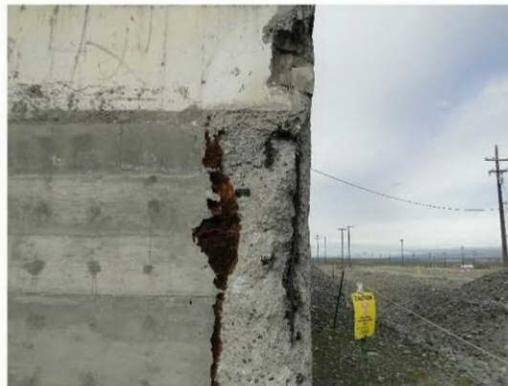
1. The pourback at the front face on the NE corner of the building (shown in Figure A-3 and included in Attachment C-5 Item # 68 and new photo 3491) includes a portion that is polyurethane foam and is badly weathered. This is not a structural issue since the inside of this pourback was observed to be dry and well-sealed. Rather it only begs a question since it is so obvious and upon close inspection is weathered so badly. At some point, scraping out the old foam and painting this area may be a prudent action just to preclude future questions.

Figure A-3 – Foam Entrained in Pourback at Northeast Corner of SSE

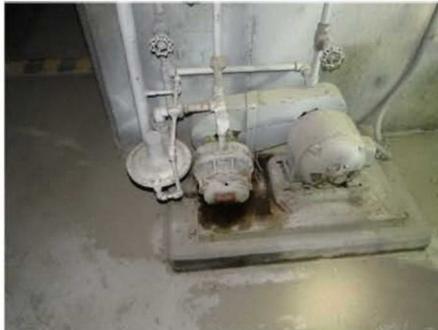
3405 Decon Room @ 0' - Minor oil weeping into tray

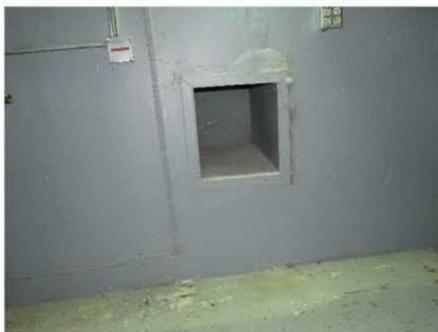
3464 Possible unauthorized personnel access point to front face.

#	New Photo #	Description	Area / Location	Future Inspection/Maintenance Recommendations
Item # 1	3464	Wall	Interior Elev. 0	Recommend welding 2 opposing bolts on exterior face. Possible unauthorized personnel access point to front face.
Item #6	3466	Pipes and Wall	Interior Elev. 0	Includes netting @ ceiling that catches debris above front face area Recommend continuing observations
	3405	Decon Room @ 0'	Interior Elev. 0	Minor oil weeping into tray Recommend a catch bowl with absorbent
	3467	Plywood glued and bolted to ground to cover CA	Interior Elev. 0 Front Face	Recommend continuing observations Note** no picture but dry at bottom of C elevator shaft
	3468	Wall vent and ceiling structure/vestibule	Interior Elev. 0 Vestibule	Possible Weather Protection issue. Previous evidence of water intrusion but no entry point seen. Could be weather protection issue

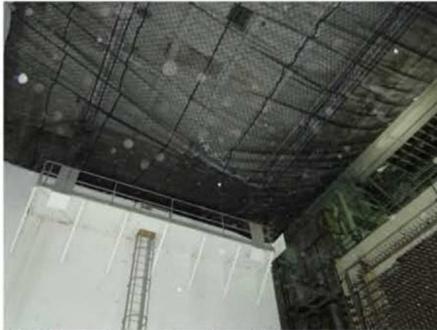
3466 Includes netting @ ceiling that catches debris above front face area.

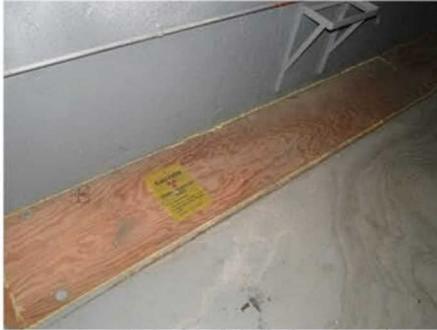
3467 Plywood glued and bolted to ground to cover CA
Note*** no picture but dry at bottom of C elevator shaft

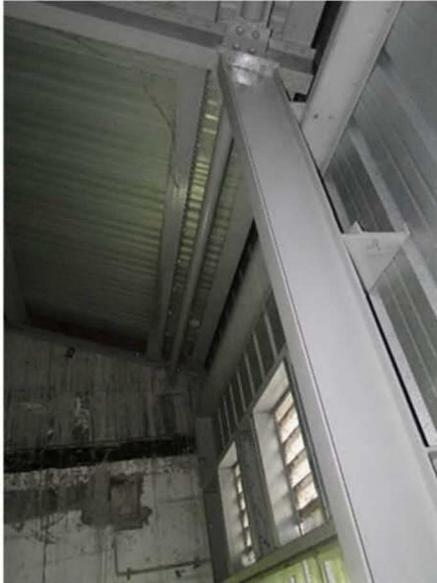
3468 wall vent and ceiling structure in vestibule—previous evidence of water intrusion but no entry point seen.

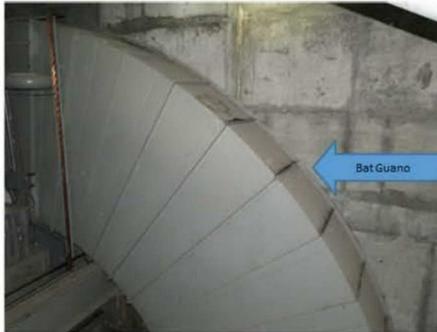
#	New Photo #	Description	Area / Location	Future Inspection/Maintenance Recommendations
	3422	Bat Guano accumulating on vent duct flange from stairs on way up to 42' level	Elev. 42' 5"	As seen from stairway to 42' elevation Recommend continuing observations.

3422 Bat guano accumulating on vent duct flanges.

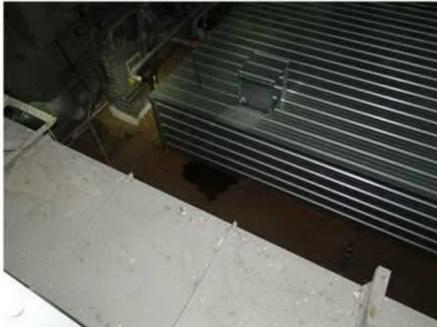
3441 wet spot @ 42' from dripping winch @ 80' level as seen from 56' walkway

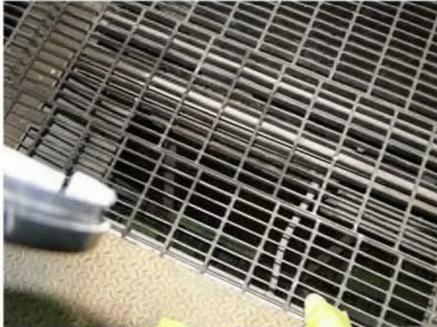
3456 Leaking winch @ +79 elevation below NE corner of diamond decking @ 80' elevation

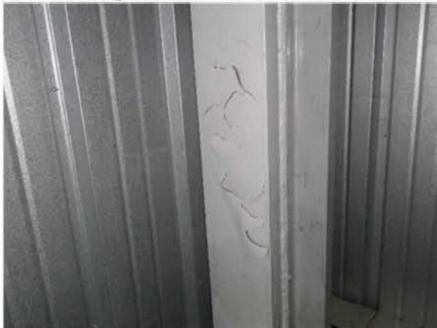
3445 Peeling paint on beam along east wall.

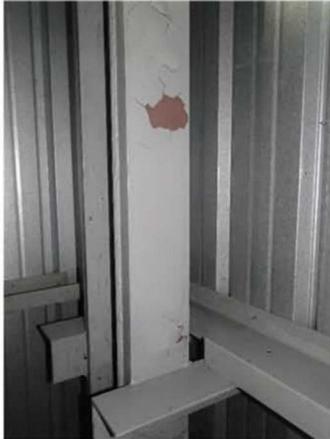
3446 Red undercoat in good condition after large blister picked off.

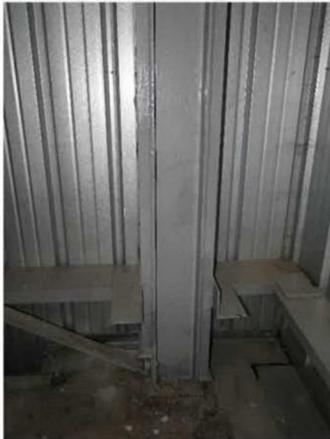
3447 Blistering/peeling grey paint. Detail of original column with modifications as part of SSE.

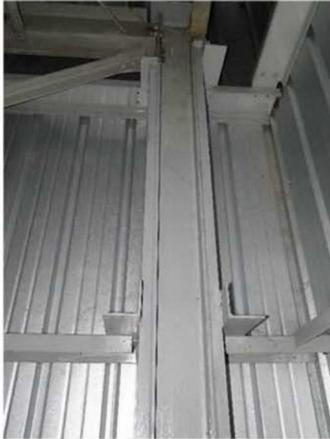
3448 Detail of original column with modifications as part of SSE.

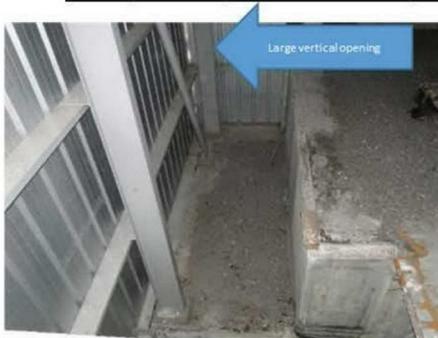
New Photo #	Description	Area / Location	Future Inspection/Maintenance Recommendations
	3454	Prior roof section east side from 80' and siding corner	Elev. 80'	No issues inside structure. Large vertical opening in siding
	3455	10-12 feet long x 1" gap at interior corner of structure	Elev. 80'	Large opening in siding Animal/bird/pest intrusion point

3454 Prior Roof sections east side from 80' elevation. Space is clean and dry with no visible issues other than siding issue.

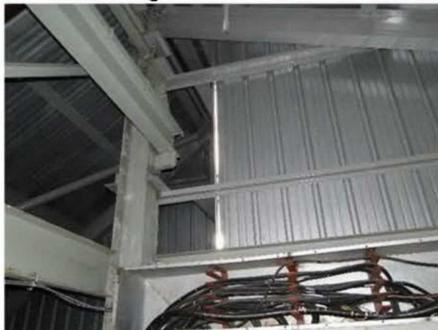
3455 10-12 feet long x 1" open gap at interior corner of structure. Animal/bird/pest intrusion point

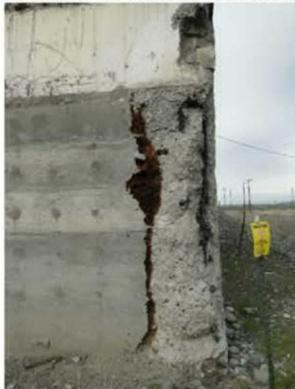
3491 - No visible change to condition. Suspected existing foam joint material. No evidence inside of deteriorating condition.

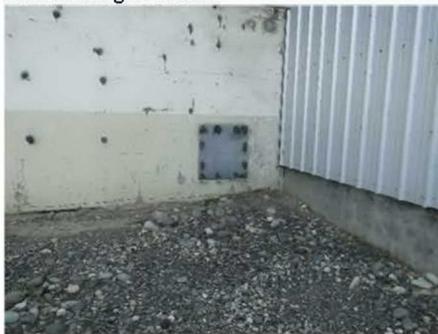
3476 exterior of view 3464 not sealed properly. At least 2 opposing bolts need to be welded shut.

1. SSE Structure – address the steel plate noted above to remove any possibility of unauthorized access to the SSE.
2. Future use of surveillance routes and S&M Plan revision should be considered to reflect actual conditions / maps in the SSE and to provide guidance when and how Routes 4 and 5 shown in the S&M Plan should be used.

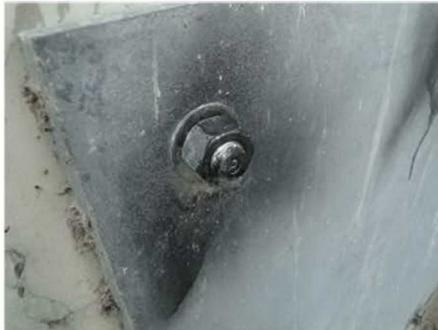
3477 bolt on metal cover plate. Recommend welding.

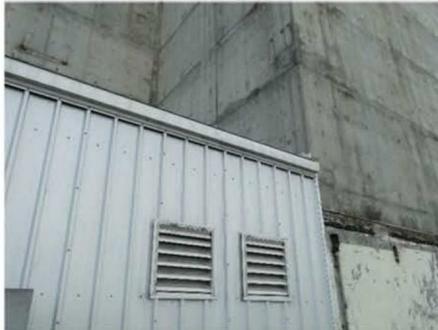
3478 exterior view of 3468
Reported water entry—no defects seen.

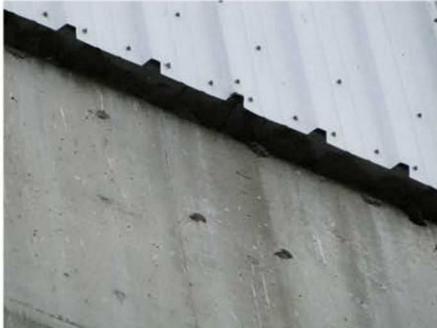
3481 100's of birds building mud nests under ledge at seam locations around entire bldg.

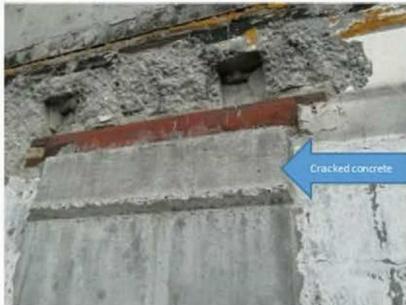
3484 cracked concrete on pour back-does not appear to be an issue but should be watched.

3484 Blow-up of crack on pour back near SW corner of building.

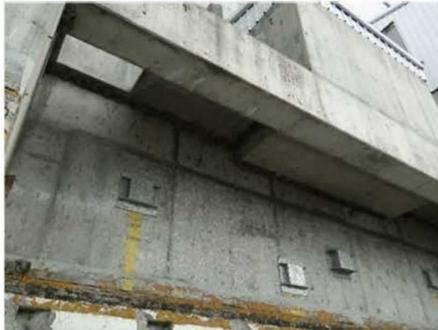
3485 Lots of bird feces on metal cap covering.

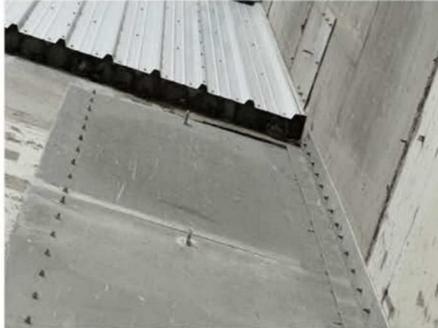
3489 Metal cover plate with birds nesting above.

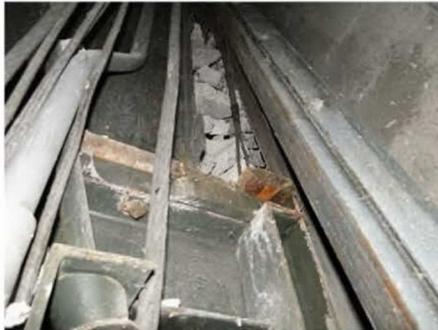
3401 Rubble at bottom of elevator shaft Looking up shaft

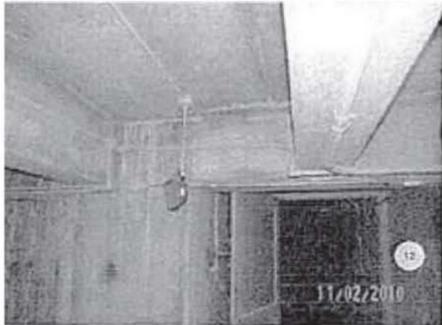
Item # 12 2010 Detail Below Grade 1 -15' Ceiling Beams and Wall, Discoloration and Corrosion

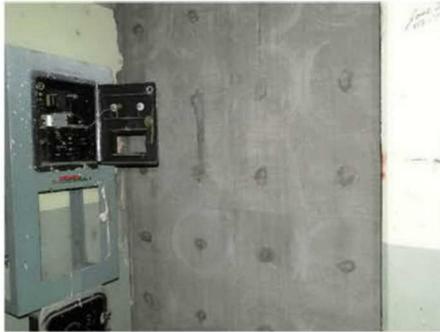
3406 Pour back in good condition

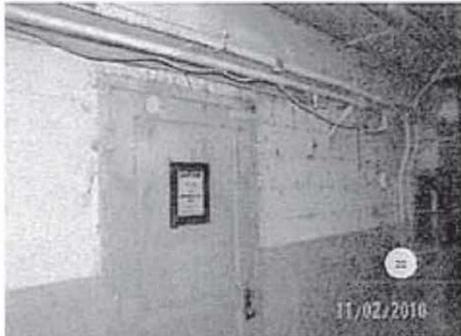
Item # 19 2010 Detail elev. 0, Ceiling Beam and Wall, No visible issues

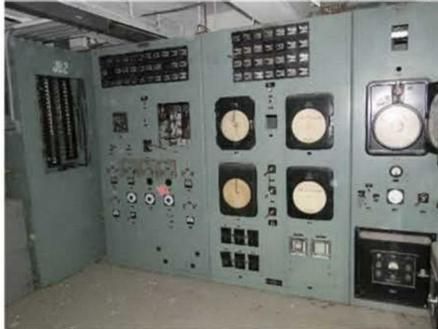
3414 12' Elevation. No visible issues.

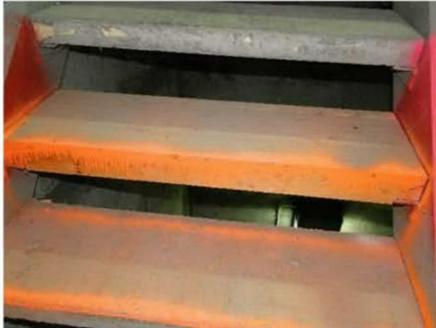
3415 on way up to 22 foot level. Wood stair in good condition

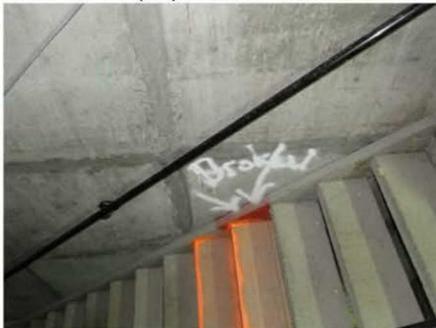
3417 Historic mark on wall. Stair has been replaced and is in good condition

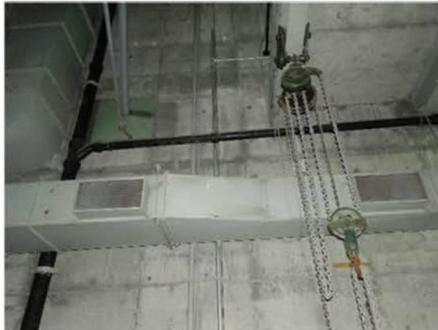
3419 Dry/Clean with no visible issues.

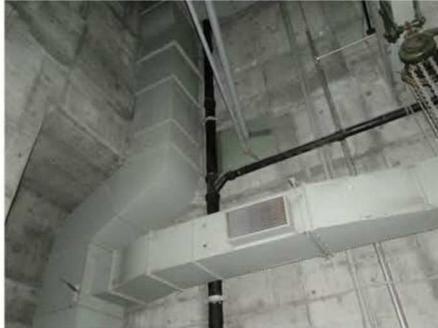
3420 Dry/Clean with no visible issues.

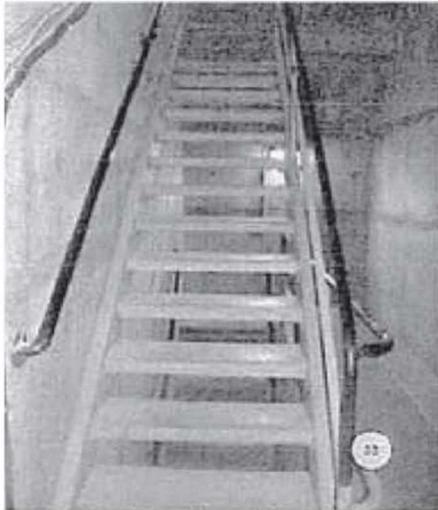
Item # 33 2010 Detail Stairs, loose steps

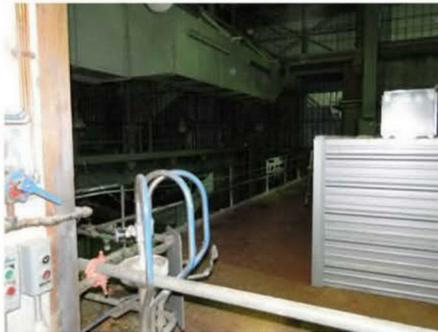
3425 42' level detail No visible issues.

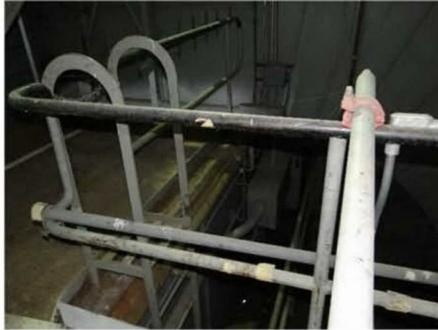
3426 42' level detail No visible issue.

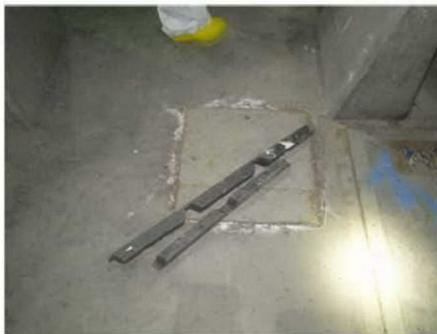
3428 Foam pieces on floor from roofing project.

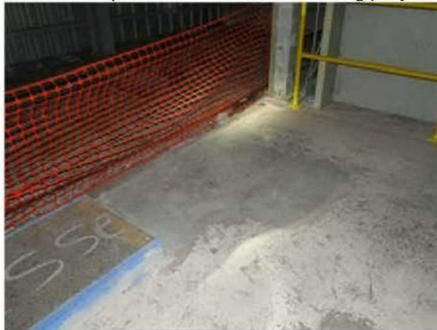
3429 Detail of roofing/floor construction. No visible issues. Comparable condition in a number of SSE Structures.

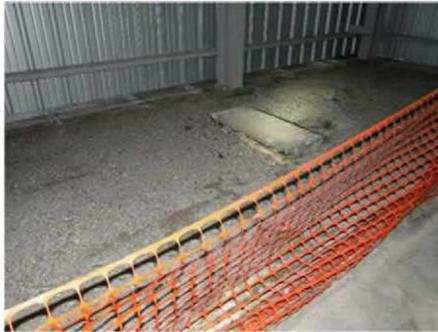
3430 detail of roofing/floor construction. No visible issues. Comparable condition of a number of SSE Structures

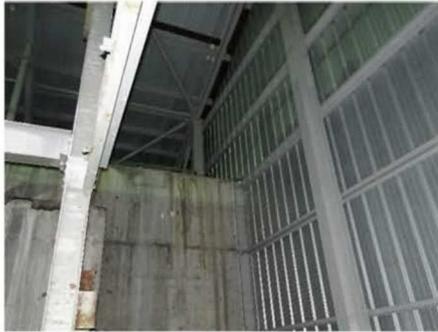
3432 Clean and Dry. No visible issues.

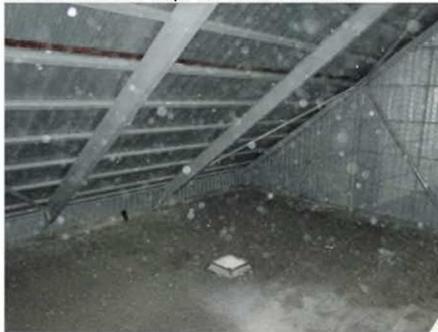
3433 Looking down onto old roofing structure—dirt in the air. No visible issues.

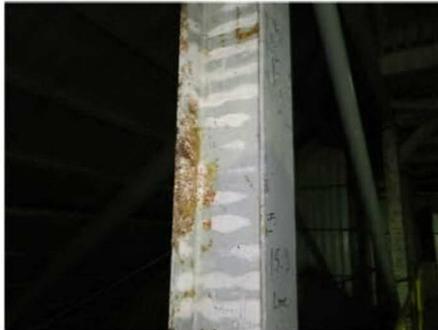
3440 Beam detail with mortar stains from masonry infills. No visible issues.

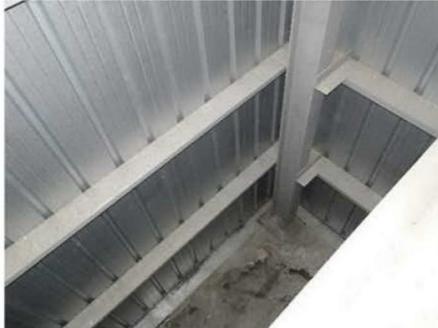
3444 Clean/Dry interior detail. NE corner along E wall 42" elev. As seen from 56'

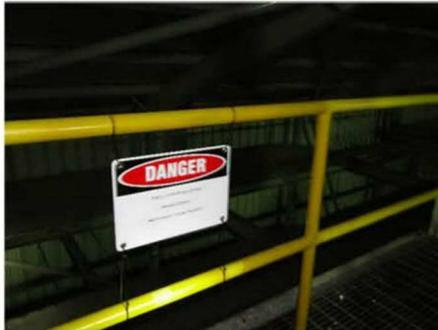
3451 Old pics 52, 53, 54, 55 general area detail. No visible issues

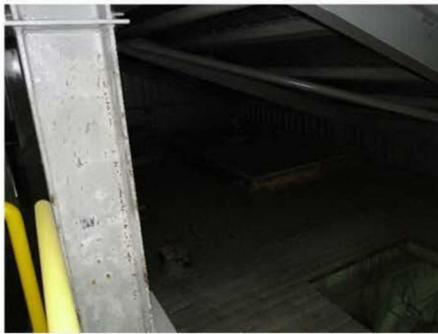
3452 80' elevation. General area detail. No visible issues

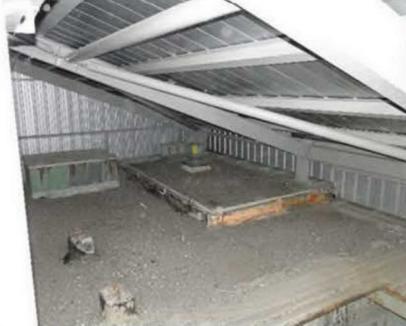
Prior roof SE corner from 80' elevation. Clean/Dry No visible issues.
