Five-Year Surveillance Report for the 105-C, 105-D, 105-H, 105-F and 105-N/109-N Safe Storage Enclosures

Document Type: RPT

D. G. Ranade
Mission Support Alliance

Date Published
March 2016

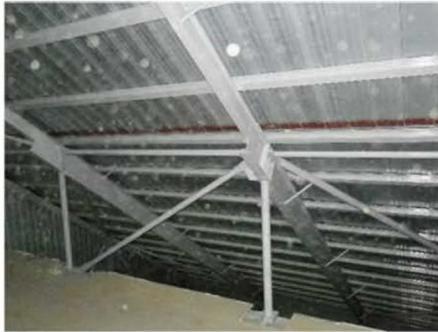
3457 General area detail. Clean/Dry. No visible issues.

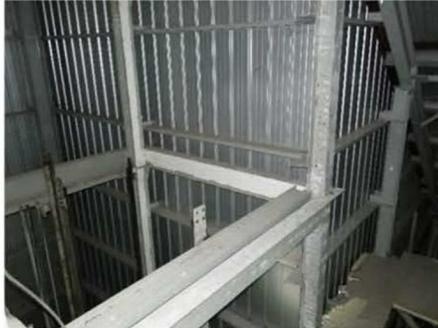
3458 General area detail Clean/Dry. No visible issues.

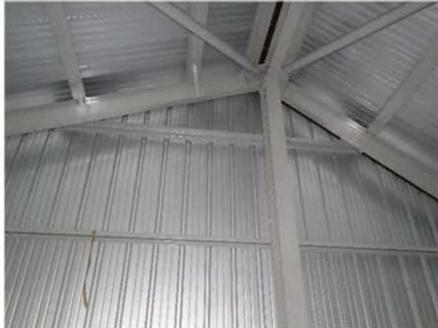
3459. General area structure. Clean and Dry. No visible issues.

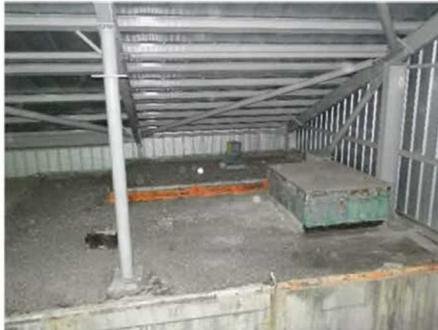
3460 Prior Roof SW corner as seen from +80' elevation. No visible issues.

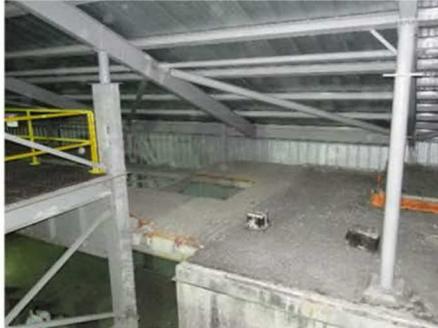
3461. Prior Roof W corner as seen from +80' elevation. No visible issues.

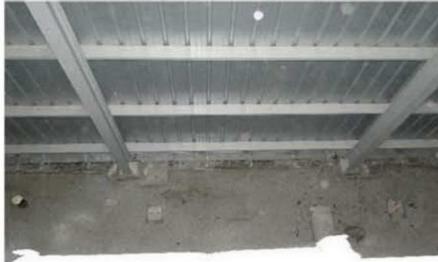
3462 Prior roof W corner as seen from +80' elevation. No visible issues.

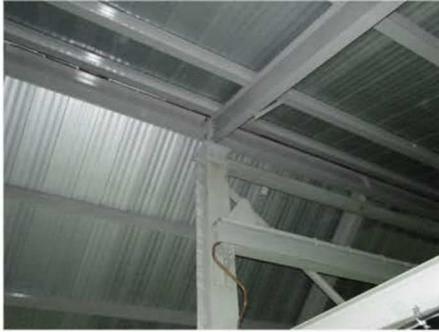
3463 General area structure detail. Clean and Dry. No visible issues.

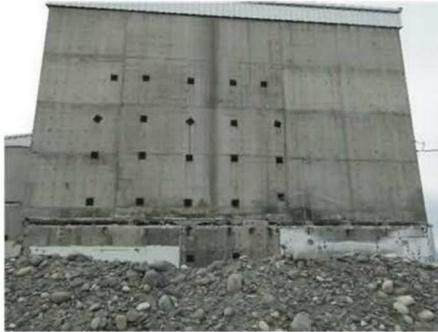
3493 No visible change to condition

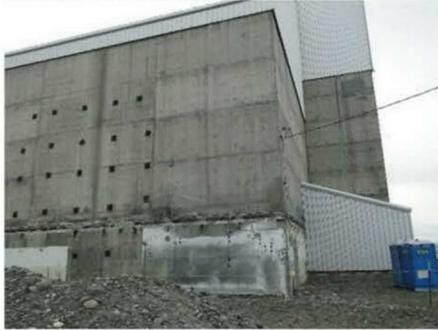
3494 No visible change to condition

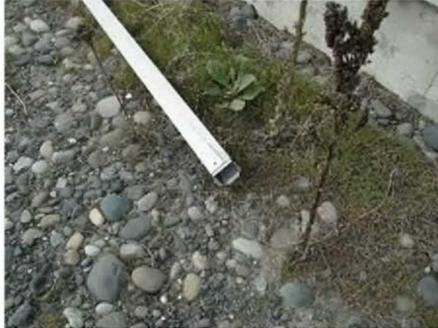
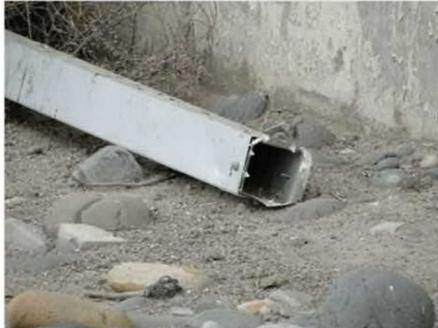
3495 Close up of fallen downspout piece. Connection piece still intact. No visible change

3496 Close up of fallen downspout piece. Connection piece still intact. No visible change

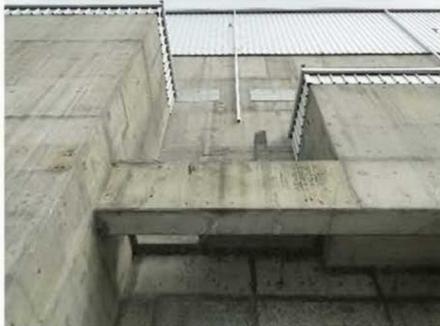
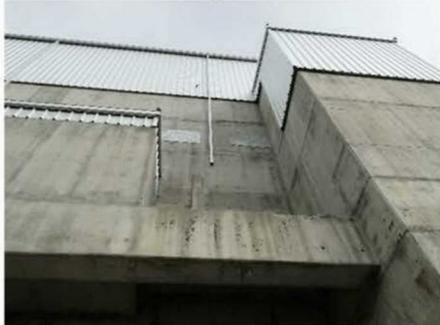
3487 Possible Weather protection issue. Small amount of erosion from downspout runoff

3488 Possible weather protection issue. Small amount of erosion from downspout runoff

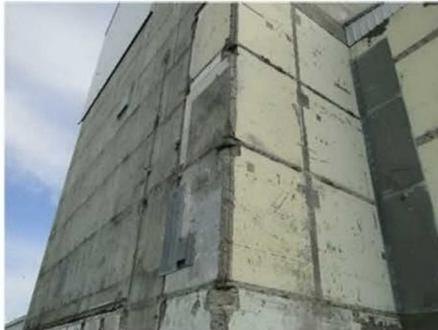
3483 spalled concrete around entire building in very good shape, no noticeable degradation/excessive rebar corrosion since original project.

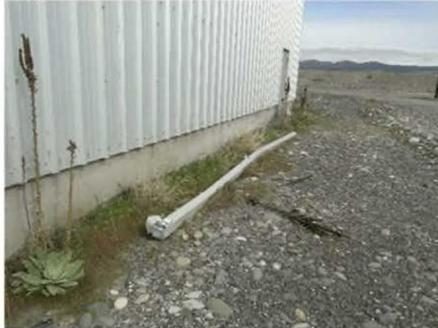
3490 2nd piece of broken downspout from S exterior wall

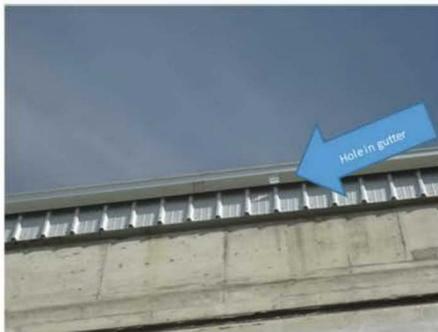
4989 shows hole in gutter where downspout was placed on left side of bldg

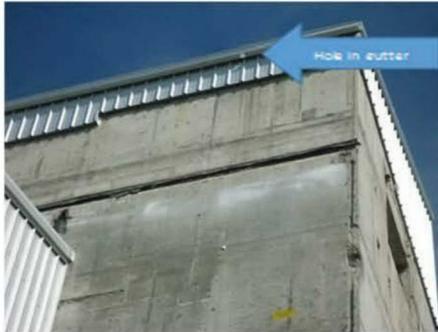
4986 shows hole in gutter where downspout was placed on left side of bldg

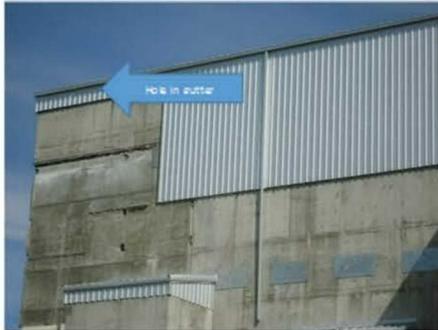
4983 shows hold in gutter where downspout was placed (on right side of bldg)

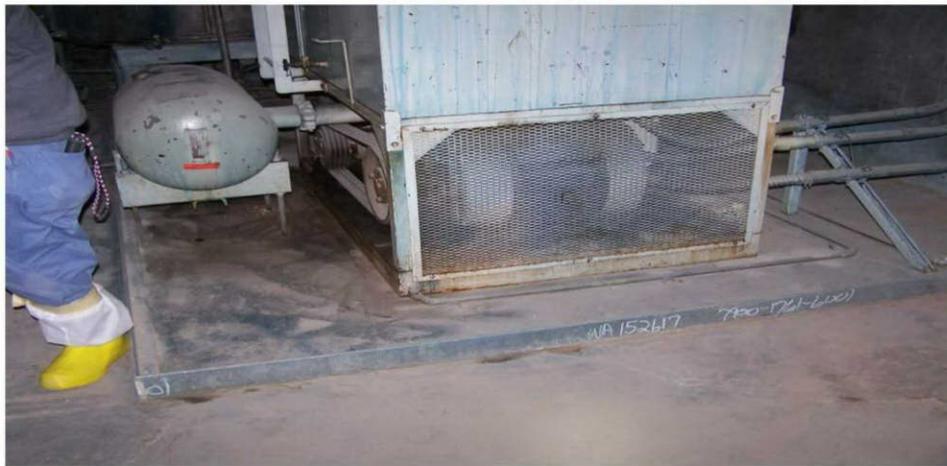
Photo 1

- Trip hazard around equipment caused by drip pan. (Photo 1)
- Trip and struck by hazards around piping. (Photo 2)
- Struck by and sharp object hazards from 2 step platform. (Photo 3)

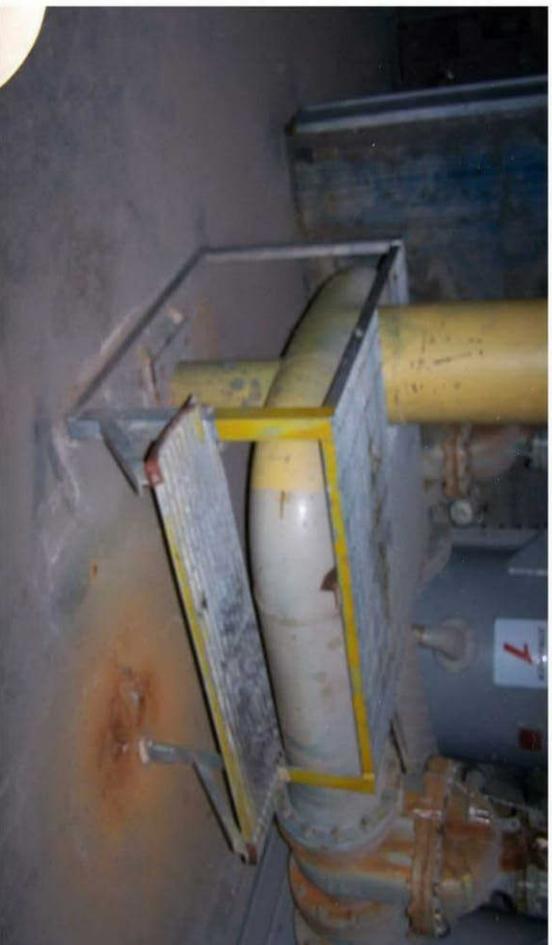
Photo 4

- (Room 401)- Tripping hazard caused by trough for door 403. (Photo 4)
- Overhead hazard caused by piping in stair well between 28' and 40' elevations. (Photo 5)

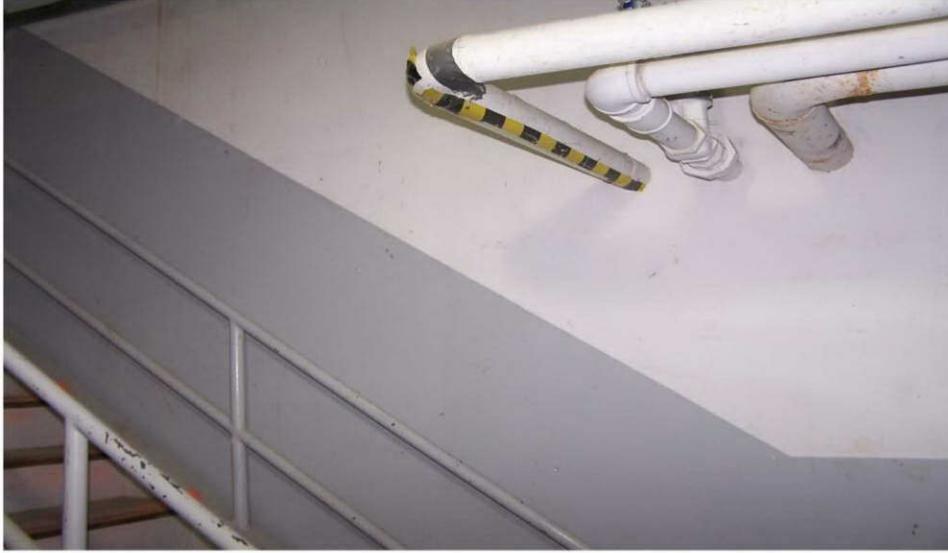
Photo 6

- Trip hazard leading into the room 503 (Painted Orange). (Photo 6)
- Numerous trip hazards and sharp edges on roof area above 109 N (many identified with orange paint, but many are not identified). (Photo 7)

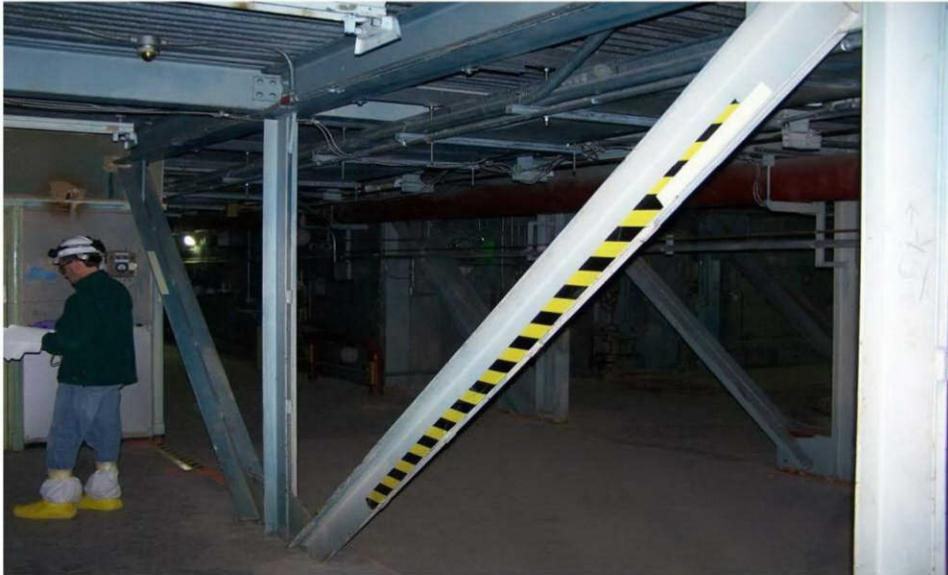
Photo 9

- Lamp burned out in room 610, with mandatory flashlights or head lamps, and other lighting in the area, this does not pose an issue at this time.
- Fire water piping running between rooms 601 and 610 is low hanging causing an overhead hazard.
- Numerous cross bracing throughout room 607 causing struck by and overhead hazards (Identified with Caution Tape). (Photo 8)
- Unexpected step down in room 607 causing a trip hazard (Painted Orange faded). (Photo 9)
- Large cable tray in the path between rooms 607 and 611. (Photo 10)

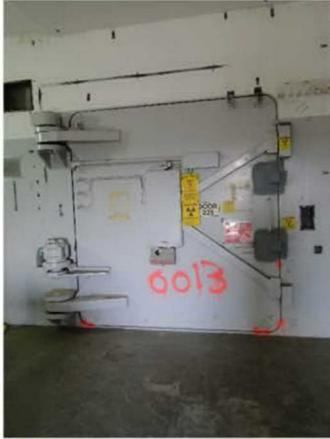
3738 Zone 1 door. welded closed yet breeze coming through

Turnover Photo #	New Photo #	Description	Area / Location	Future Inspection/Maintenance Recommendations
	3738	Zone 1 door, welded closed yet breeze coming through	105N +5'	Need to evaluate if this type of leakage is acceptable from a radiological and environmental (inside the SSE and external "release").
	3737	Zone 1 door, welded closed yet breeze coming through	105N +5'

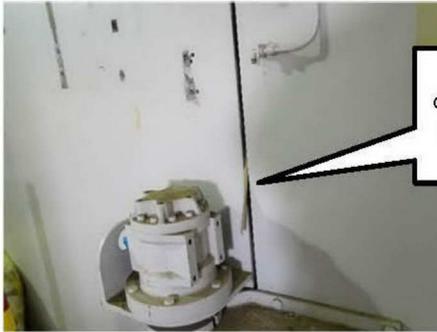
Notice piece of maslin cloth, presumable placed here at some time past to indicate air flow.

3737 Zone 1 door. welded closed yet breeze coming through

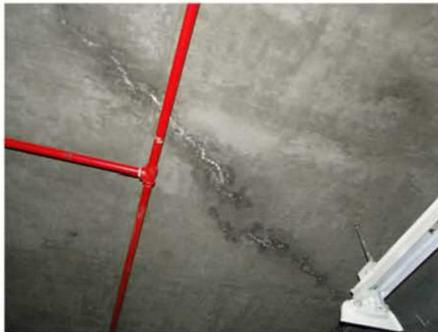
3721 Picture of possible calcium carbonate bleeding on ceiling in room 302

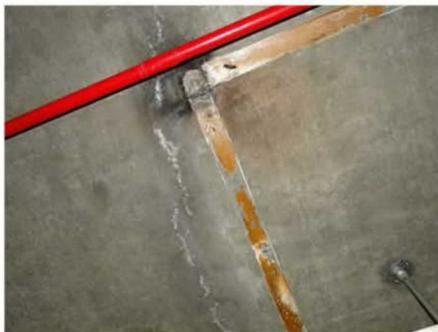
3722 Same as above

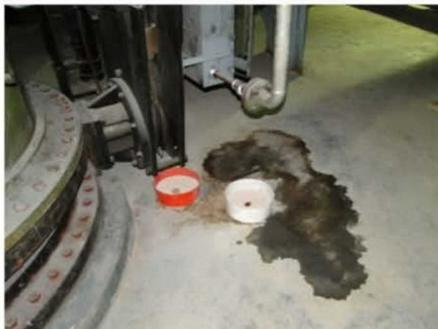
3693 Old fluid stains on floor next to containers of kitty litter. Good practice for weeping hydraulic fluids

Turnover Photo #	New Photo #	Description	Area / Location	Future Inspection/Maintenance Recommendations
422	3693	105N: Rm.#607- NE Corner at El.+60'- 6" dated 02-07-2012	105N +60'	Continue observation, good practice recommended for other weeping hydraulic / oil lines shown in photo 3693.

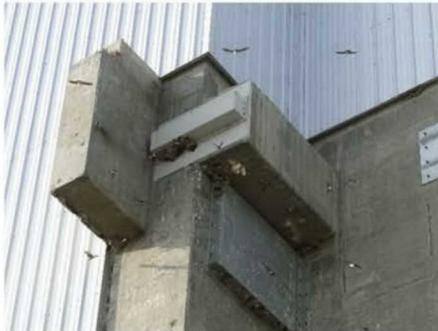
- Swallow nesting at concrete / siding junction point and in some cases (Attachment C, Photo 3682) directly on the steel plate / boxes installed as closures.

3682 Swallow nesting directly on metal caps/closures

Turnover Photo #	New Photo #	Description	Area / Location	Future Inspection/Maintenance Recommendations
	3682	Swallows nesting directly on metal caps/closures	Exterior	Continue observation for damage to any steel surfaces.
	3683	Possible water intrusion/corrosion with backfill @ door	Exterior	Consider moving soil from adjacent to doors and grading away from door sill to ensure no in-leakage and prevent accelerated corrosion of the Zone 1 doors.
	3685	Possible water intrusion/corrosion with backfill @ door	Exterior	
	3686	Possible water intrusion/corrosion with backfill @ door	Exterior

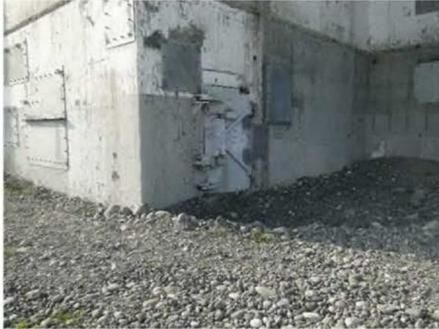
4. Possible water intrusion/corrosion from outside caused by contact with backfill at the door (Appendix F, Photo 3683).

3683 Possible water intrusion/corrosion issue w backfill over bottom sill of door

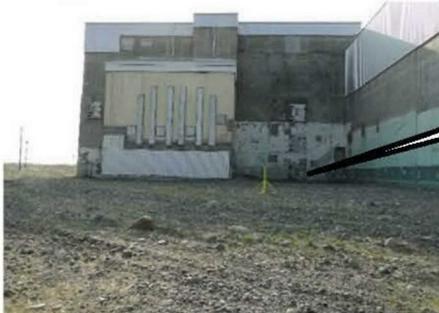
3685 Possible water intrusion/corrosion issue with backfill at door

Same location as photo
3686 below

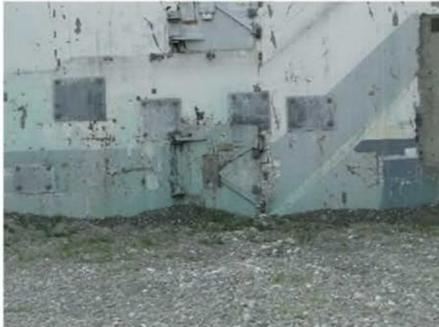
3686 Possible water intrusion/corrosion issue with backfill over the sill at this Zone 1 door

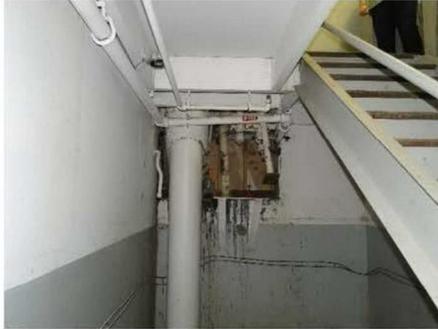
3728 4/15 - Interior pour back framing remains

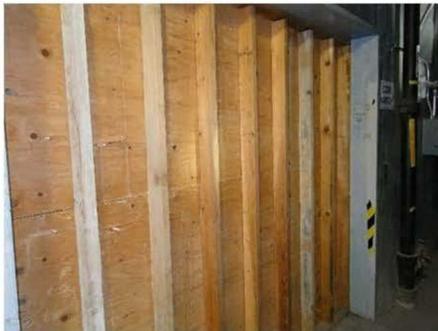
3723 Interior pour back framing remains

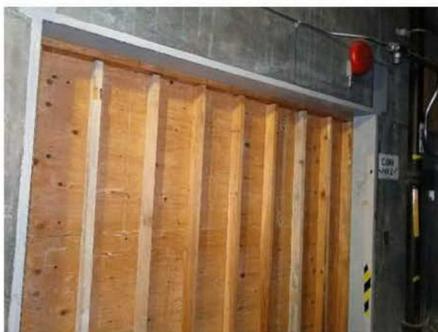
3724 Interior pour back framing remains

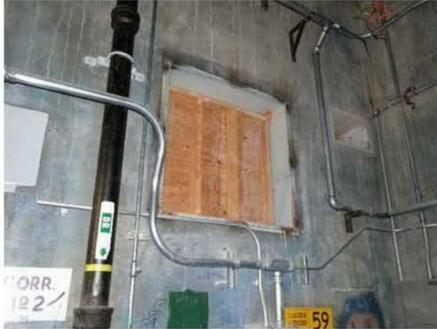
3725 Interior pour back framing remains

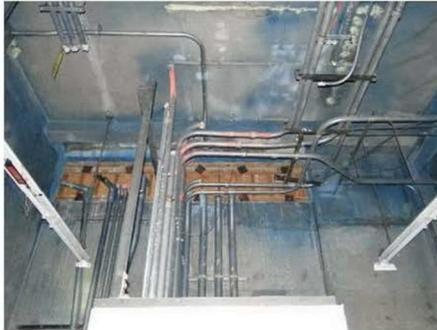
3727 Interior pour back framing remains

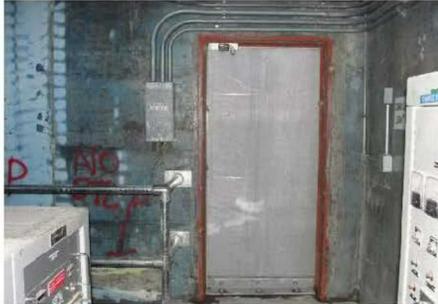
377 105N/Rm.#301 Cover Plate Over Doorway-East Wall at El.+16'-6" dated 02-15-2012

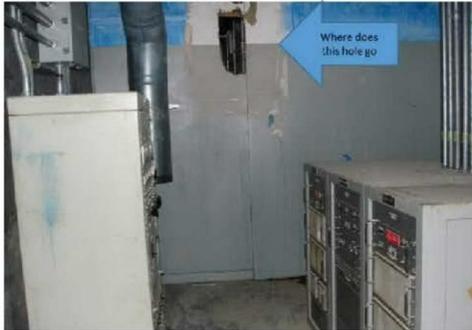
378 - 105N/Rm.#301-Looking West at El.+16'-6" dated 02-15-2012

Confirmed that this "hole" in the photo above is in a drywall partition and goes to an adjacent room on this floor.

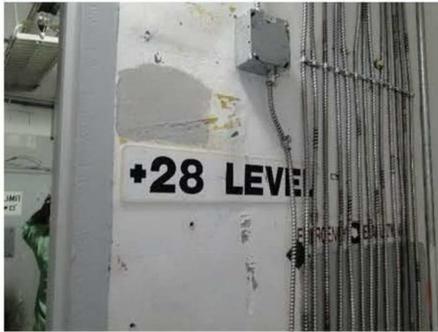
3711 Sign on wall at door entrance from stairwell

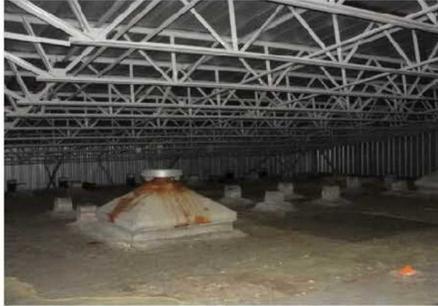
116 - 109N: Area under SSE Roof-South Wall, West End at El.40' dated 02-07-2012

NOTE - No roof leaks were noticed during inspection. It was a dry day and had not rained for several days previous.

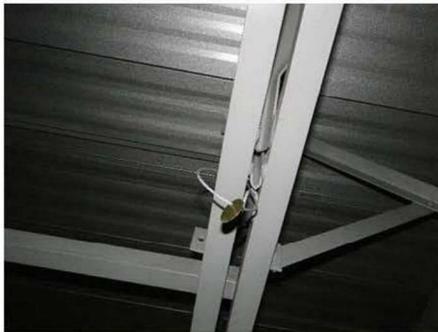
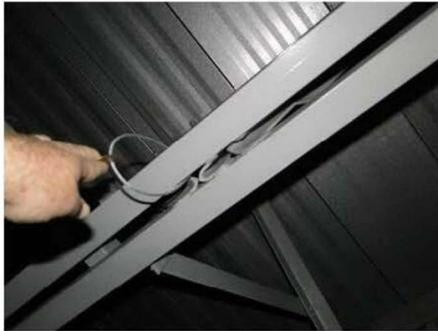
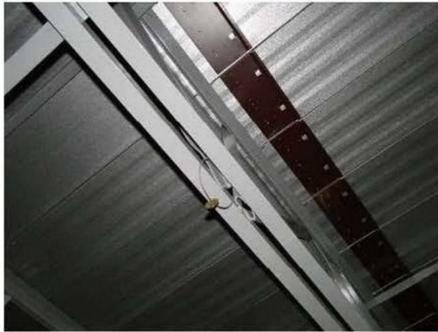
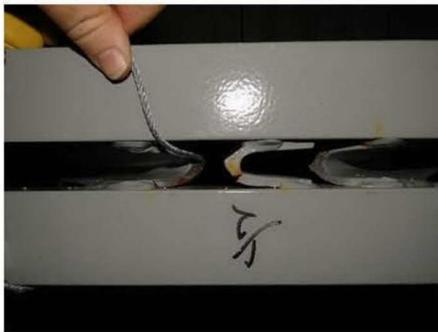
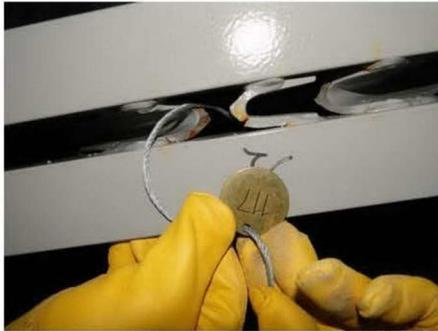
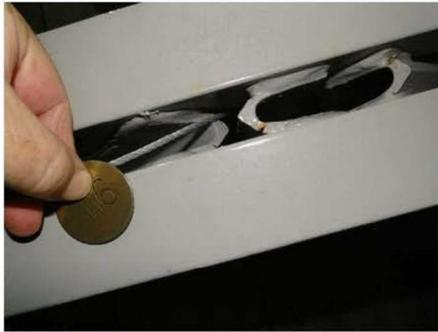
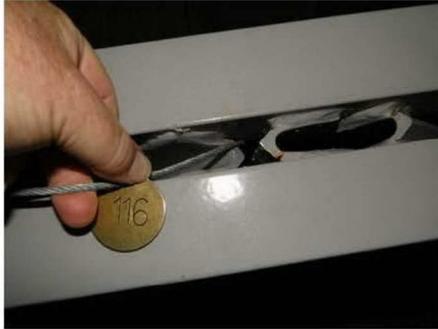
The following several photos were taken during the inspection efforts in the 109-N "attic" space for the joist tears as called out in Ref 1 Section 3 and Appendix A. As noted in Attachment A of this report, structural evaluation of the 2015 as found conditions and with review the previous evaluation documented in Ref 3, recommend this item not be continued for further inspections.

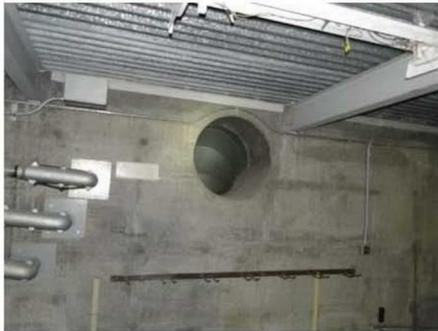
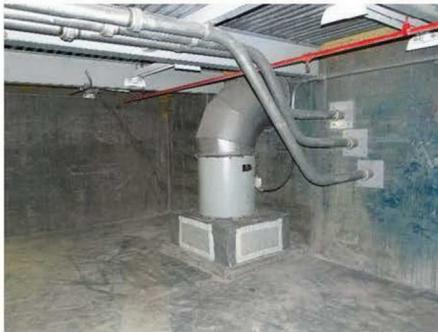
3697 – This photo and the one below shows the “hole” in photo 407 above is actually an open ventilation duct.

3698 – duct on the opposite side of wall from photo 3697 above

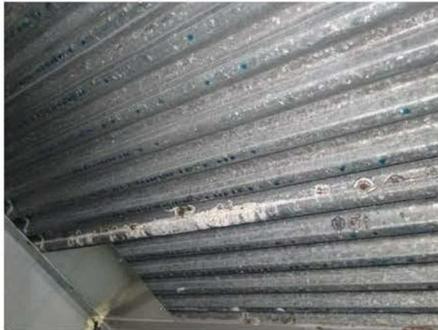
3690 Typical old roof corrosion

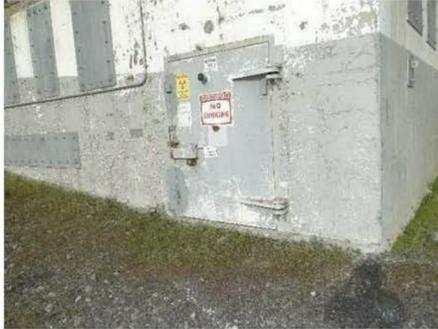
3679 Good clearance at door sill. No concern about water intrusion.

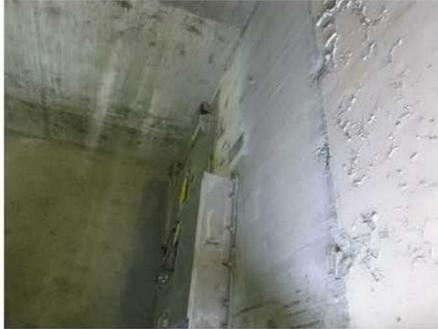
3731 109N Entrance Pit Clean and Dry

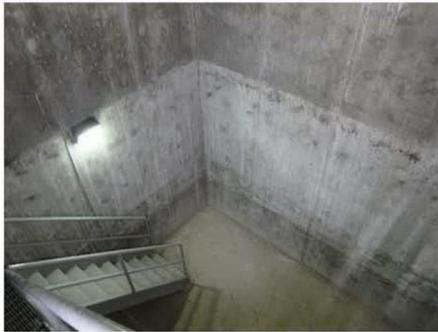
3732 109N Entrance Pit Clean and Dry
