FINAL REPORT

CONSTRUCTION QUALITY ASSURANCE (CQA)

FINAL REPORT
CONSTRUCTION QUALITY ASSURANCE (CQA)
ENVIRONMENTAL RESTORATION DISPOSAL FACILITY (ERDF)
SUPER CELLS 9 & 10
SUBCONTRACT S013213A00
010.032-00-ROB

PHOTOGRAPH LOG

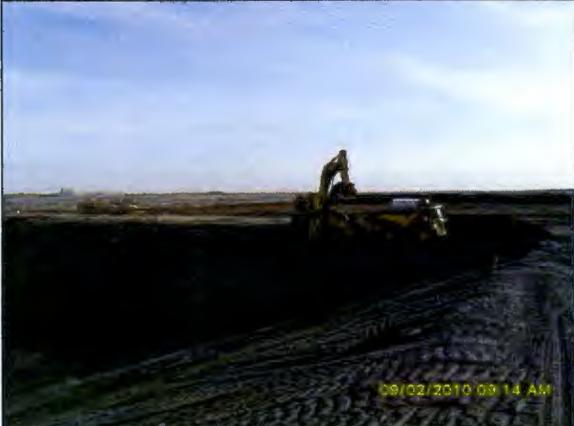
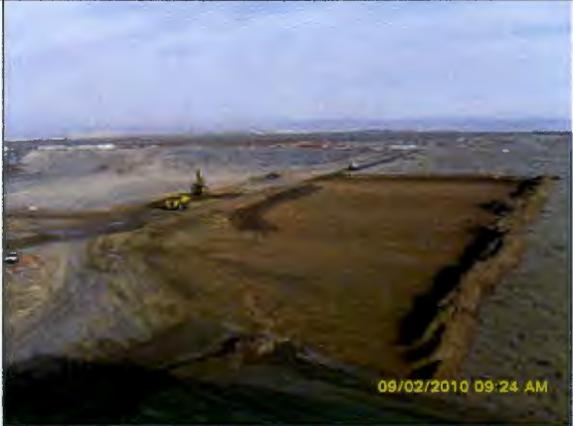
<p>09/02/2010 09:24 AM</p>
Facing E (2/10/10) – TWS excavating base soil from the Cell 10 footprint.	Facing NW (2/10/10) – TWS excavating base soil from the Cell 10 footprint.

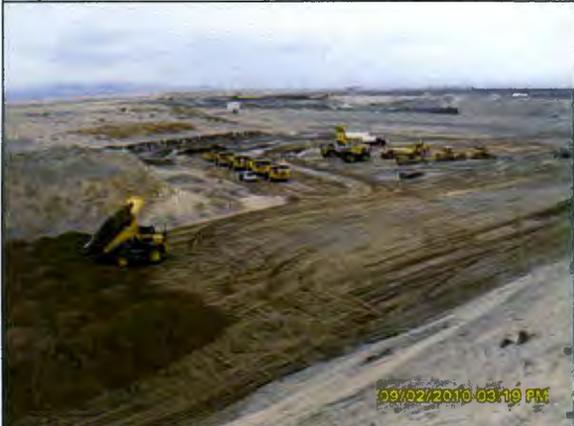
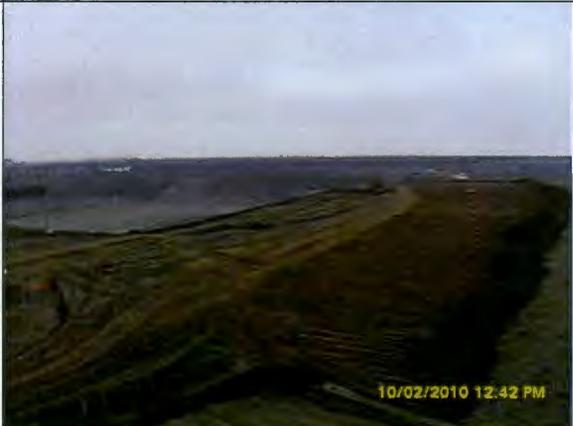
<p>10/02/2010 12:42 PM</p>
Facing NW (2/10/10) – TWS stockpiling base soil south of Cell 10.	Facing NW (2/11/10) – TWS excavating base soil from the Cell 10 footprint.

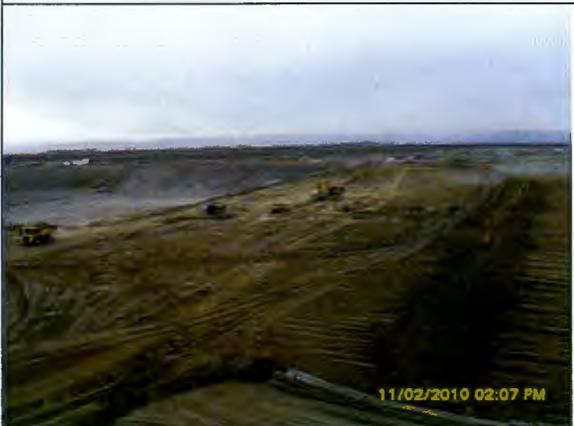
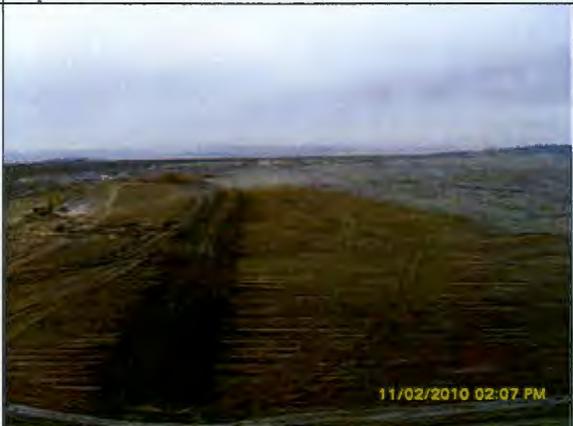
<p>11/02/2010 02:07 PM</p>
Facing NE (2/12/10) – TWS excavating base soil from the Cell 10 footprint.	Facing NE (2/12/10) – TWS excavating base soil from the Cell 10 footprint.
Note: Dates are incorrect on photographs. Correct dates appear in annotation below photographs.

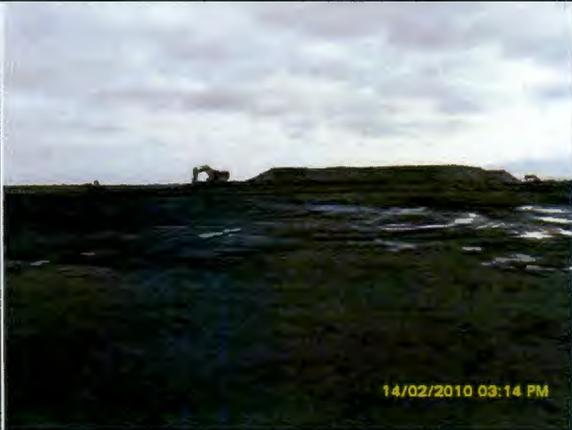
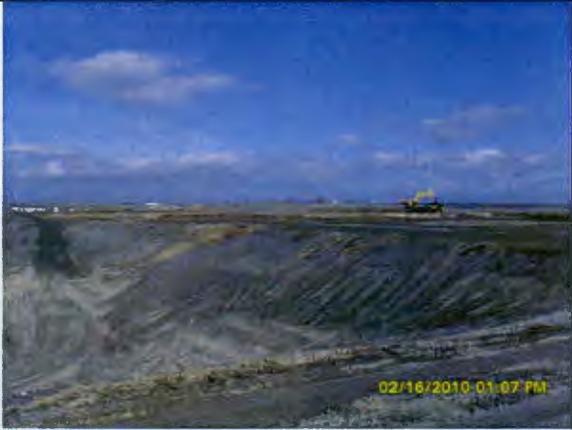
Facing SE – TWS excavating the base soil from the Cell 10 footprint.	Facing NE – TWS excavating the base soil from the Cell 10 footprint.

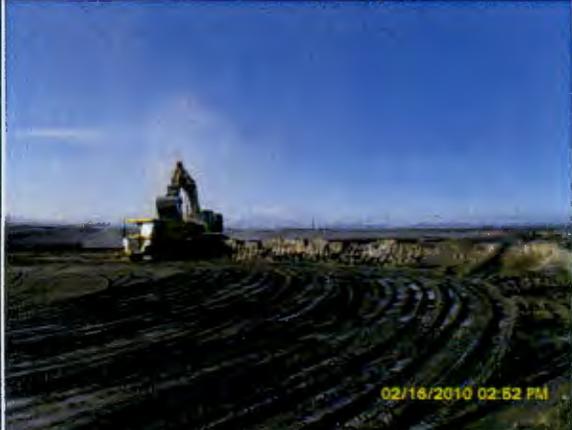
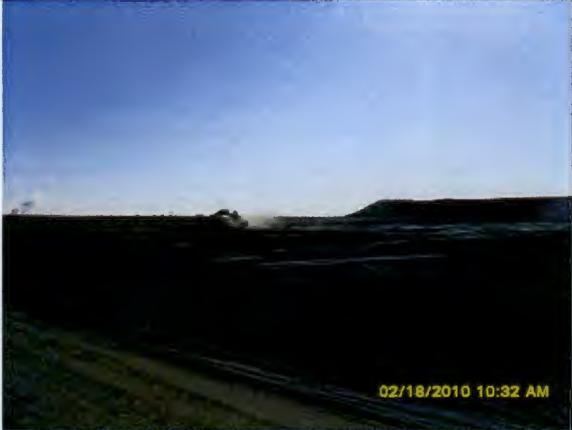
Facing SE – TWS excavating the base soil with the CAT 5110 from the Cell 10 footprint.	Facing E – TWS excavating the base soil from the Cell 10 footprint.

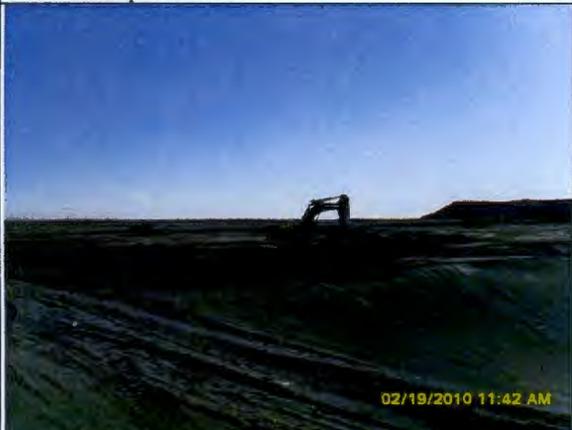
Facing E – The CAT 5110 excavating base soil from the Cell 10 footprint.	
Note: Dates are incorrect on some photographs. Corrected dates appear in the annotation below the incorrectly labeled photographs.

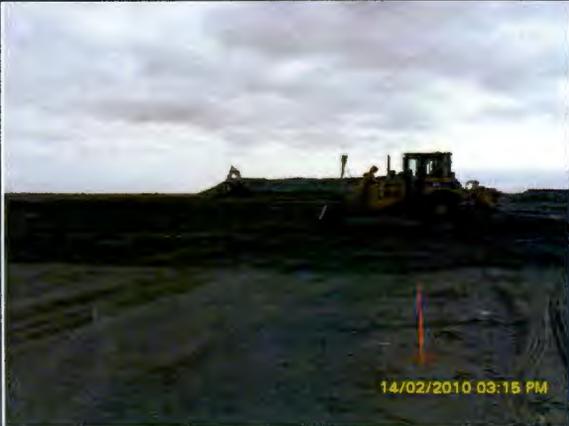
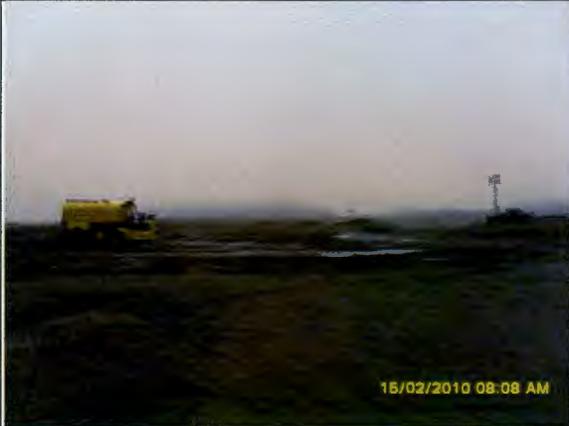
Facing S (2/15/10) – TWS scarifying the subgrade on the north berm with a CAT D6R.	Facing E (2/16/10) – TWS recompacting the subgrade on the north berm with the payhauler water truck.

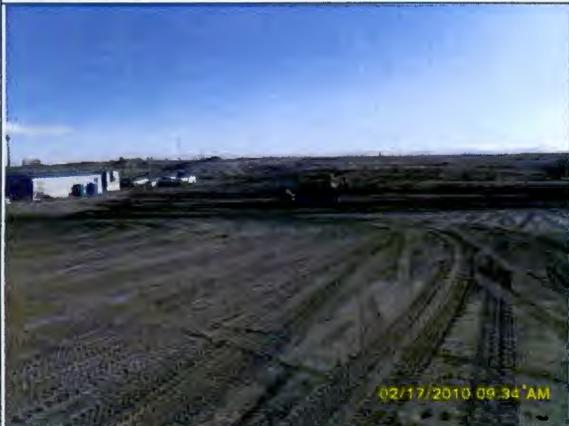
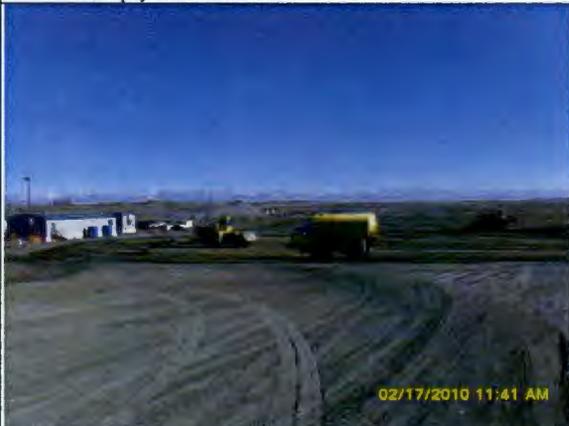
Facing E – TWS placing lift 1 of the Cell 10 north embankment.	Facing E – TWS compacting the first lift on the north embankment with the payhauler water truck.

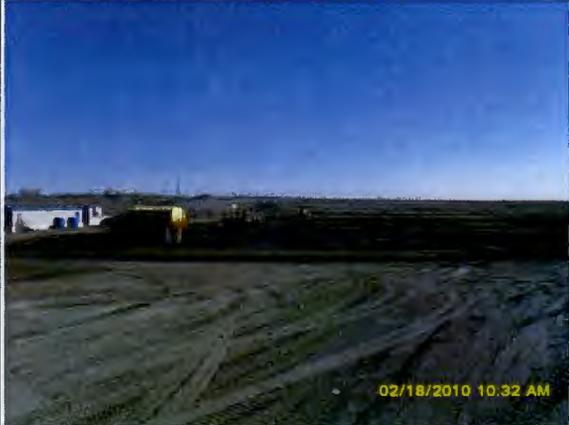
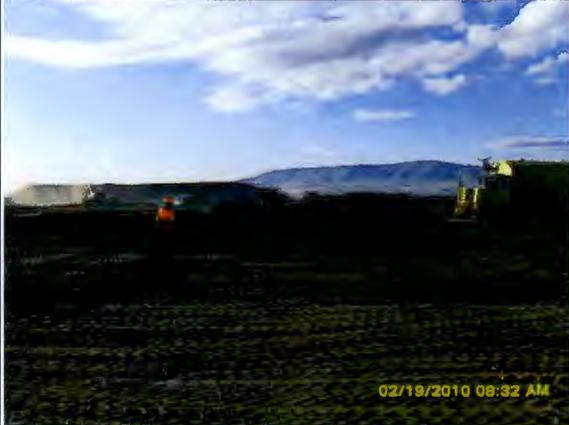
Facing E – TWS moisture conditioning and placing lift 2 on the north embankment.	Facing S – TWS moisture conditioning and compacting lift 2 on the north berm.
Note: Dates are incorrect on some photographs. Corrected dates appear in the annotation below the incorrectly labeled photographs.

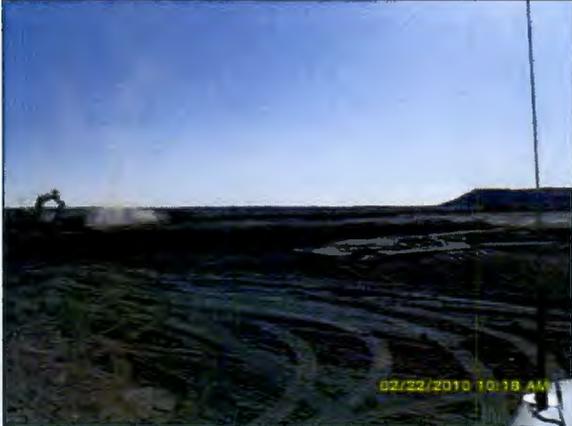
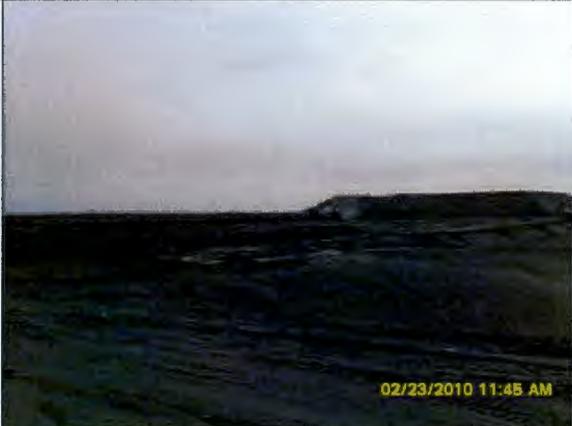
Facing SE – TWS excavating operations layer soil from Cell 10 with the CAT 5110	Facing SE – TWS excavating operations layer soil from Cell 10 with the CAT 5110

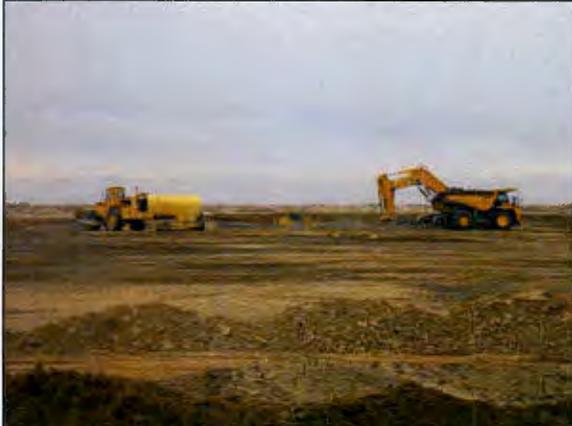
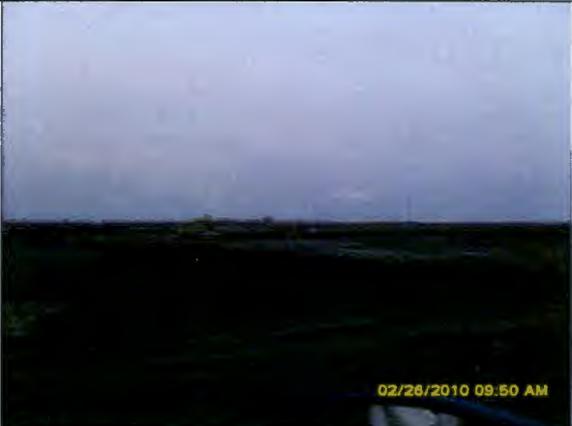
Facing N (2/24/2010) – TWS excavating operations layer soil from Cell 10 with the CAT 5110	Facing NE – TWS excavating operations layer soil from Cell 10 with the CAT 5110

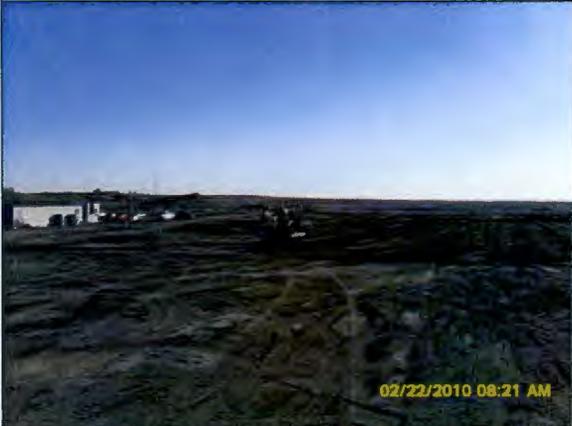
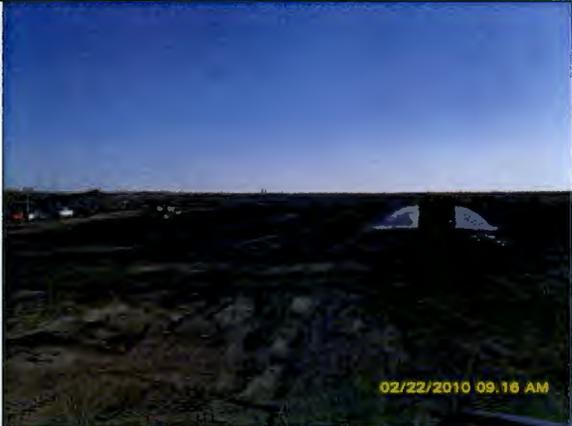
<p>02/22/2010 09:16 AM</p>
Facing E – TWS placing the third lift on the north embankment.	Facing E – TWS watering the third lift on the north embankment.

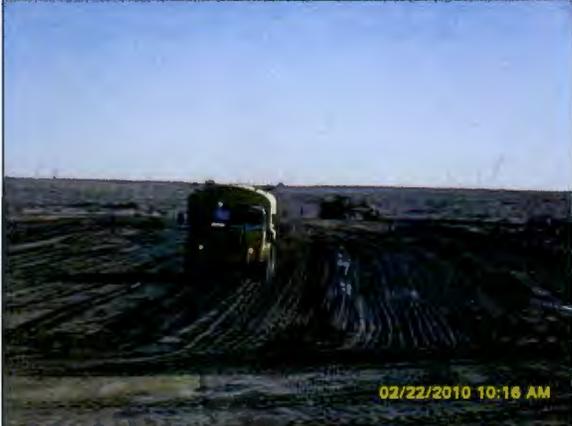
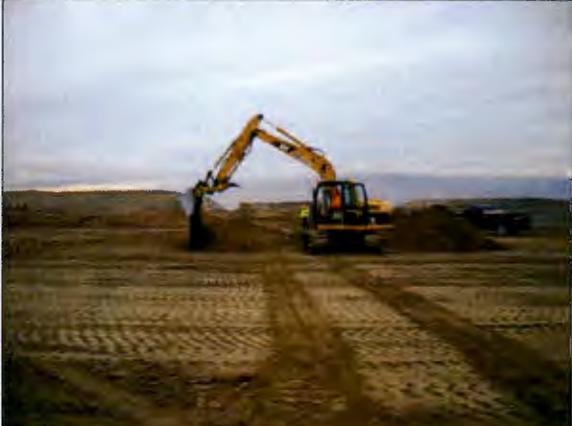
Facing E – TWS compacting the third lift on the north embankment.	Facing S – TWS excavating old utility trench across N. embankment.

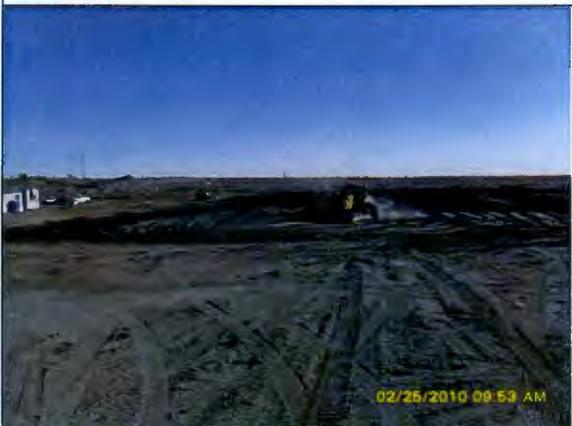
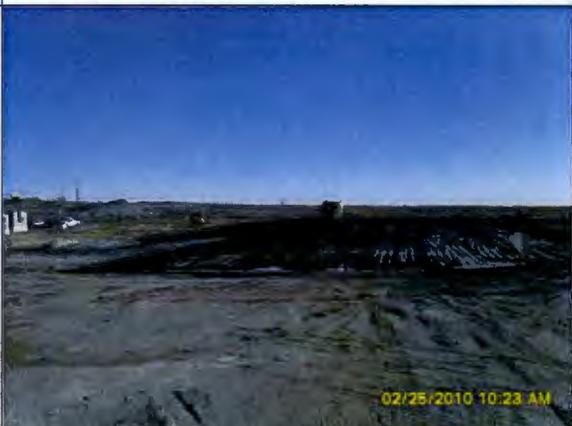
<p>02/25/2010 10:23 AM</p>
Facing E – TWS placing the fifth lift on the north embankment.	Facing E – TWS watering and compacting the fifth lift on the north embankment.

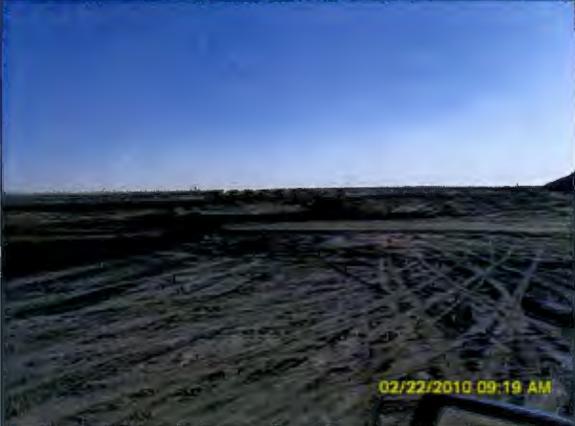
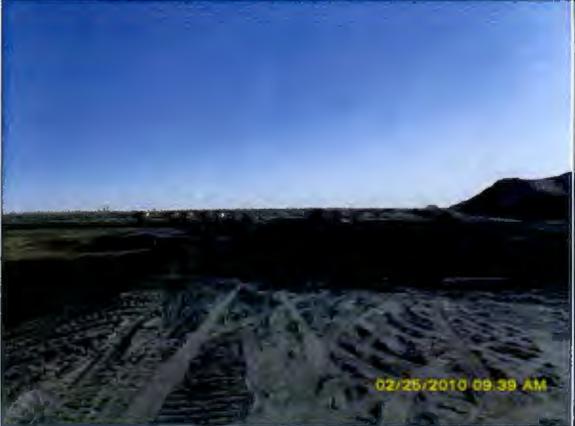
<p>02/26/2010 09:39 AM</p>
Facing E – TWS placing the third lift on the north embankment.	Facing E – TWS watering the third lift on the north embankment.

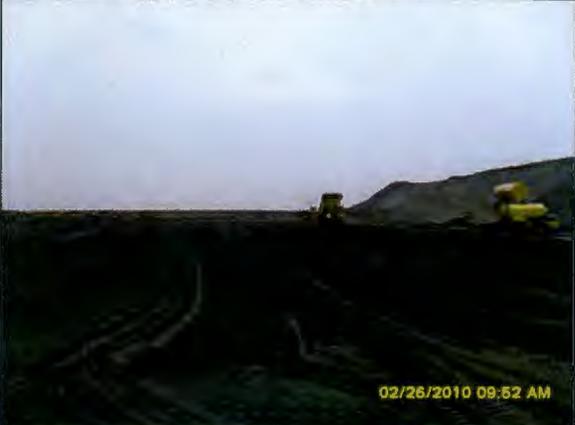
<p>02/26/2010 09:52 AM</p>	
Facing E – TWS compacting the third lift on the north embankment.

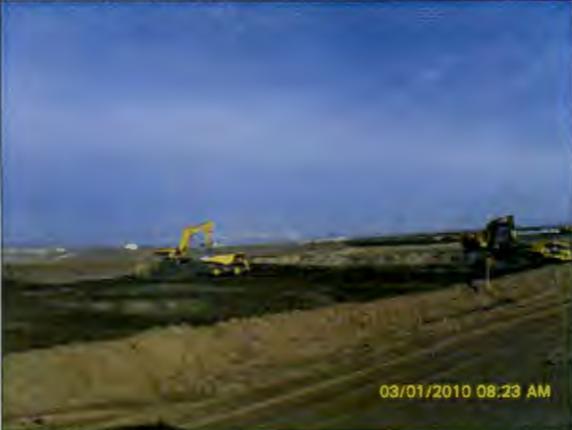
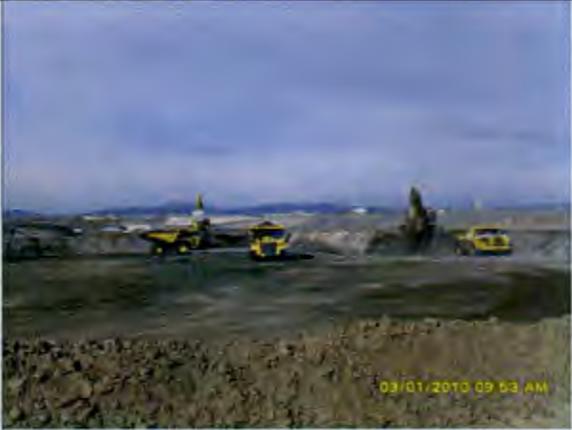
<p>03/01/2010 09:53 AM</p>
<p>Facing NW – TWS utilizing two CAT excavators to excavate from Cell 10.</p>	<p>Facing W – TWS utilizing two CAT excavators to excavate from Cell 10.</p>

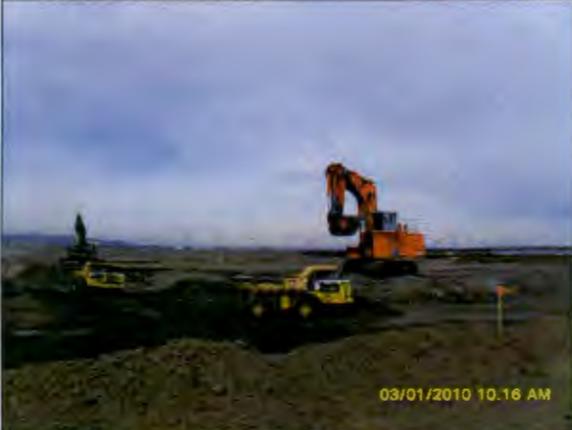
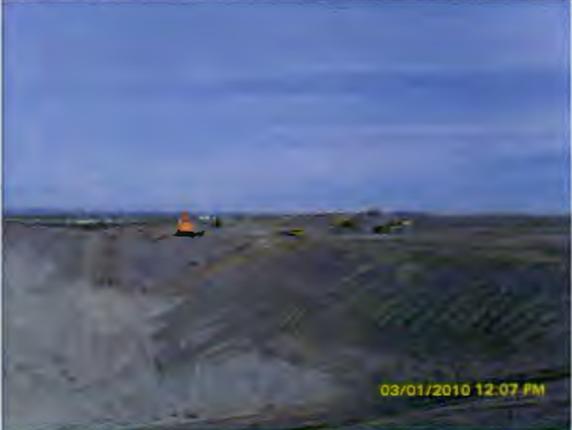
<p>03/01/2010 12:07 PM</p>
<p>Facing NW – TWS utilizing the CAT 5110 and the Hitachi 1800 to excavate from Cell 10.</p>	<p>Facing NE – TWS utilizing the CAT 5110 and the Hitachi 1800 to excavate from Cell 10.</p>

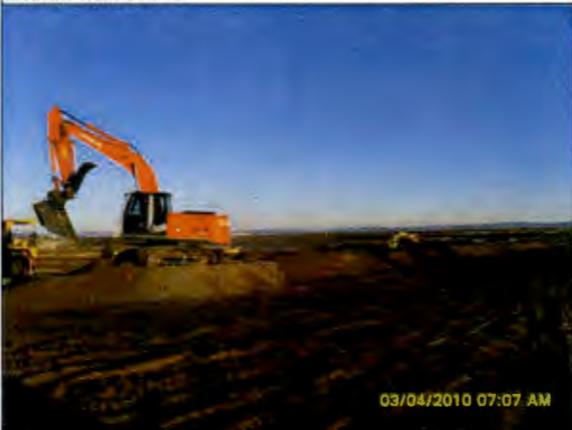
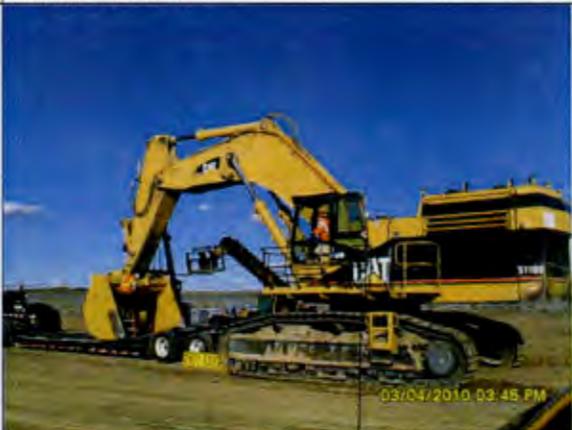
<p>03/04/2010 03:45 PM</p>
<p>Facing NW – TWS utilizing a Hitachi 200 to build the Run on Control Berm along the east side of Cell 10</p>	<p>Facing NE – TWS replacing the bucket on the CAT 5110 with a 13-cy bucket.</p>

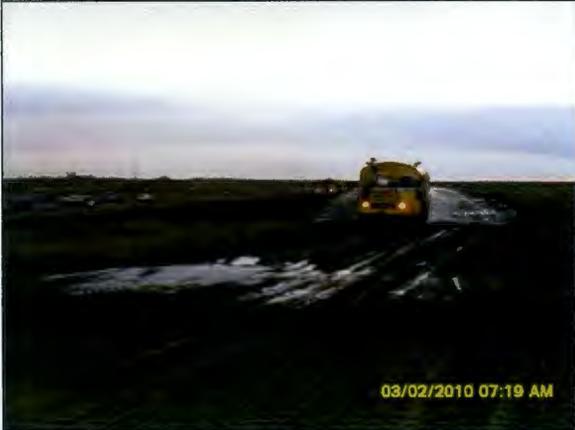
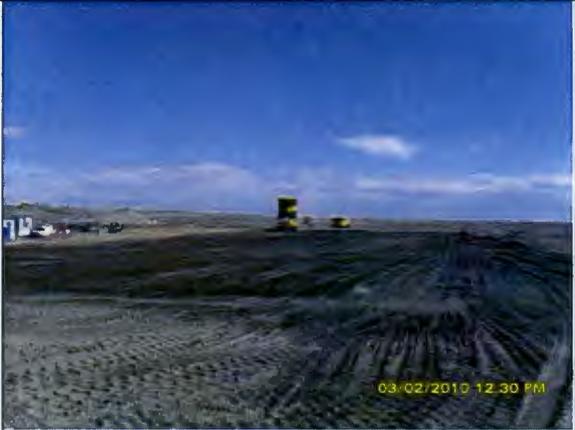
<p>03/02/2010 12:30 PM</p>
Facing E – TWS watering seventh lift on the north embankment prior to placing the eighth lift.	Facing E – TWS placing the eighth lift on the north embankment

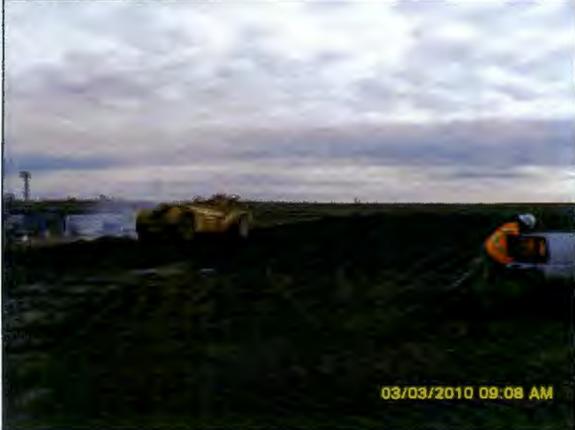
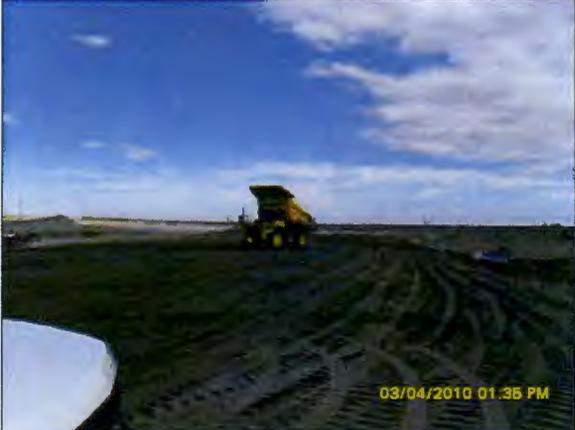
<p>03/04/2010 01:35 PM</p>
Facing E – TWS watering and compacting the ninth lift on the north embankment.	Facing E – TWS placing the tenth lift on the north embankment.

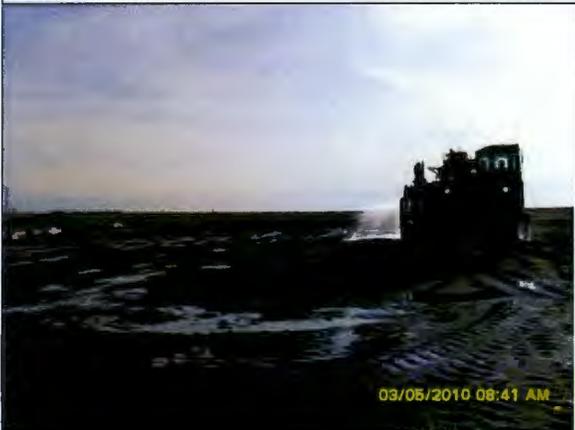
<p>03/05/2010 08:41 AM</p>	
Facing E – TWS watering and compacting the eleventh lift on the north embankment.

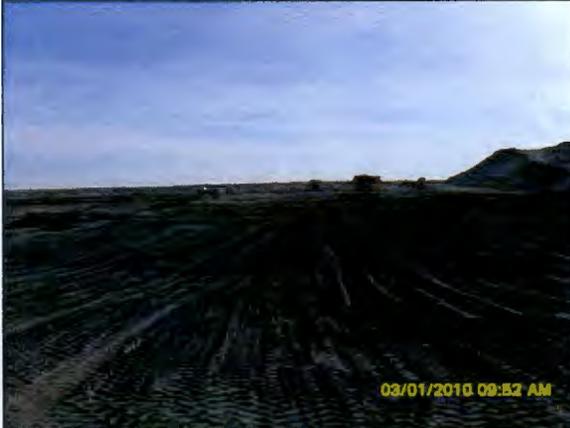
Facing E – TWS placing the third lift on the south embankment.

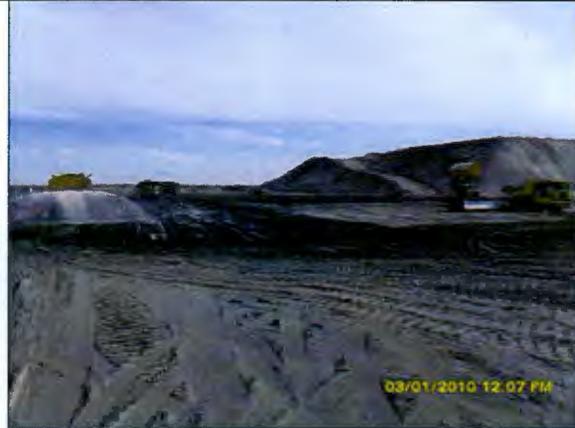
Facing E – TWS placing and watering the fourth lift on the south embankment.

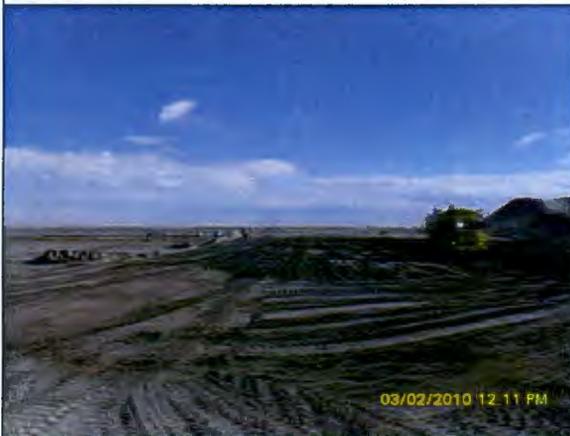
Facing E – TWS utilizing the weight of the "Ladybug" water truck to compact the sixth lift on south embankment.

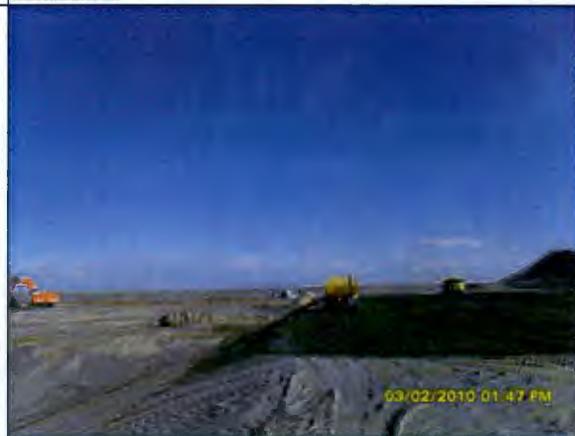
Facing E – TWS compacting the sixth lift on the south embankment.

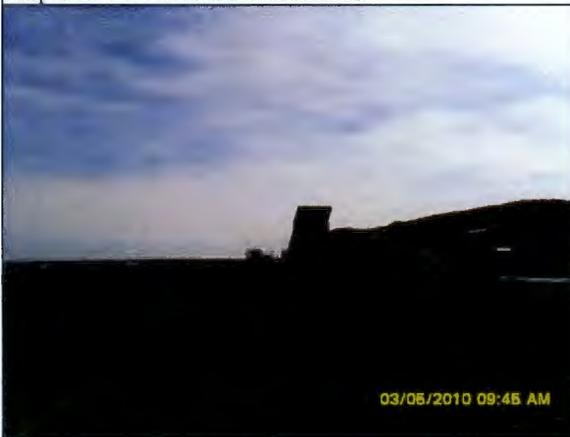
Facing E – TWS placing the ninth lift on the south embankment.

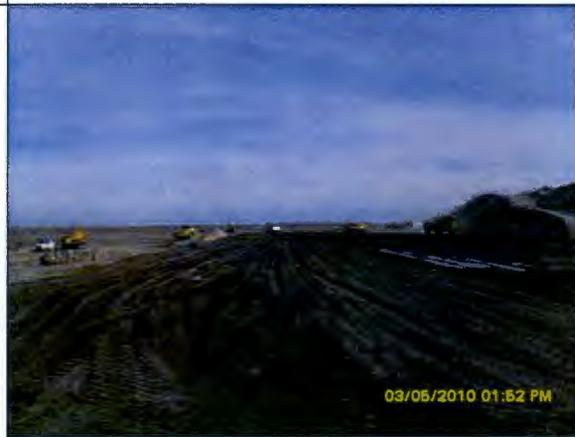
Facing E – TWS watering and compacting the ninth lift on the south embankment.

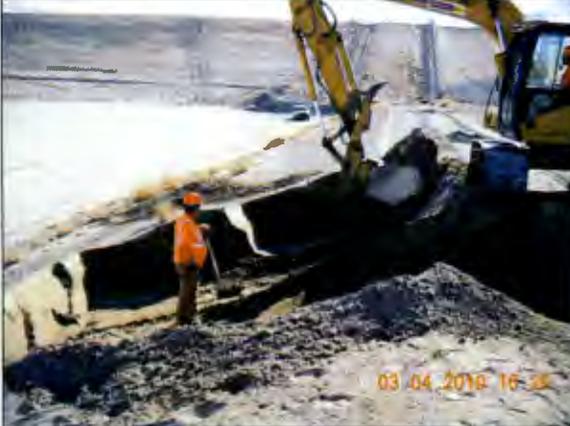
Facing S (Correct Time - 12:20) - TWS utilizing the CAT 312 excavator and a spotter to expose the Cell 9 Liner tie in.

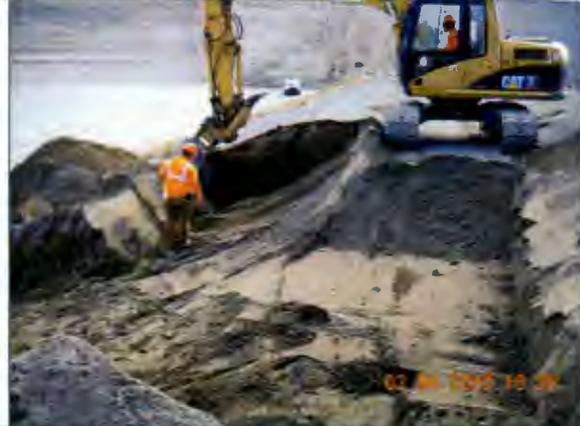
Facing S (Correct Time 12:38) - TWS utilizing the CAT 312 excavator and a spotter to expose the Cell 9 Liner tie in.

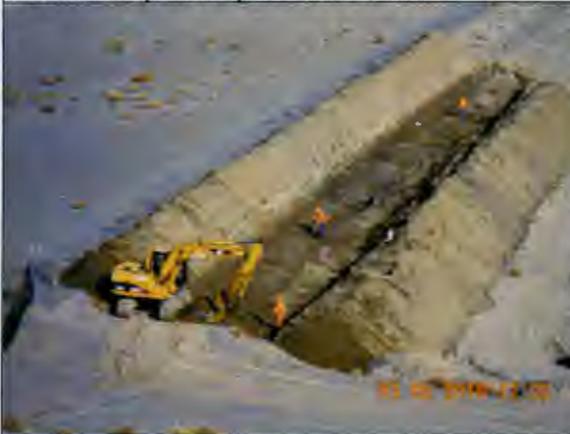
Facing N (Correct Time 8:33) - TWS exposing the Cell 9 Liner tie in with the excavator and hand digging.

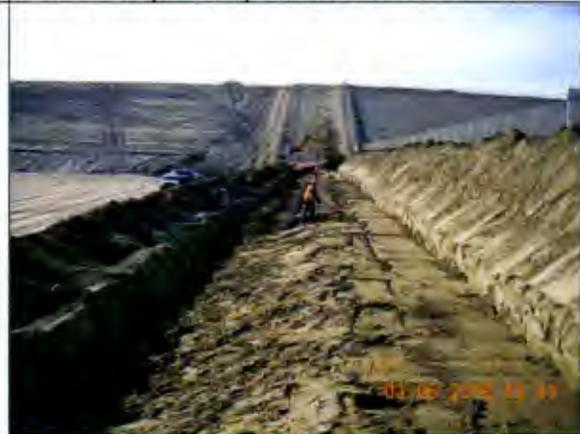
Facing S (Correct Time 8:41) - TWS utilizing hand digging to remove the last few inches of overburden from the line tie in.

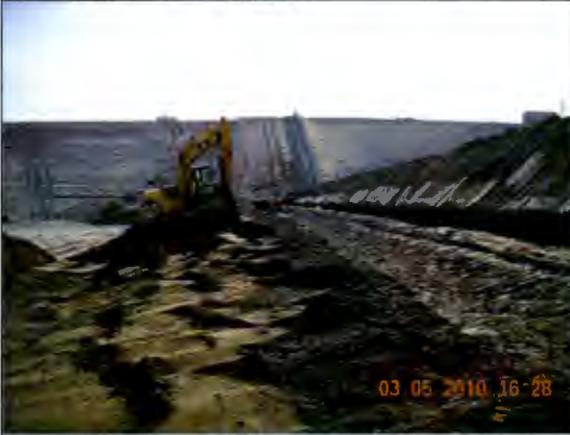
Facing S (Correct Time 8:28) - TWS utilizing the CAT 312 excavator to expose the Cell 9 liner tie in.

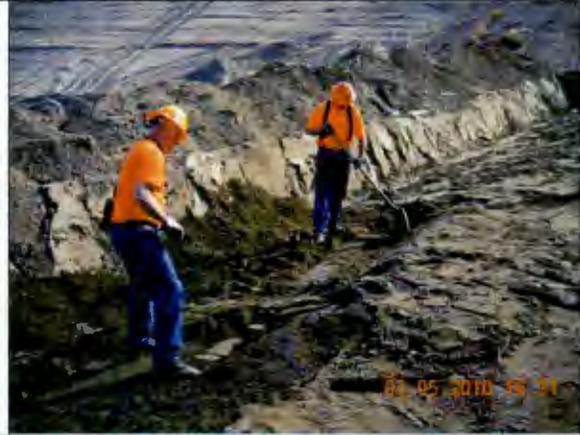
(Correct Time 8:31) TWS utilizing hand digging to remove soil close to liner and geotextile.

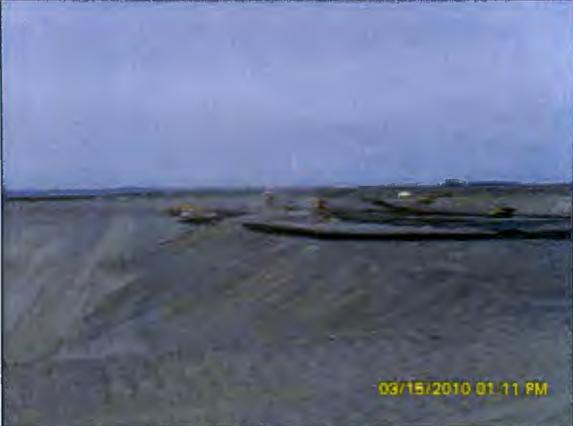
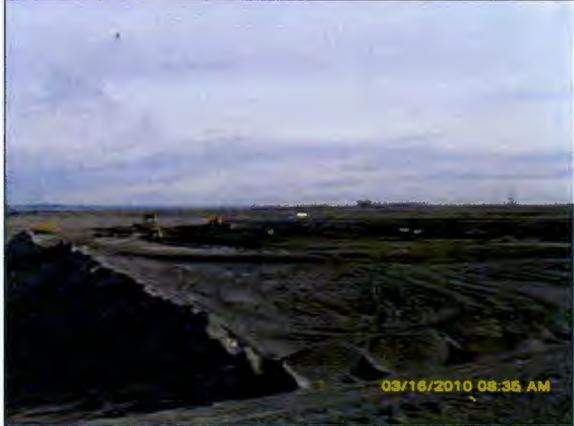
<p>03/16/2010 08:35 AM</p>
Facing NE – TWS excavating from Cell 10.	Facing NE – TWS excavating from Cell 10.

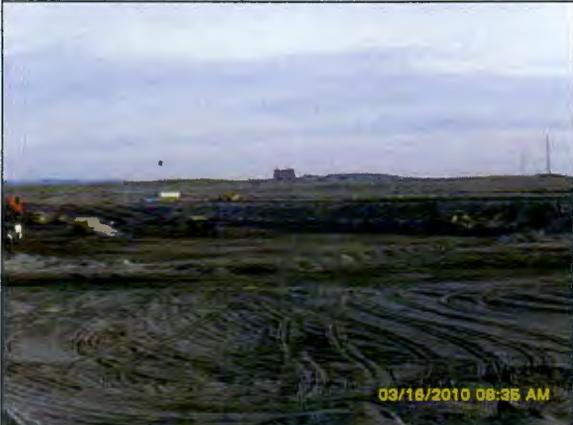
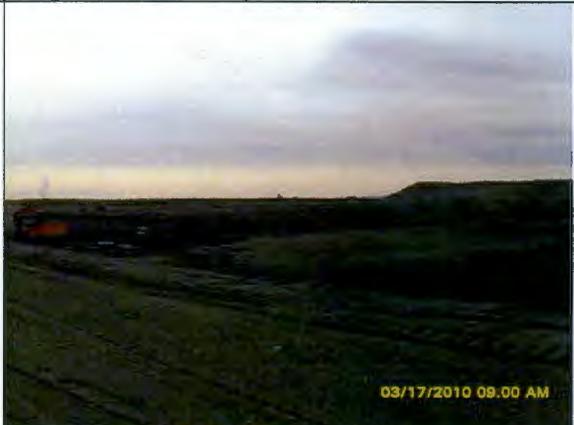
<p>03/17/2010 09:00 AM</p>
Facing NE – TWS excavating from Cell 10.	Facing SE – TWS excavating from Cell 10.

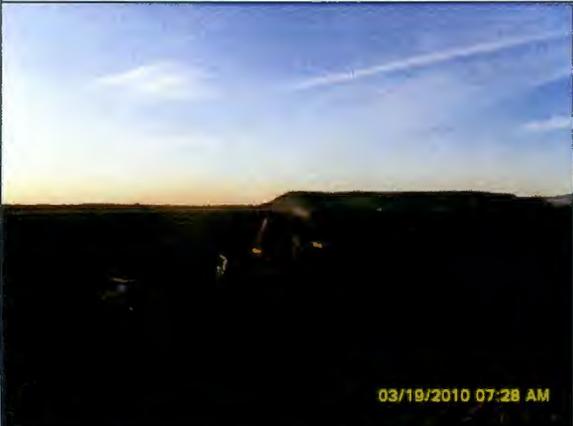
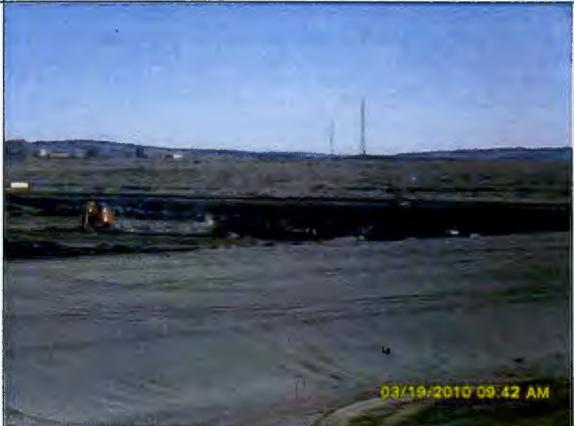
<p>03/19/2010 09:42 AM</p>
Facing SE – TWS excavating from Cell 10.	Facing NE – TWS excavating from Cell 10.

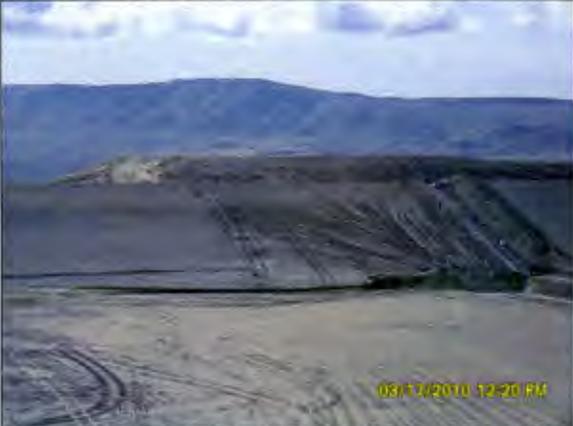
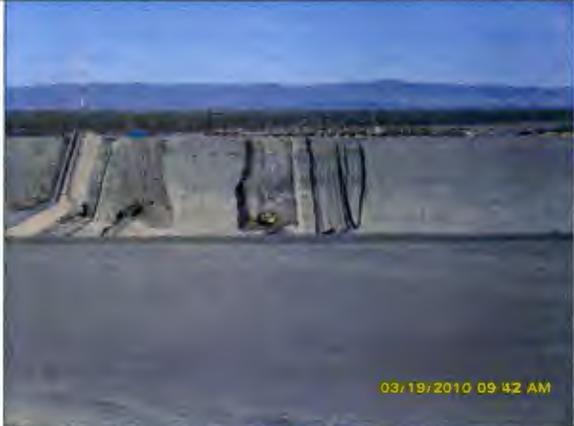
Facing SW – TWS cutting the Cell 9 south embankment to grade.	Facing N – TWS cutting the Cell 9 north embankment to grade.

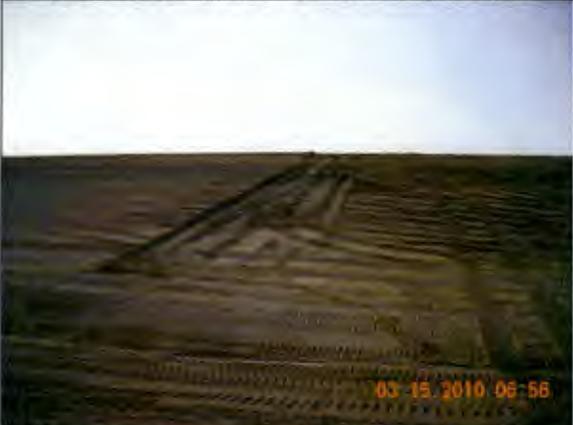
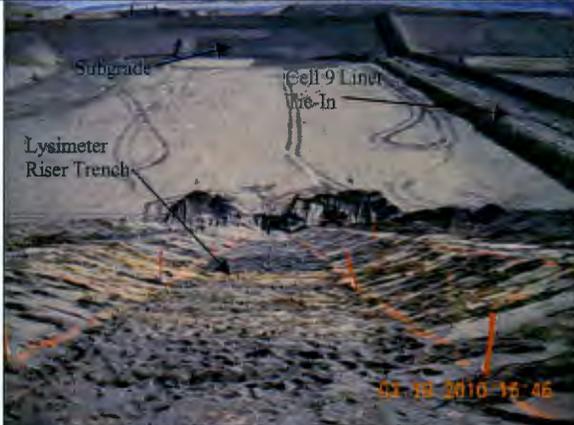
Facing S – A portion of the Cell 9 south embankment has been cut to grade.	Facing S – Overview of Cell 9.

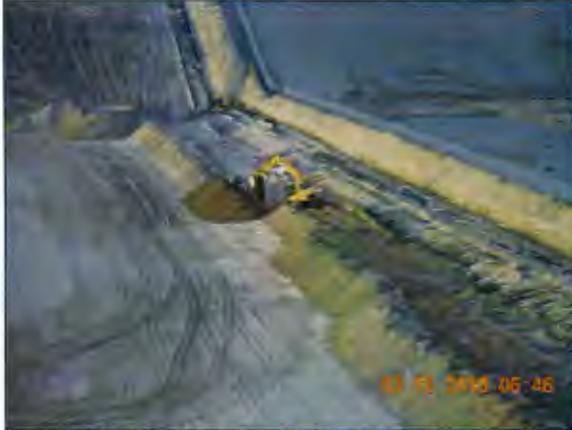
Facing SSW – TWS exposing the Cell 9/8 liner tie-in.

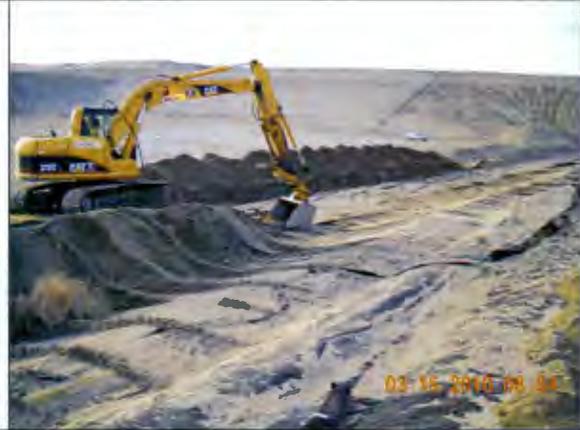
Facing SE – TWS exposing the Cell 9/8 liner tie-in.

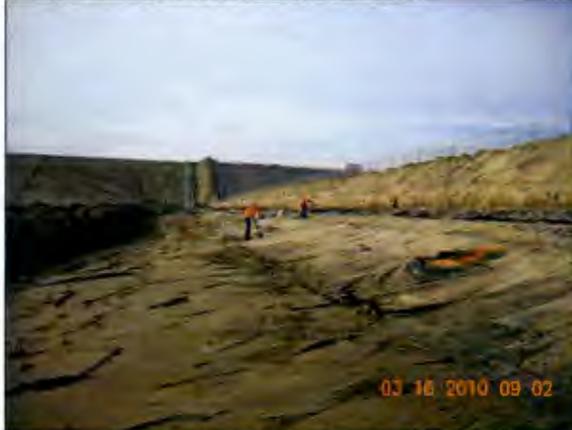
Facing S – TWS exposing the Cell 9/8 liner tie-in.

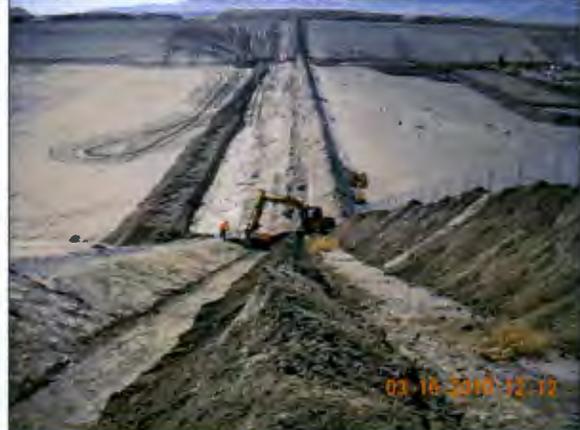
Facing S – TWS exposing the Cell 9/8 liner tie-in.

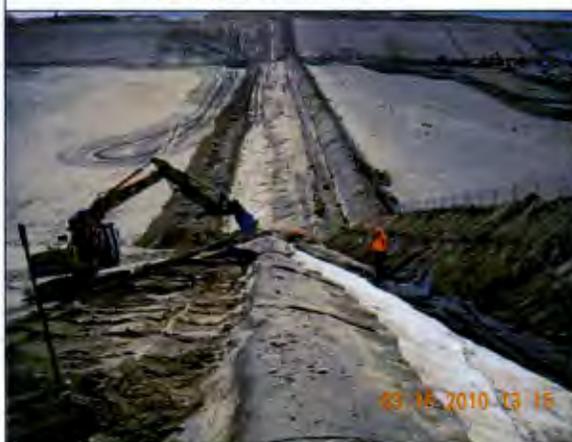
Facing S – TWS exposing the Cell 9/8 liner tie-in.

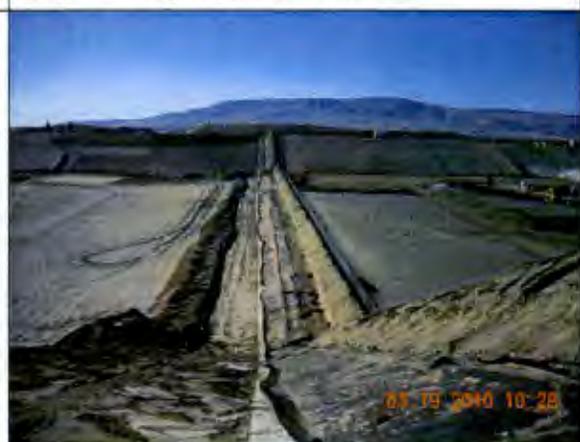
Facing S – TWS exposing the Cell 9/8 liner tie-in.

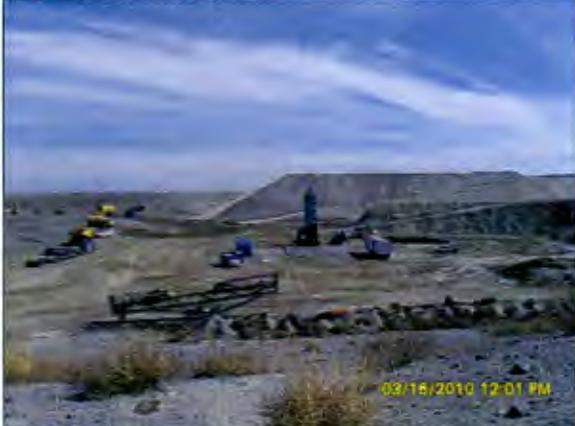
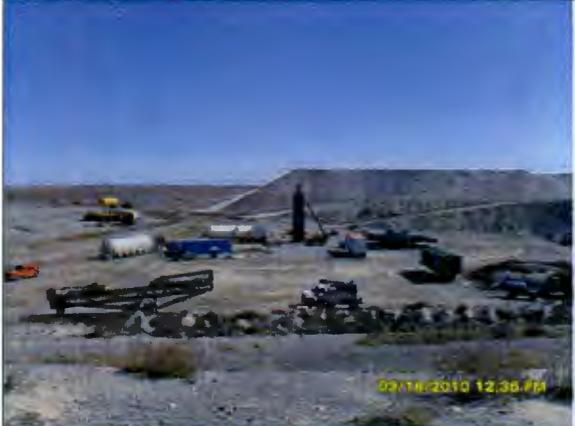
<p>03/16/2010 12:38 PM</p>
Facing E – TWS erecting the first bentonite silo.	Facing E – TWS erecting the first bentonite silo.

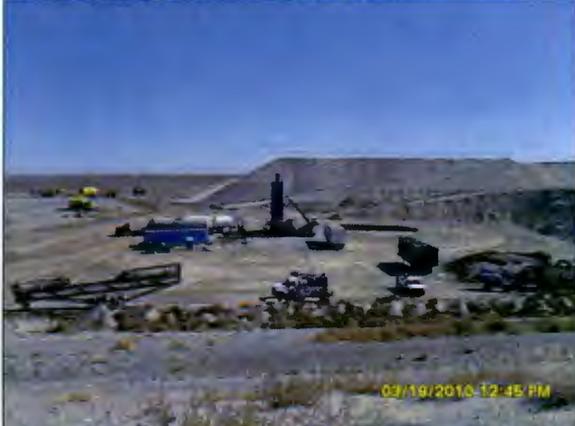
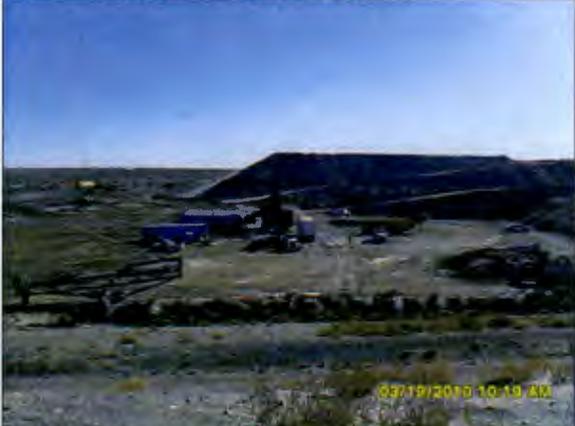
<p>03/19/2010 10:19 AM</p>
Facing E – TWS setting the pug.	Facing E – TWS erecting the second bentonite silo.

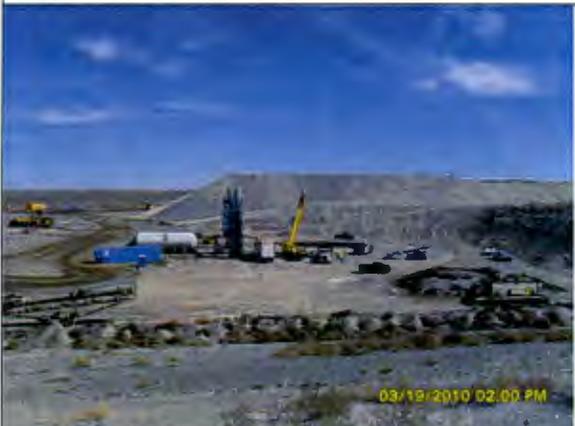
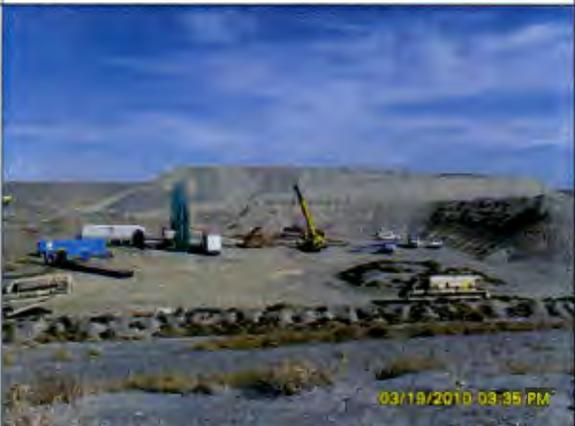
<p>03/19/2010 03:35 PM</p>
Facing E – TWS setting the pugmill hopper.	Facing E – TWS setting the base soil conveyor belt.

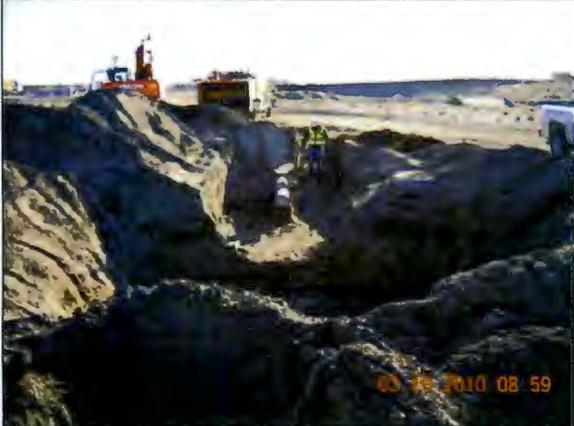
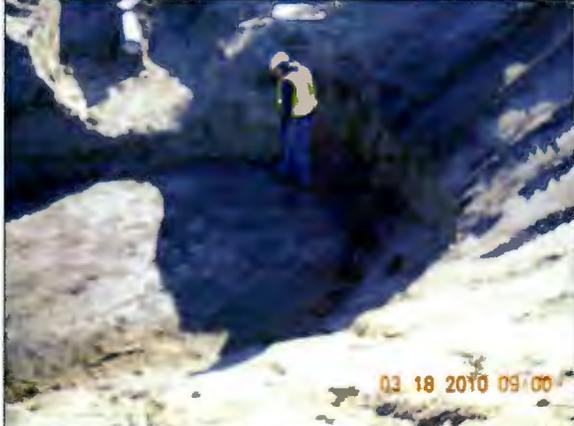
<p>03 18 2010 09 00</p>
Facing SE – CQA inspecting the excavation for MH-21	Facing SE – CQA inspecting the excavation for MH-21

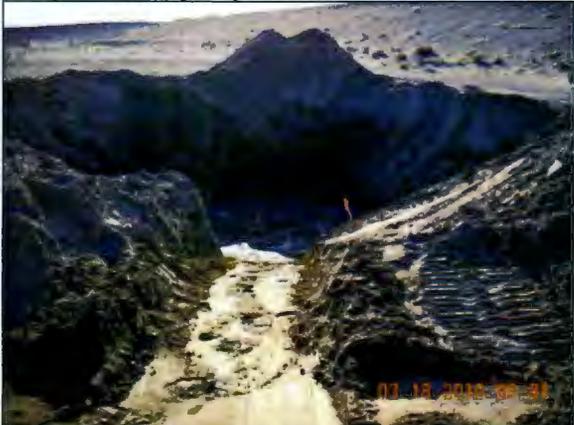
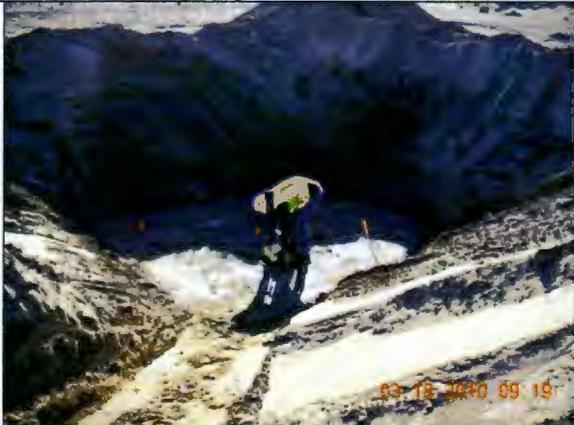
<p>03 18 2010 09 19</p>
Facing SE – CQA inspecting the excavation for MH-39	Facing SE – CQA inspecting the excavation for MH-39

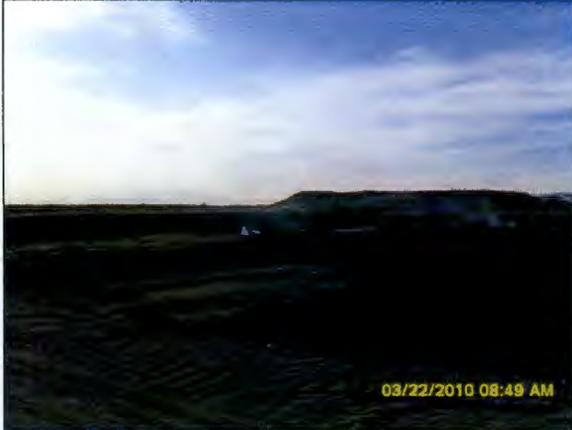
Facing SE – Cell 10 Excavation

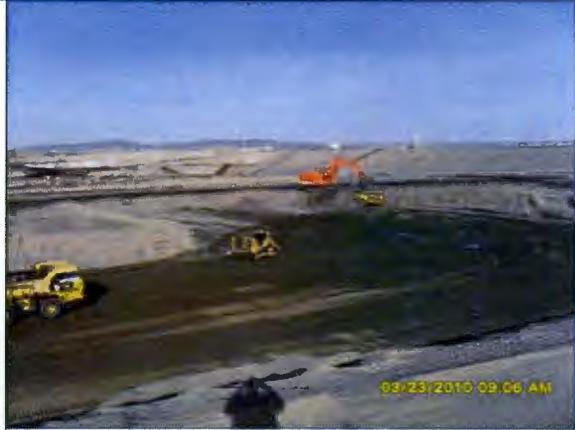
Facing NW – Cell 10 Excavation

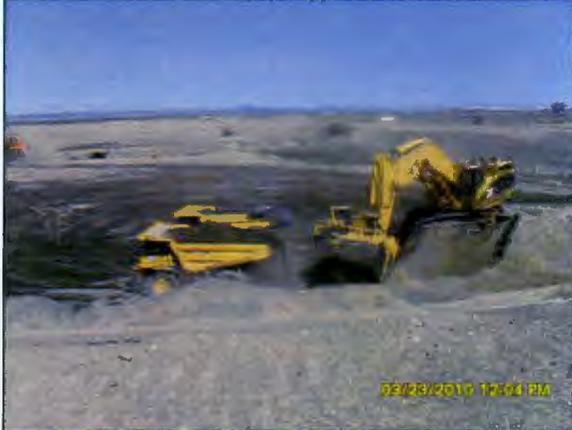
Facing N – Cell 10 Excavation

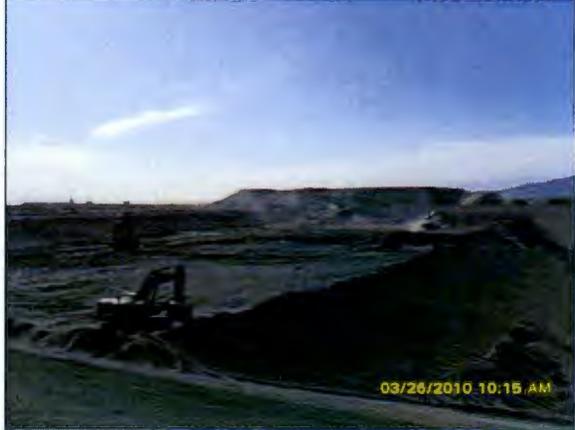
Facing SE – Cell 10 Excavation

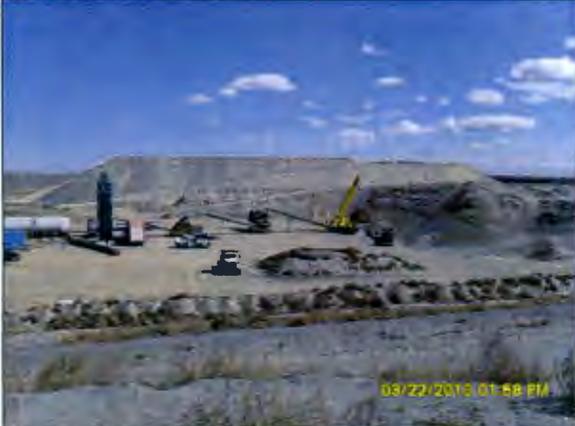
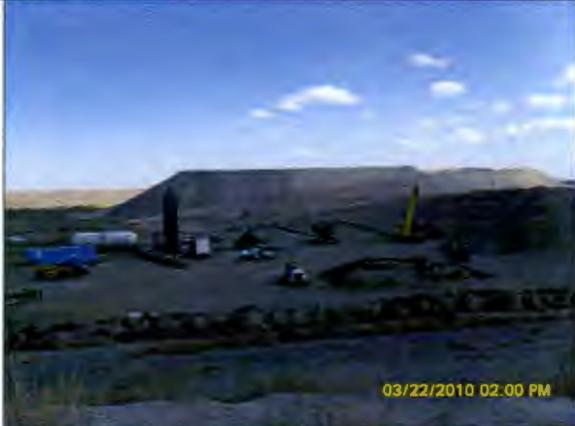
Facing E – Pugmill setup.	Facing E – Pugmill setup.
