FINAL REPORT

CONSTRUCTION QUALITY ASSURANCE (CQA)

FINAL REPORT
CONSTRUCTION QUALITY ASSURANCE (CQA)
ENVIRONMENTAL RESTORATION DISPOSAL FACILITY (ERDF)
SUPER CELLS 9 & 10
SUBCONTRACT S013213A00
010.032-00-ROB

PHOTOGRAPH LOG

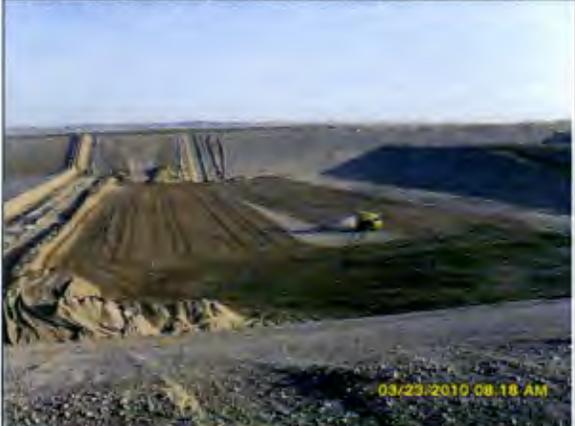
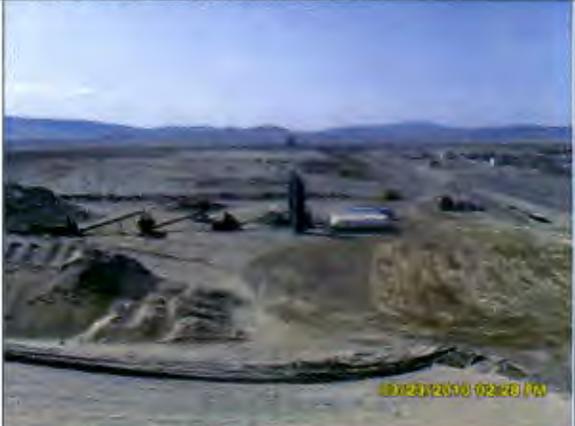
Facing N – TWS keeping the Cell 9 subgrade moisture conditioned.	Facing W – Pugmill setup.

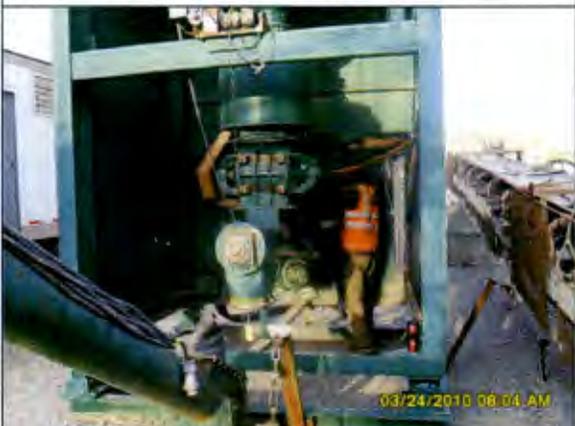
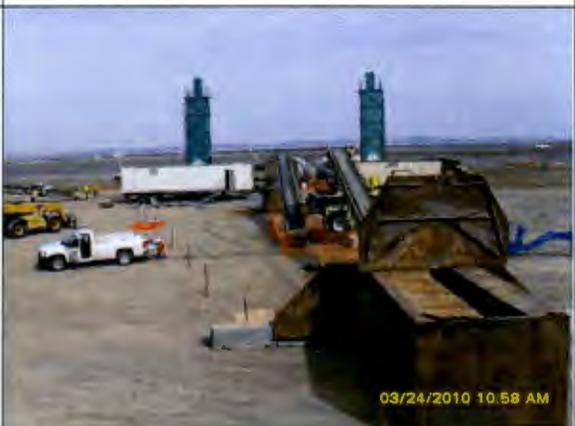
TWS connecting readout panel in the P9 (west) bentonite silo.	Facing N – Pugmill setup.

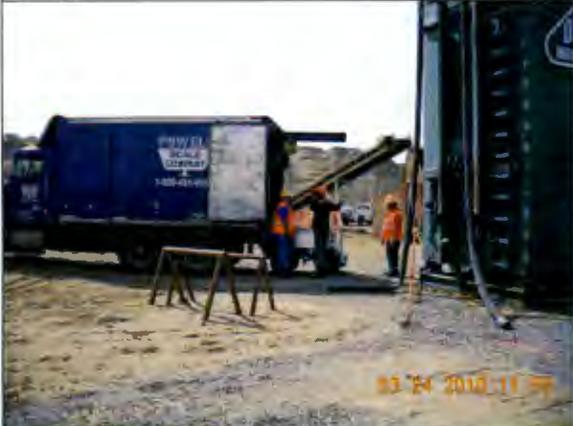
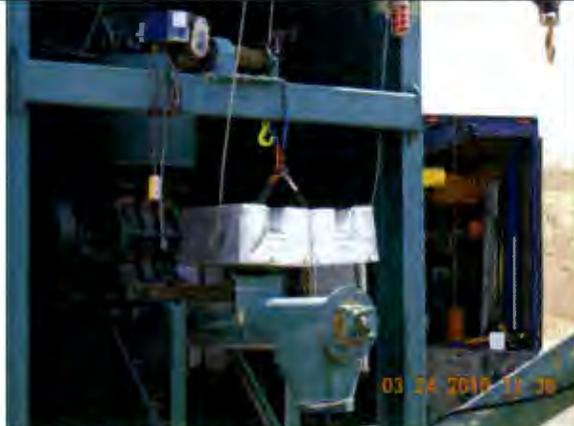
Powell Scale Co. calibrating the P19 (east) bentonite silo.	Calibration weights hanging from the P19 (east) silo

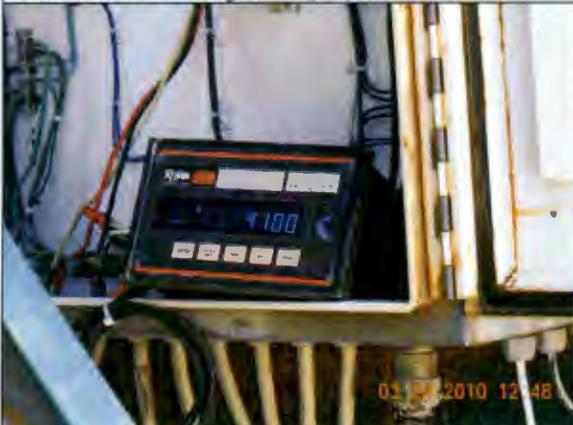
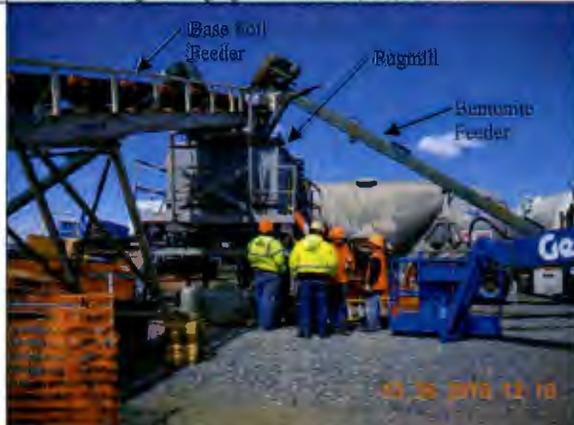
Bentonite silo P19 (east) scale calibration readout..	Pugmill set up

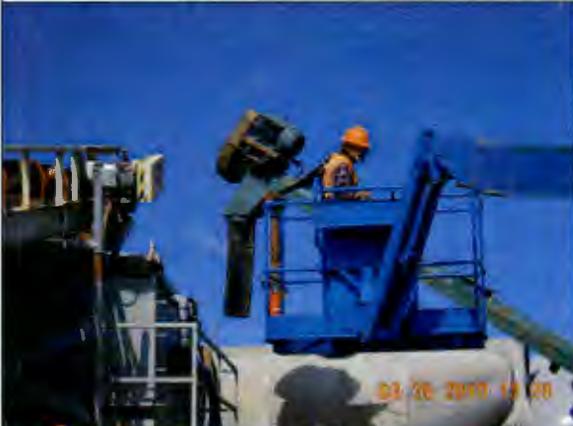
Unloading P19(east) silo.

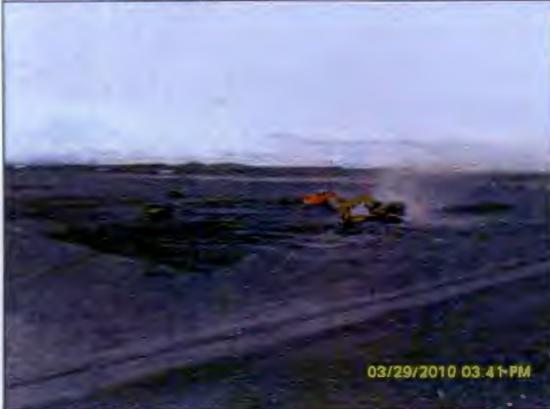
Facing NE - Excavation from Cell 10

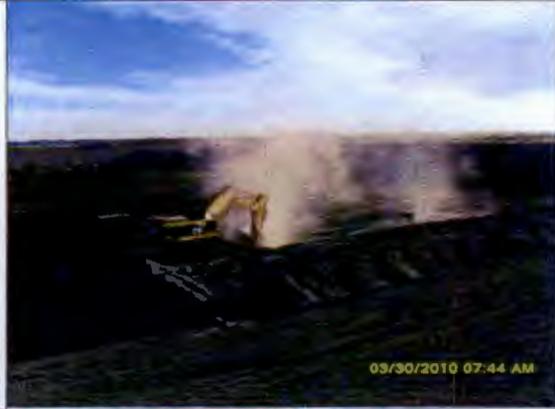
Facing NE - Excavation from Cell 10

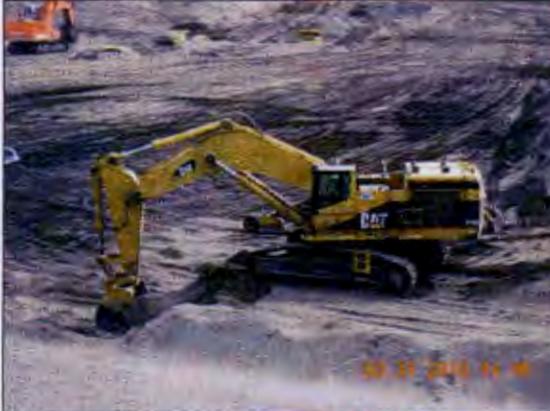
Facing S - The CAT 5110 excavating from Cell 10.

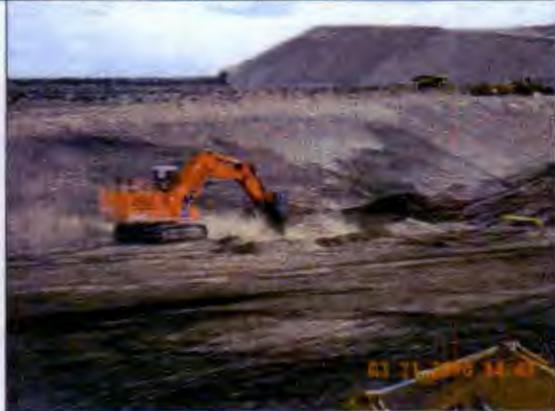
Facing SE - The Hitachi 1800 excavating from Cell 10.

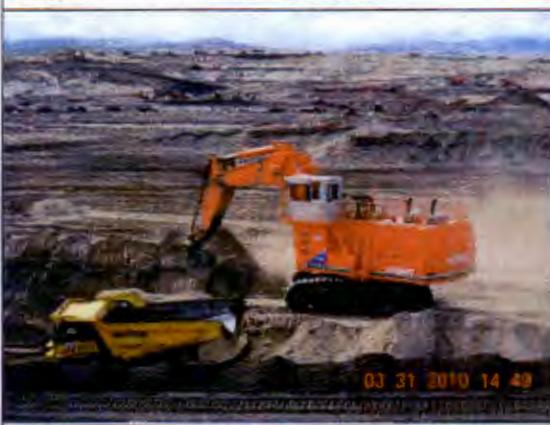
Facing W - The Hitachi 1800 excavating from Cell 10.

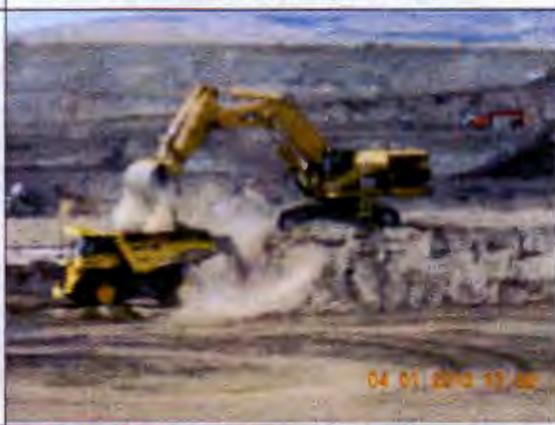
Facing W - The CAT 5110 excavating from Cell 10.

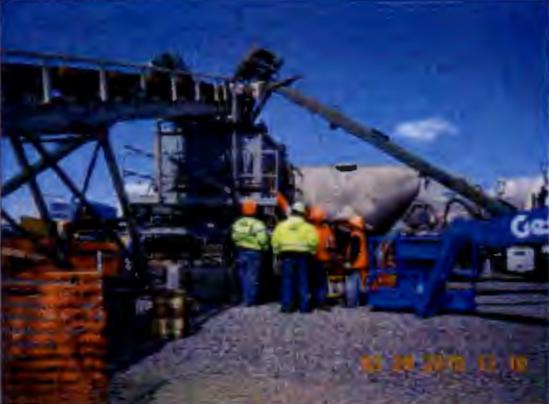
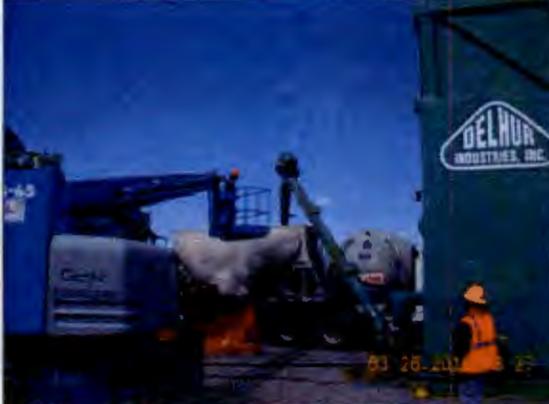
Facing N – Preparing for bentonite calibration at the pugmill.	Facing N - Transferring bentonite from the P19 east silo into a waiting truck for calibration.

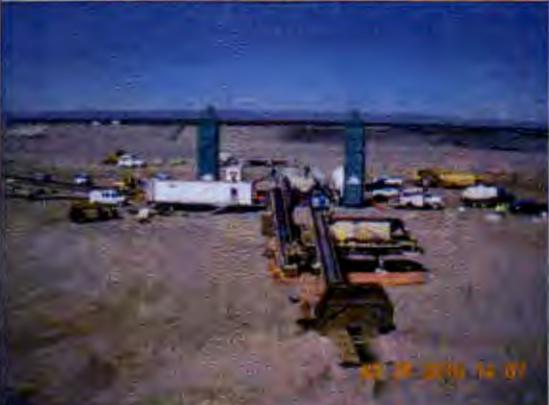
Facing N - Pugmill Setup	Facing NW - Belt scale calibration test.

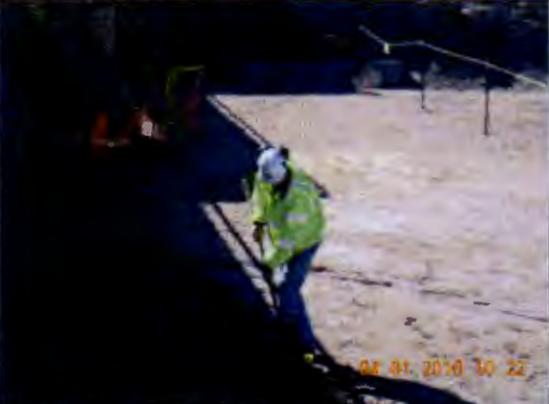
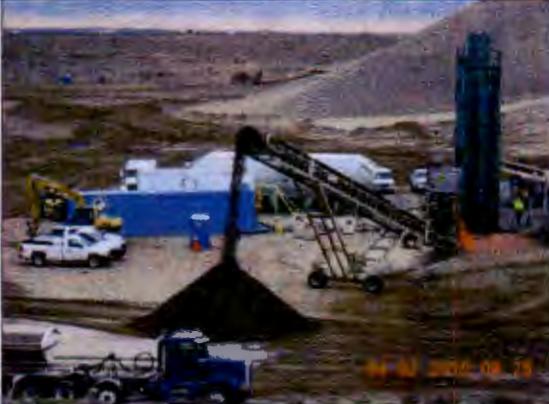
Facing S - TWS sampling the base soil for moisture content verification.	Facing E – TWS beginning admix production.

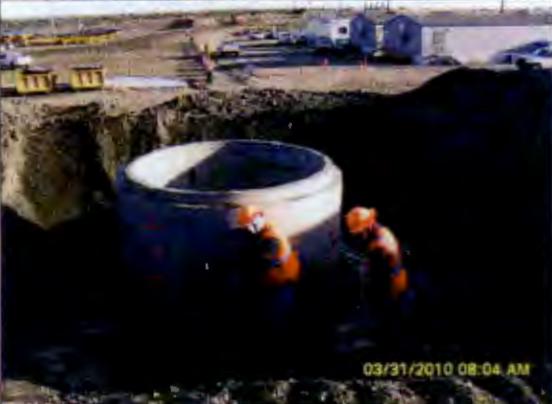
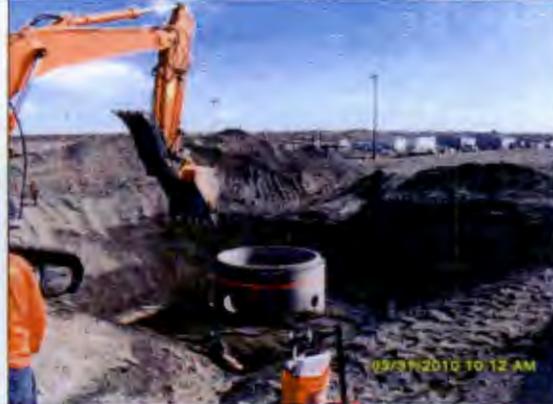
<p>03/31/2010 10:12 AM</p>
<p>Facing N - TWS backfilling around MH-32.</p>	<p>Facing NE - TWS backfilling around MH-33.</p>

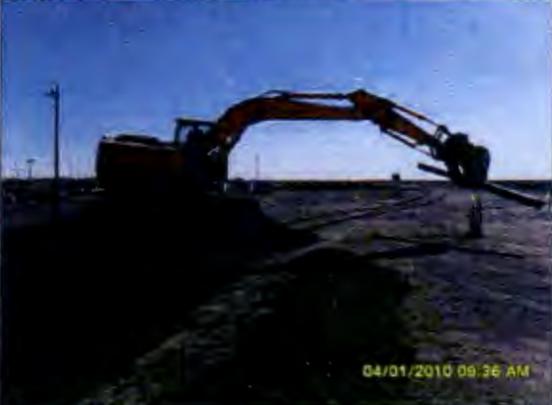
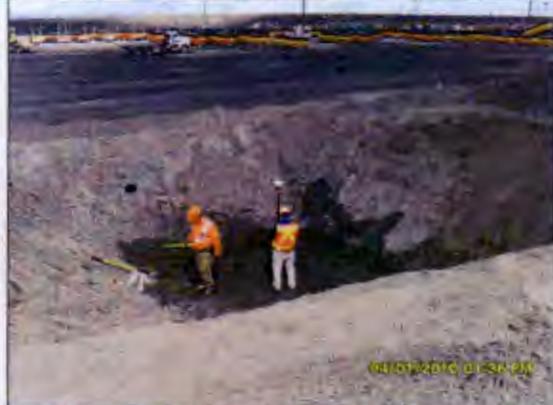
<p>04/01/2010 01:34 PM</p>
<p>Facing E - TWS excavating for MH-34.</p>	<p>Facing NE - TWS laying out the location of MH-34.</p>

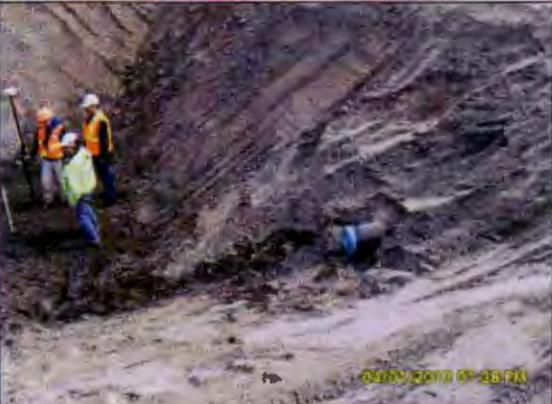
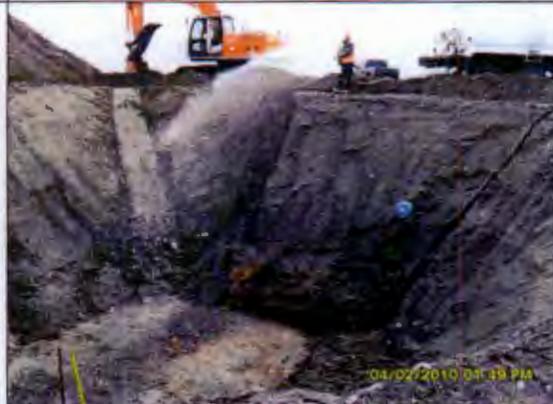
<p>04/02/2010 04:49 PM</p>
<p>Excavation of MH-34. The fresh water discharge line from Cell 7 has been cut and capped.</p>	<p>Excavation of MH-34. The fresh water discharge line from Cell 7 has been cut and capped.</p>

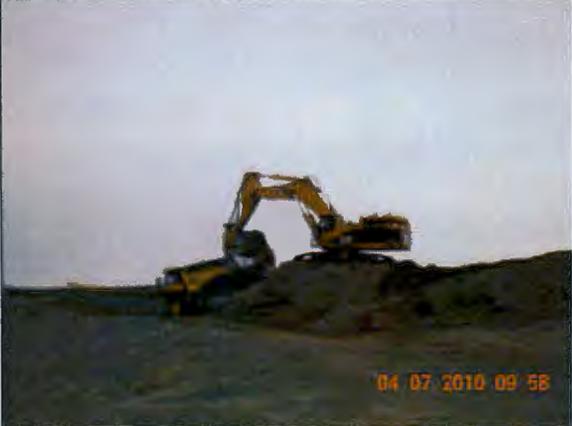
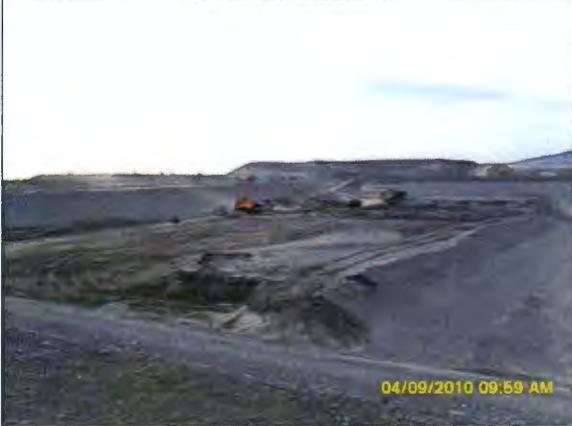
<p>04/09/2010 09:59 AM</p>
Facing E – TWS utilizing the CAT 5110 to excavate from Cell 10.	Facing SE – TWS excavating from Cell 10

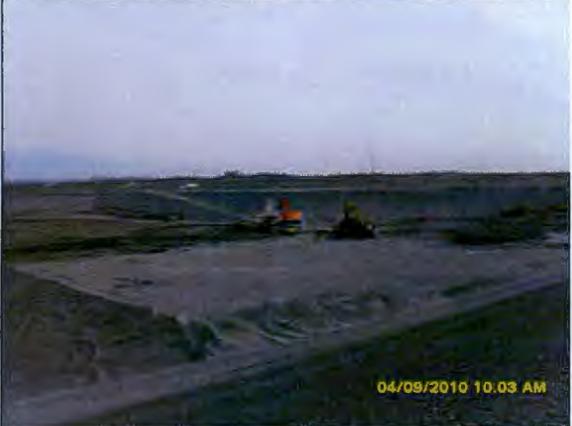
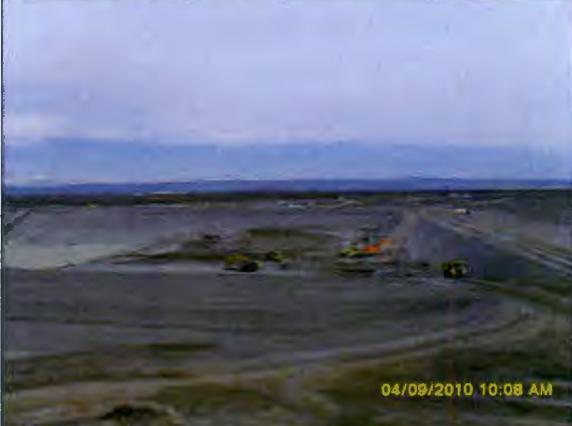
<p>04/09/2010 10:08 AM</p>
Facing NE – TWS excavating from Cell 10	Facing N – TWS excavating from Cell 10

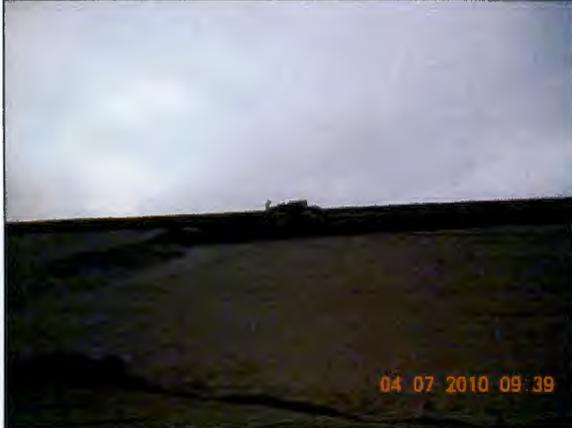
Facing S – TWS using the CAT D6 GPS dozer to cut the south interior slope of Cell 9 to grade.

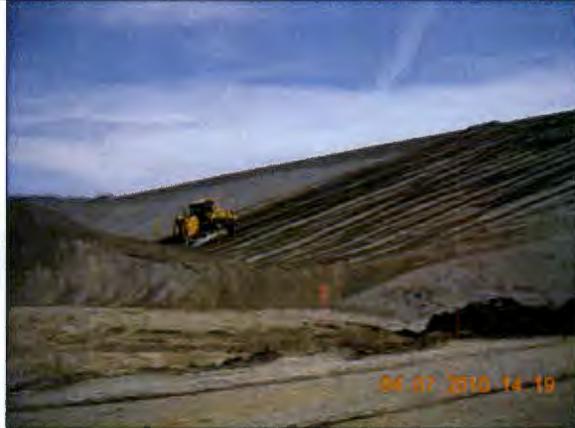
Facing SE – TWS using the CAT D6 GPS dozer to cut the south interior slope of Cell 9 to grade.

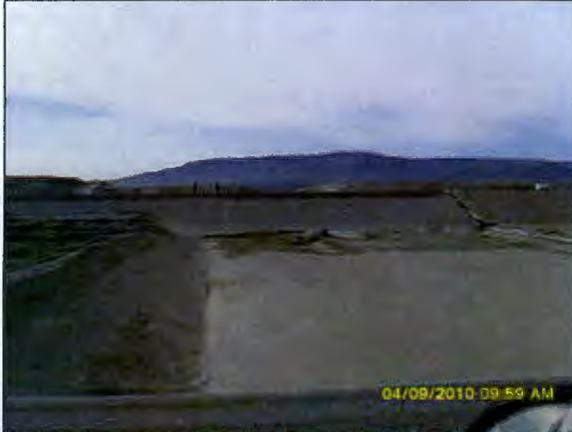
Facing S – TWS mucking out the clippings from Cell 9.

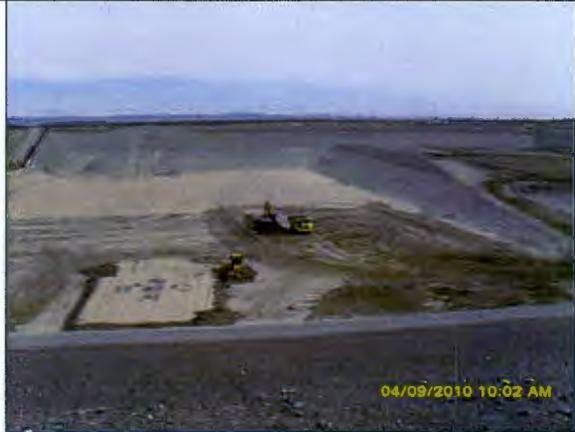
Facing N – TWS mucking out the clippings from Cell 9.

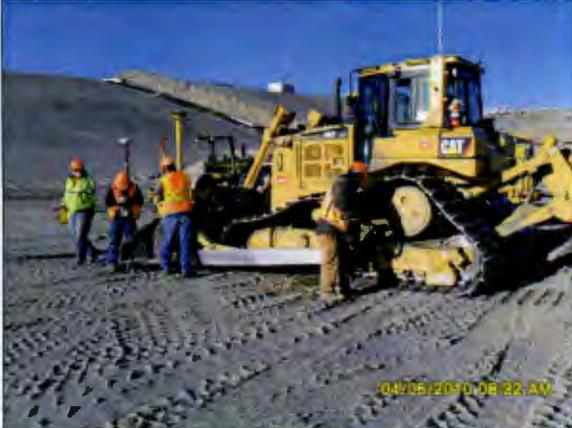
Facing W – TWS and CQA surveyors checking the GPS on the CAT D6 GPS dozer.

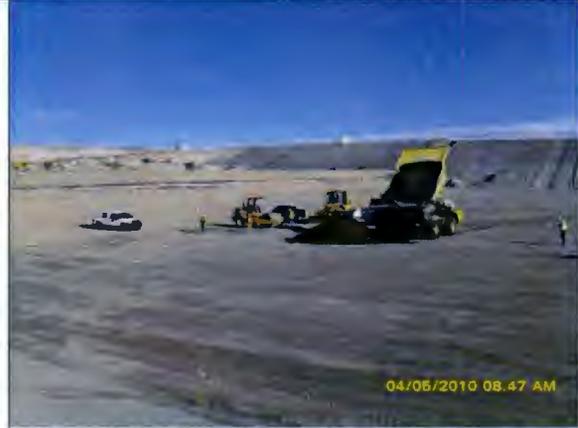
Facing NW – TWS placing the first of the admix for the testpad.

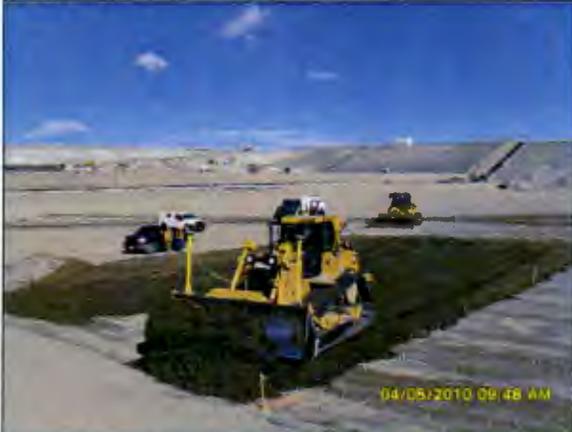
Facing NW – TWS using the CAT D6 GPS dozer to spread the first lift of admix for the test pad.

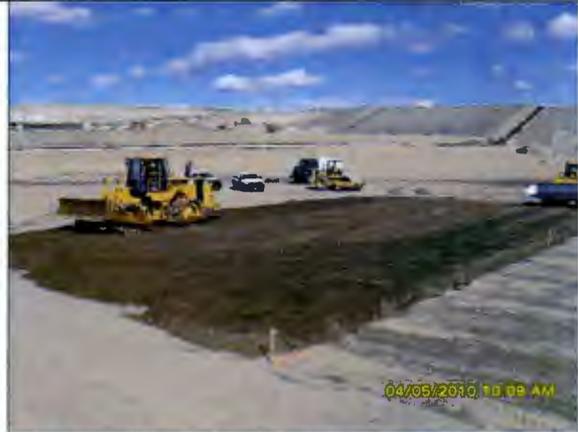
Facing NW – TWS using the CAT 825 compactor to compact the first lift of the test pad..

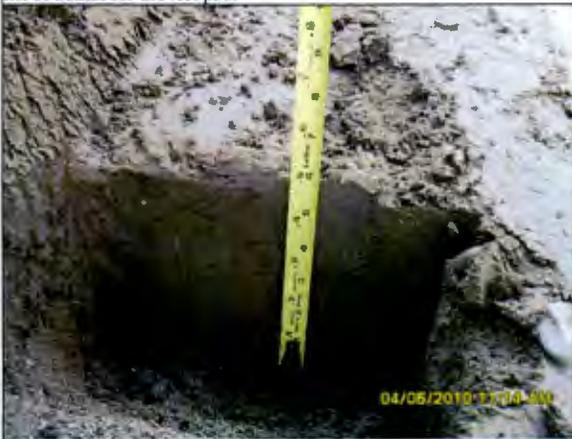
TWS measuring the thickness of the first lift.

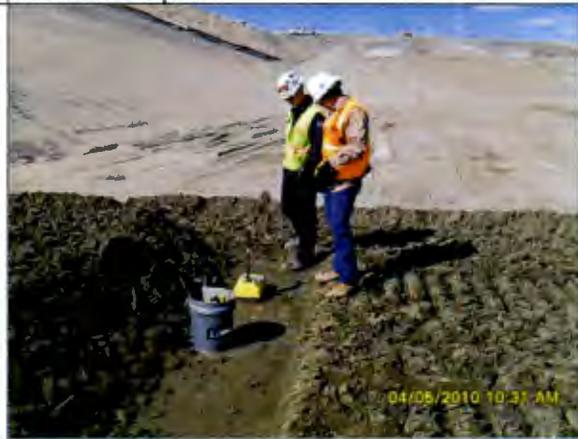
Facing W – CQA testing the density and moisture of the first lift..

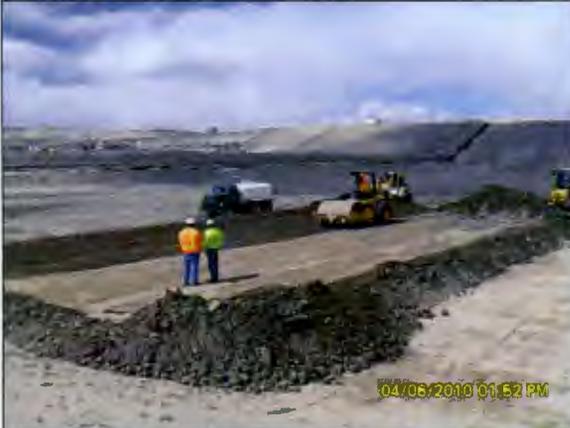
Facing NW – TWS static rolling the final lift of the test pad to demonstrate finishing of the admix liner layer.

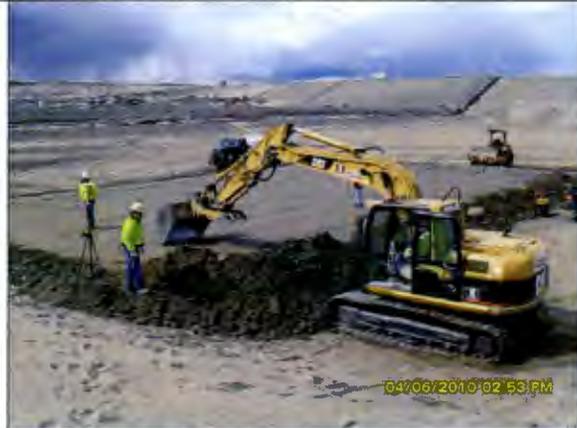
Facing E – TWS excavating one of two test pits to demonstrate that all six lifts are bonded together seamlessly.

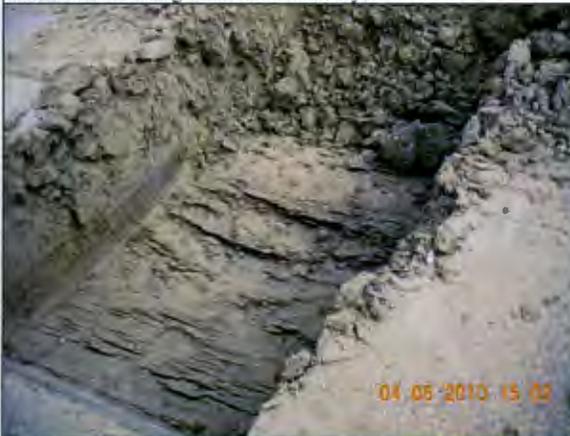
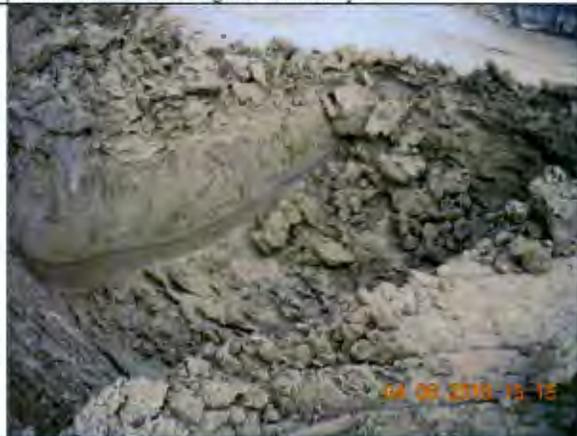
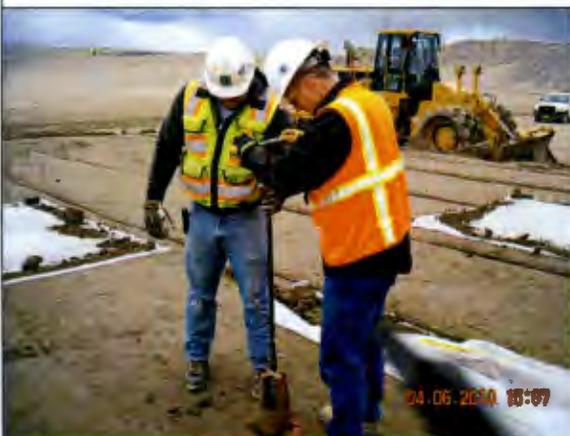
Facing NE – CQA digging the Boutwell boreholes

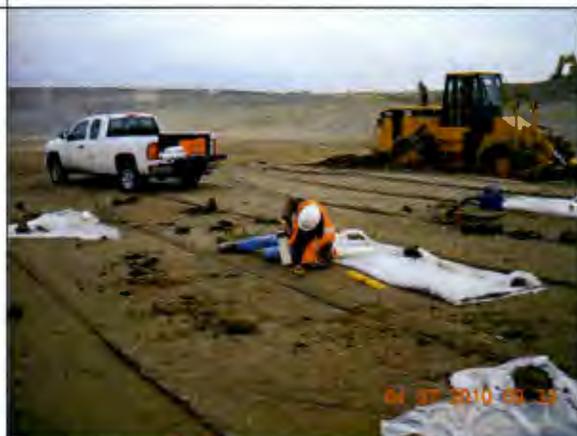
Facing NE – CQA preparing each hole for Boutwell installation.

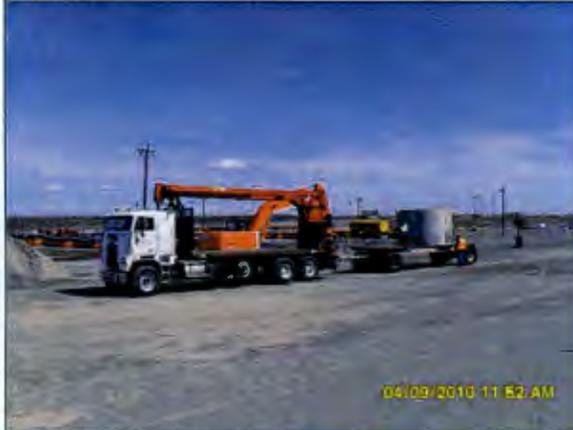
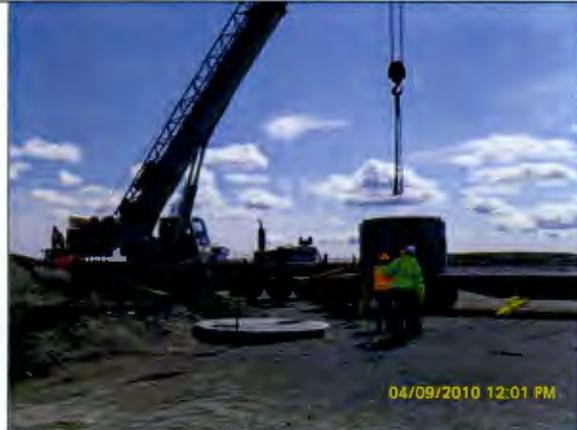
Facing NE – Manhole MH-34 arriving on-site.

Facing E – TWS utilizing Hooks Crane service to set MH-34.

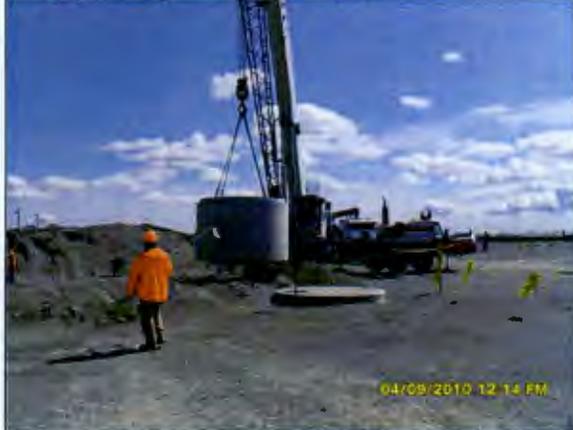
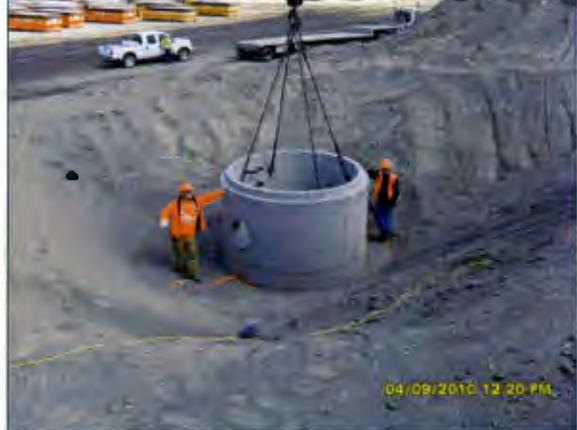
Facing E – TWS utilizing Hooks Crane service to set MH-34.

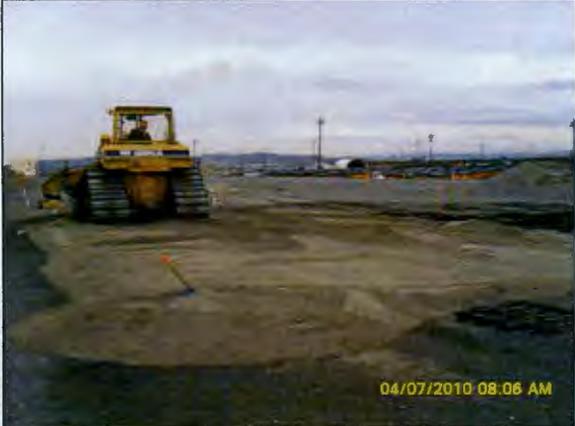
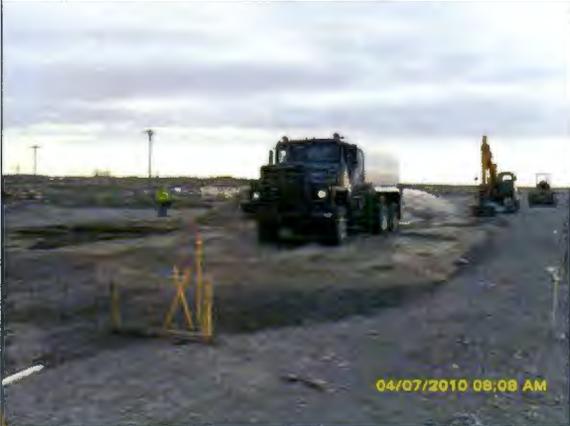
Facing W – TWS placing structural fill on Cell 9 Crest pad.	Facing E – TWS moisture conditioning the lifts placed on the Cell 9 Crest Pad.

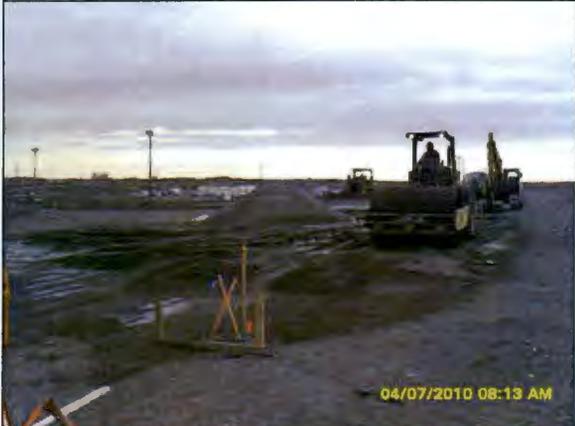
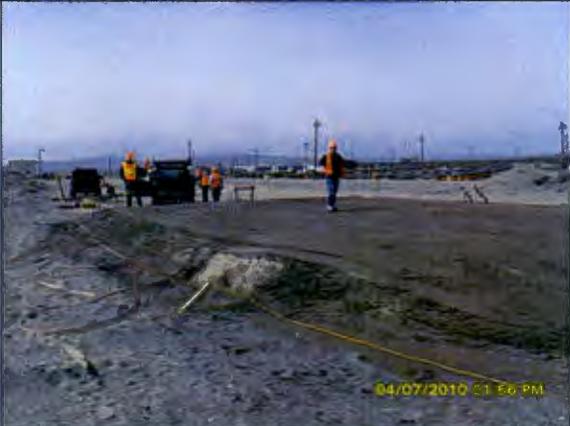
Facing E – TWS using the CAT CS 563 smooth drum roller to compact the lifts placed on the Cell 9 Crest Pad.	Facing W – The completed Cell 9 Crest Pad.

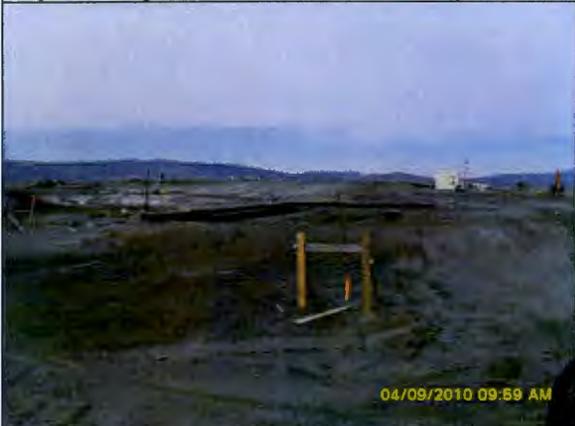
Facing W – TWS has begun to place wooden form along the south and west side of the Crest Pad.

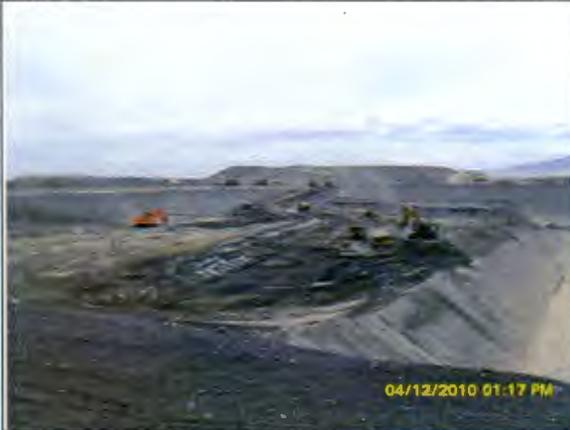
Facing SE – TWS continuing Cell 10 excavation

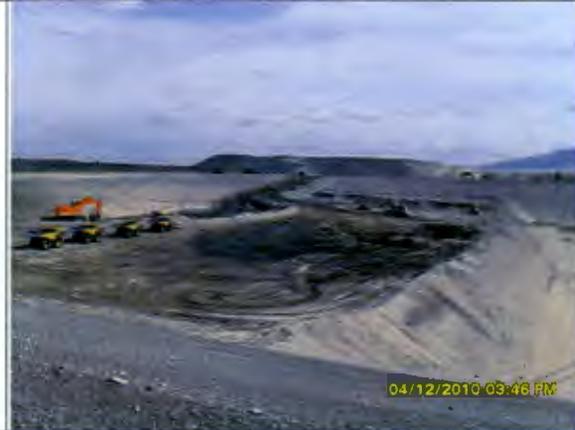
Facing SE – TWS continuing Cell 10 excavation

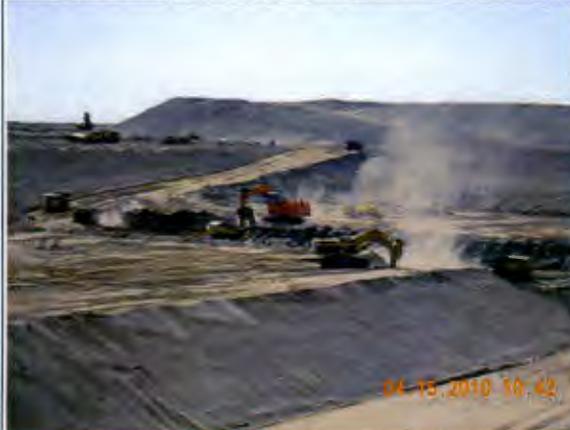
Facing SE – TWS continuing Cell 10 excavation

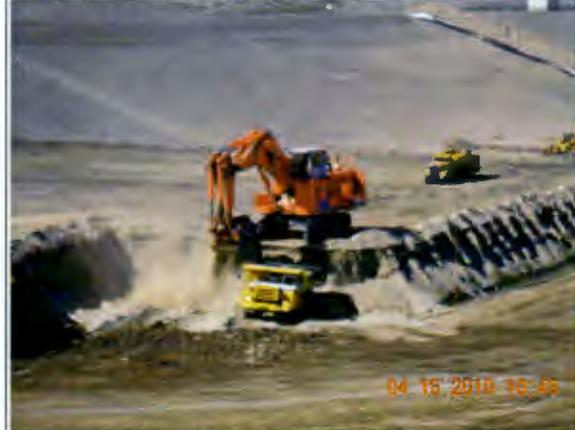
Facing SW – TWS continuing Cell 10 excavation

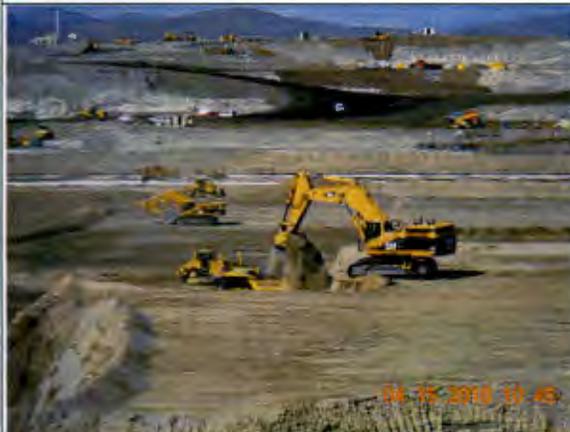
Facing W – TWS continuing Cell 10 excavation

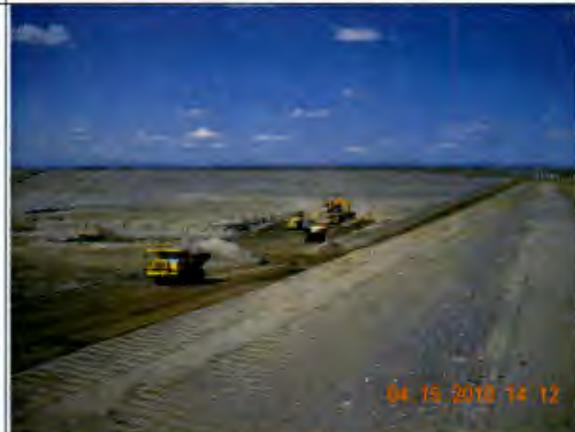
Facing NW – TWS continuing Cell 10 excavation

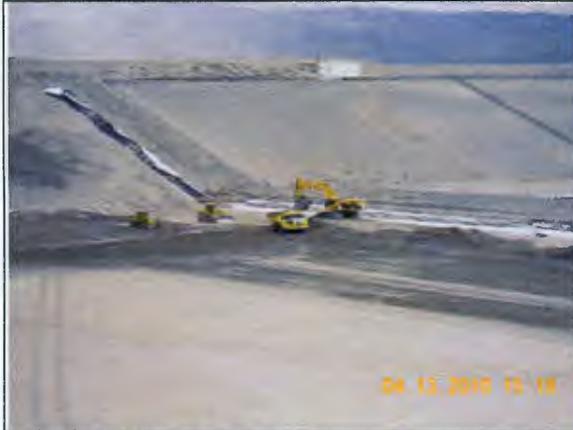
Facing SW – TWS mucking out Cell 9.

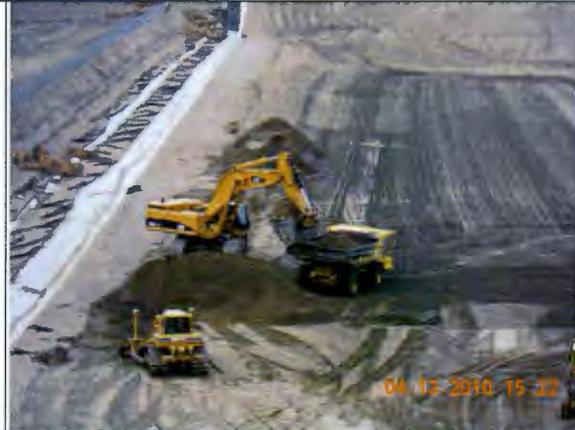
Facing N – TWS mucking out Cell 9.

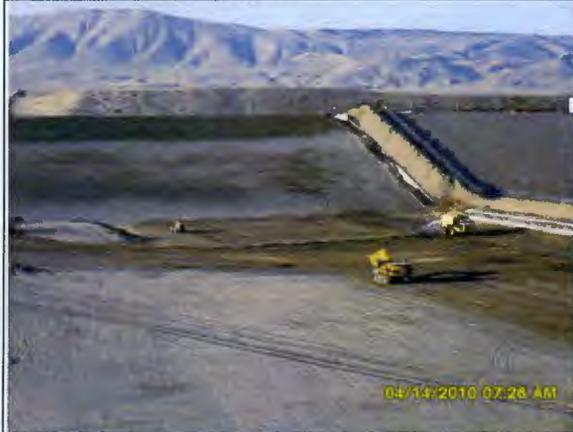
Facing SW – TWS moisture conditioning the subgrade for Cell9.

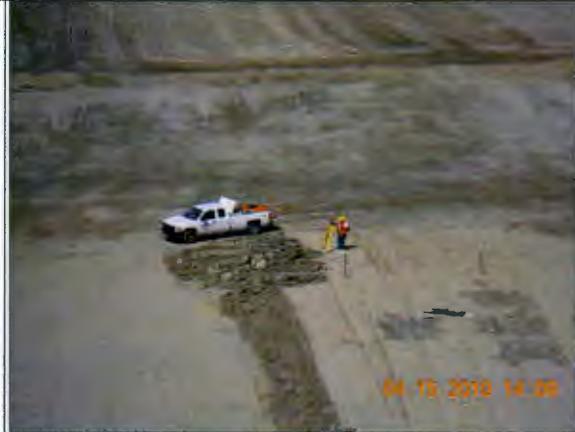
Facing N – Rogers Surveying shooting the elevation of the Cell9 subgrade for TWS.

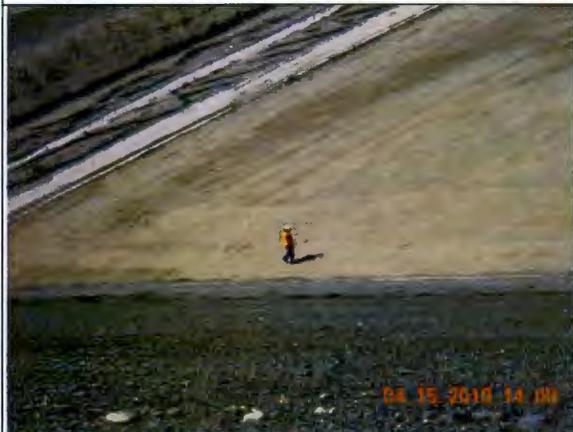
Facing N – Rogers Surveying shooting the elevation of the Cell 9.

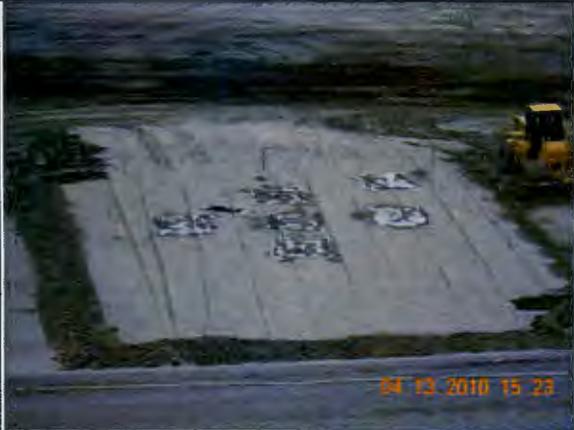
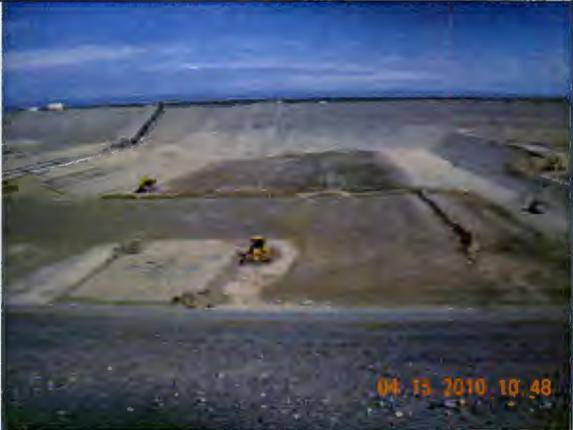
Facing N – Test pad Boutwell locations.	Facing N – Test Pad location in Cell 9.

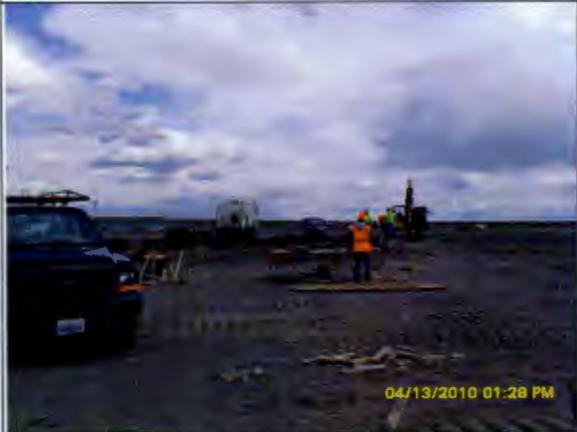
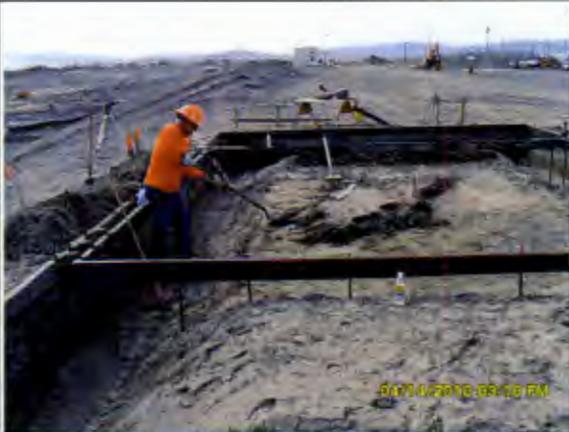
Facing E – TWS building concrete forms for Cell 9 Crest Pad.	Facing W – TWS preparing the subgrade for Cell 9 Crest Pad.

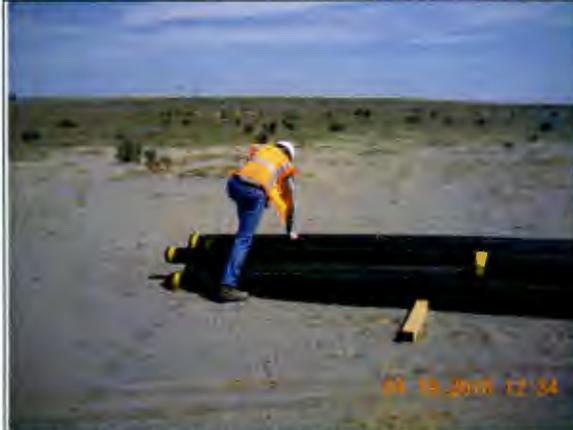
Facing E – CQA inspecting the HDPE double containment pipe.

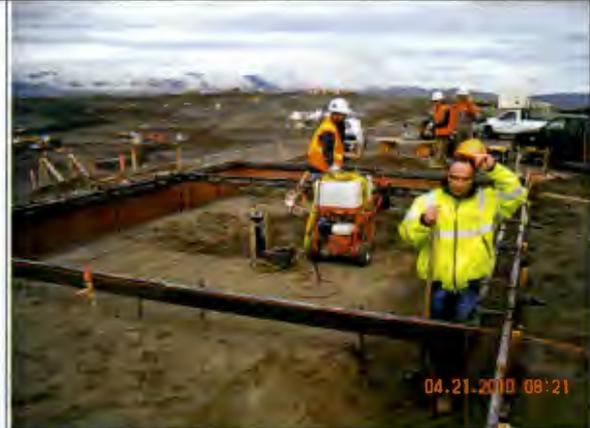
Facing N – BMWC preparing to pressure test the 2x6 in drainage line in the Cell 9 crest pad building.

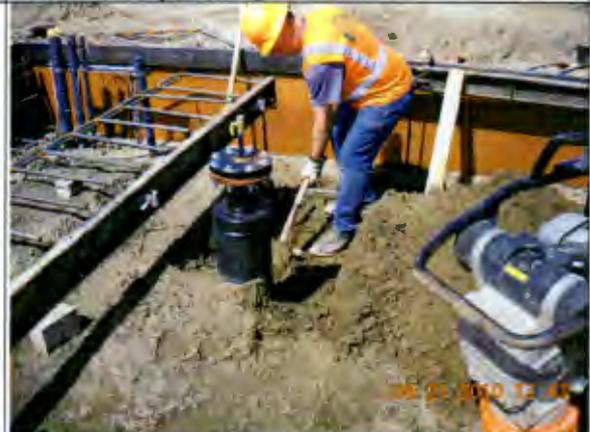
Facing NW – DHI excavating unaccepted backfill from over the 4x8 in. discharge pipe in the Cell 9 crest pad building.

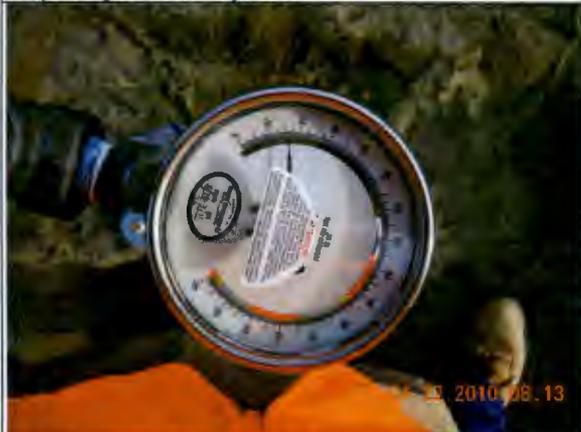
Facing down – TWS hydrostatically testing the 2 in. inner containment drainage line in the Cell 9 crest pad.

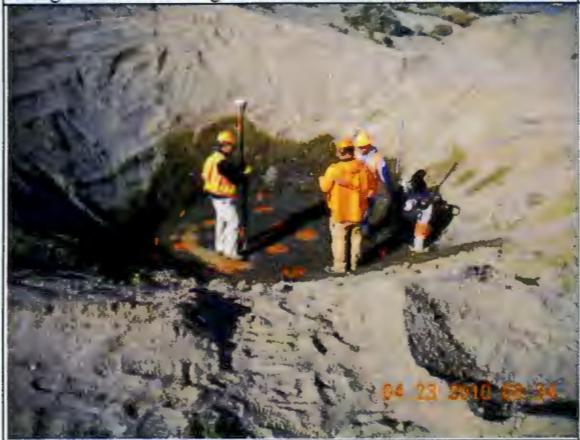
<p>04 23 2010 09:34</p>	
<p>Facing E – TWS setting subgrade elevation on MH-38.</p>

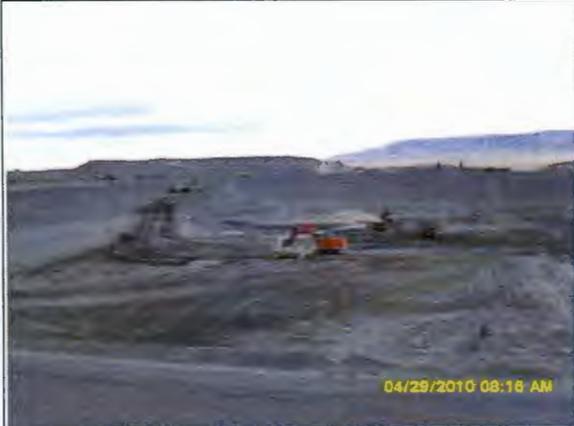
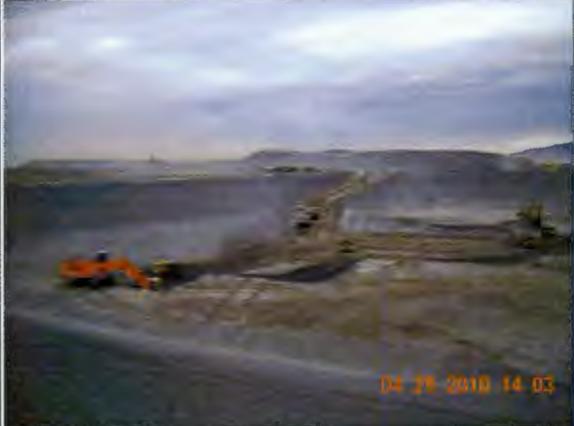
Facing S – TWS excavating operations soil from Cell 10	Facing S – TWS excavating operations soil from Cell 10

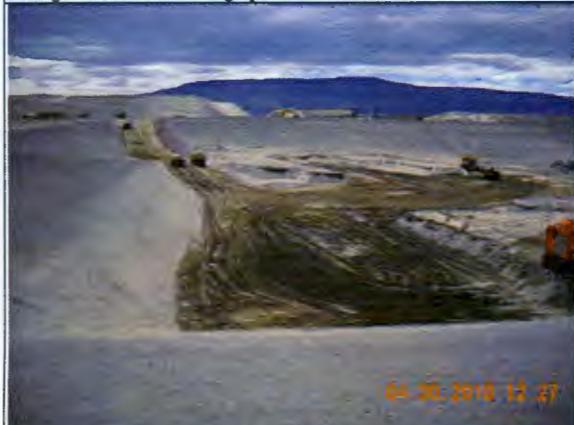
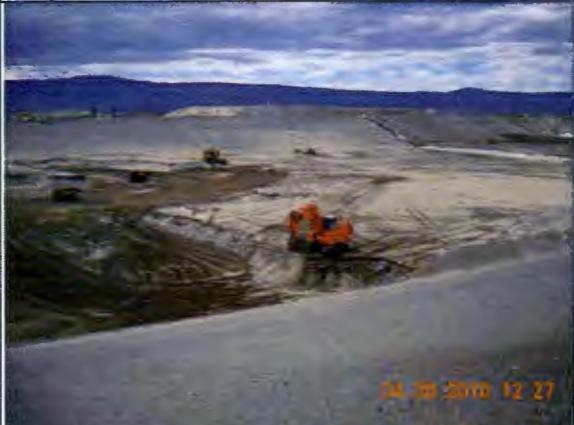
Facing S – TWS excavating operations soil from Cell 10	Facing SW – TWS excavating operations soil from Cell 10

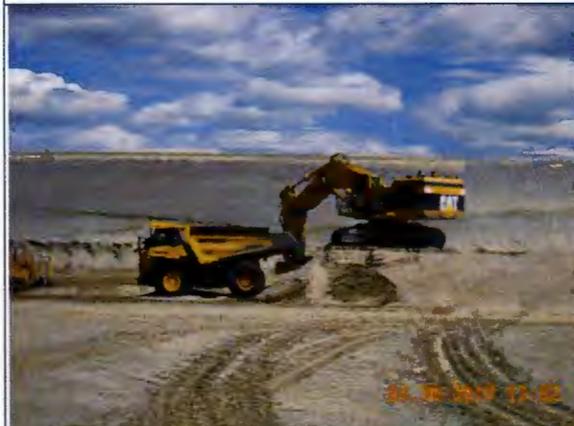
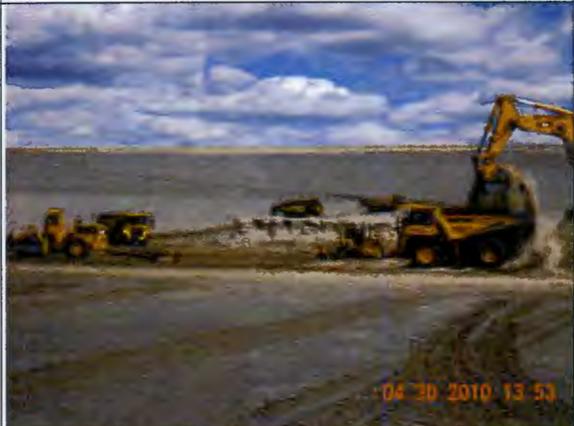
Facing E – TWS excavating the final lift from Cell 10.	Facing E – TWS excavating the final lift from Cell 10.

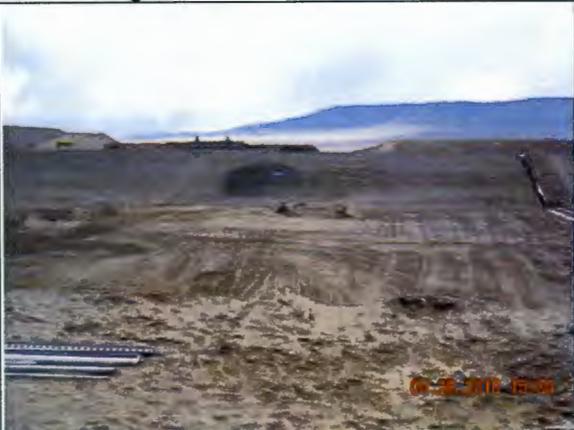
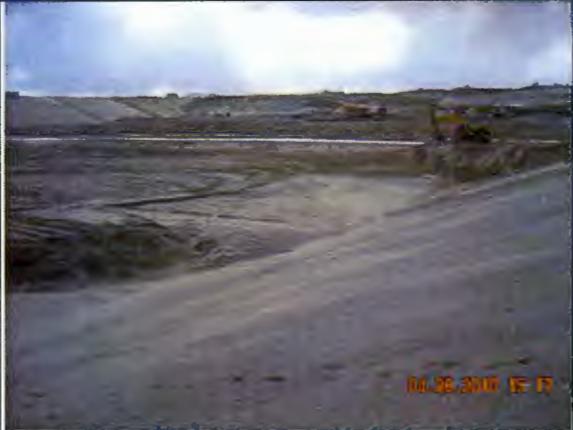
Facing S – Cell 9 Subgrade.	Facing SW – Cell 9 Subgrade.

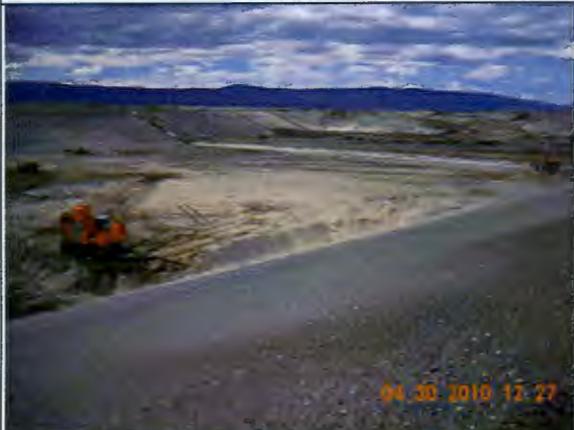
Facing S – Cell 9 Subgrade.	Facing SW – Cell 9 Subgrade.

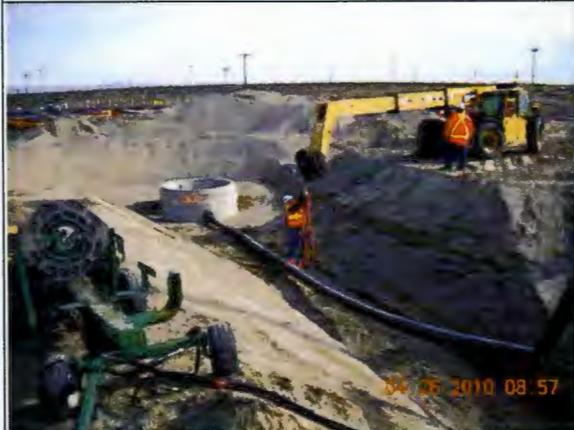
Facing N – TWS and BMWC placing the Cell9 Crest Pad discharge line.

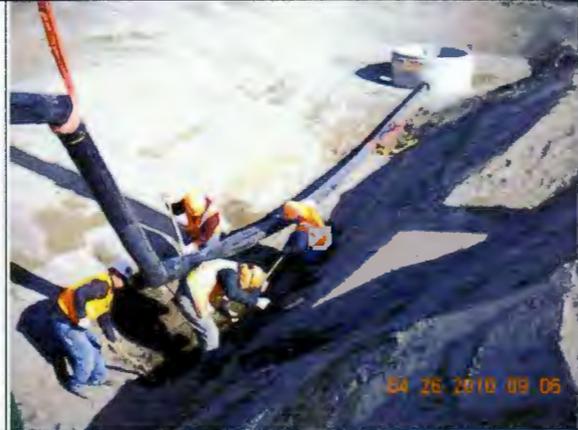
Facing N – TWS digging under the Cell9 discharge line to obtain the correct alignment with in place portion of piping installed in the Crest Pad.

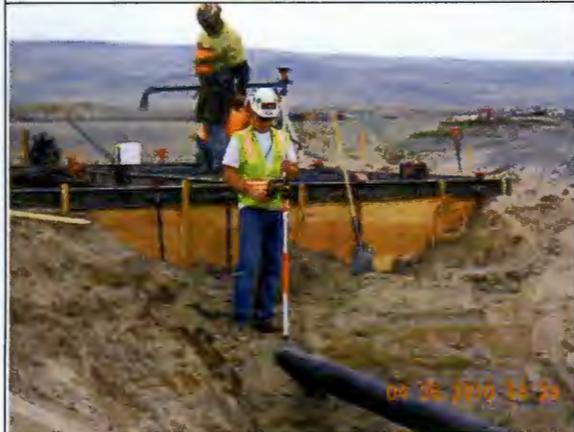
Facing S – CQA surveyor (Stratton Surveying) conducting an As-Built survey of the Cell9 discharge piping.

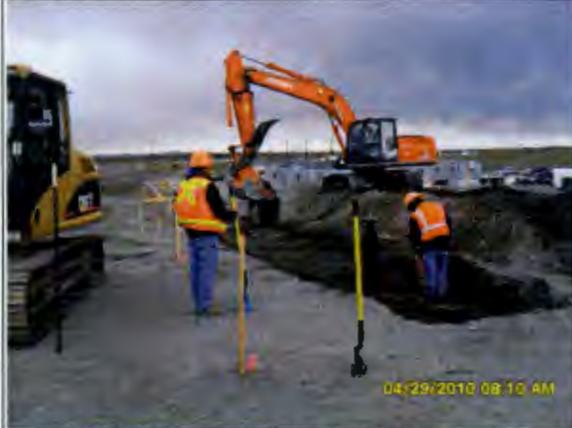
Facing N – TWS backfilling around the Cell 10 Discharge line.

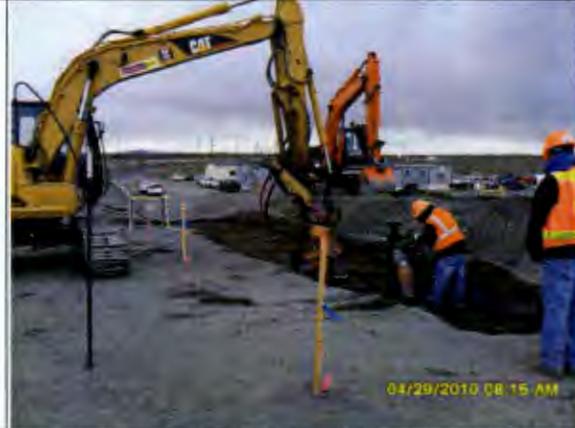
Facing N – TWS using the CAT "hoepack" to compact around the Cell 10 discharge line.
