FINAL REPORT

CONSTRUCTION QUALITY ASSURANCE (CQA)

FINAL REPORT
CONSTRUCTION QUALITY ASSURANCE (CQA)
ENVIRONMENTAL RESTORATION DISPOSAL FACILITY (ERDF)
SUPER CELLS 9 & 10
SUBCONTRACT S013213A00
010.032-00-ROB

PHOTOGRAPH LOG

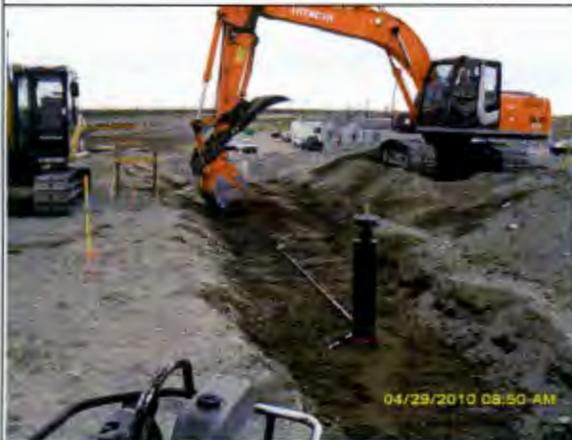
Facing N – TWS Placing lifts to backfill around the Cell 10 discharge line.

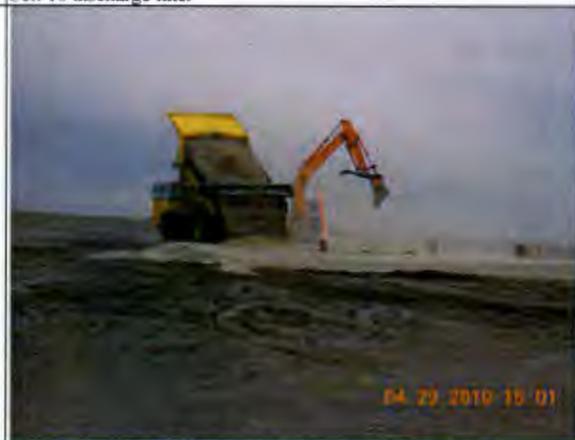
Facing E – TWS using the a Payhauler and the Hitachi 200 excavator to place lifts for the Cell 10 Crest Pad.

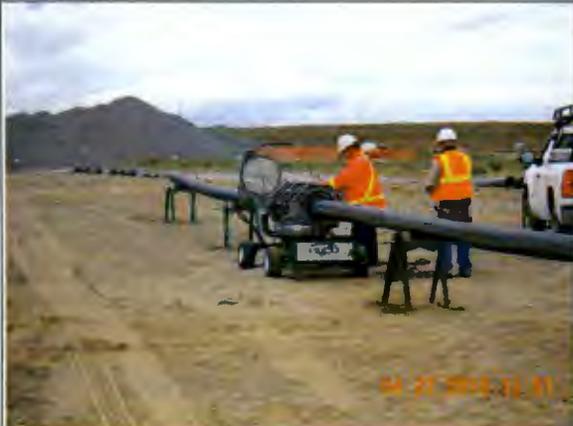
Facing N – BMWC welding the 8-in lysimeter piping.

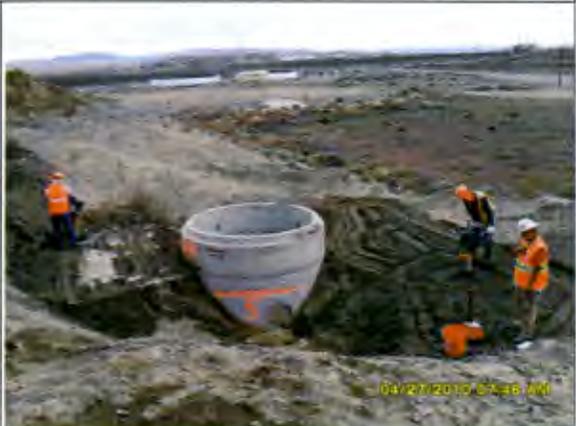
Facing W – TWS backfilling around MH-37.

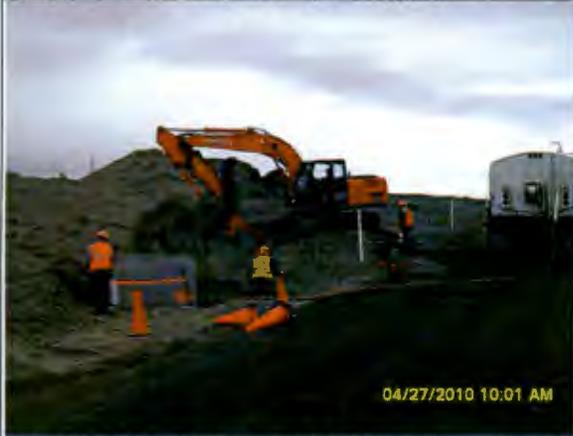
Facing W – TWS backfilling around MH-36.

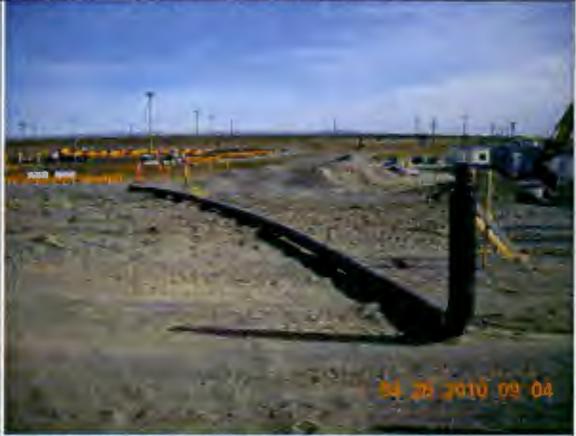
Facing NE – 4x8-in HDPE discharge line for Cell 10.

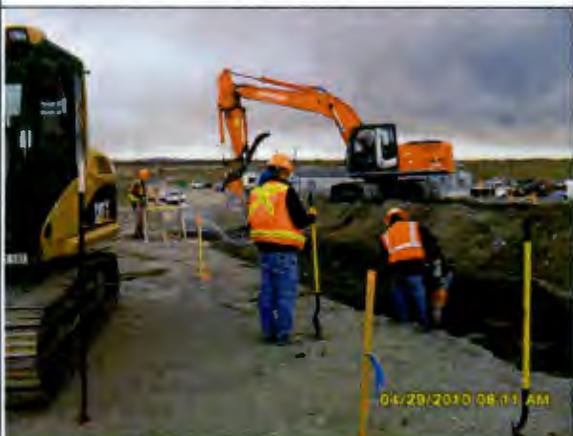
Facing N – TWS utilizing "Jumping Jack" hand compactors to compact lifts over the Cell 10 discharge line.

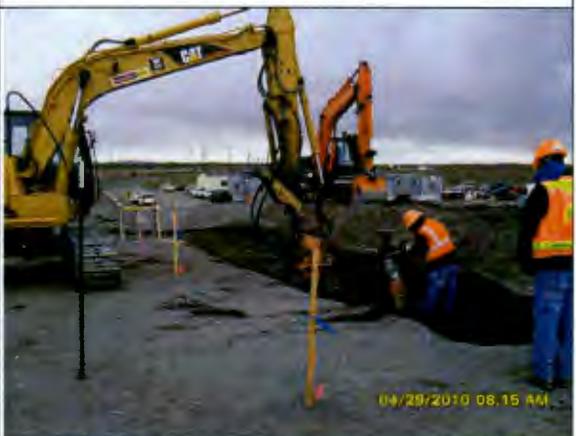
Facing N – TWS utilizing the pneumatic compactor on the CAT 314 excavator with to compact lifts over the Cell 10 discharge line.

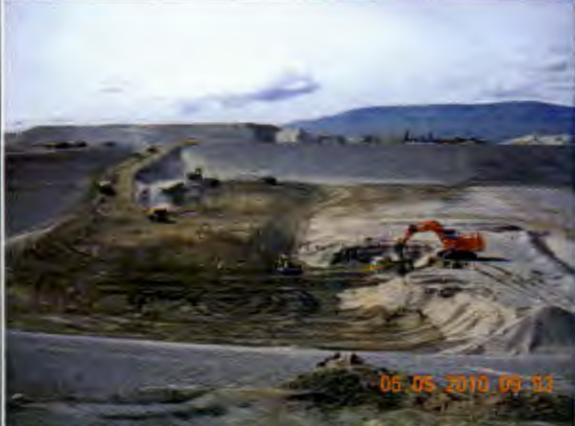
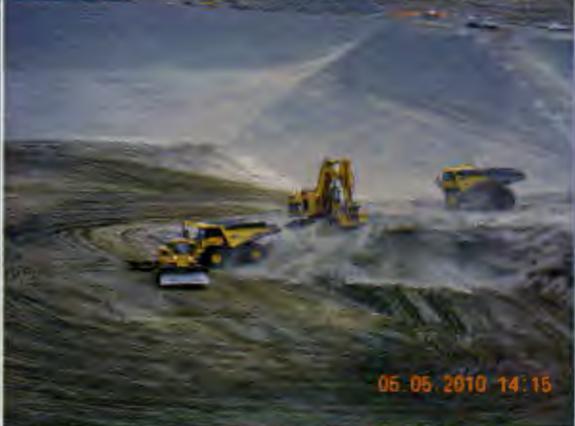
Facing S – TWS excavating operations soil from Cell 10	Facing N – TWS excavating operations soil from Cell 10

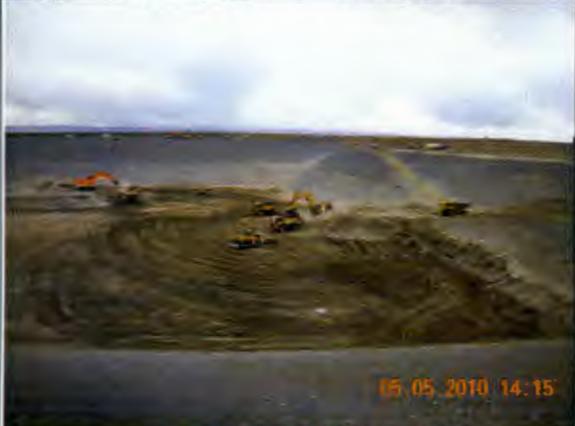
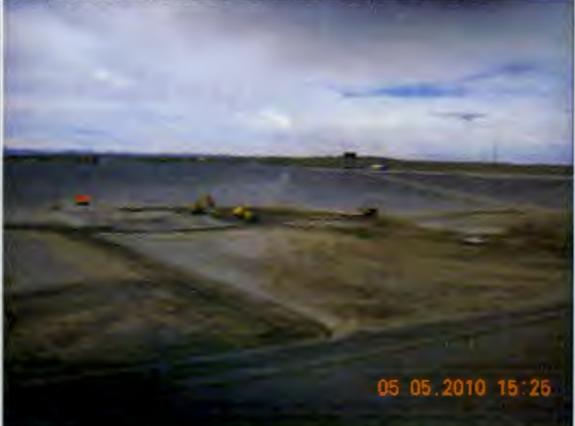
Facing N – TWS excavating operations soil from Cell 10	Facing NE – TWS excavating operations soil from Cell 10

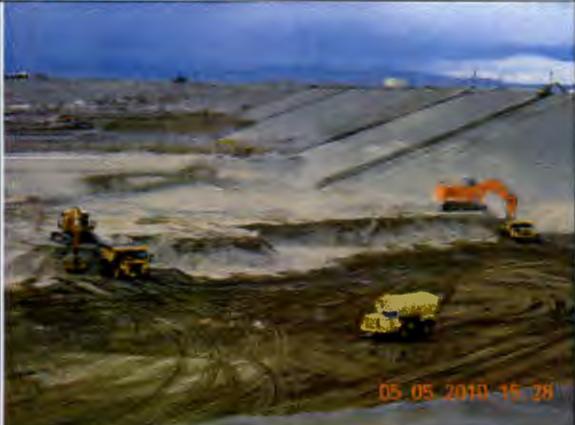
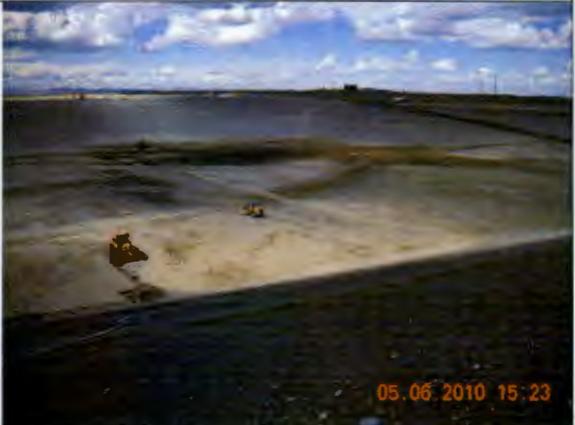
Facing NW – TWS excavating the final lift from Cell 10.	Facing NE – Completed bulk excavation of ERDF Cell 10..

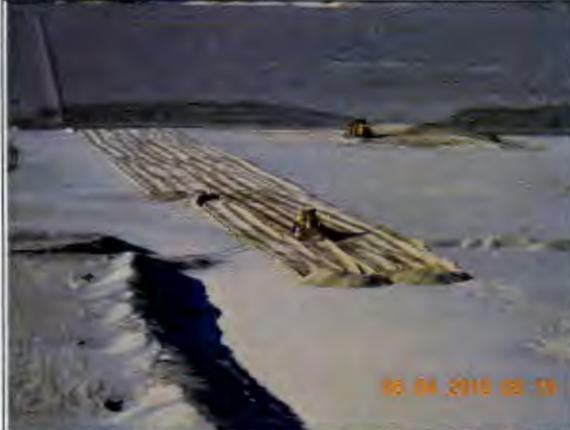
05.04.2010 08.19

Facing S – TWS Re-grading Cell 9 after the wind storm on 5-3-2010

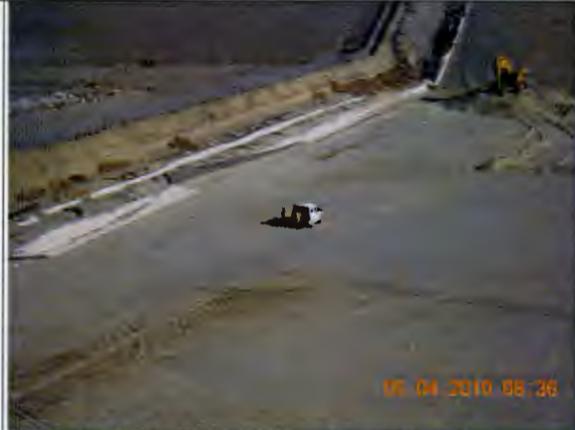
05.04.2010 08.36

Facing NE – CQA Surveyors (Stratton Surveying) on site to survey the subgrade for Cell 9.

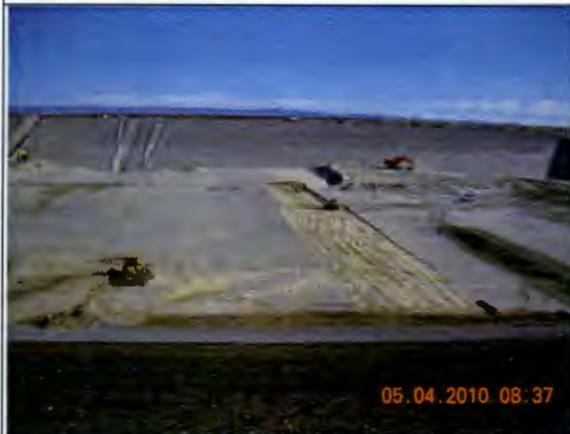
05.04.2010 08.37

Facing N – TWS Re-grading Cell 9 after the wind storm on 5-3-2010

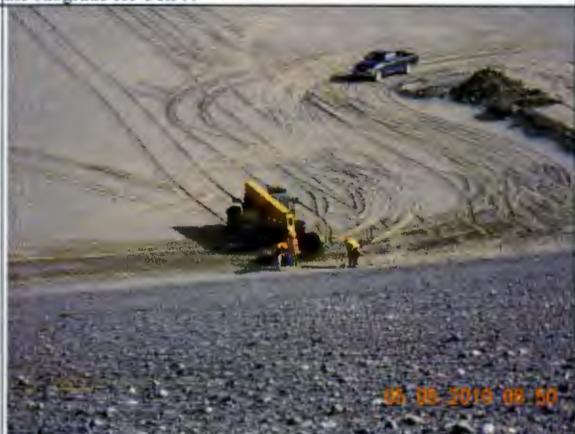
05.05.2010 09.50

Facing N – TWS using hand shovels to remove windblown sand from the south toe of Cell 9.

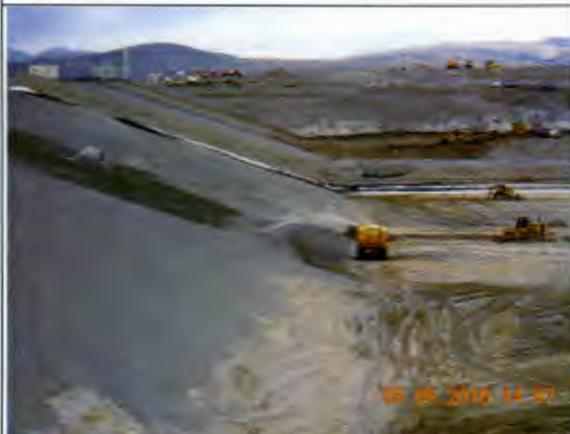
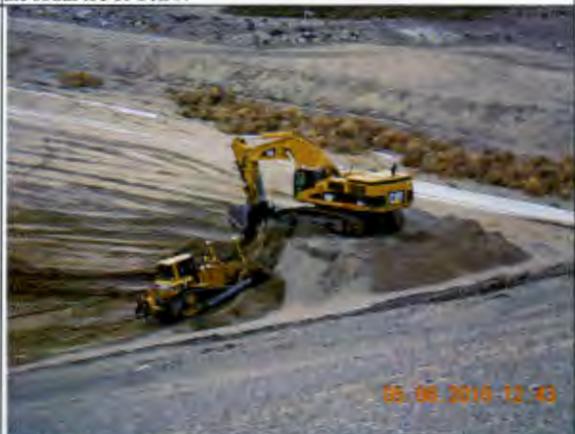
Facing W – TWS moisture conditioning the interior south slope of Cell 9 with the "Ladybug" water truck and a hand held water hose.

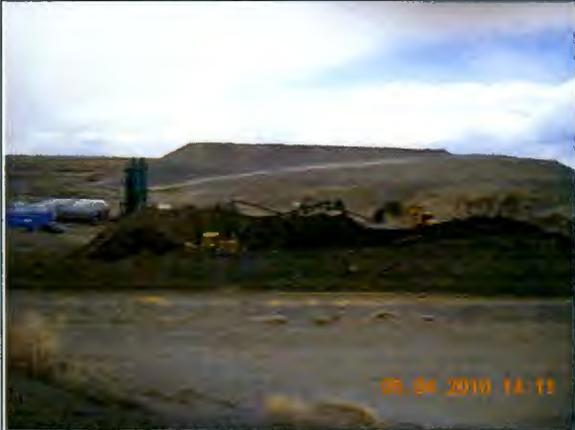
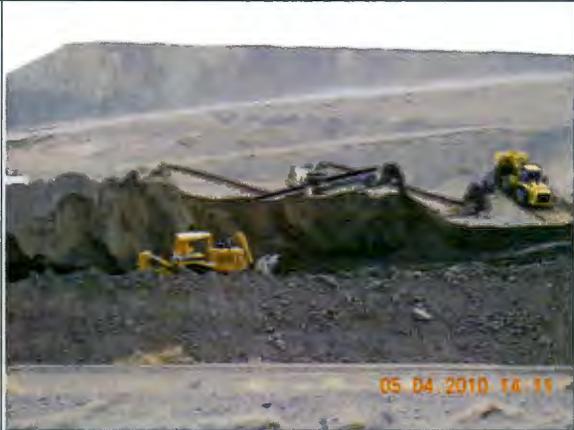
Facing E – TWS using the CAT D8 dozer to create more area for Admix storage..	Facing E – TWS using the CAT D8 dozer to create more area for Admix storage..

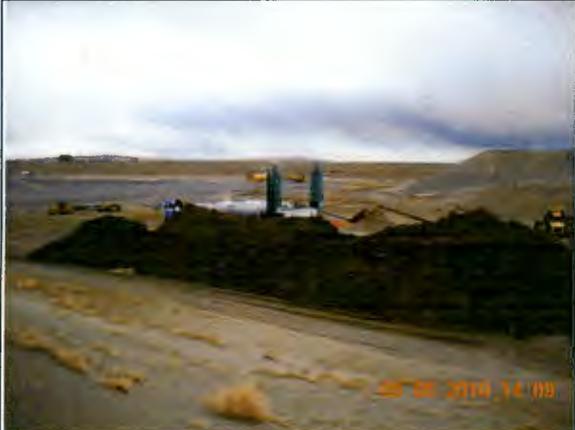
Facing NE – Pug mil set up and stockpiled Admix.

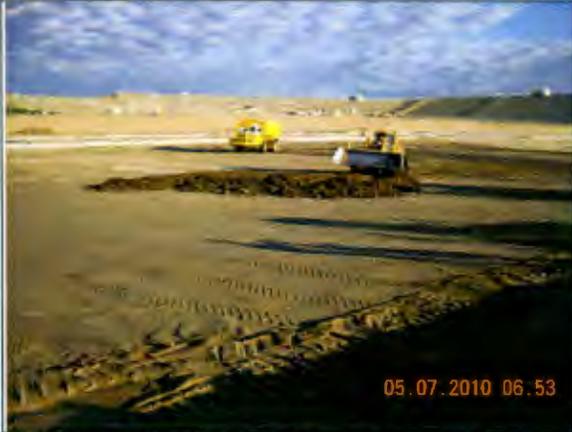
Facing NW – TWS beginning the placement of admix in Cell 9.

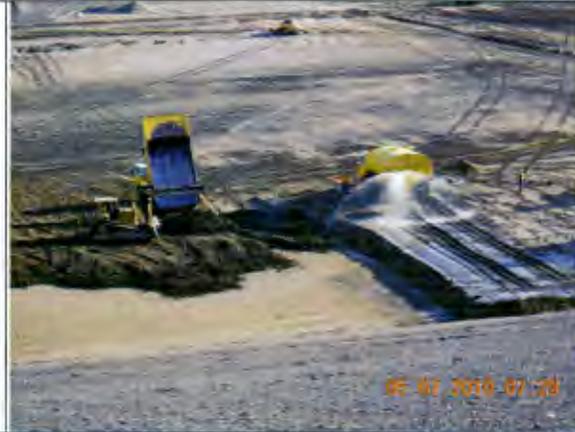
Facing N – TWS moisture conditioning the admix as it is placed.

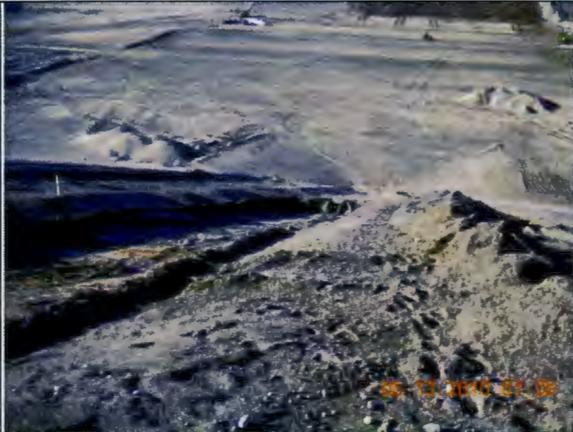
Facing S – Cell 9 subgrade partially complete.	Facing S – Cell 9 riser trench needs to be re-excavated after the wind storm on May 3, 2010.

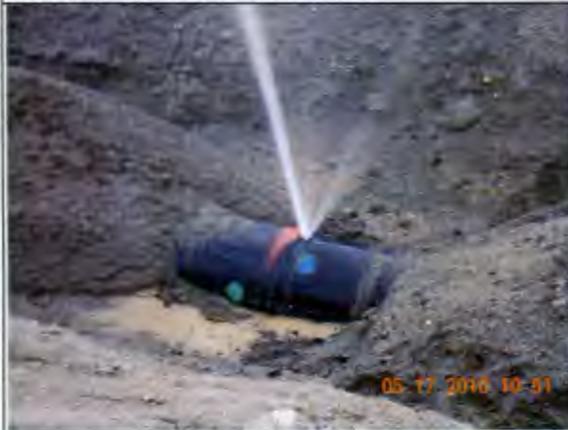
05-17-2010 10:51

Facing Down – BMWC releasing water from the outer containment of the 10x16-in pipe between MH-32 and MH-33 after a failed weld.

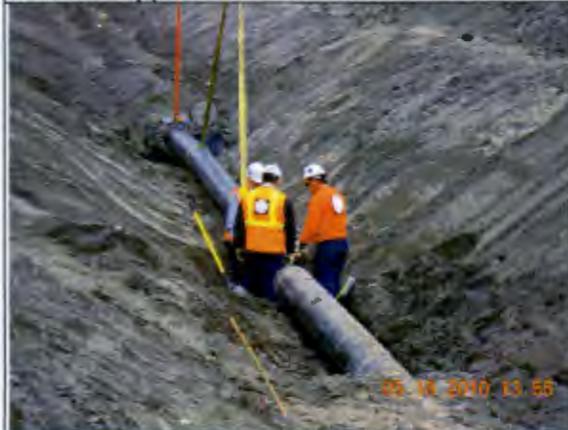
05-18-2010 13:55

Facing W – BMWC repairing the failed portion of piping between MH-32 and MH-33.

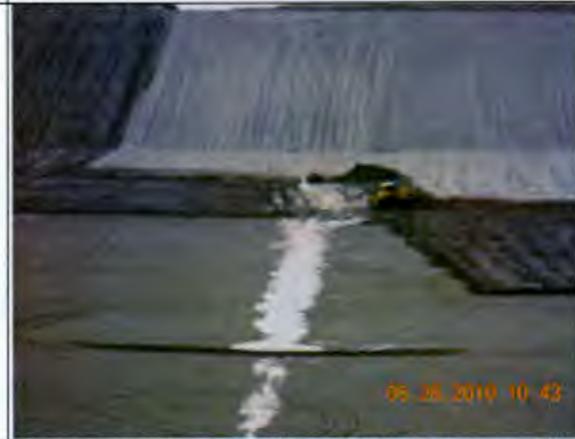
Facing S – Rainwater running off the admix through the center of Cell 9. TWS built dams to keep the water from reaching the sump.

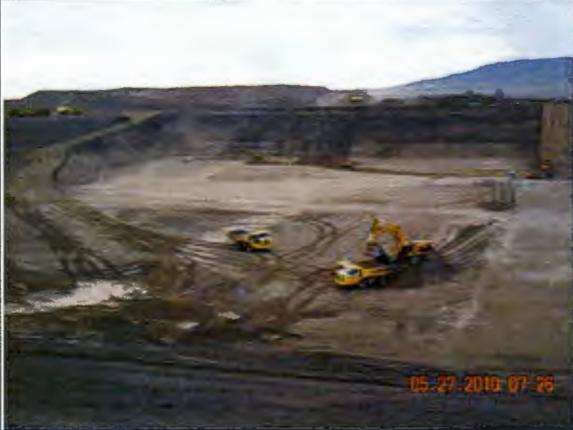
<p>05.27.2010 07:26</p>
<p>Facing N - TWS using the water truck to moisten the subgrade on the north embankment of Cell 9.</p>	<p>Facing S - TWS using the CAT 385 excavator and Payhauler trucks to remove the subgrade slipping from the floor of Cell 10.</p>

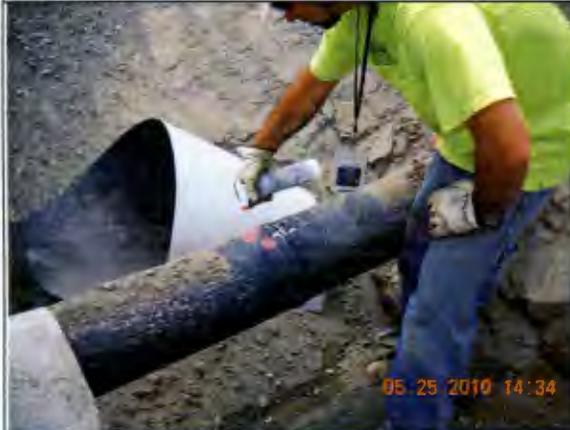
Facing Down – BMWC soap testing the welds on the 4x8-in HDPE discharge line from Tank #3 to MH-22.

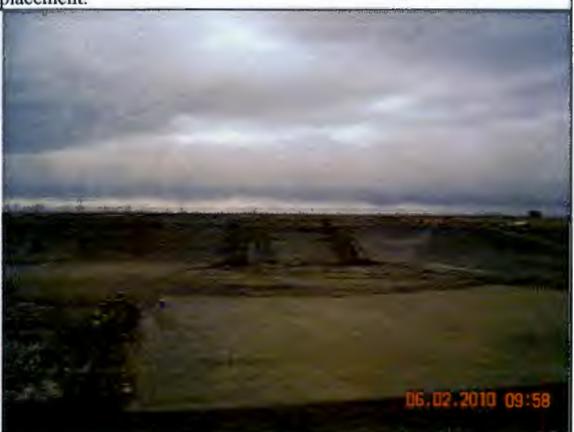
<p>06.02.2010 09:58</p>
<p>Facing N – ESI exposing the secondary geomembrane tie-in. Subgrade requires additional preparation.</p>	<p>Facing N – Rain showers on 6/2/10 halted admix placement.</p>

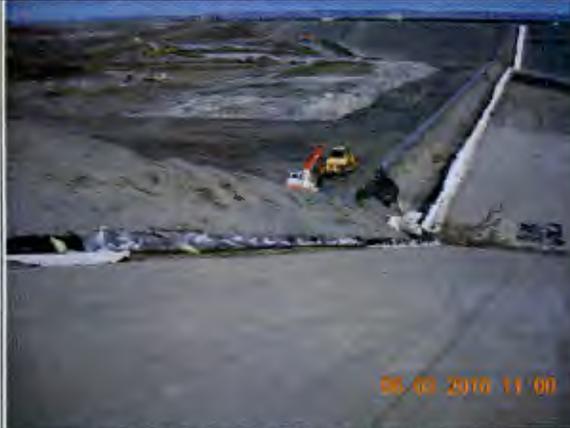
Facing SW – Rain showers on 6/2/10 eroded the admix surface.

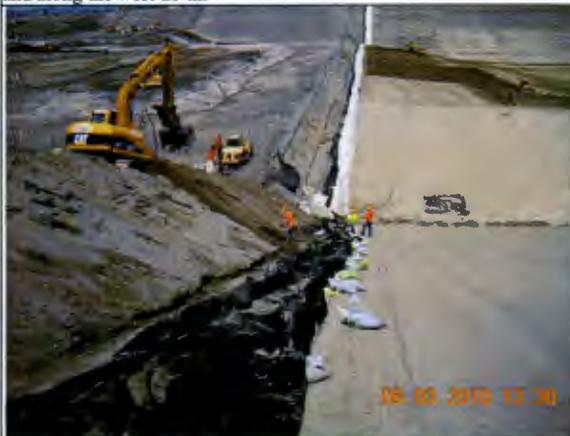
Facing N – TWS exposing geomembrane on the tie-in to allow ESI enough room to tie-in.

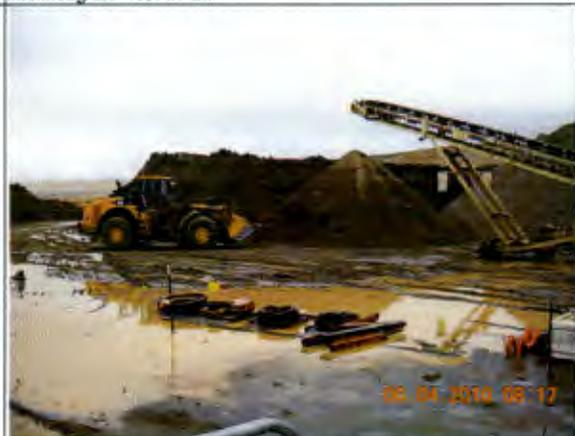
Facing S – TWS removing the non-conforming admix material produced on 6/4/10.

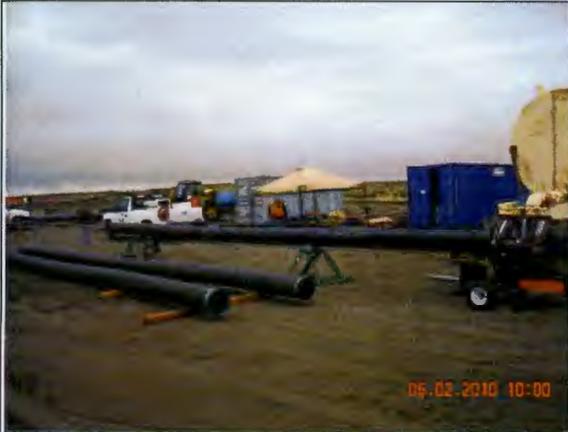
Facing NE – BMWC cutting the weld bead out from inside the 12-in leachate riser pipe.

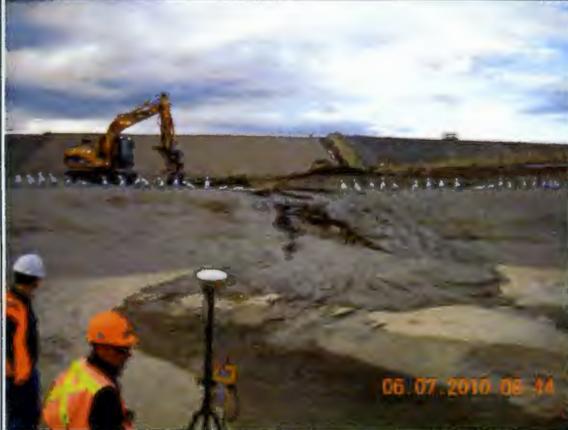
Facing SW – TWS repairing the lysimeter sump in Cell 9

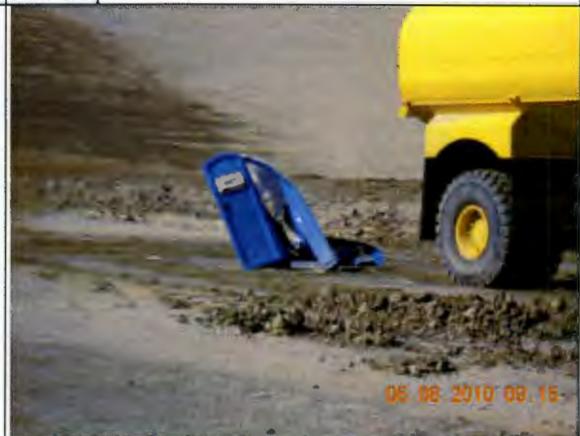
Facing SW – On Tuesday, a water truck backed into a port-a-john, resulting in a Stop Work for earthwork and admix activities.

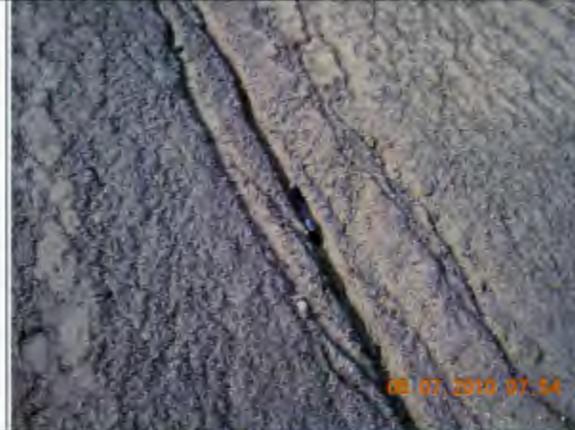
Facing down – Storm water drainage runnels in the Cell 9 south slope admix subgrade.

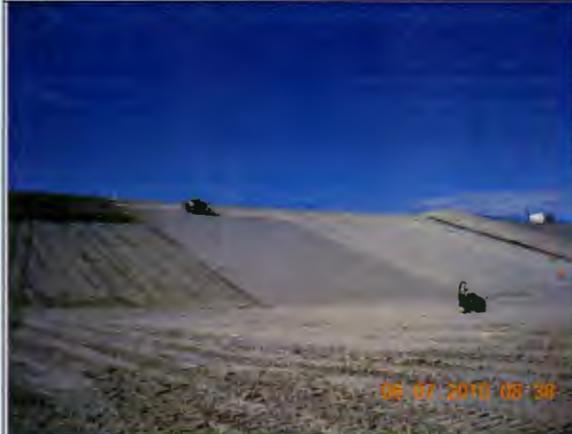
Facing S – TWS roughing up the admix subgrade with the CAT D6 dozer in order to remove unacceptable run-off runnels.

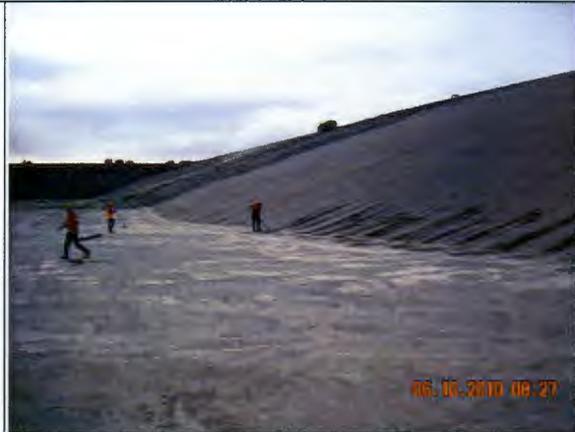
Facing E – TWS removing runnels and other irregularities with hand tools prior to secondary geomembrane deployment.

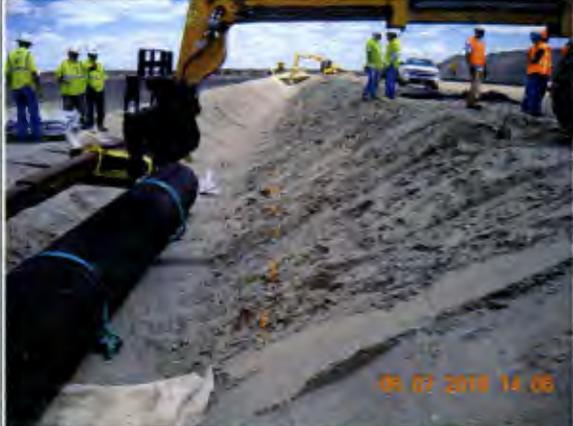
<p>06.07.2010 14:06</p>
<p>Facing SW – ESI preparing to deploy secondary geomembrane in Cell 9.</p>	<p>Facing E – The forklift began to tip over during deployment of the secondary geomembrane. The roll was set in the anchor trench.</p>

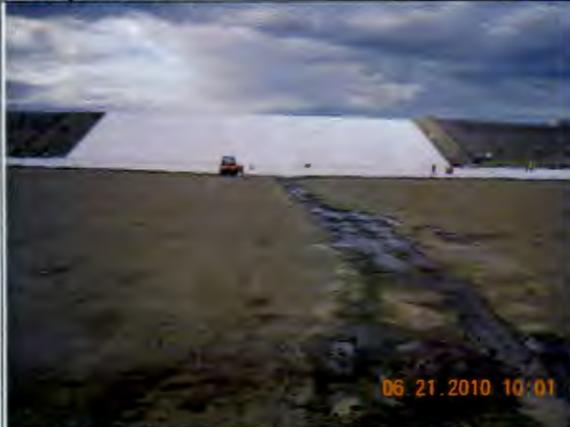
Facing S – Secondary liner activities on hold due to unacceptable subgrade in the trough of Cell 9.

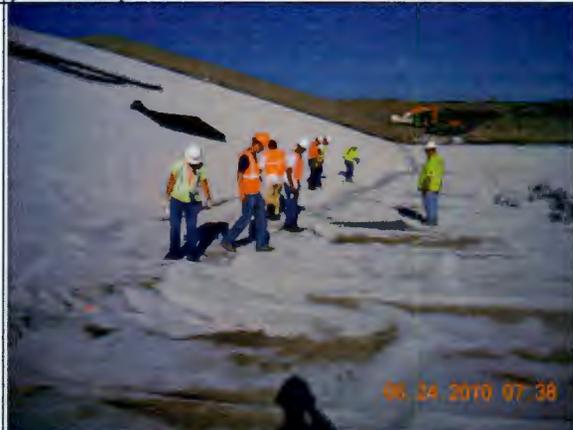
Facing W – Due to heat a large wrinkle formed near the south toe of Cell 9. ESI was instructed to cut the liner, remove the wrinkle and patch the area.

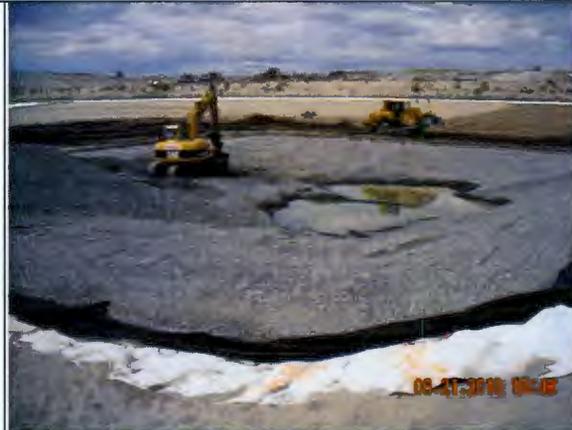
Facing W – TWS is removing excess gravel from the lysimeter sump after gravel placement was complete.

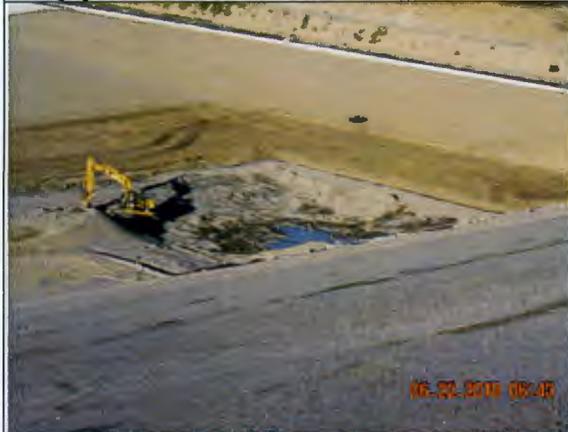
Facing SW – TWS is removing excess gravel from the lysimeter sump after gravel placement was complete.

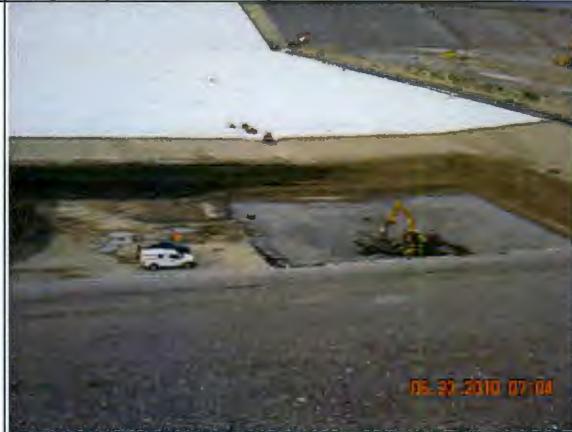
Facing SW – TWS completing final grading of the Cell 9 lysimeter sump.

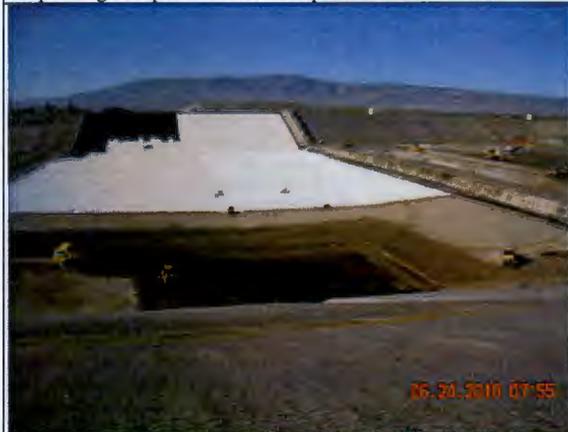
Facing S – TWS placing admix over the Cell 9 lysimeter sump.

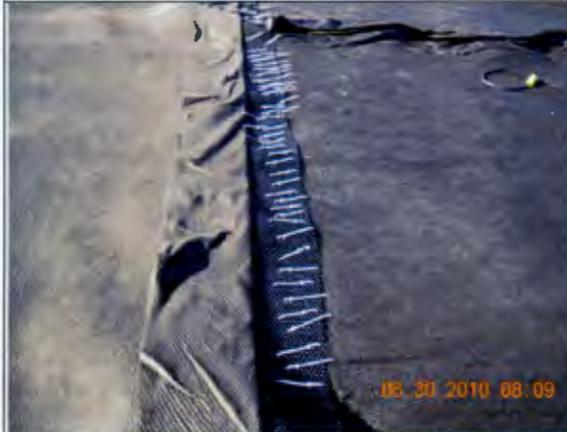
Facing Down – End-to-End seams of geocomposite zip tied together.

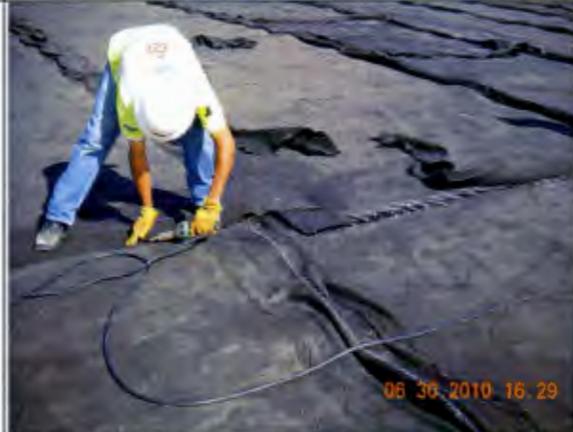
Facing Down – ESI capping End-to-End seam with geotextile to seal out sand or debris.

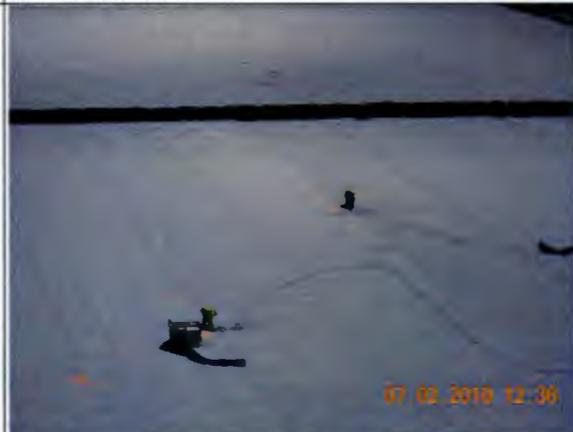
Facing N – ESI making primary repairs on the south half of the floor in Cell 9.

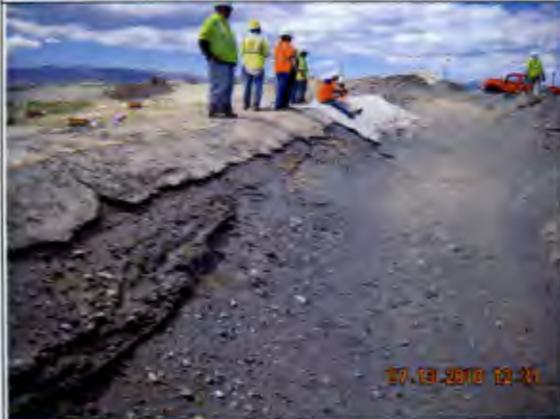
Facing W – The anchor trench interior side slope was unacceptable for liner deployment.

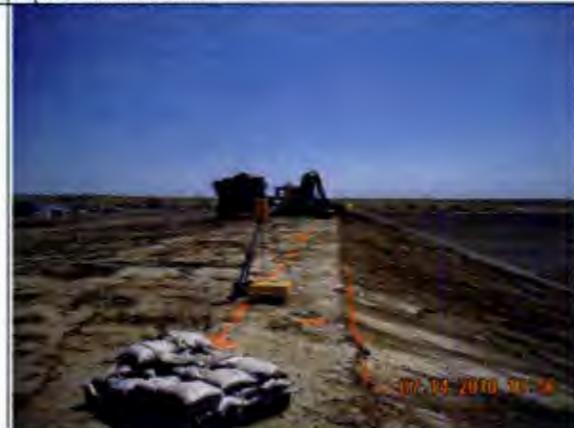
Facing E – TWS overbuilt the admix shoulder by a couple of feet.

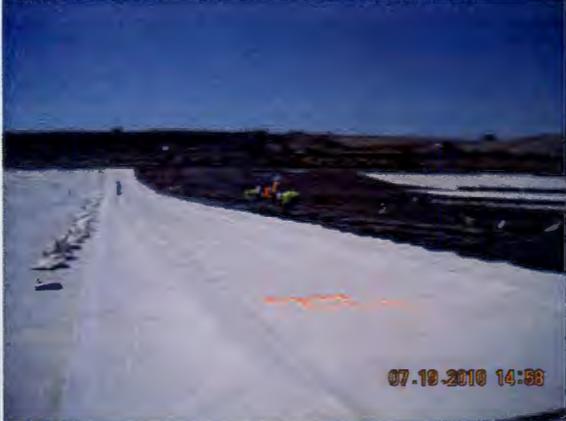
<p>07.19.2010 14:58</p>
<p>Facing N – During the stop work initiated last week, a panel of secondary geomembrane was folded in the wind.</p>	<p>Facing W – ESI placing primary geomembrane over secondary geocomposite on the floor of Cell 9.</p>

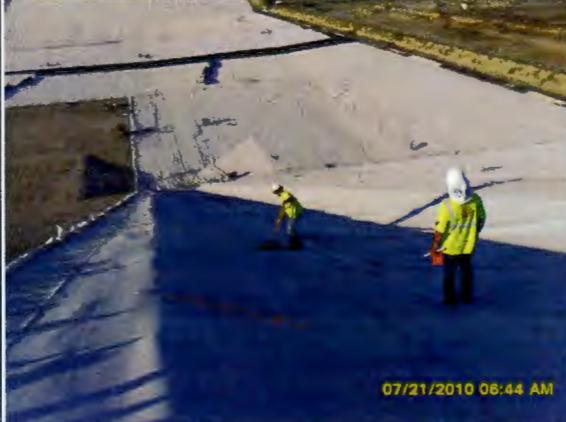
<p>07/21/2010 08:44 AM</p>
<p>Facing W – ESI repairing the secondary geomembrane in the Cell 9 sump.</p>	<p>Facing NE – ESI deploying 16 oz. geotextile in the Cell 10 lysimeter sump.</p>

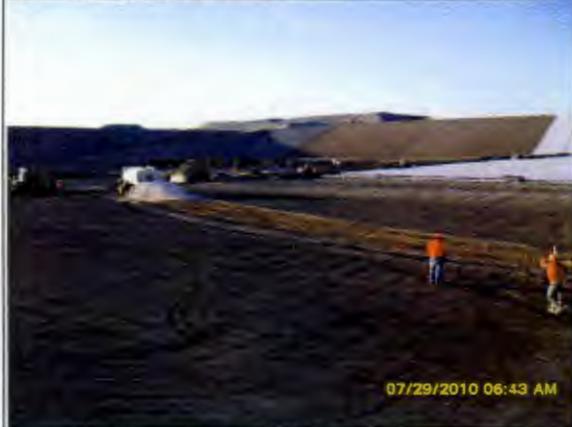
Facing SE - TWS moisture conditioning the reworked area with a water truck.

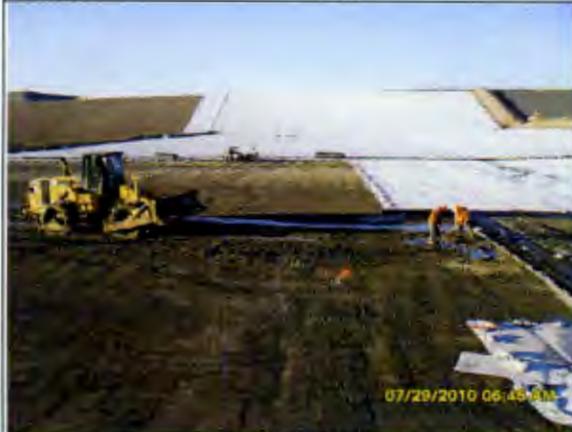
Facing S - TWS utilizing had tools to spread out the saturated admix material.

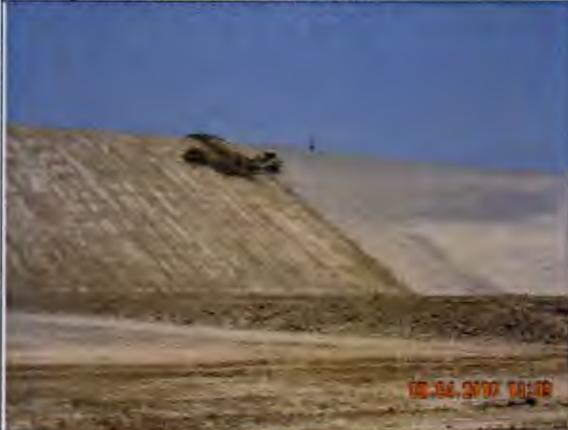
Facing NE – TWS overbuilt the east termination of the admix. TWS utilized a CAT dozer to trim back the excess admix material.

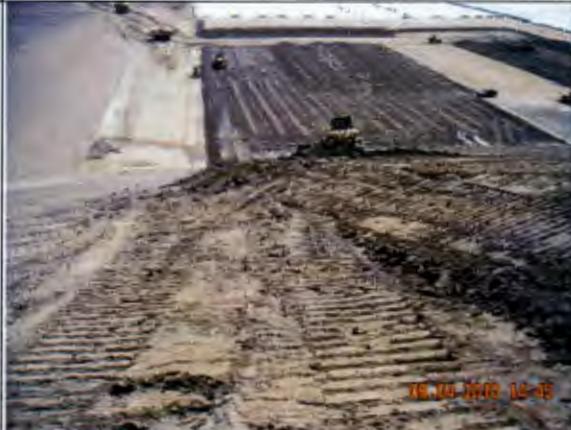
Facing S – CQA verified that no subgrade was placed into the admix during trimming operations.

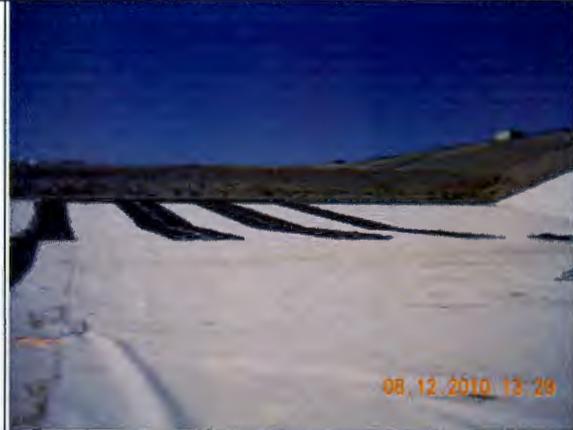
Facing W – Due to exposure limits, ESI folded the geocomposite over, exposing the underside, and increasing the 14 day expose limit.

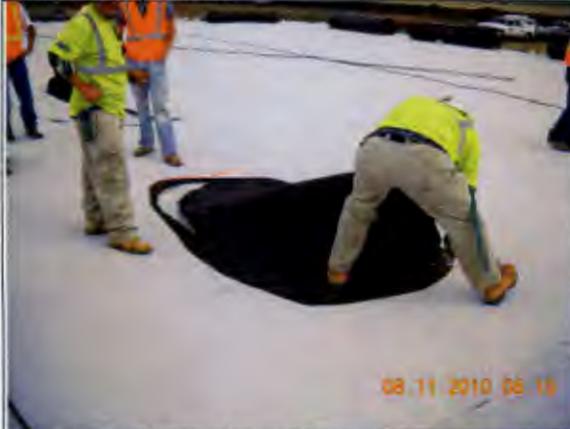
08.11.2010 06:19

Facing NW – During installation of the primary geomembrane, CQA noticed a rut in the admix surface.

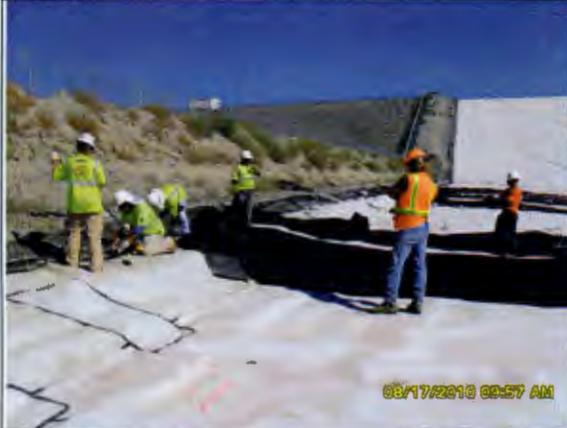
Facing NW – ESI welding and repairing the secondary geomembrane tie-in in Cell 9.

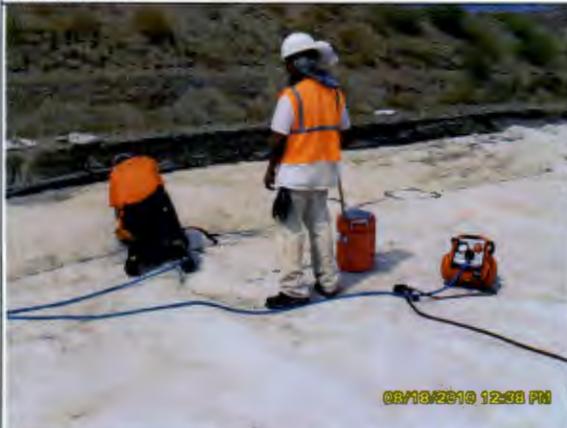
Facing NW – ESI vacuum testing the repairs on the Cell 8/9 tie-in.

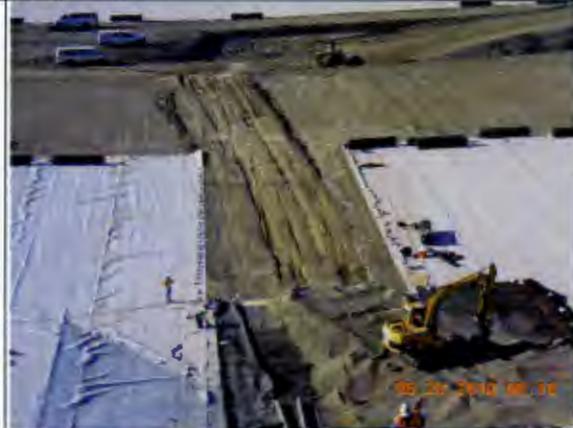
Facing S – The rutting created by the payhaulers during placement of the drainage gravel in the Cell 10 sump.

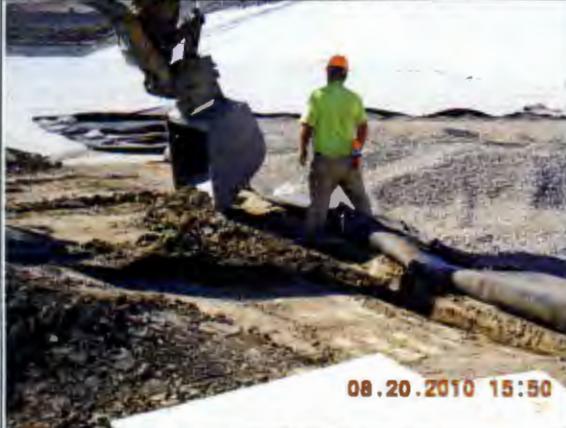
Facing NW – TWS protecting the leading edge of the secondary geomembrane in the Cell 10 sump prior to leaving for the weekend.

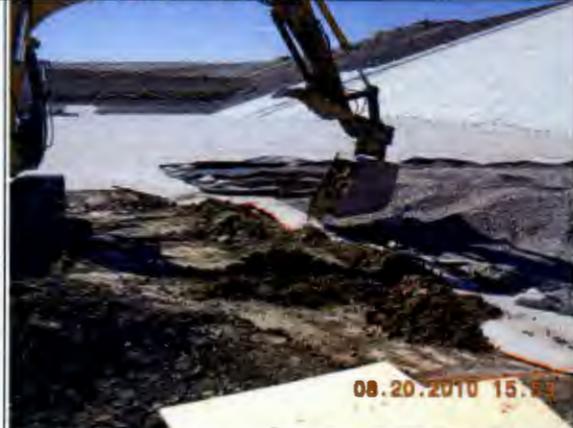
Facing W – TWS creating a small berm over the leading edge of the secondary geomembrane in Cell 10.

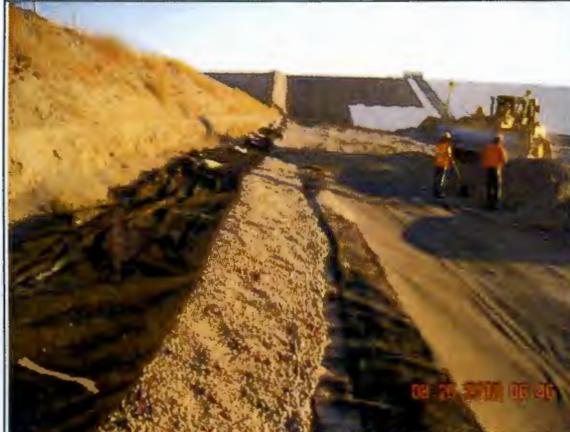
Facing N – TWS spreading rock near the Cell 7/9 tie-in; two laborers work on minimizing wrinkle propagation.

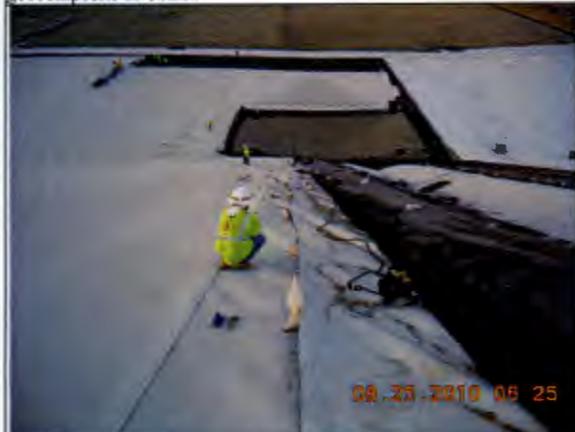
<p>08-25-2010 09:57</p>
<p>Facing S – ESI cut the secondary geomembrane near the Cell 9 riser trench in order to remove large wrinkles in the geomembrane.</p>	<p>Facing NW – ESI "walking-out" the wrinkles on the north slope of Cell 9.</p>

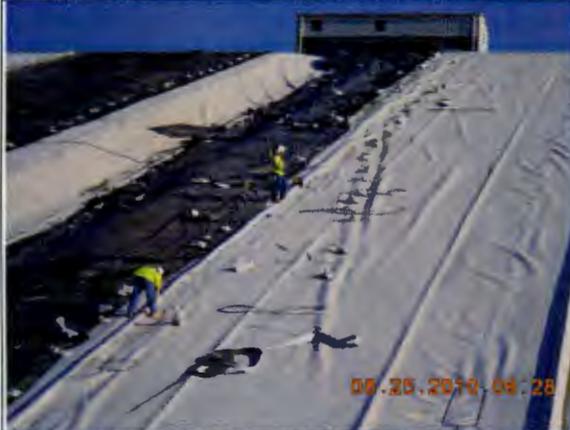
Facing NW – ESI welding the panel that was cut in order to remove the wrinkles east of the Cell 9 riser trench.

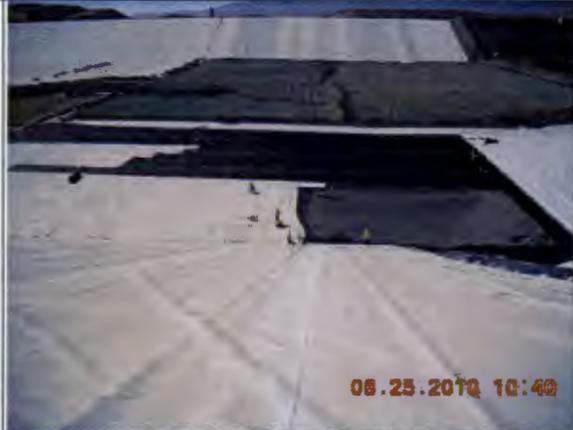
Facing S – The north slope of Cell 9 after the wrinkles had been removed.
