TANK 4 AND LEACHATE TRANSMISSION SYSTEM REPORT
CONSTRUCTION QUALITY ASSURANCE (CQA)

CQA PHOTOGRAPH LOG WEEK 22
(7/6/10 TO 7/9/10)

ERDF CONSTRUCTION CELLS 9-10

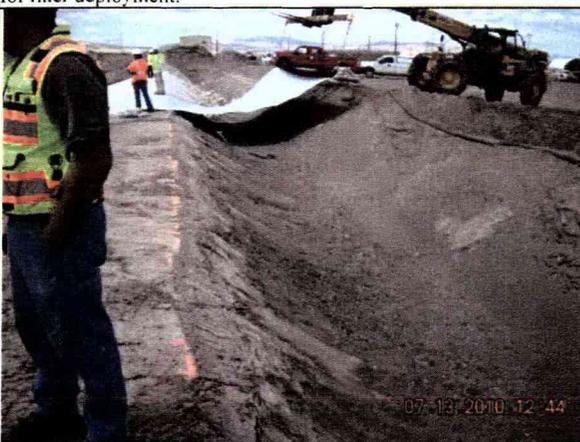
Facing W – The finished surface of the interior side slope of the anchor trench.

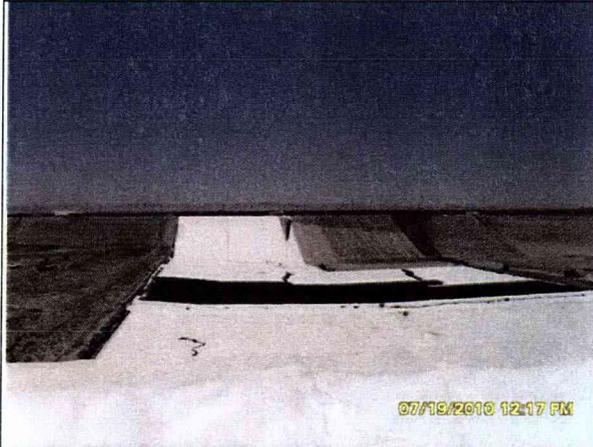
Facing N – During the stop work initiated last week, a panel of secondary geomembrane was folded in the wind.

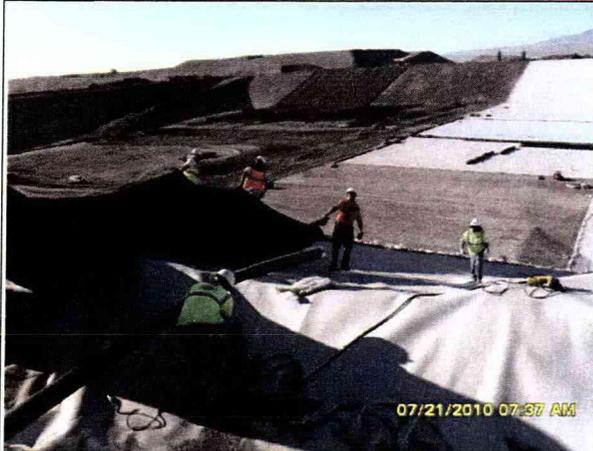
07/21/2010 07:37 AM

Facing SE – ESI deploying sec. geocomposite in the Cell 9 riser trench, while a technician repairs a hole in the sec. geomembrane.

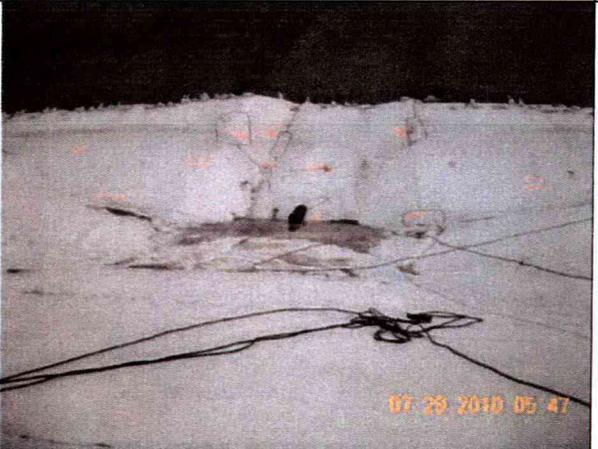
Facing N – The installed tertiary geomembrane. Stormwater runoff gathered in the sump after an early morning storm.

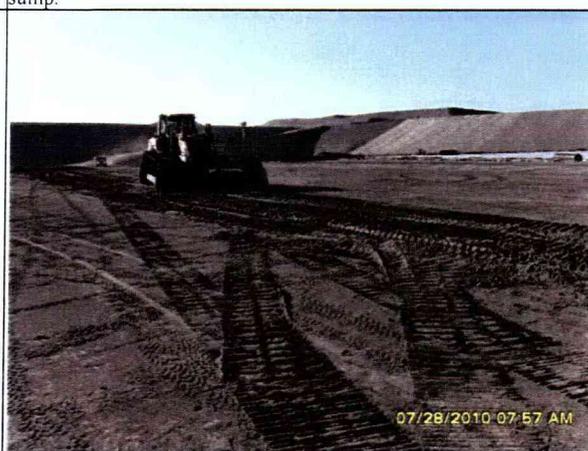
Facing SE – TWS removing the ruts from the drainage gravel haul road to the Cell 9 secondary sump.

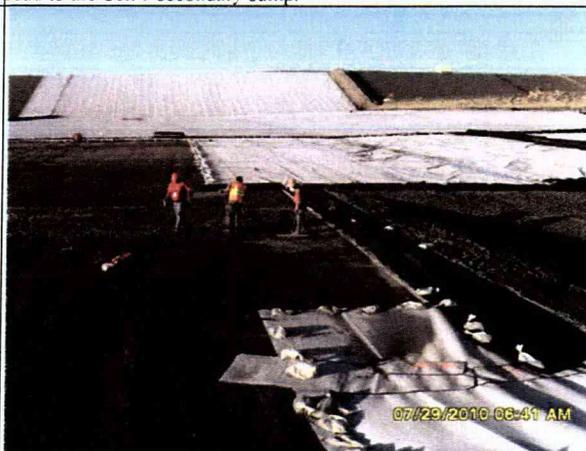
Facing S – TWS utilizing hand tools to remove the ruts near the Cell 9 sump.

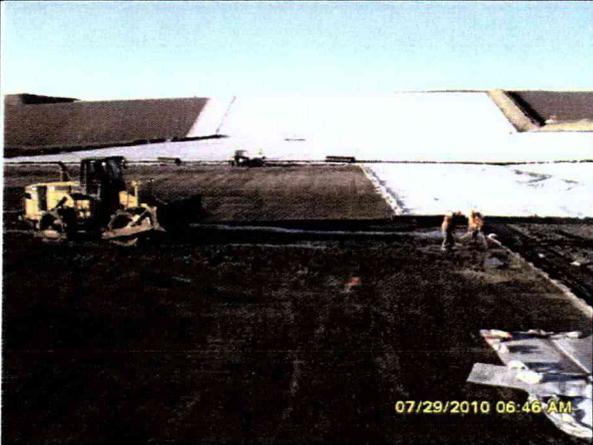
Facing S – TWS utilizing had tools to spread out the saturated admix material.

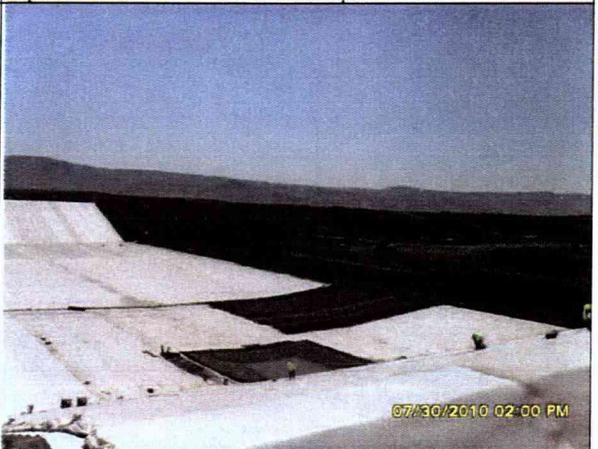
Facing SW – ESI left a hole in the secondary geomembrane due to a saturated admix subgrade next to the Cell 9 sump.

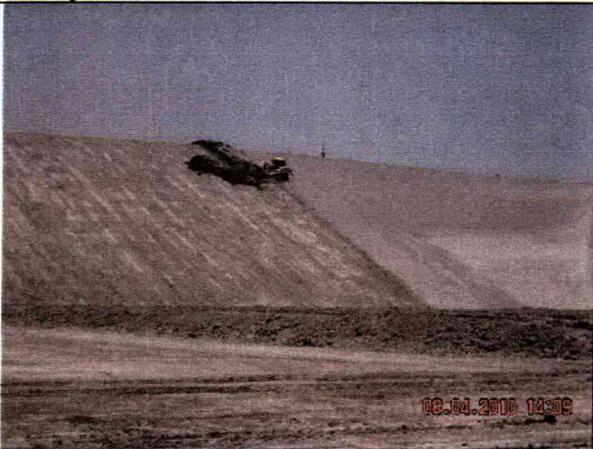
Facing NE – TWS overbuilt the east termination of the admix. TWS utilized a CAT dozer to trim back the excess admix material.

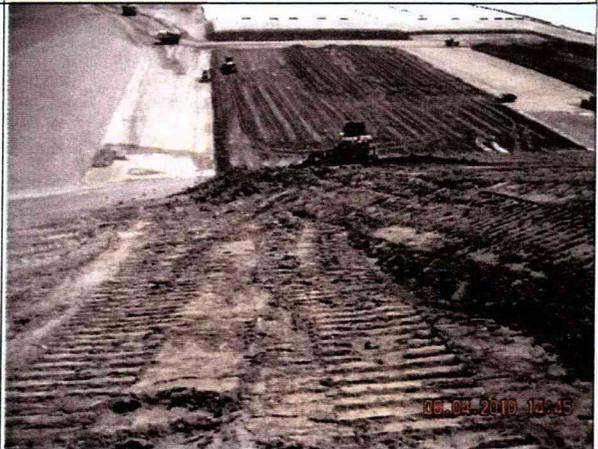
Facing S – CQA verified that no subgrade was placed into the admix during trimming operations.

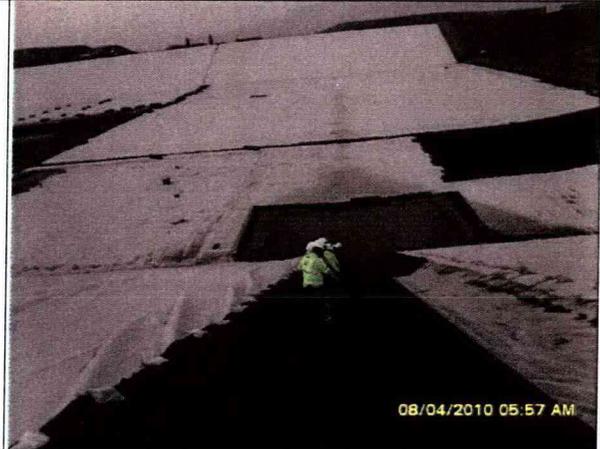
Facing S – The geotextile on the geocomposite reached its exposure limit. ESI is folding the composite over to prolong the exposure date.

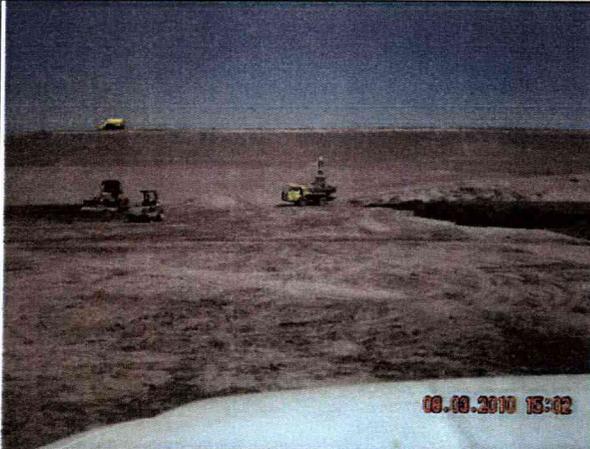
Facing E – TWS excavating an area of the subgrade near the trench access ramp that was left higher than design grade.

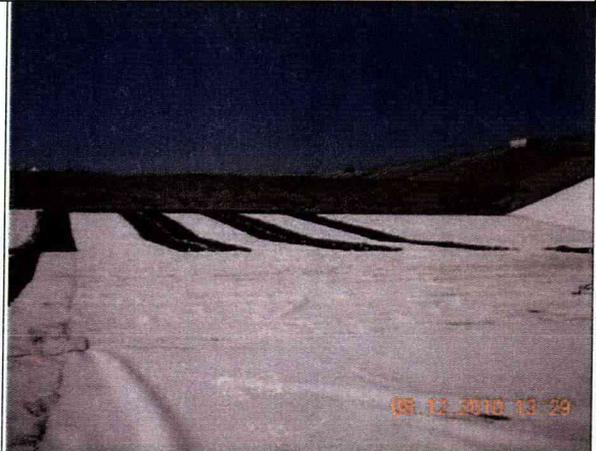
Facing W – Due to exposure limits, ESI folded the geocomposite over, exposing the underside, and increasing the 14 day expose limit.

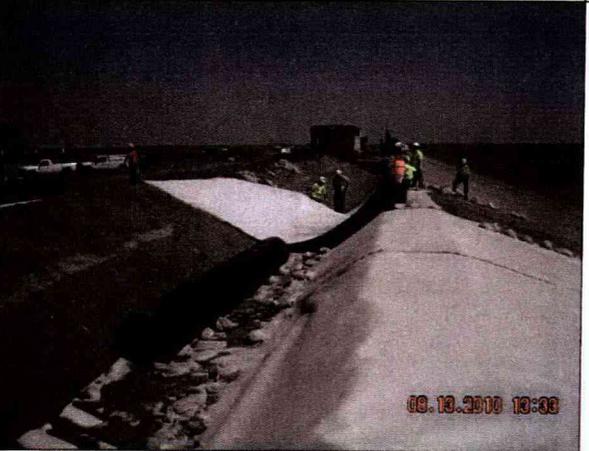
Facing E – ESI preparing to deploy geomembrane in Cell 9, but high winds halted deployment.

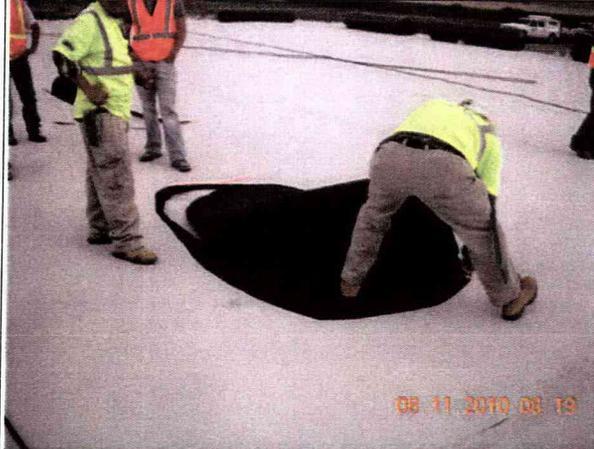
Facing NW – During installation of the primary geomembrane, CQA noticed a rut in the admix surface.

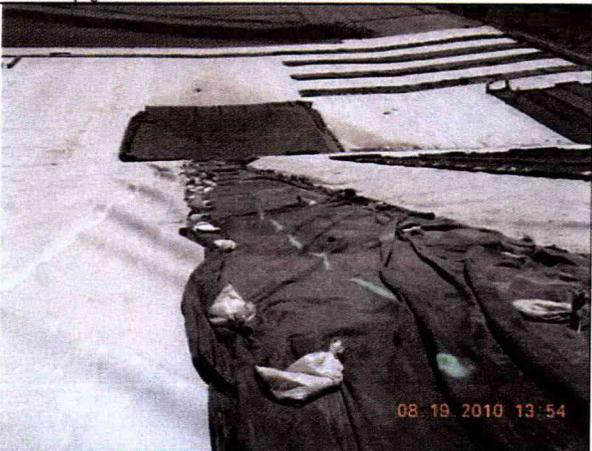
Facing S – The protective rubsheet that was placed over the geotextile in the Cell 10 secondary riser trench.

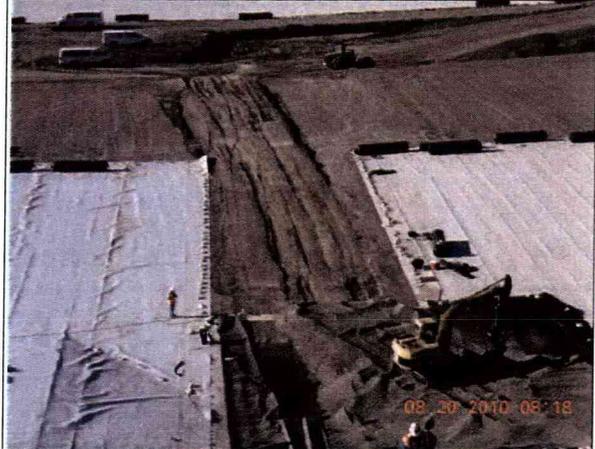
Facing S – The rutting created by the payhaulers during placement of the drainage gravel in the Cell 10 sump.

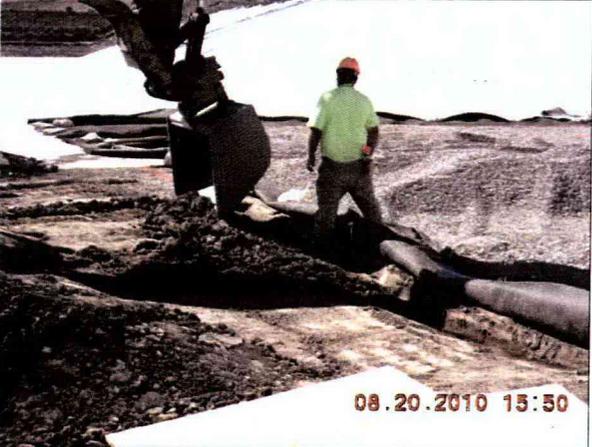
Facing NW – TWS protecting the leading edge of the secondary geomembrane in the Cell 10 sump prior to leaving for the weekend.

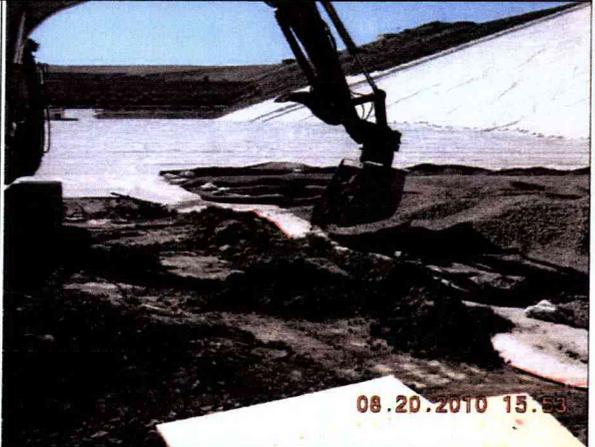
Facing W – TWS creating a small berm over the leading edge of the secondary geomembrane in Cell 10.

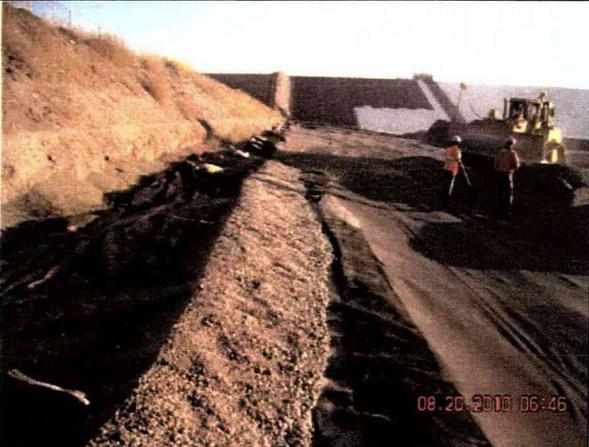
Facing N – TWS spreading rock near the Cell 7/9 tie-in; two laborers work on minimizing wrinkle propagation.

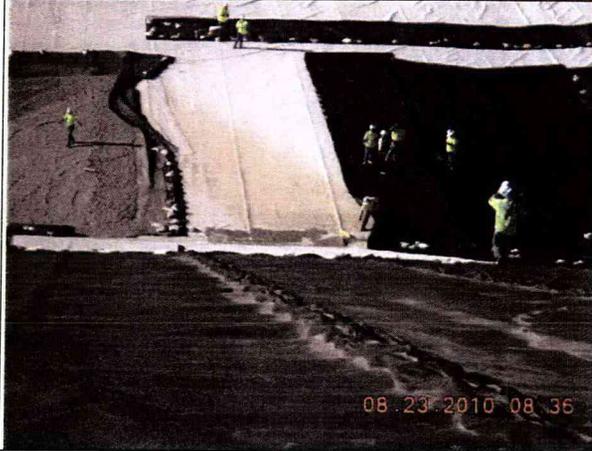
Facing S – ESI removing dirt from the secondary geomembrane prior to placing secondary geocomposite in Cell 9.

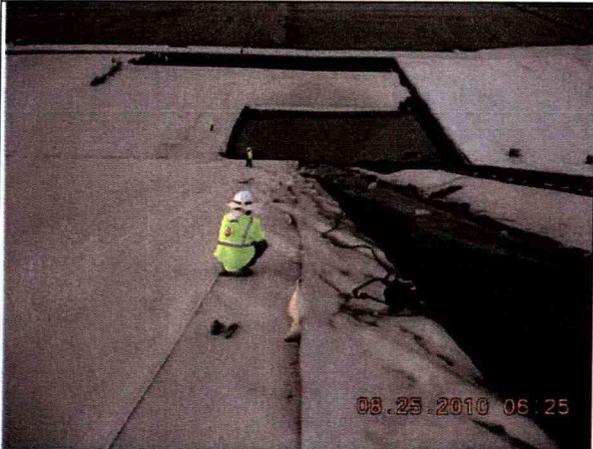
Facing S – ESI cut the secondary geomembrane near the Cell 9 riser trench in order to remove large wrinkles in the geomembrane.

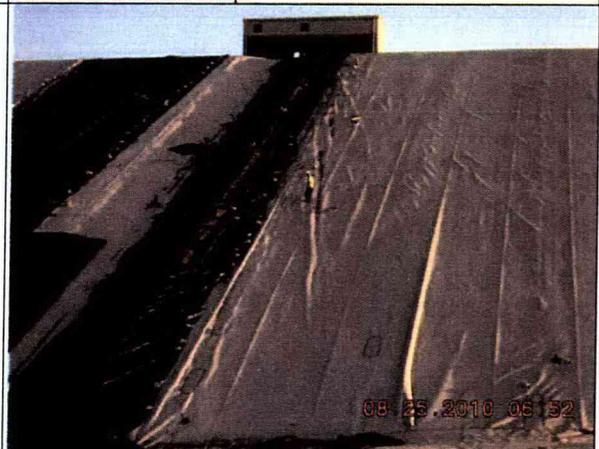
Facing NW – ESI "walking-out" the wrinkles on the north slope of Cell 9.

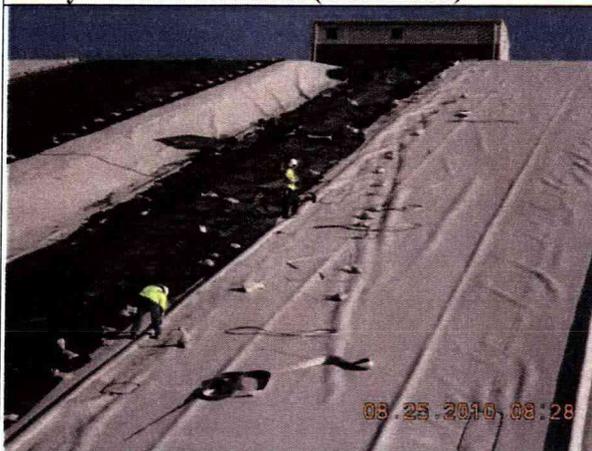
Facing NW – ESI welding the panel that was cut in order to remove the wrinkles east of the Cell 9 riser trench.

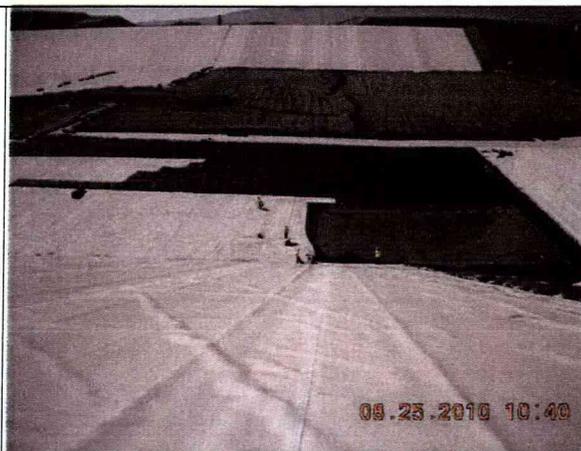
Facing S – The north slope of Cell 9 after the wrinkles had been removed.

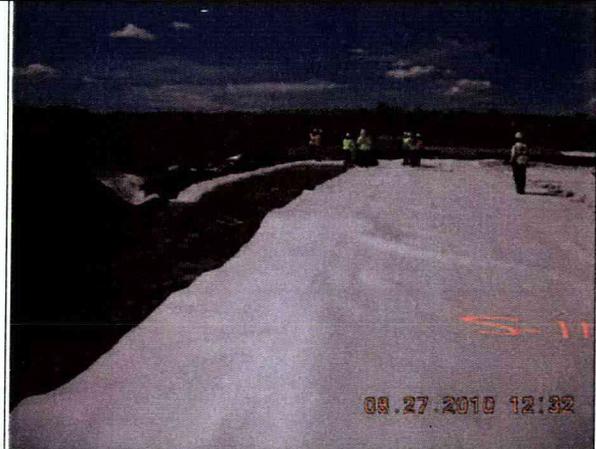
Facing W – ESI deploying secondary geomembrane across unacceptable subgrade. TWS will fix subgrade at a later date.

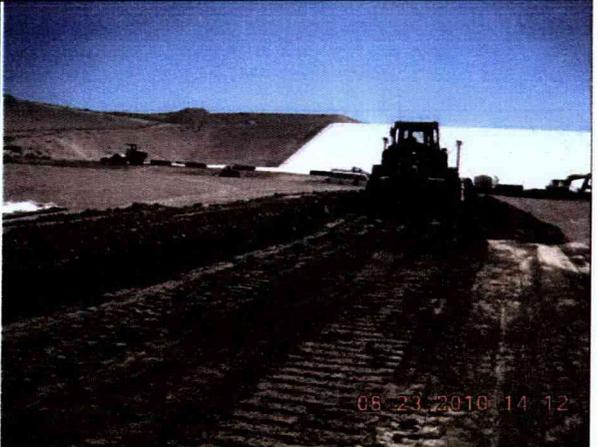
Facing SE – After the admix was compacted and clipped to grade, CQA inspected the surface. Due to the large amount of overbuilt admix, CQA determined that rutting did not extended into the admix.

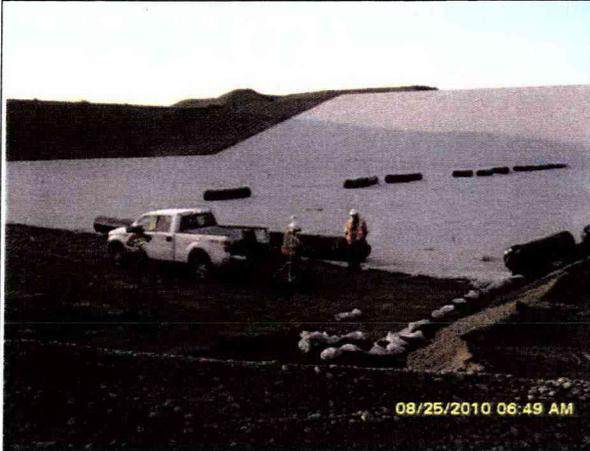
Facing SE – WCH preparing to use ground penetrating radar to check the admix for ruts under the three (3) primary gravel haul roads.

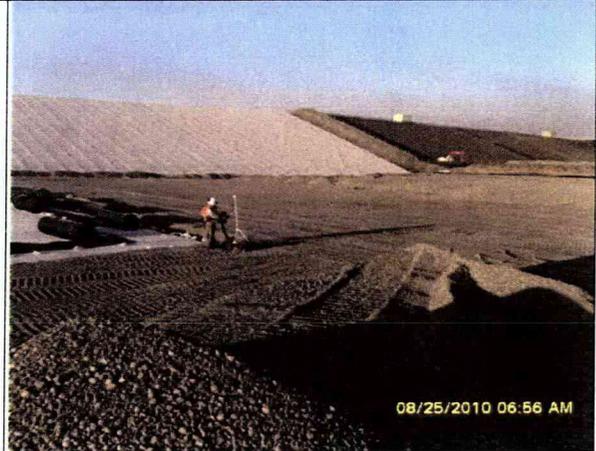
Facing SW – WCH utilizing ground penetrating radar on the primary gravel haul roads.

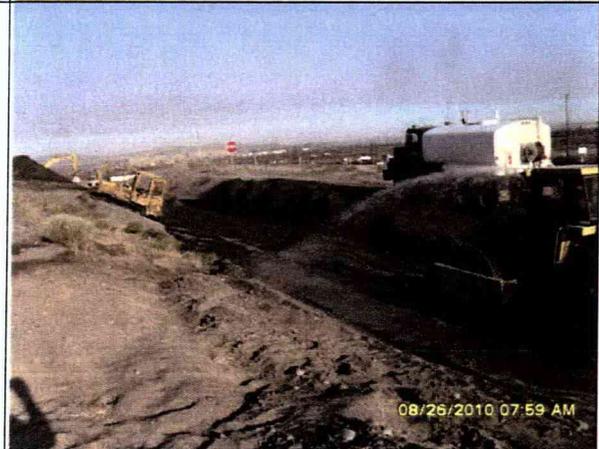
Facing W – TWS placing, moisture conditioning, and compacting fill over the leachate transmission pipes between MH-36 and MH-37.

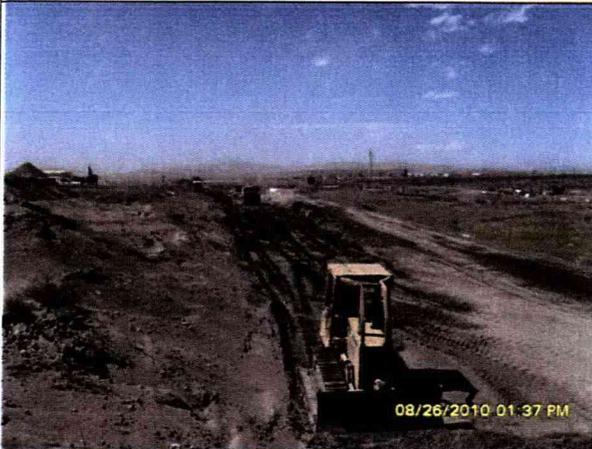
Facing W – TWS placing and moisture conditioning backfill over the leachate transmission trench between MH-36 and MH-37

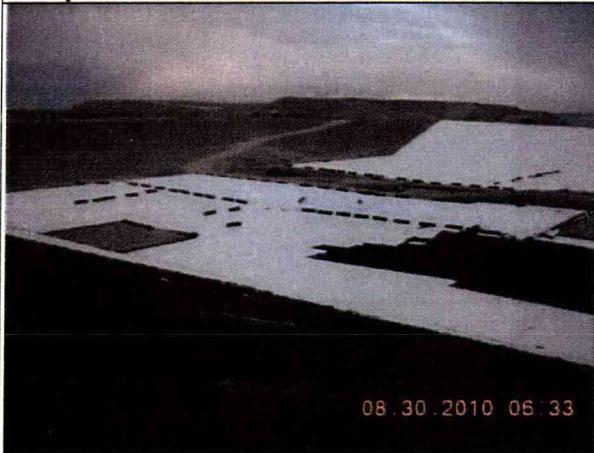
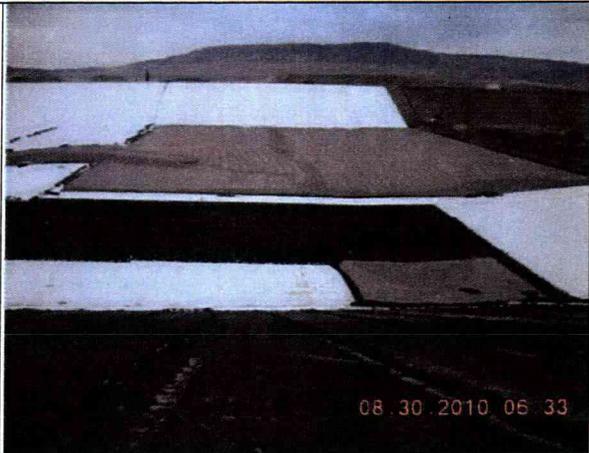
<p>08.30.2010 06:33</p>
Facing SE – Extent of geocomposite placement in Cell 10.	Facing S – Extent of geocomposite placement in Cell 9.

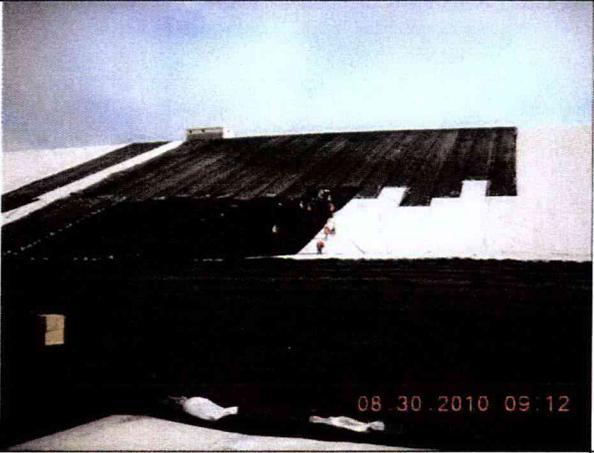
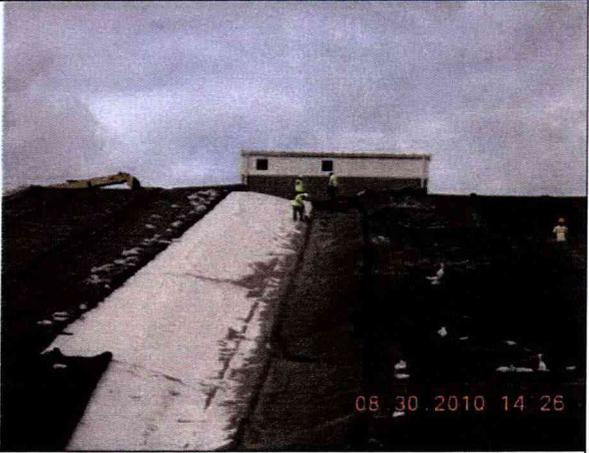
<p>08.30.2010 14:26</p>
Facing NW – ESI deploying secondary geocomposite on the north slope of Cell 9.	Facing N – ESI removing blow sand from the Cell 9 secondary riser trench.

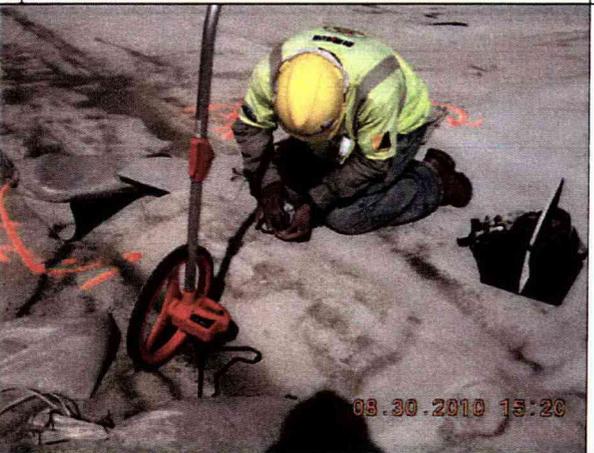
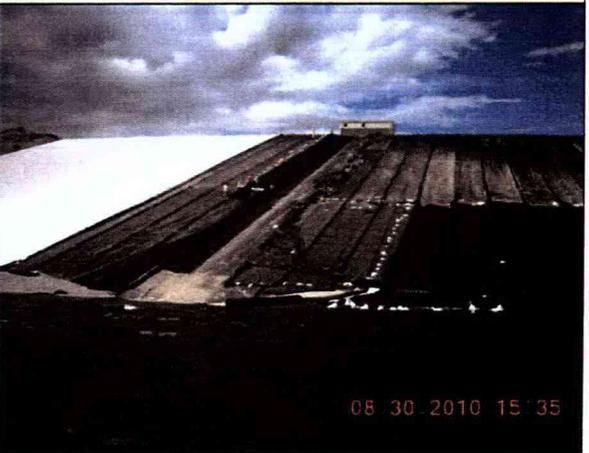
<p>08.30.2010 15:35</p>
Facing SW – ESI conducting pressure testing on the primary geomembrane in Cell 9.	Facing NW – ESI deploying secondary geocomposite in the Cell 9 riser trench.

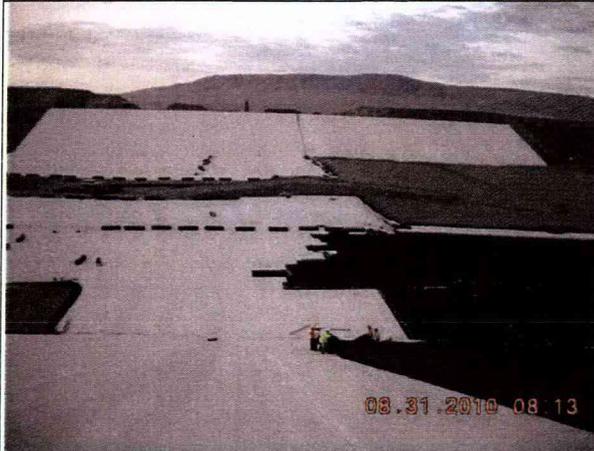
Facing S – ESI deploying secondary geocomposite on the north slope of Cell 10.

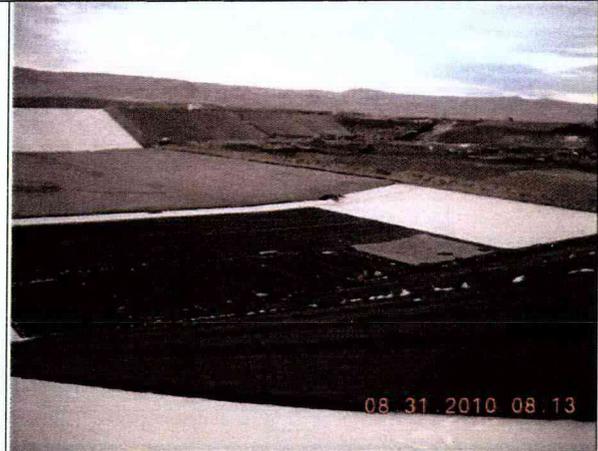
Facing SW – ESI joining the geocomposite in Cell 9 together with zip ties.

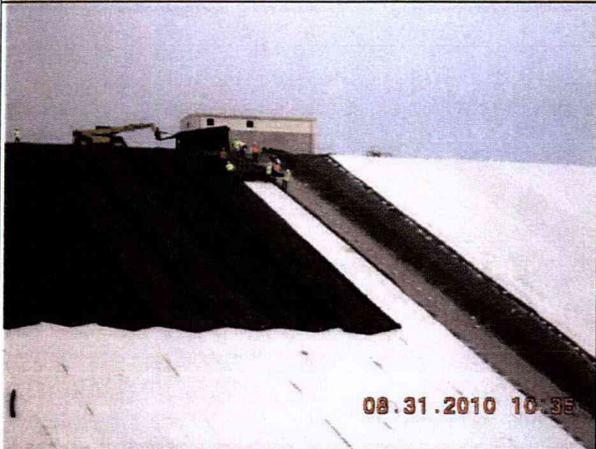
Facing NE – ESI deploying secondary geocomposite on the north slope and floor west of the Cell 10 sump.

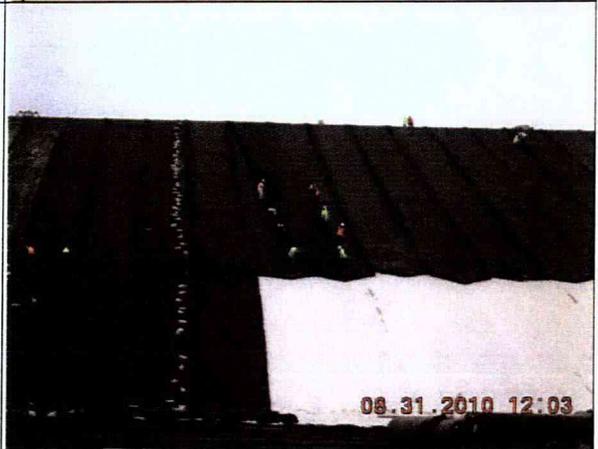
Facing N – ESI deploying secondary geocomposite on the north slope of Cell 10.

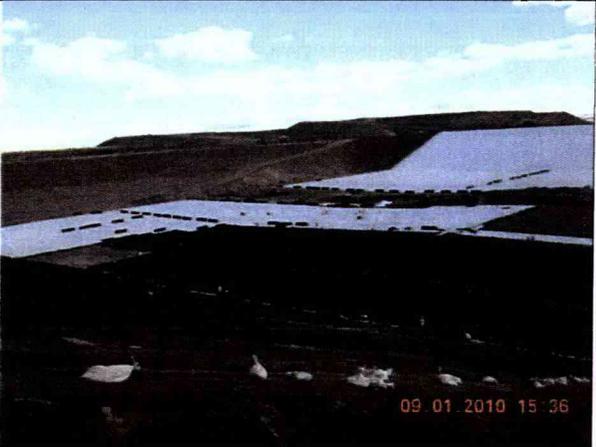
Facing SE – ESI zip tying secondary geocomposite in Cell 10, while a second crew completes repairs on the secondary geomembrane.

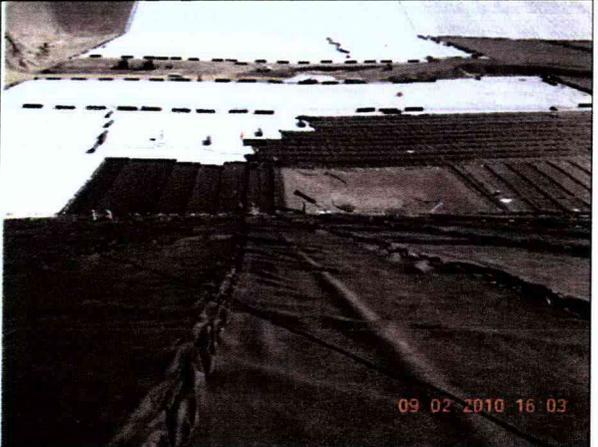
Facing S – ESI deploying secondary geocomposite on the north slope and floor of Cell 10, east of the Cell 10 sump.

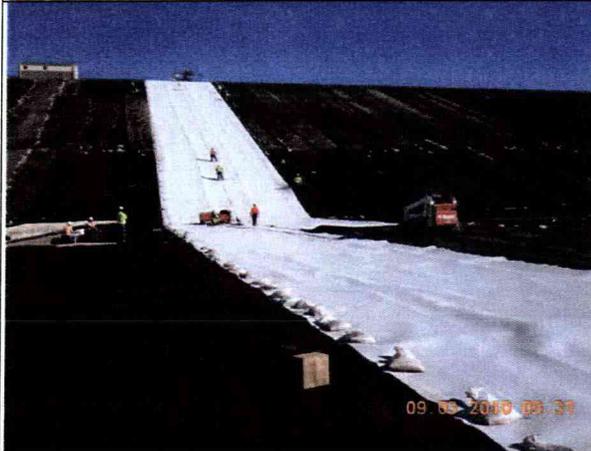
Facing N – ESI deploying primary geomembrane east of the sump in Cell 9.

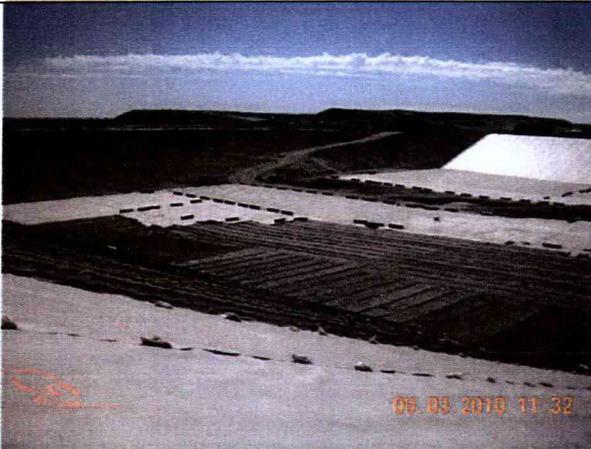
Facing SE – Extents of geocomposite deployment in Cell 10.

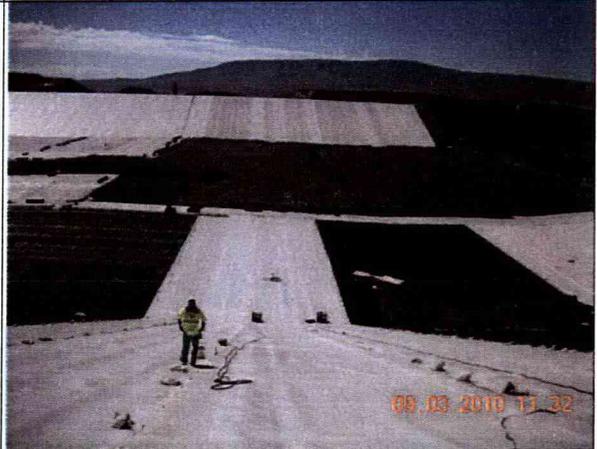
Facing S – Extents of secondary geomembrane and secondary geocomposite deployment in Cell 9.

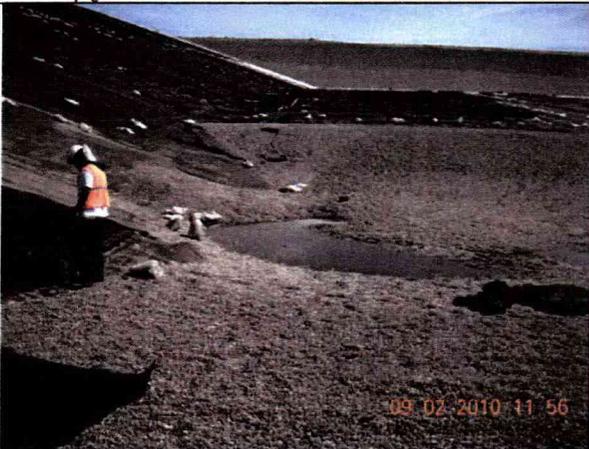
Facing E – After ESI had remove the water from the Cell 9 sump, water was discovered under the Cell 9 secondary geomembrane.

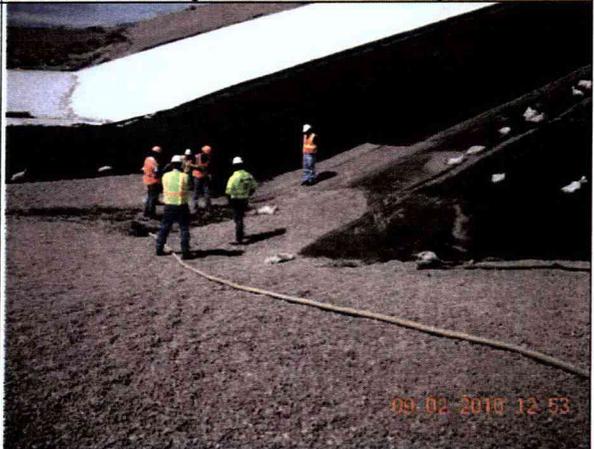
Facing W – ESI, CQA, and TWS investigation of the trapped water in the Cell 9 sump.

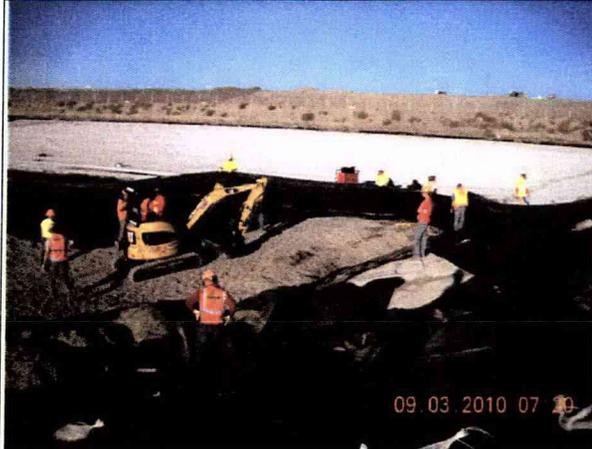
Facing SW – ESI, TWS, and CQA tracing the source of the stormwater to the northwest corner of the sump.

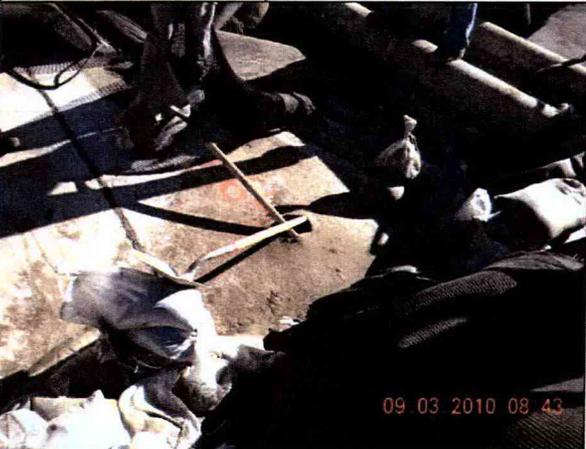
Facing NE – TWS left the admix to dry under the secondary geomembrane.

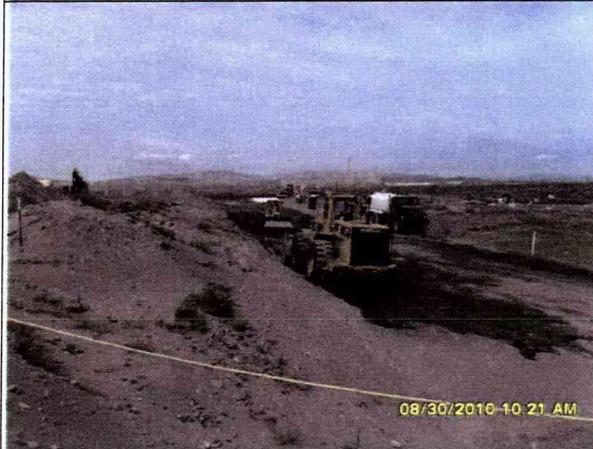
Facing W – TWS backfilling the leachate transmission trench between MH-36 and MH-37.

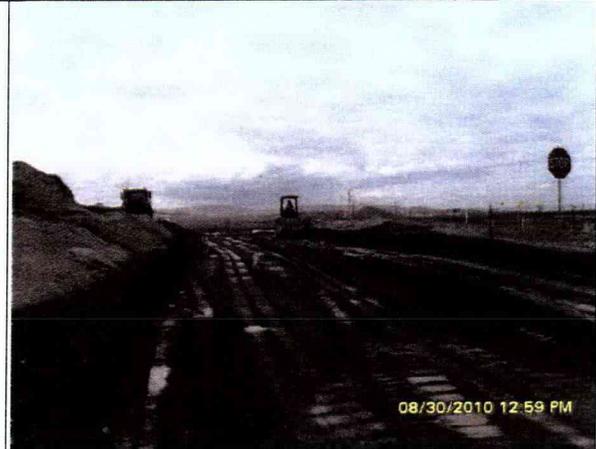
Facing W – TWS compacting the leachate transmission trench backfill between MH-36 and MH-37 with a smooth drum roller.

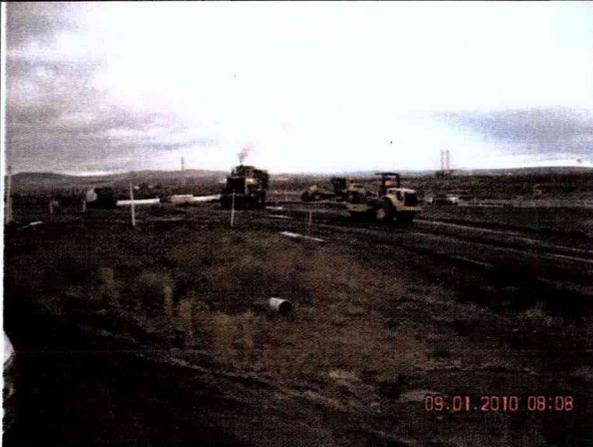
Facing NW – TWS backfilling and compacting the base course on the operations haul ramp that was removed for the placement of the leachate transmission trench between MH-36 and MH-37

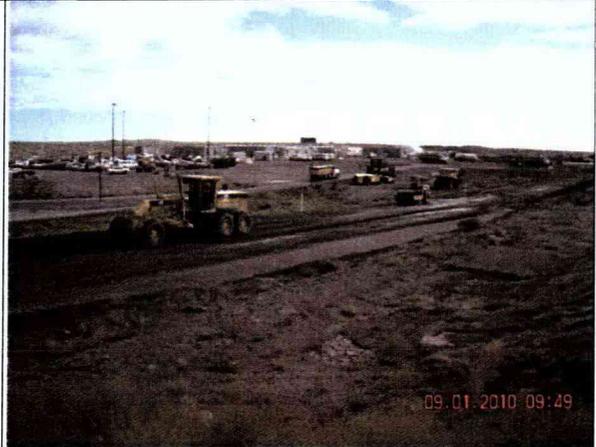
Facing NE – ESI grading and compacting the base course rock on the operations haul road.

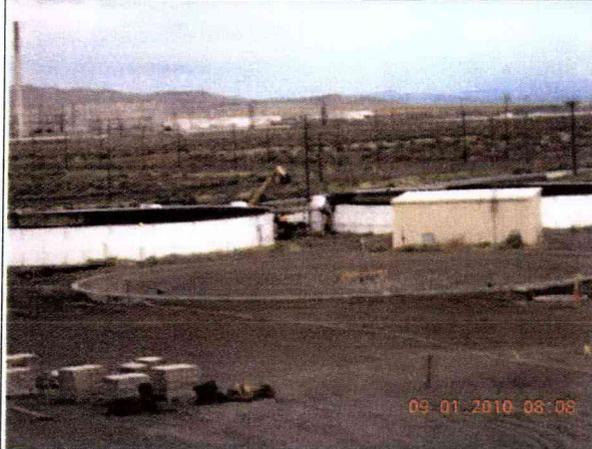
Facing NW – BMWC and TWS removing the transfer pipe between Tank #1 and Tank #2.

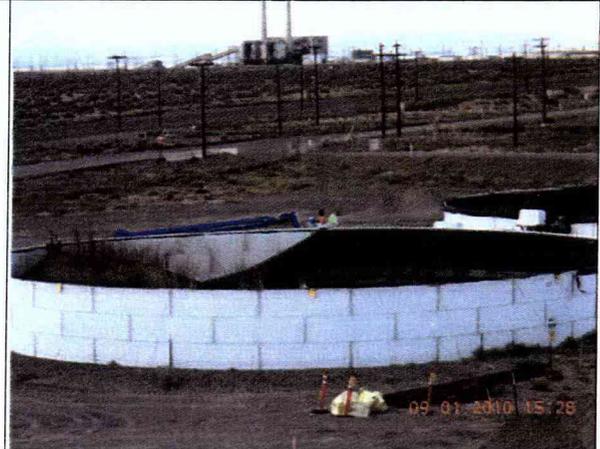
Facing NW – TWS cutting the liner from the tank wall.

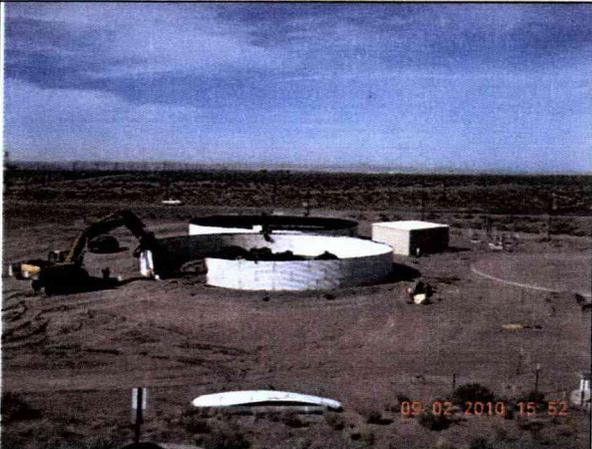
Facing NW – TWS removing the metal tank wall with an excavator.

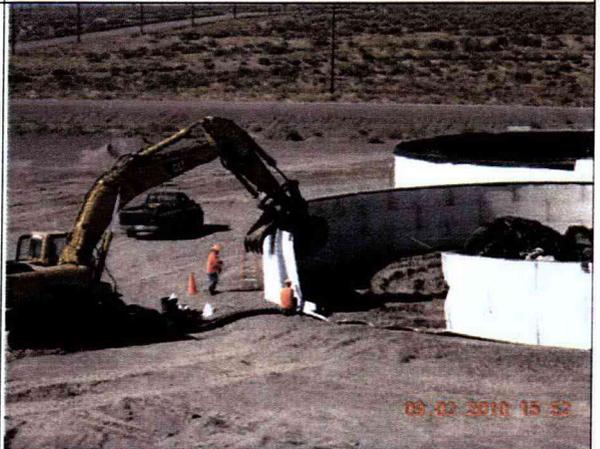
Facing NW – TWS removing the anchor bolts from the metal tank walls.

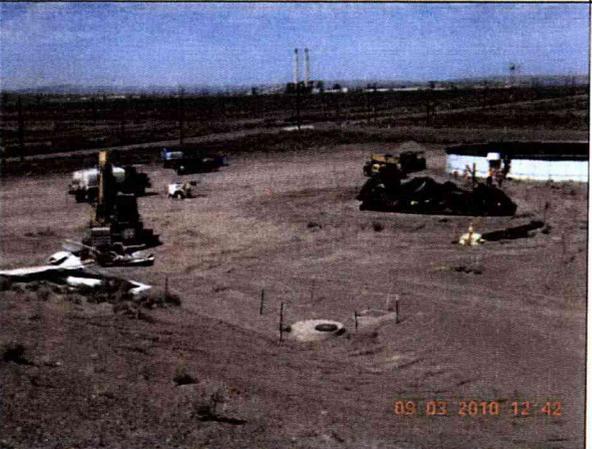
Facing N – TWS removed the tanks walls and folded the geomembrane for disposal in roll-off containers.

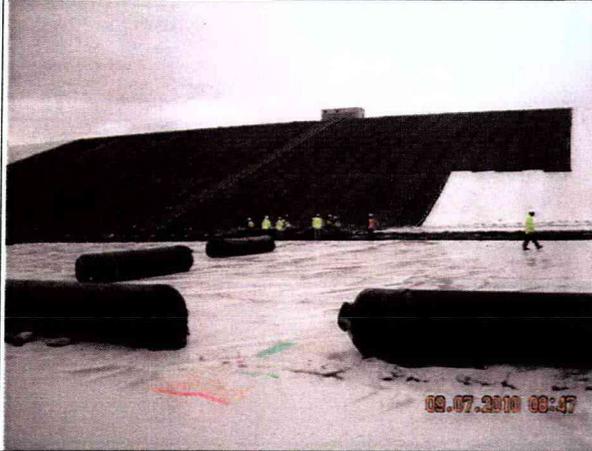
Facing NW – ESI placing geocomposite in Cell 10.

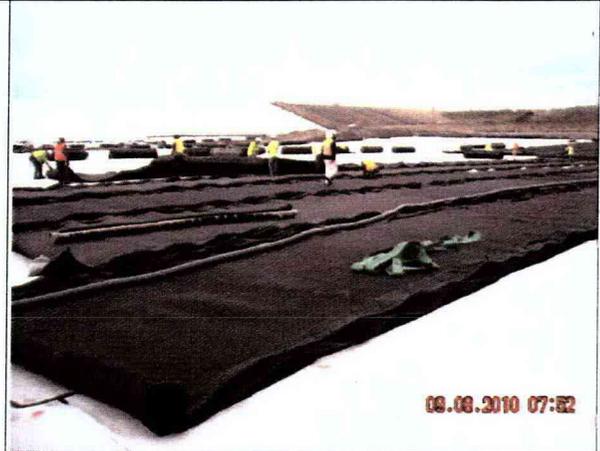
Facing SW – ESI placing geocomposite in Cell 10.

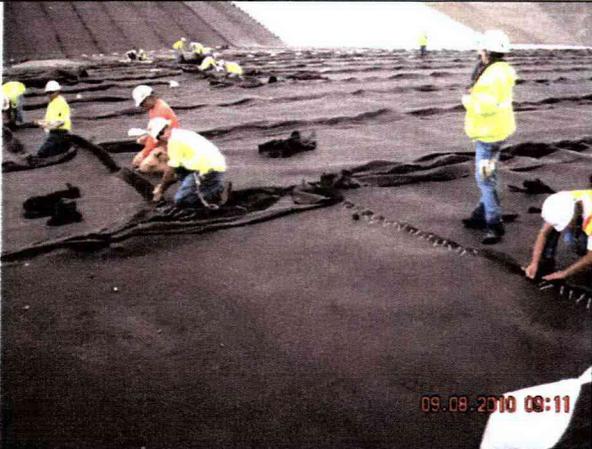
Facing NE – ESI joining the composite rolls together with zip ties.

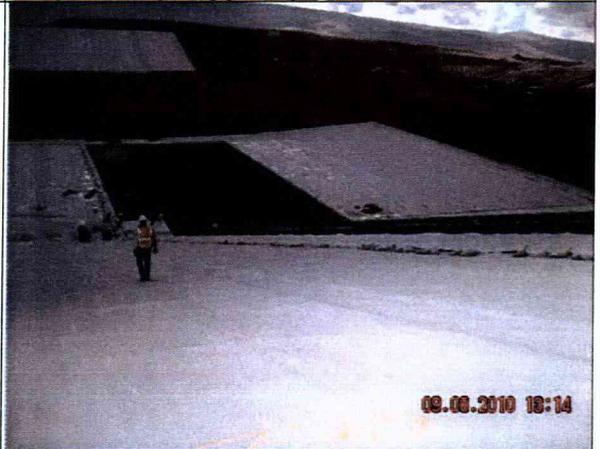
Facing SW – ESI deploying secondary geomembrane panel P-57 to the east of the Cell 9 sump.

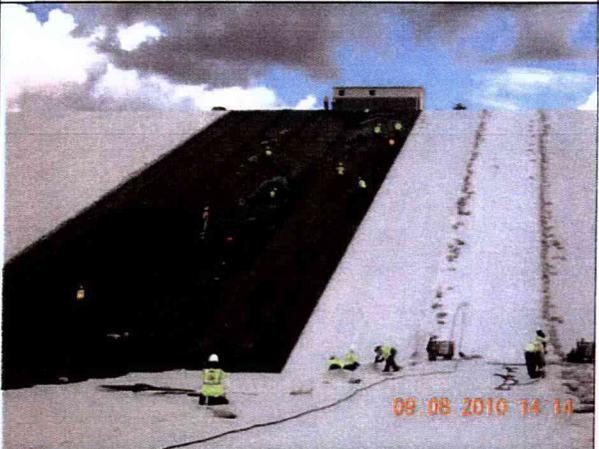
Facing N – ESI removing the rub sheet from the Cell 9 riser trench protecting the 16 oz. geotextile.

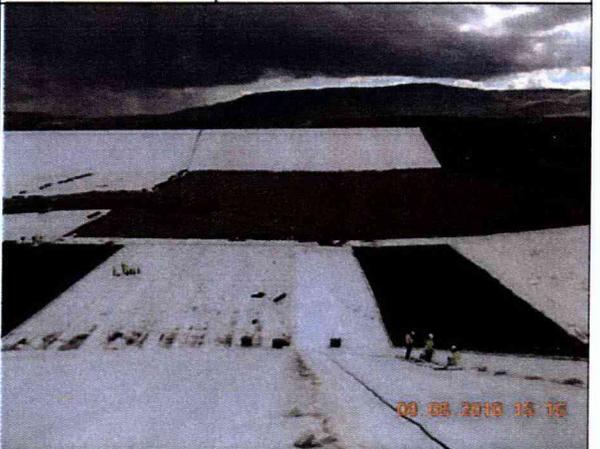
Facing S – ESI deploying panel P-58 in the Cell 9 sump.

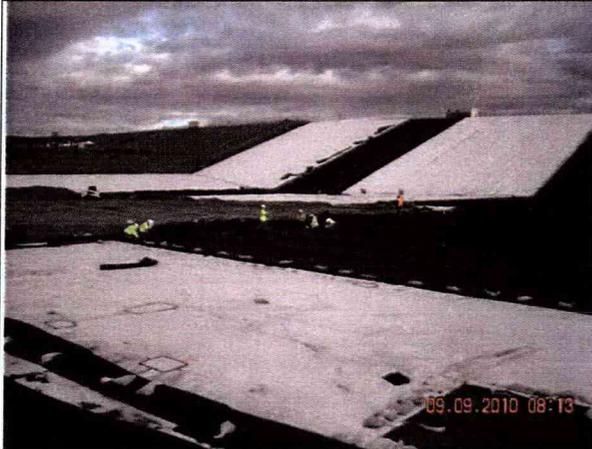
Facing NW – ESI joining the secondary geocomposite on the Cell 10 floor.

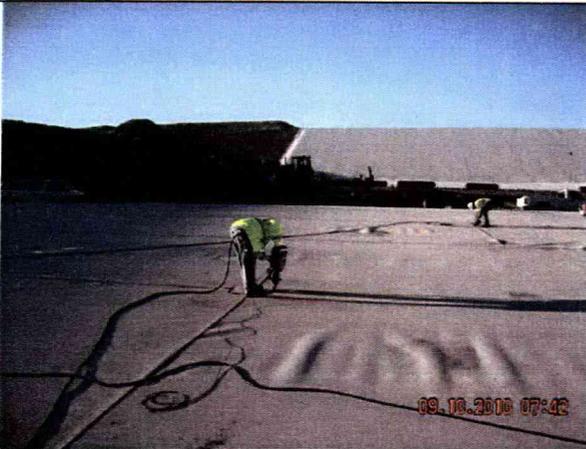
Facing SE – ESI performing repairs on the secondary geomembrane in Cell 10 south of the sump.

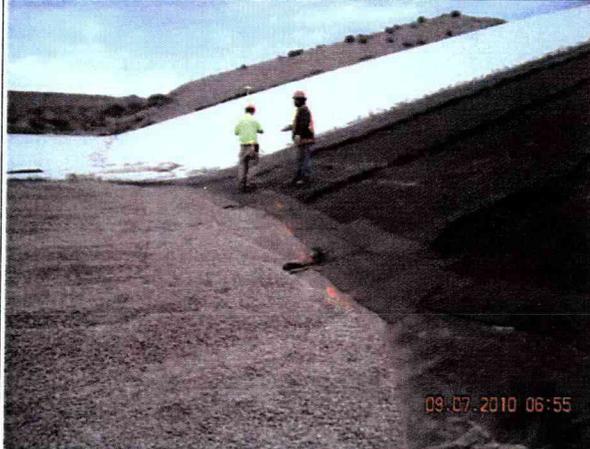
Cell 9 Sump Repair

Facing W – TWS surveyor setting the grade for the secondary drainage gravel in Cell 9.

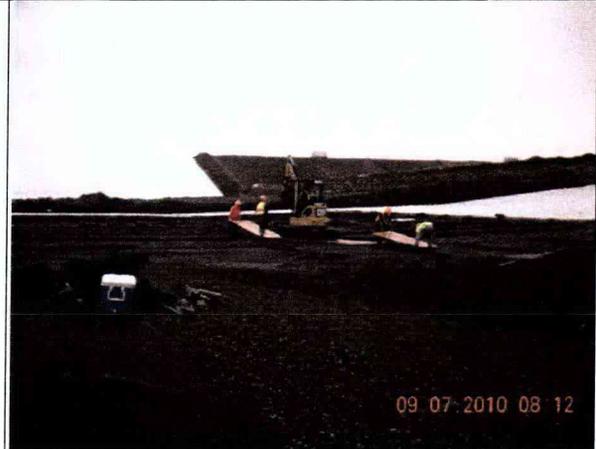
Facing SW – ESI removing the CAT 303 excavator from the Cell 9 sump after spreading the drainage gravel as per design drawings.

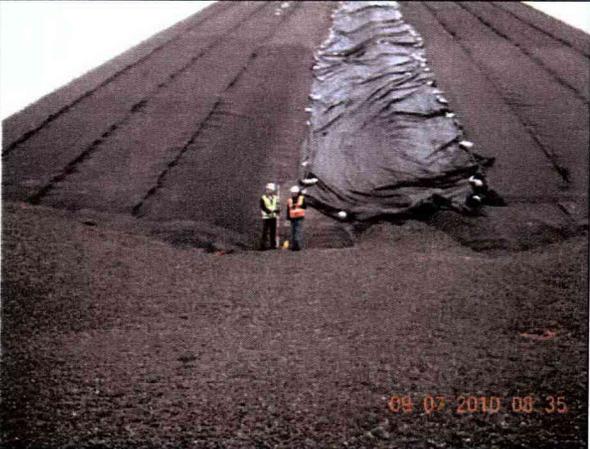
Facing N – CQA surveyor verifying that the drainage gravel matches the design drawings.

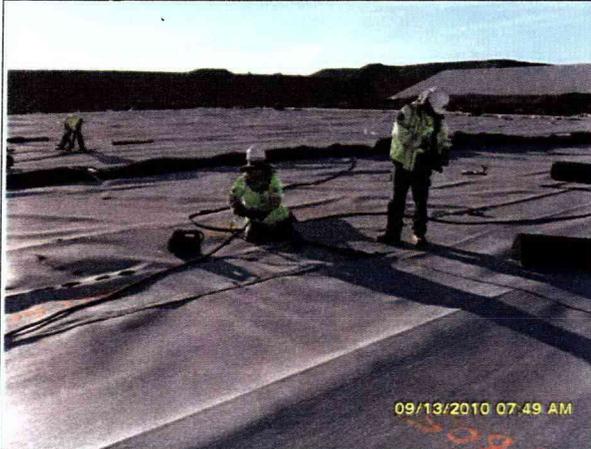
Facing SE – ESI performing an air pressure test on the Cell 9 primary geomembrane, while a second technician patches the hole in the liner.

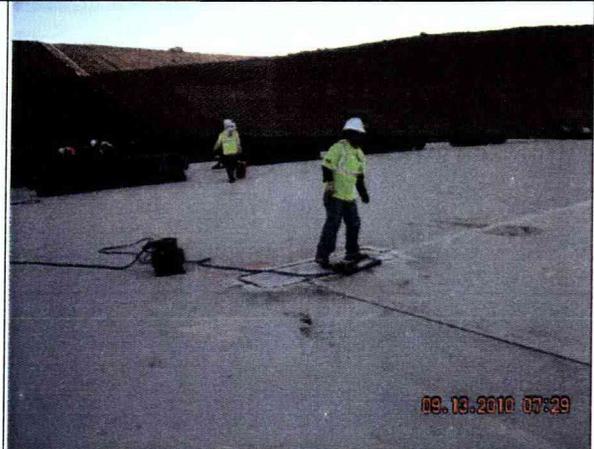
Facing NE – ESI vacuum testing repairs on the secondary geomembrane in Cell 10 south of the sump.

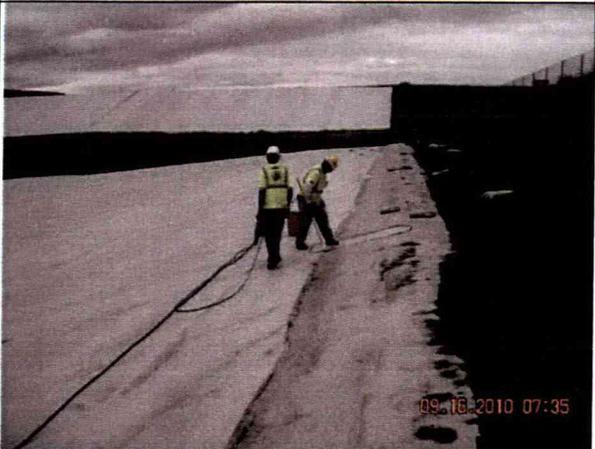
Facing S – ESI vacuum testing the Cell 9 primary geomembrane tie-in.

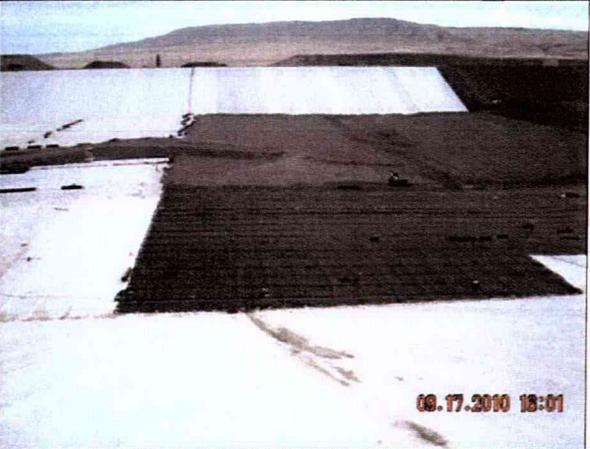
Facing SE – Extent of geosynthetic deployment in Cell 10.

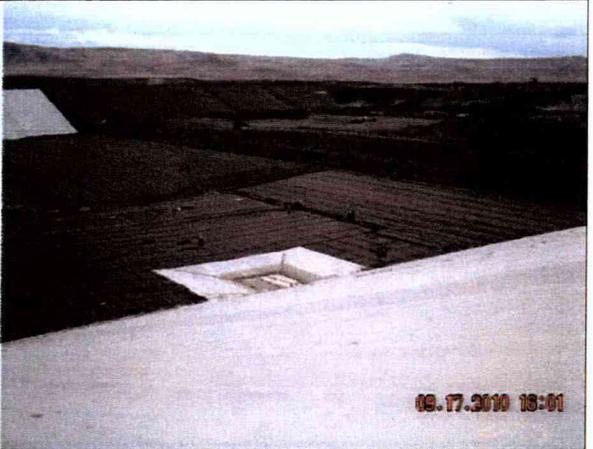
Facing S – Extent of geosynthetic deployment in Cell 9.

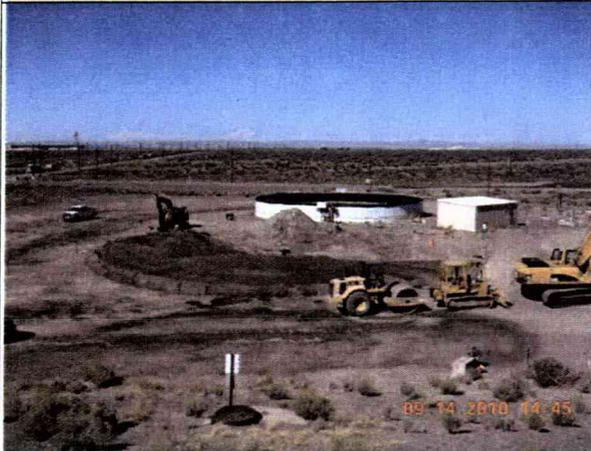
Facing NW – TWS compacting the southwest half of the Tank 4 foundation.

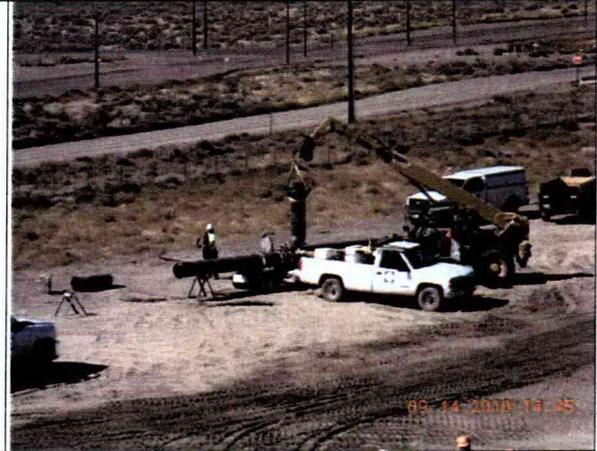
Facing NW – BMWC welding the 16x10-in double containment inlet line for Tank 4.

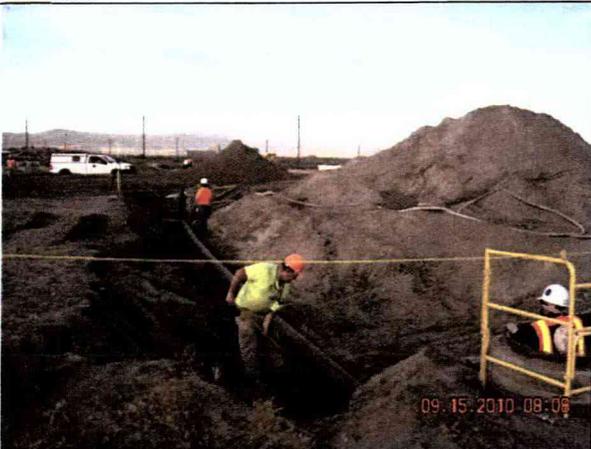
Facing SW – TWS and BMWC installing the 4x8-in drain line for Tank 4.
