TANK 4 AND LEACHATE TRANSMISSION SYSTEM REPORT
CONSTRUCTION QUALITY ASSURANCE (CQA)

CQA PHOTOGRAPH LOG WEEK 22
(7/6/10 TO 7/9/10)

ERDF CONSTRUCTION CELLS 9-10

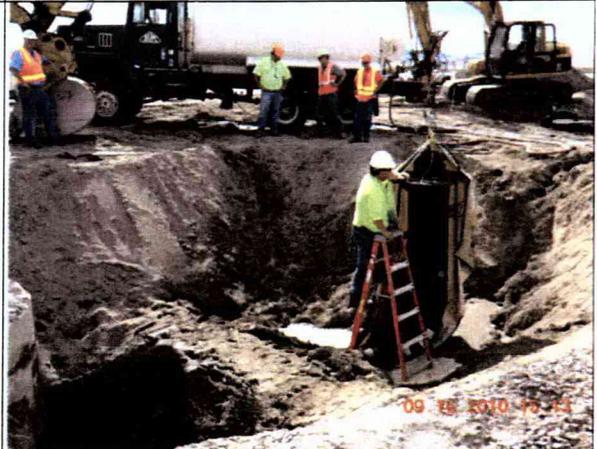
Facing SW – BMWC pressure testing the inner pipe of the 10x16-in inlet pipe for Tank 4.

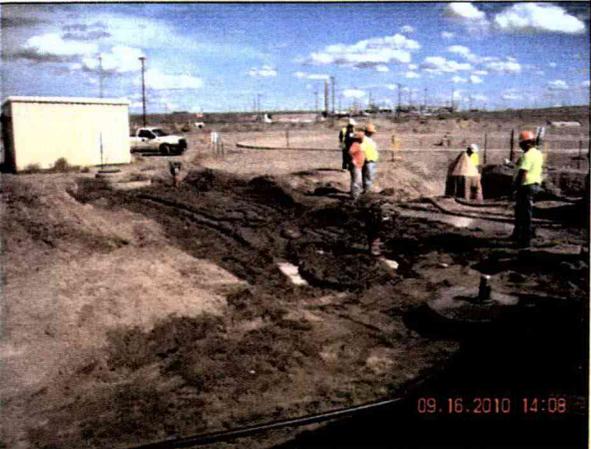
Facing NE –TWS backfilling the 4x8-in drain line for Tank 4.

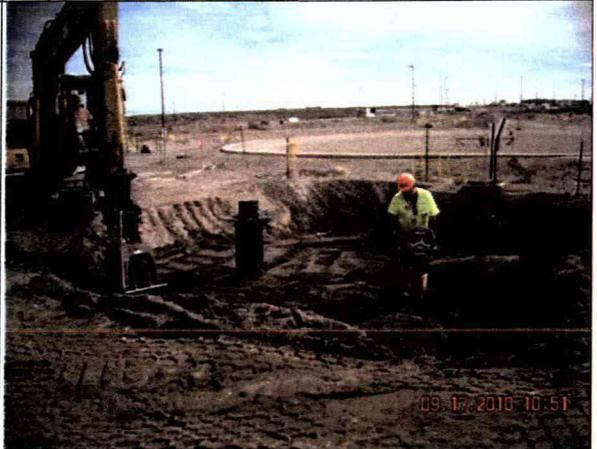
Facing NE – TWS compacting the Tank 4 inlet pipe backfill with both a jumping jack hand compactor and a hoe-pack.

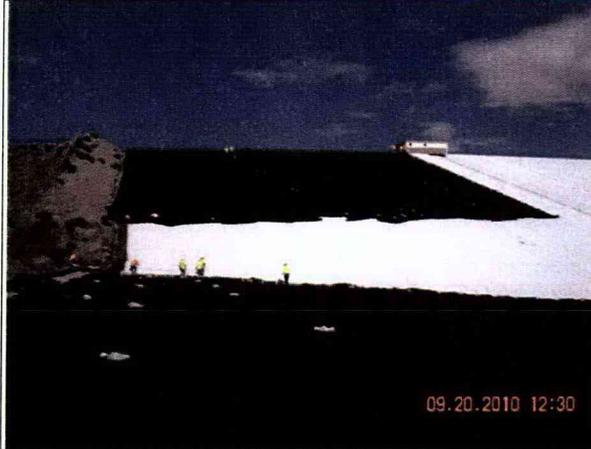
Facing N – ESI deploying primary geocomposite on the north slope of Cell 9.

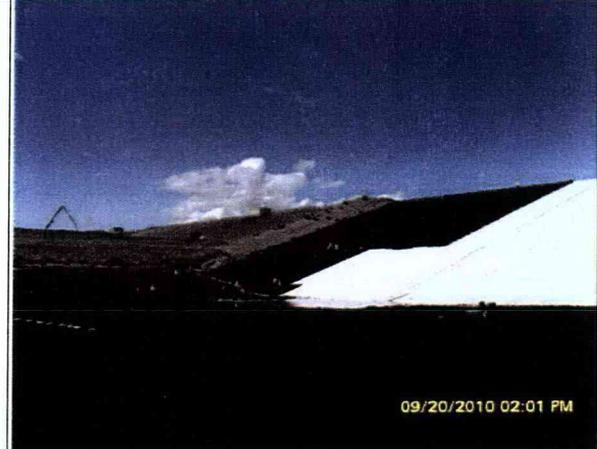
Facing NW – ESI deploying primary geocomposite on the north slope of Cell 9.

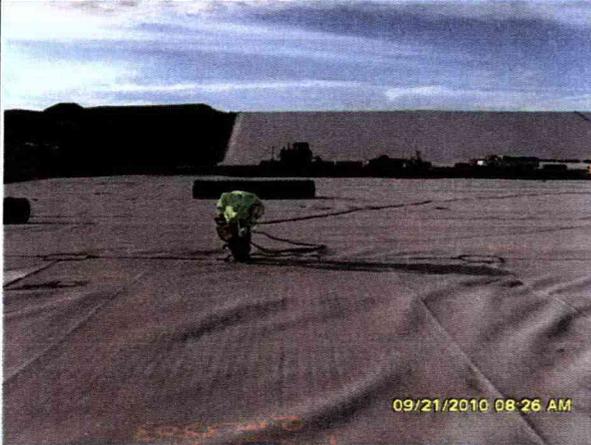
Facing S – ESI performing repairs on the primary geomembrane on the Cell 10 floor.

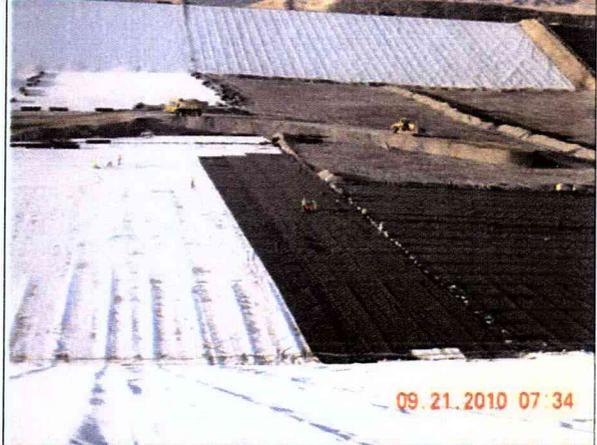
Facing S – ESI deploying primary geotextile on the floor of Cell 10.

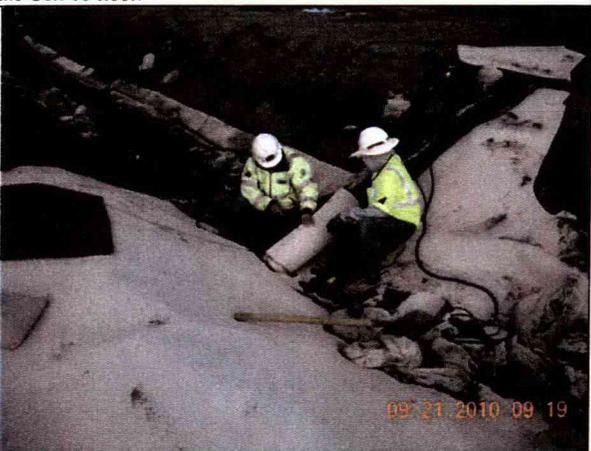
Facing NW – ESI installing the pipe boot and sock on the Cell 9 lysimeter pipe.

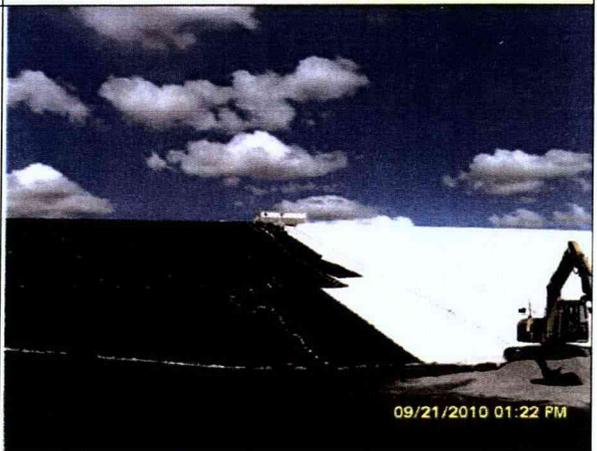
Facing N – ESI deploying primary geocomposite on the north slope of Cell 10.

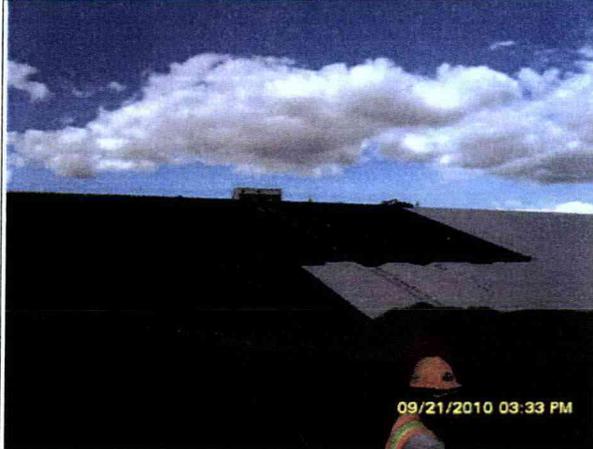
Facing NE – ESI deploying primary geocomposite on the north slope of Cell 10.

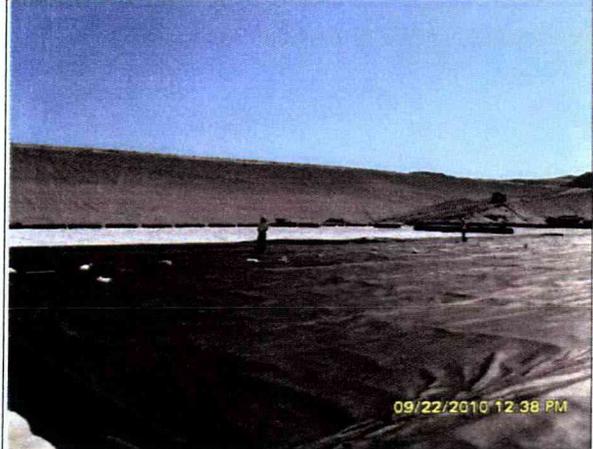
Facing SE – ESI double wedge welding primary geotextile on the floor of Cell 10.

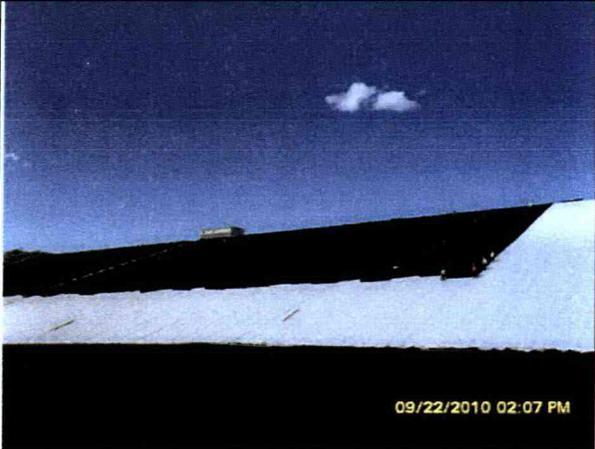
Facing NW – ESI deploying primary geocomposite on the north slope of Cell 10.

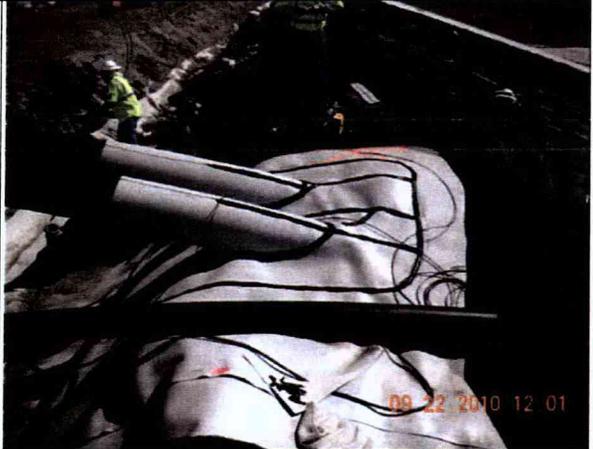
Facing E – ESI welding the pipe boots and skirts for the secondary leachate pipes in Cell 10.

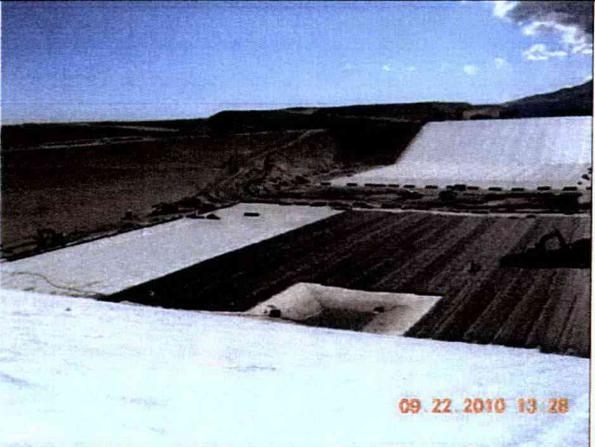
Facing SE – Extents of primary geotextile deployment in Cell 10.

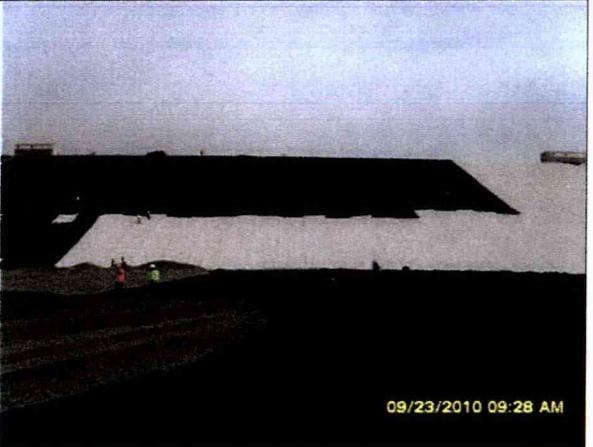
Facing N – ESI deploying primary geocomposite on the north slope of Cell 10.

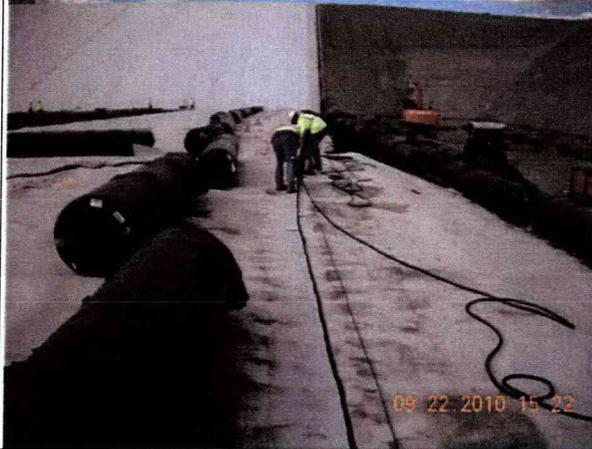
Facing N – Extrusion welding the primary termination of Cell 10 as per the design drawings.

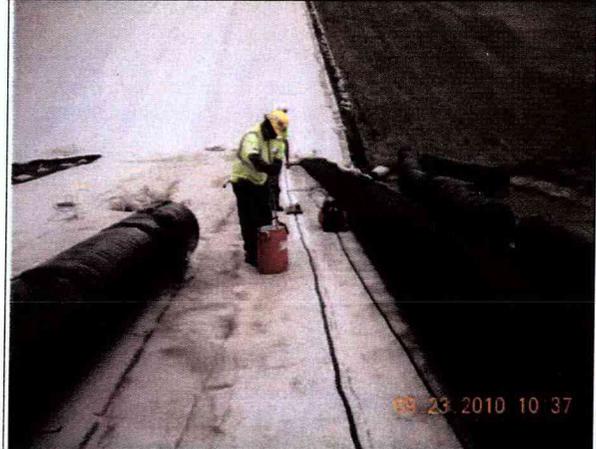
Facing N – ESI performing vacuum testing on the extrusion welded primary termination on the north side of Cell 10.

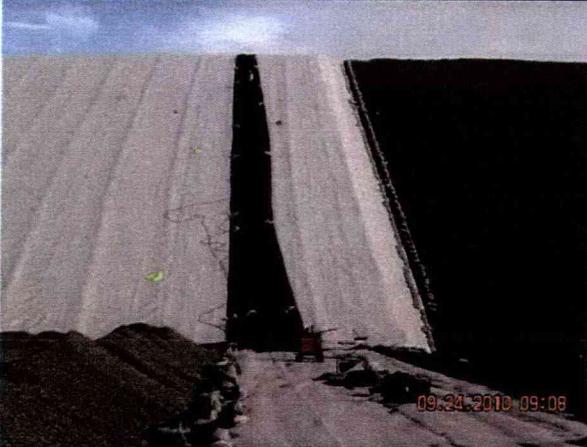
Facing N – ESI cutting the primary geomembrane and exposing the secondary geomembrane on the Cell 10 north slope termination.

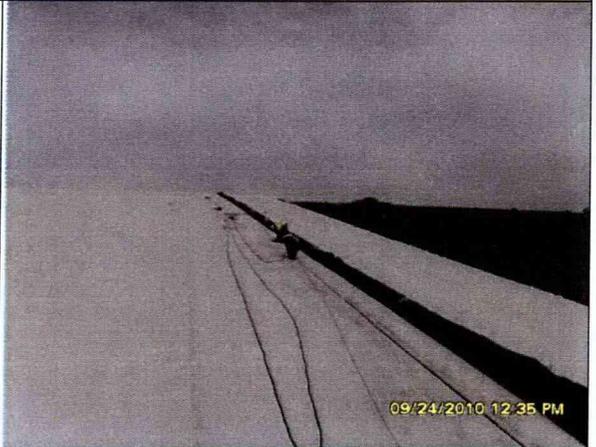
Facing NE – ESI leistering down the primary geomembrane to the secondary geomembrane on the Cell 10 north slope termination.

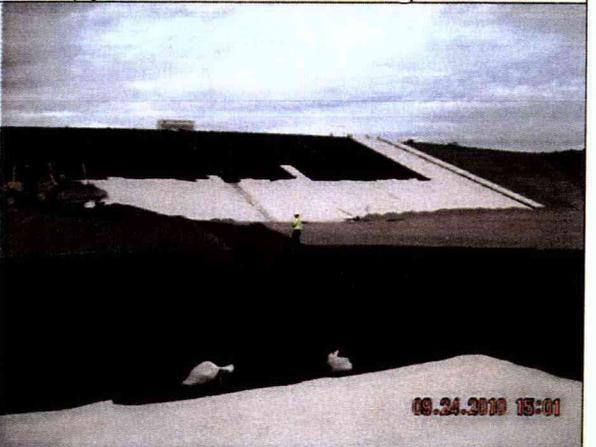
Facing NE – ESI deploying primary geocomposite on the north slope of Cell 10.

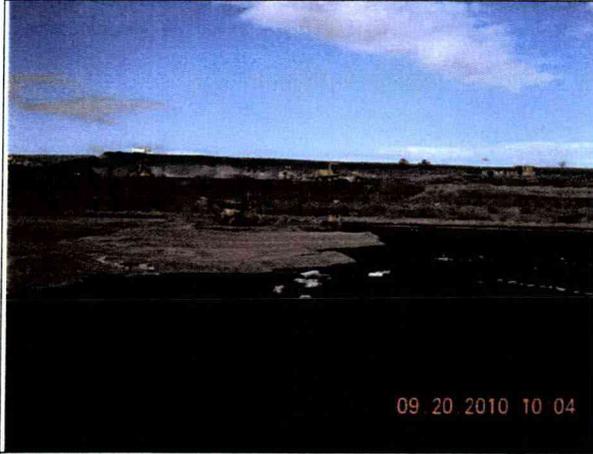
Facing W – TWS spreading the stockpiled drainage gravel in Cell 9 onto the north quarter of the Cell 9 floor.

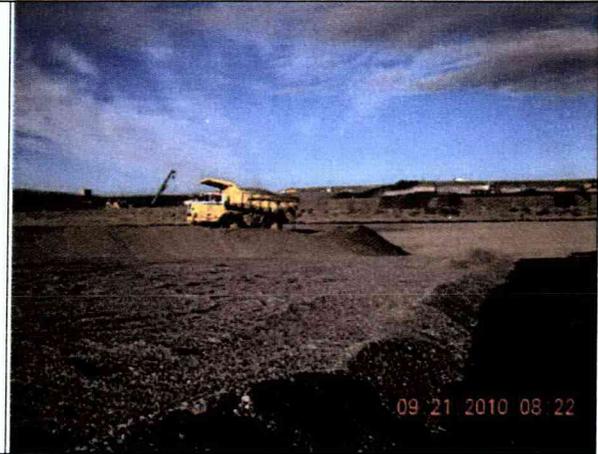
Facing W – TWS constructing a 7-ft high haul road to the Cell 9 sump.

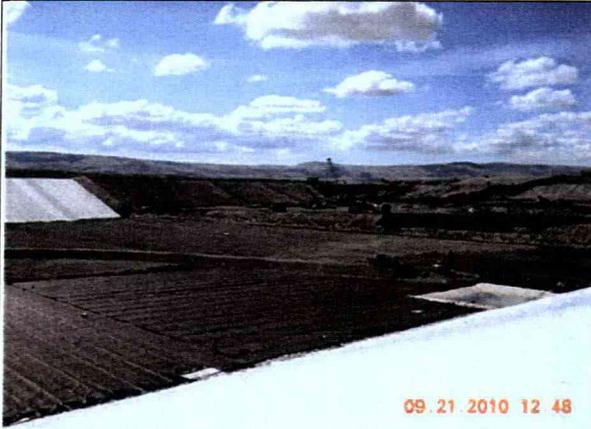
Facing SW – TWS constructing a 7-ft high haul road to the Cell 9 sump.

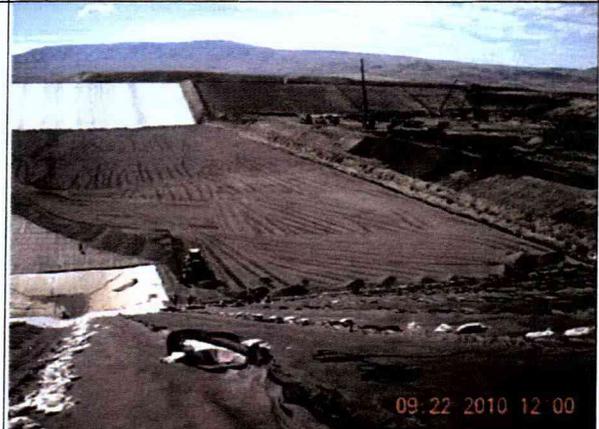
Facing S – TWS spreading the gravel from the Cell 9 sump haul road across the north half of the Cell 9 floor with a CAT D6 LGP dozer.

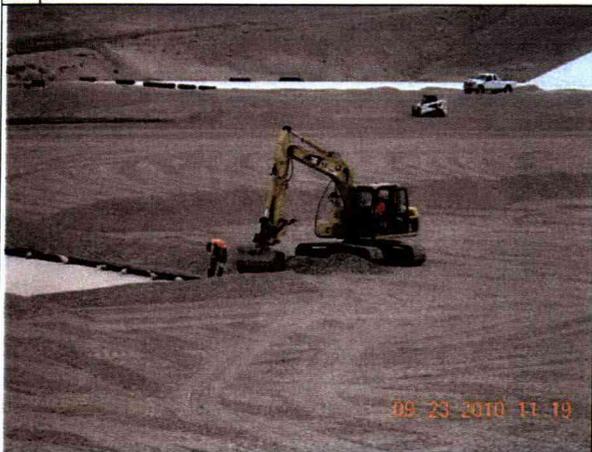
Facing SE – TWS removing excess drainage gravel that was spread too close to the Cell 9 sump.

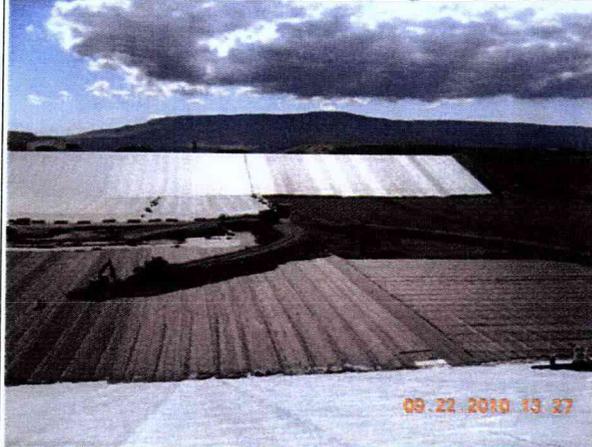
Facing S – TWS constructing the northeast gravel haul road across Cell 10.

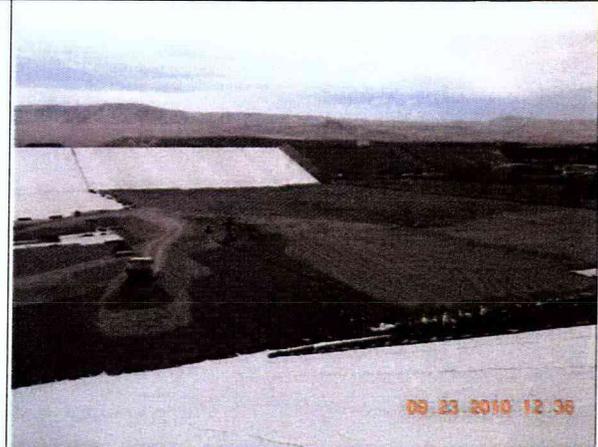
Facing SW – TWS constructing the Cell 10 north gravel haul road to the toe of the Cell 10 slope.

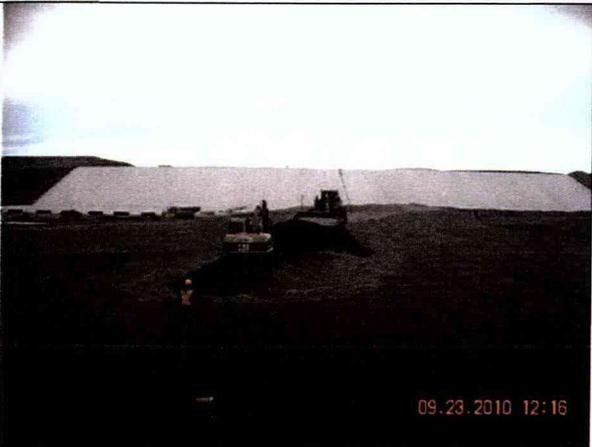
Facing S – TWS spreading gravel on the Cell 10 north haul road with a CAT 312 excavator to minimize wrinkles to the liner.

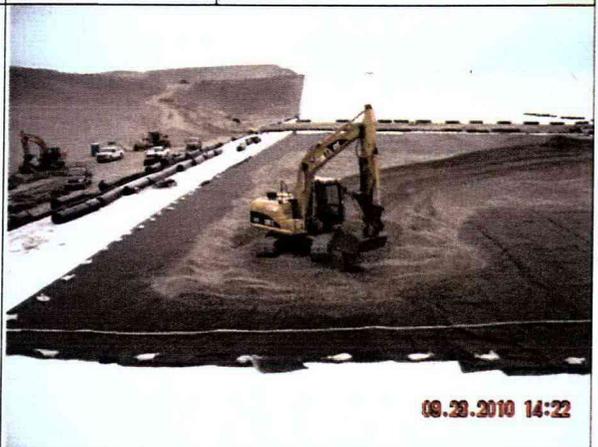
Facing S – TWS spreading gravel on the Cell 10 northeast haul road with a CAT 312 excavator to minimize wrinkles to the liner.

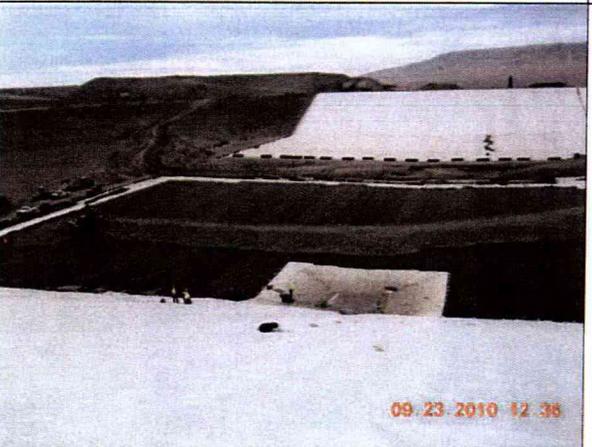
Facing SE – TWS constructing the 7-ft high northeast drainage gravel haul road across Cell 10.

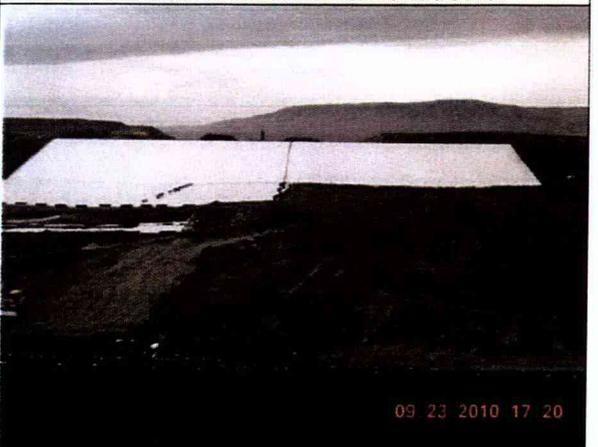
Facing S – TWS trimming the gravel to grade in Cell 9 with a CAT GPS D6 LGP dozer.

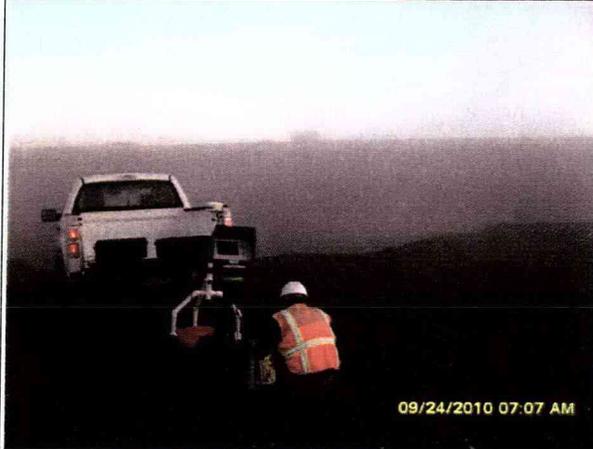
Facing N – WCH ground penetrating radar (GPR) preparing to survey the gravel haul roads in Cell 9.

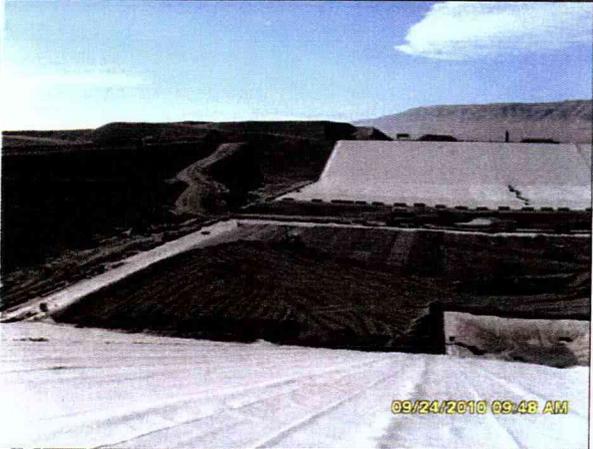
Facing SE – TWS spreading gravel from the Cell 10 north east haul road across the north half of the Cell 10 floor.

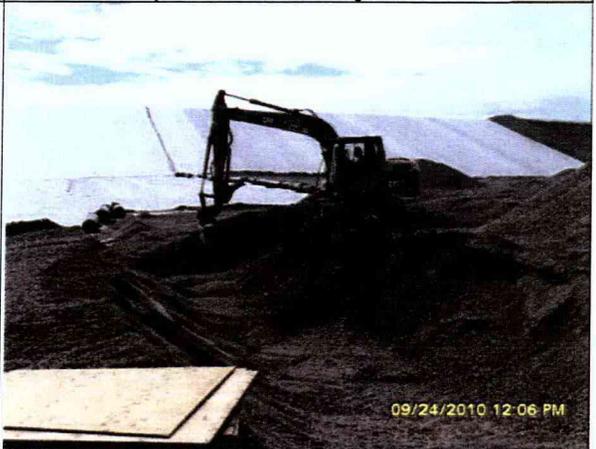
Facing S – TWS removing a portion of the drainage gravel ramp into Cell 9.

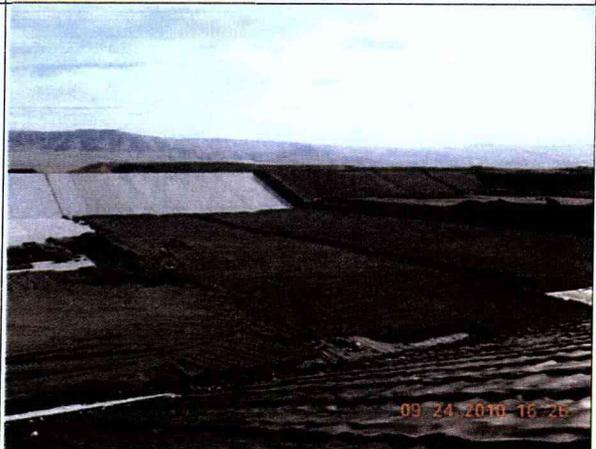
Facing SW – TWS trimming gravel to grade in Cell 10.

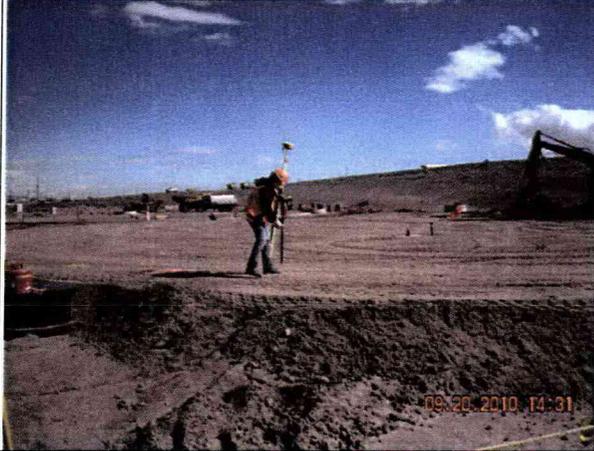
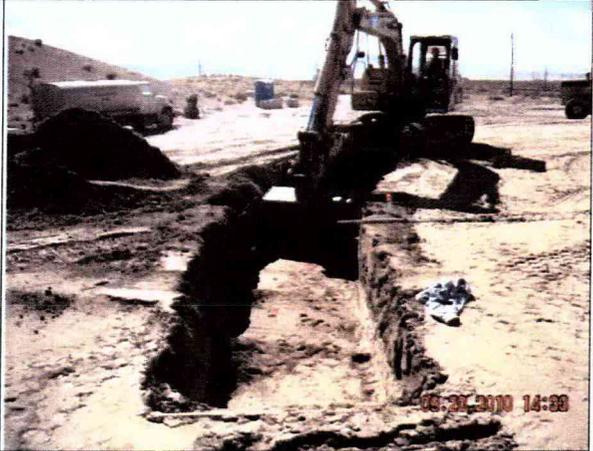
Facing SE – The TWS surveyor staking out the ringwall on the Tank 4 foundation.	Facing W – TWS excavating the ringwall trench in the Tank 4 foundation.

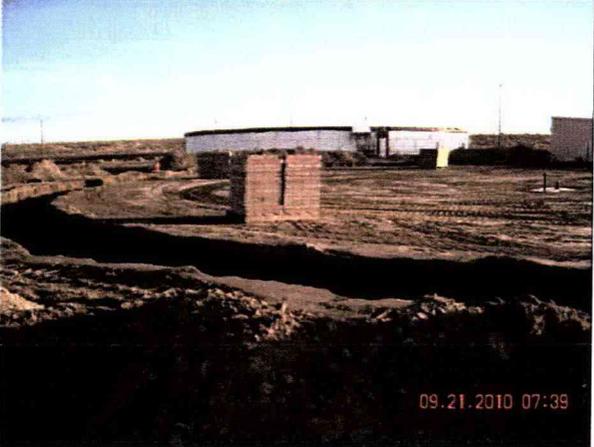
Facing SE – The Tank 4 ringwall trench.

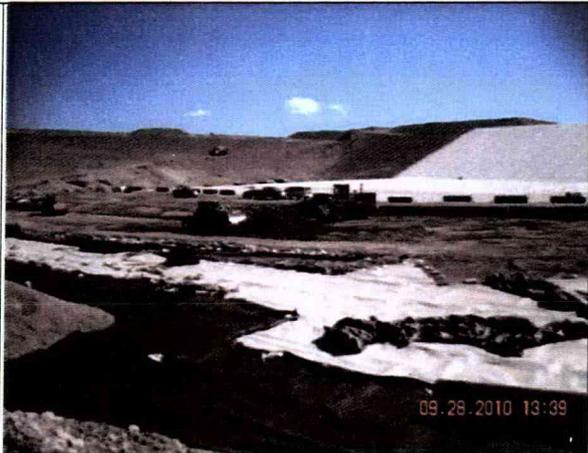
<p>Facing E – ESI uncovering the admix tie-in, while TWS stockpiles the unacceptable subgrade material in Cell 10.</p>	<p>Facing SE – TWS stockpiling and removing the unacceptable subgrade material from Cell 10.</p>

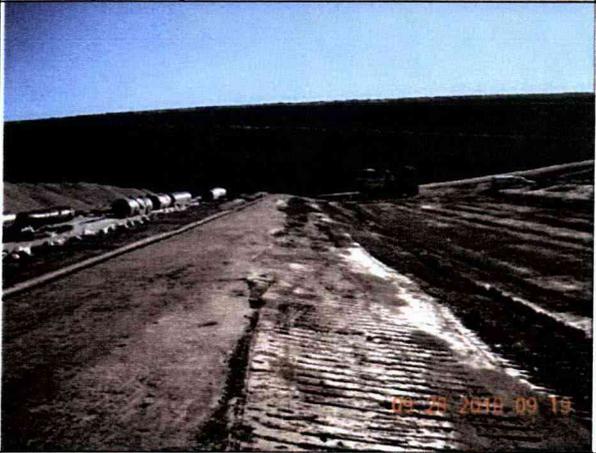
<p>Facing E – TWS preparing to place admix on the Cell 10 subgrade. The admix tie-in was moisture conditioned and abraded prior to admix placement.</p>

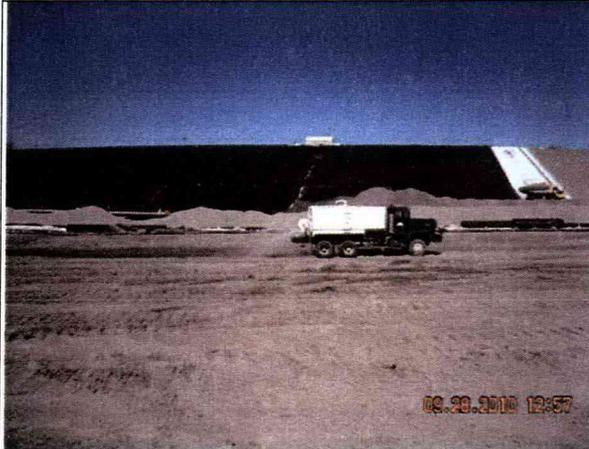
Facing N – TWS moisture conditioning the exposed dry admix in Cell 10.

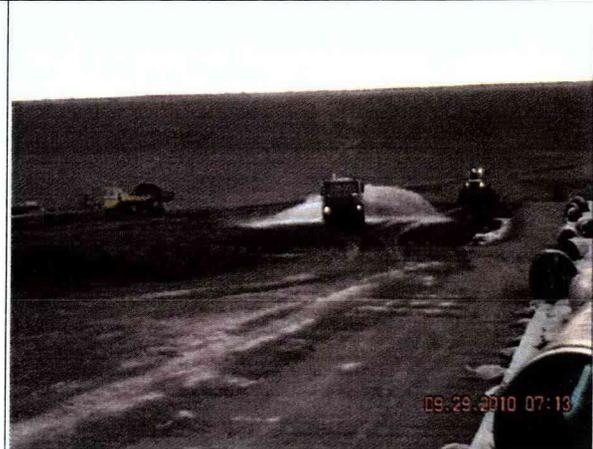
Facing E – TWS moisture conditioning and reworking the admix surface prior to admix placement.

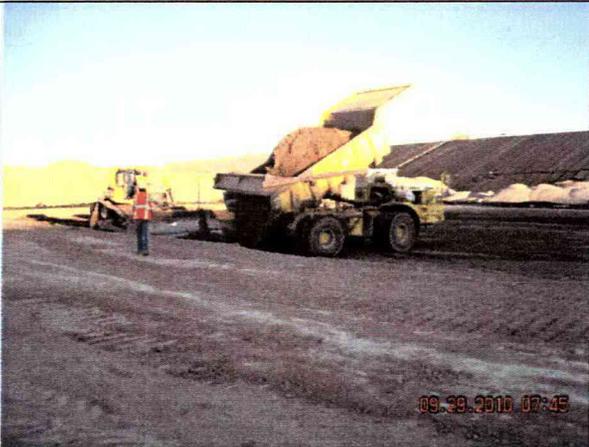
Facing NW – TWS placing admix on the Cell 10 subgrade.

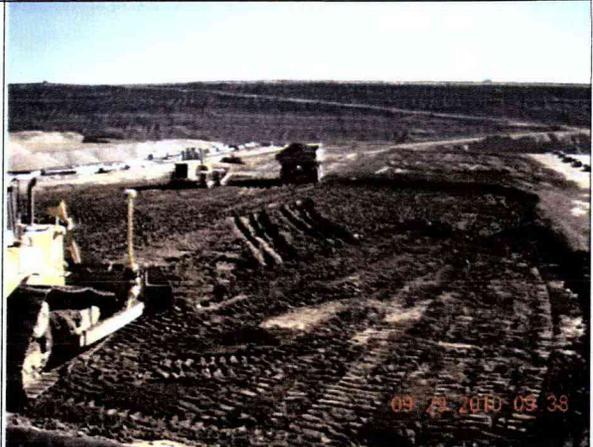
Facing E – TWS placing, spreading, and compacting admix in Cell 10.

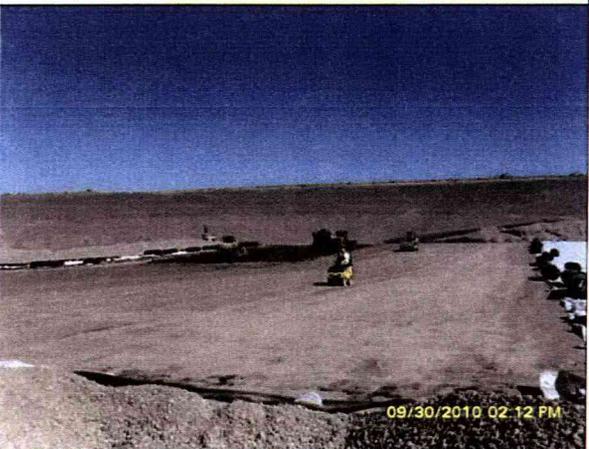
Facing NE – TWS placing and compacting admix in Cell 10, while two (2) smooth drum rollers finished the 6th lift of admix.

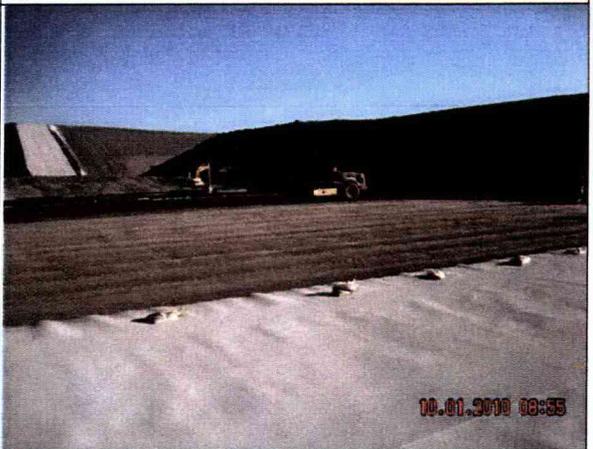
Facing NE – TWS completing the final proof rolling of the last of the admix in Cell 10.

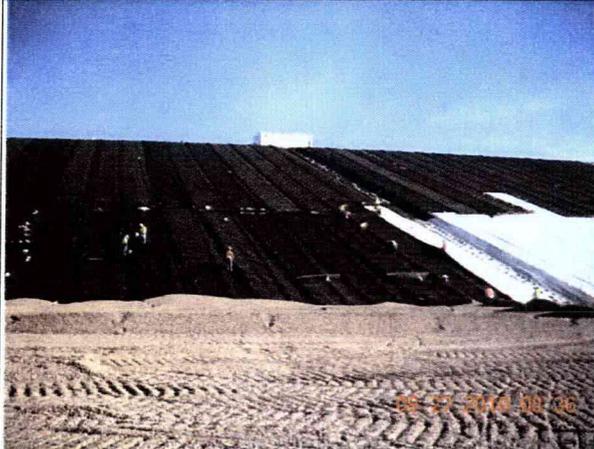
Facing N – ESI placing and joining the primary geocomposite on the north slope of Cell 10.

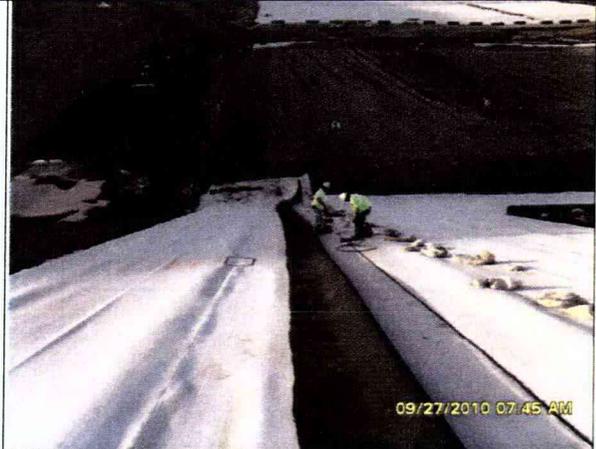
Facing S – ESI performing vacuum testing on the rain flap detail in Cell 10.

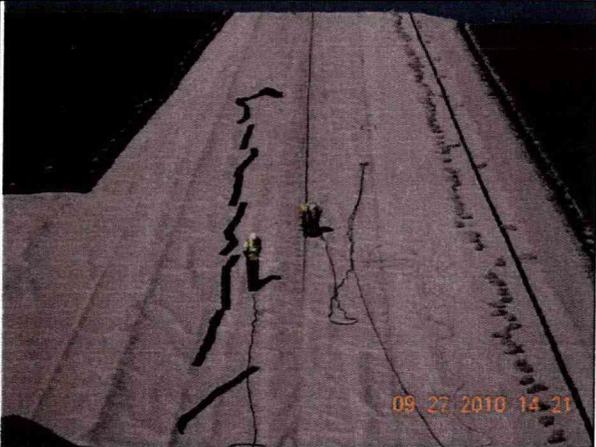
Facing N – ESI performing the primary to secondary weld for the rain flap on the north slope of Cell 10.

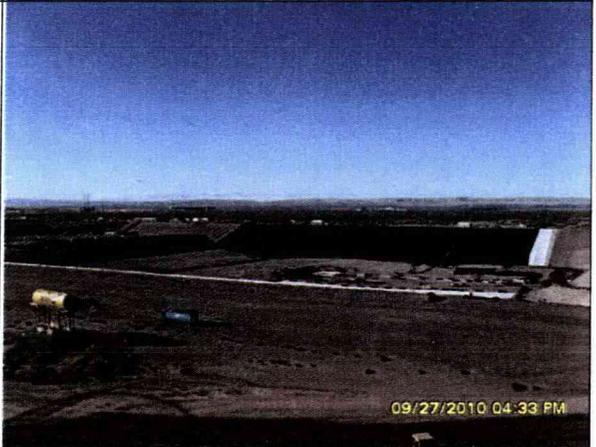
Facing N – ESI completes placement of primary geocomposite west of the Cell 10 rain flap.

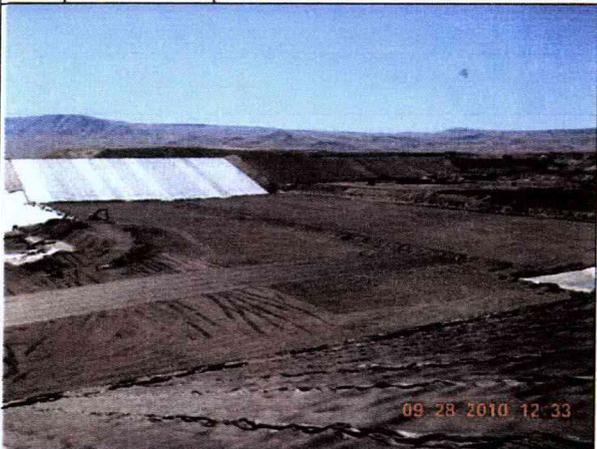
Facing SW – ESI deploying 8 oz. geotextile in Cells 9 and 10.

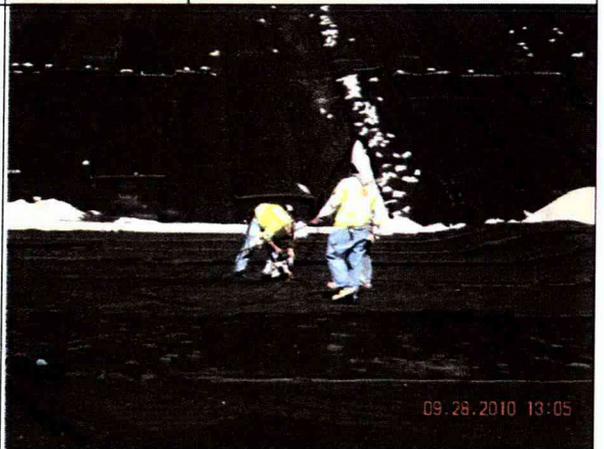
Facing N – ESI sewing the deployed 8 oz. geotextile in Cell 9.

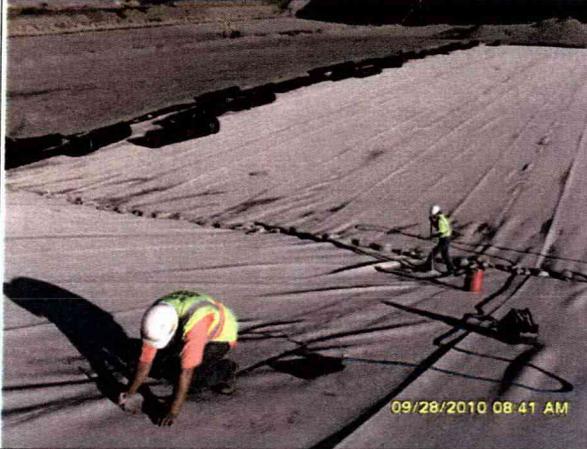
Facing NW – ESI conducting vacuum testing on the secondary geomembrane on the south slope of Cell 10.

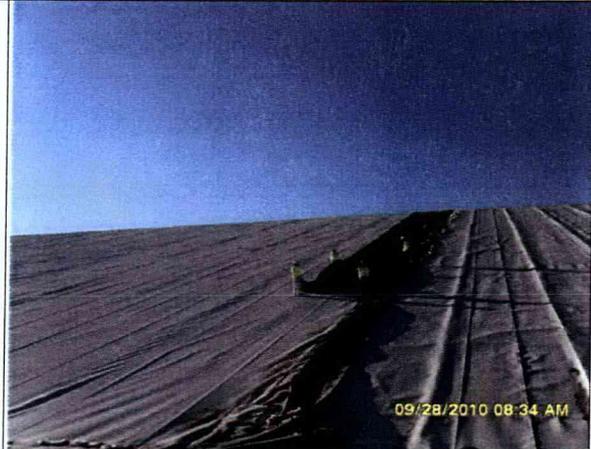
Facing E – ESI deploying secondary geocomposite on the south slope of Cell 10 at the Cell 9/10 tie-in.

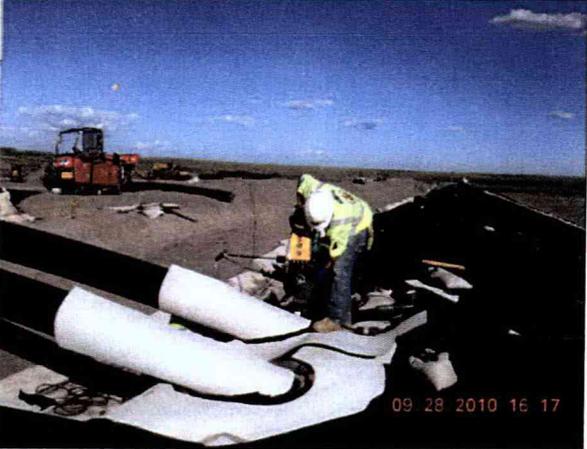
Facing E – ESI welding the pipe boot and sock for the secondary leachate riser pipes in Cell 10.

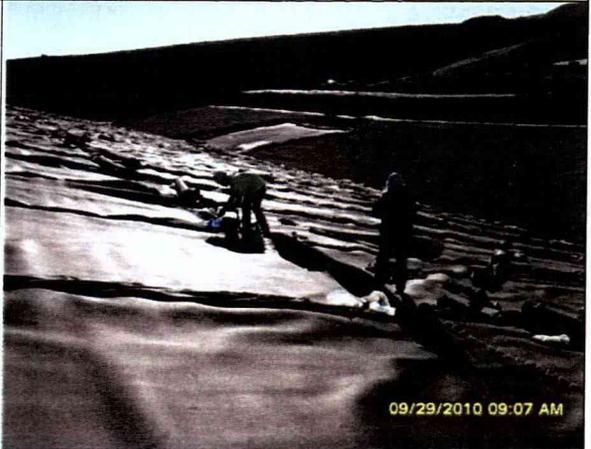
Facing SE – ESI joining the butt seams of the primary geocomposite in Cell 9 with plastic zip ties.

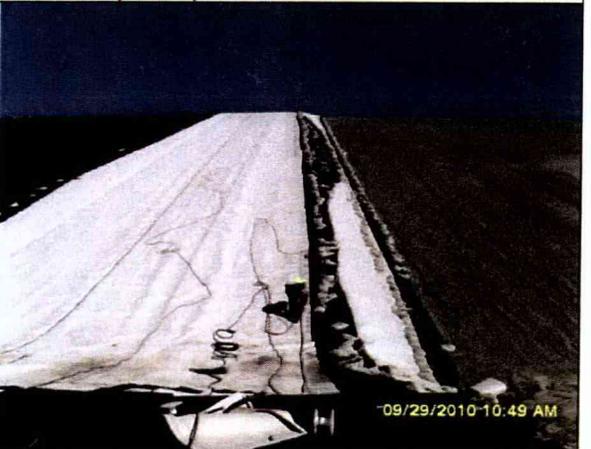
Facing N – ESI welding the primary to secondary geomembrane weld to the east side of the Cell 10 rain flap.

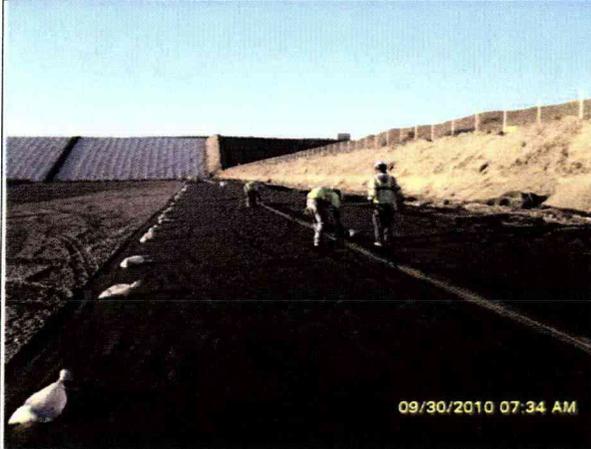
Facing S – ESI sewing the 8 oz. geotextile on the floor of Cell 9.

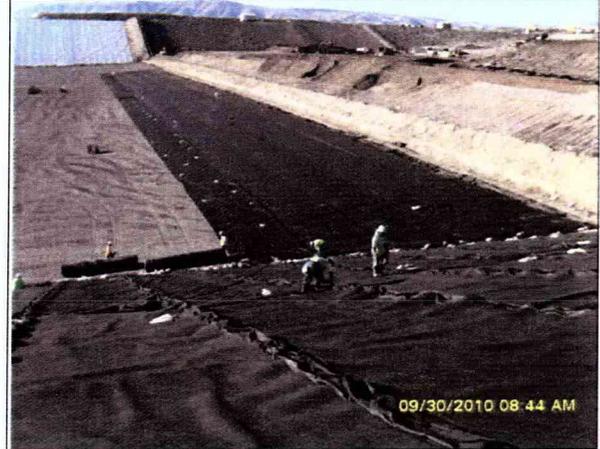
Facing SE – ESI deploying geotextile on the floor of Cell 9, while a crew joins the butt seams of the geomcomposite together with zip ties.

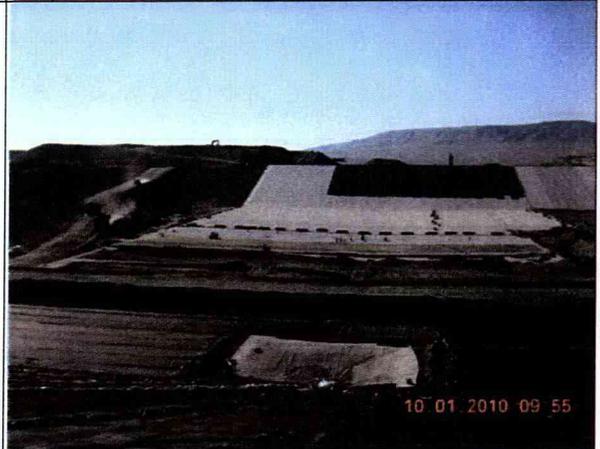
Facing S – ESI deploying geomembrane in the center of Cell 10.

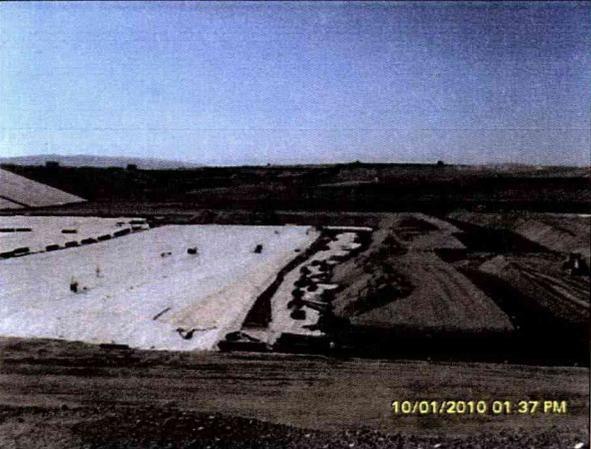
Facing W – ESI completing geomembrane deployment in the center of Cell 10.

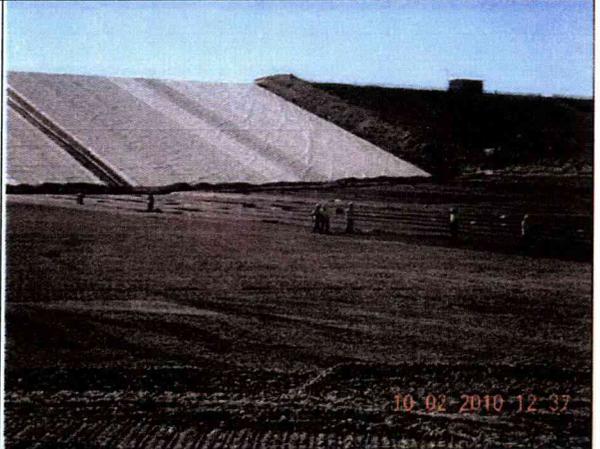
Facing SW – ESI deploying and sewing the 8 oz. geotextile on the floor of Cell 9.

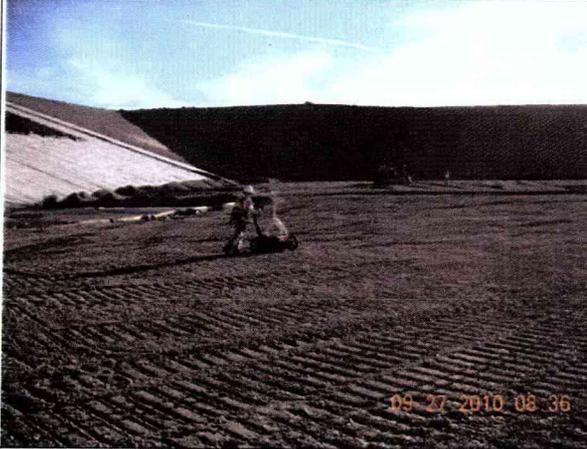
Facing NE – WCH utilizing ground penetrating radar to survey the admix under the north east gravel haul road.

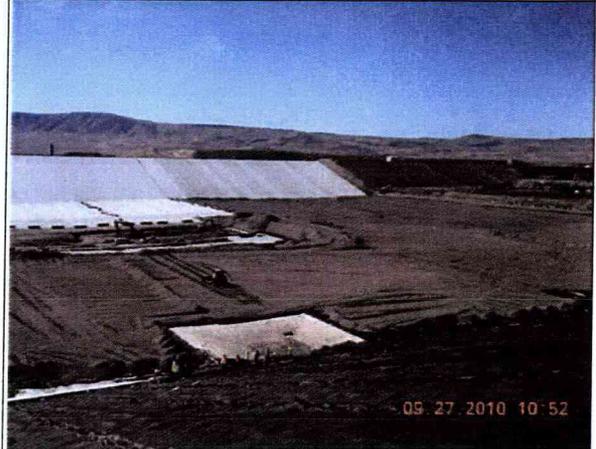
Facing SW – TWS grading the drainage gravel on the south half of the Cell 10 floor.

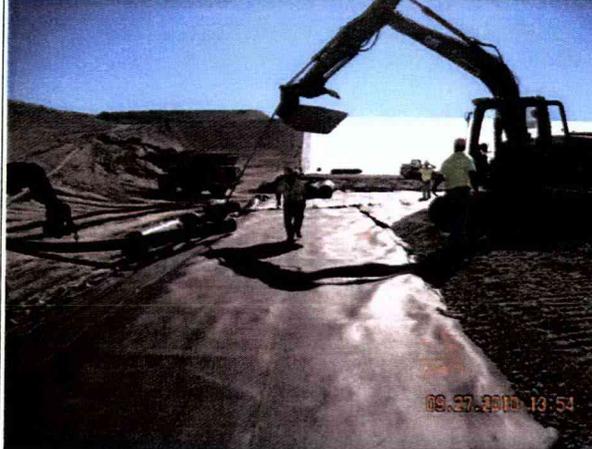
Facing S – ESI bringing the leachate collection pipe into Cell 10.

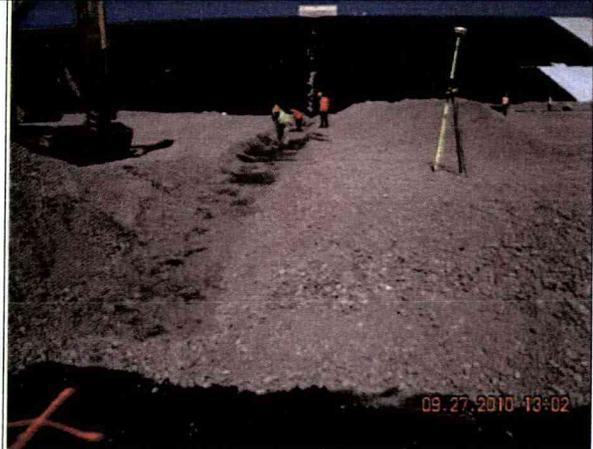
Facing NW – TWS utilizing hand shovels to remove the drainage gravel to place the primary leachate collection pipe.

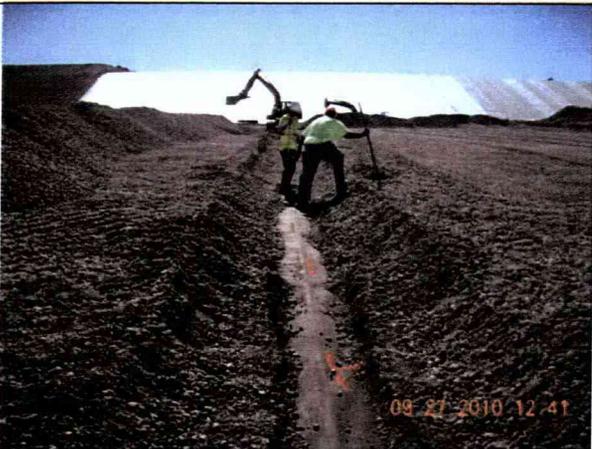
Facing S – ESI removing the drainage gravel from the south half of the Cell 10 floor for the placement of the leachate collection pipe.

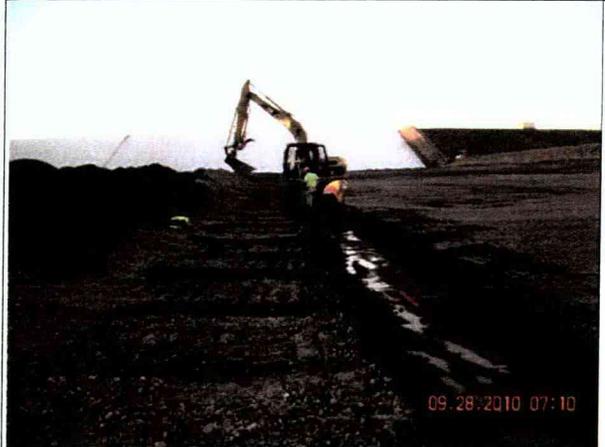
Facing S – ESI excavating the primary drainage gravel for the Cell 9 leachate collection pipe.

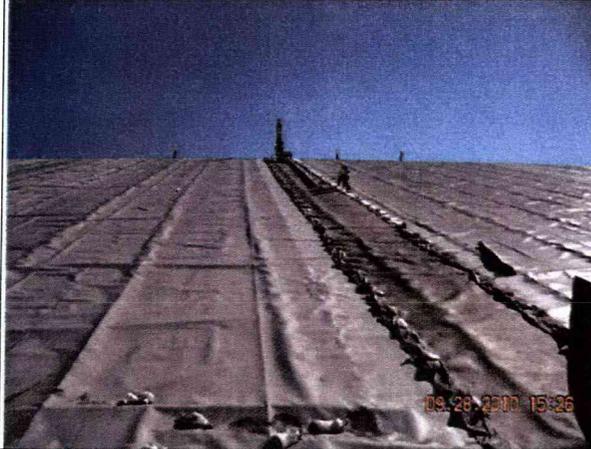
Facing S – TWS bringing the leachate collection pipe down the south slope of Cell 9.

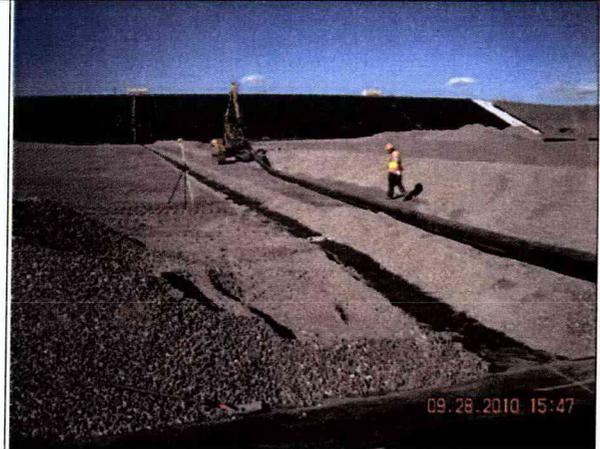
Facing NE – TWS walking the Cell 10 leachate collection pipe across the Cell 9 floor.

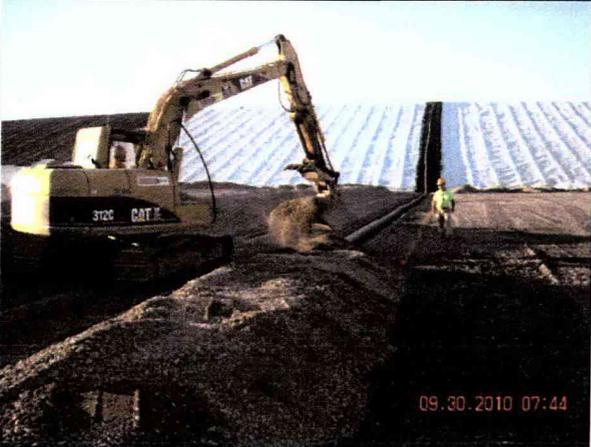
Facing S – TWS constructing the 1-ft high berm over the leachate collection pipe in Cell 9. The clean out riser pipe rests on the south berm of Cell 9.

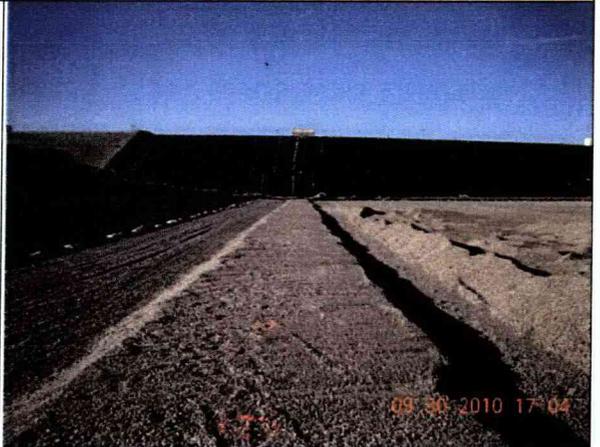
Facing N – The completed leachate collection pipe berm bisecting Cell 9.

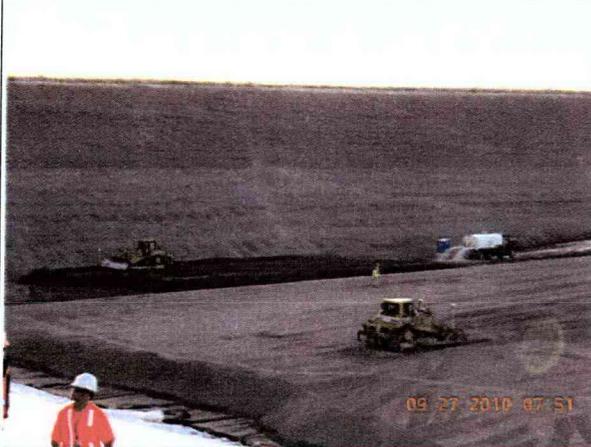
Facing SE – TWS building up the operations soil ramp, while a dozer grades the primary gravel in Cell 10.

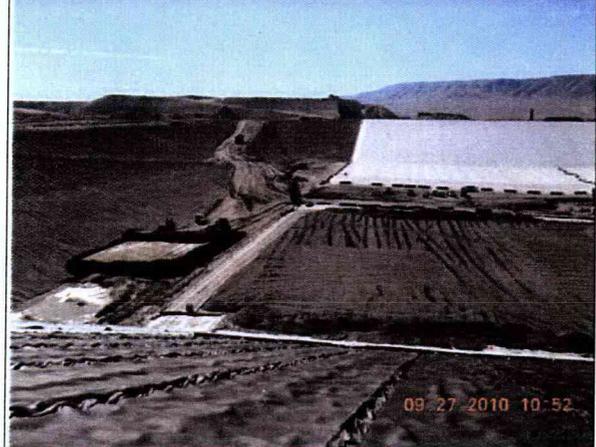
Facing S – TWS constructing the operations soil ramp into Cell 10.

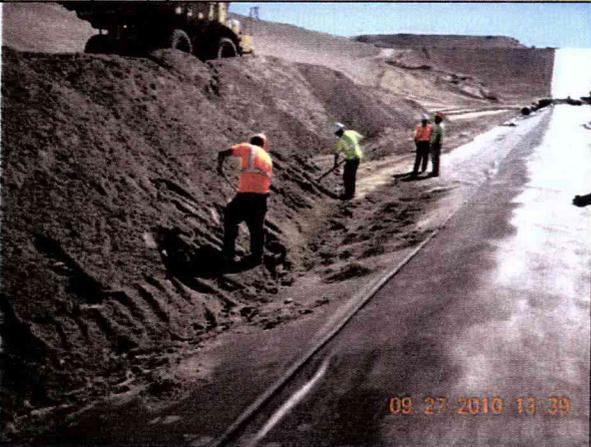
Facing SE – TWS utilizing hand equipment to place operations soil over the Cell 10 tie-in to anchor the leading edge of the geotextile.

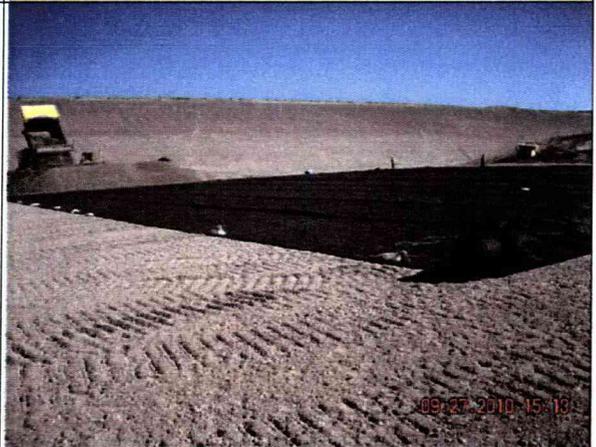
Facing SE – TWS placing operations soil into Cell 10.

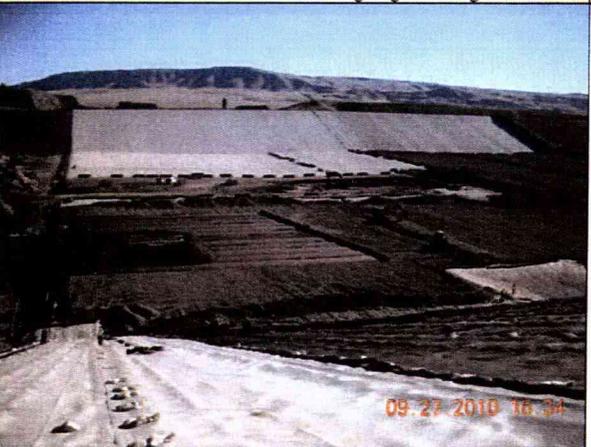
Facing S – TWS constructing a 9-ft high operations soil haul road east to west across Cell 10.

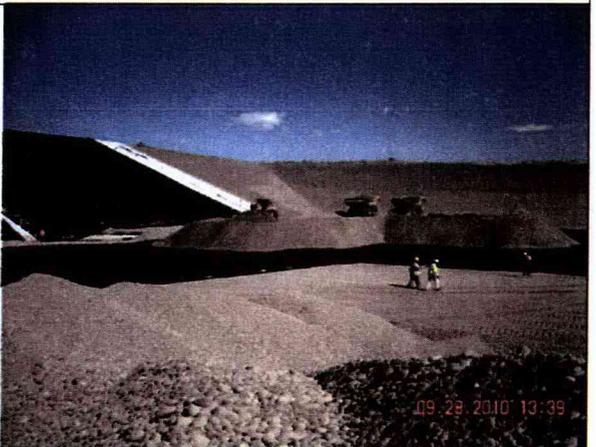
Facing NE – TWS continuing to place a 9ft high operations soil haul road across Cell 10.

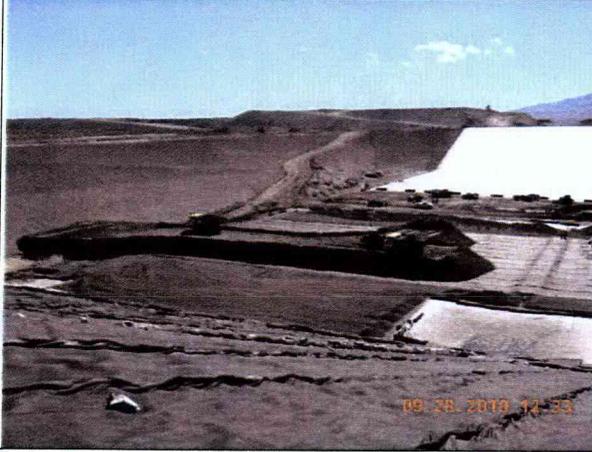
Facing SE – TWS placing a 9ft high operations soil haul road across Cell 10.
