TANK 4 AND LEACHATE TRANSMISSION SYSTEM REPORT
CONSTRUCTION QUALITY ASSURANCE (CQA)

CQA PHOTOGRAPH LOG WEEK 22
(7/6/10 TO 7/9/10)

ERDF CONSTRUCTION CELLS 9-10

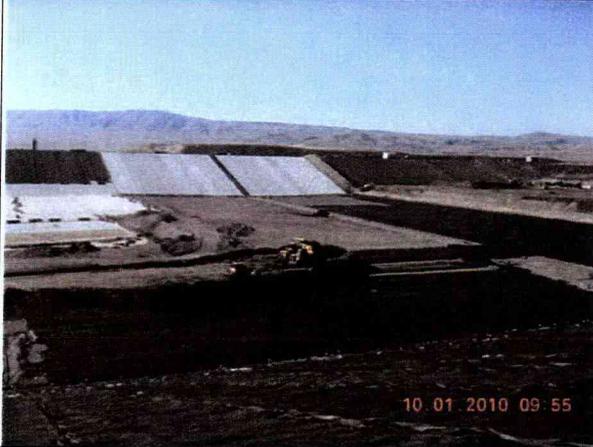
Facing SW – TWS placing a 9ft high operations soil haul road into Cell 9.

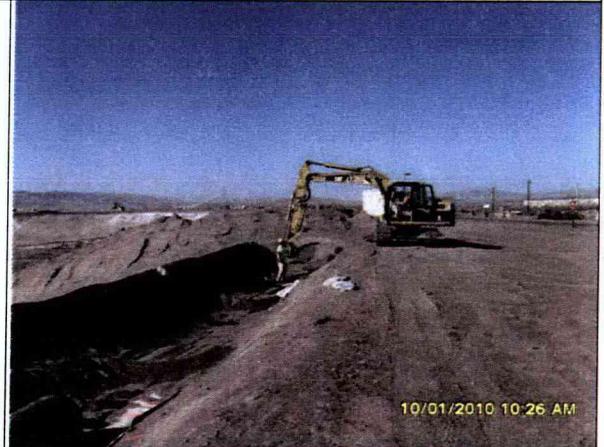
Facing W – TWS placing and compacting backfill soil into the Cell 9 anchor trench.

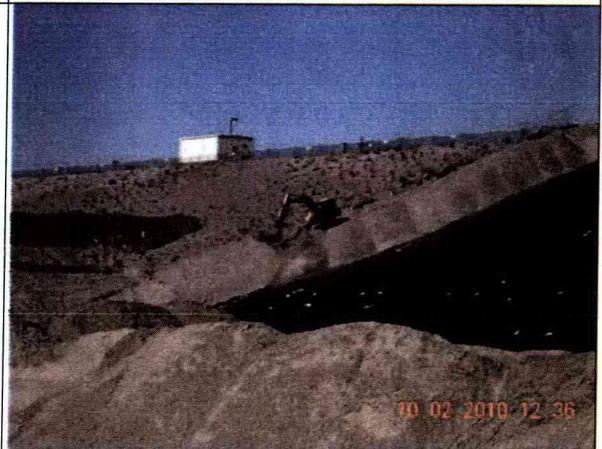
Facing NW – TWS placing operations soil onto the Cell 9 slope with a CAT 312 excavator.

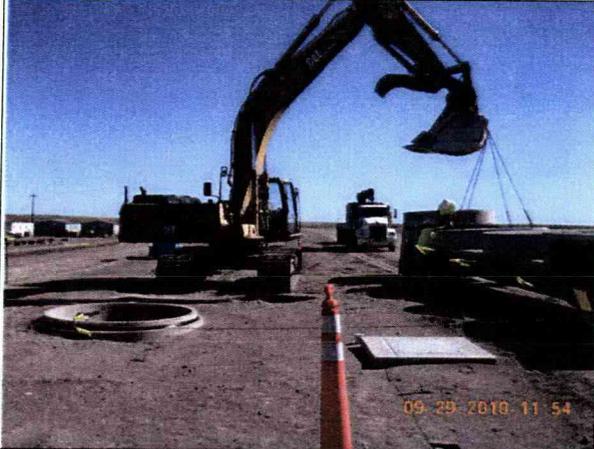
Facing E – TWS lifting the MH-33 lid into place.

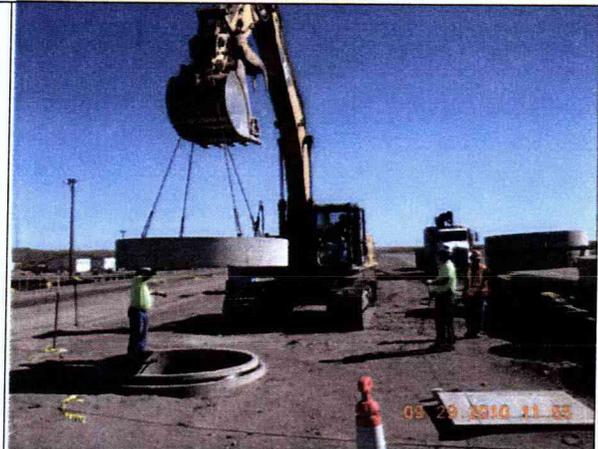
Facing E – TWS placing the lid onto MH-33.

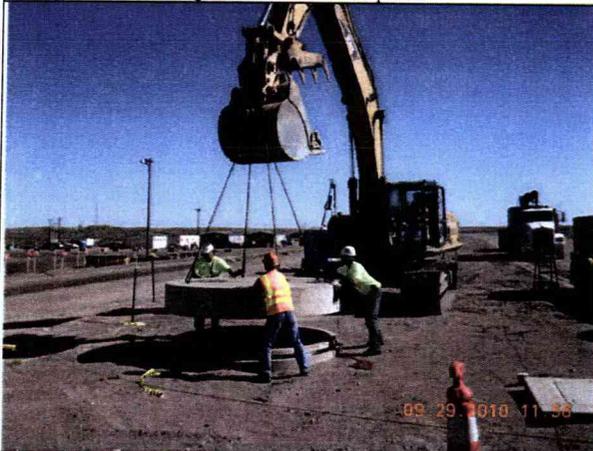
Facing – TWS and BMWC placing the lid over the rubber gasket and onto MH-33.

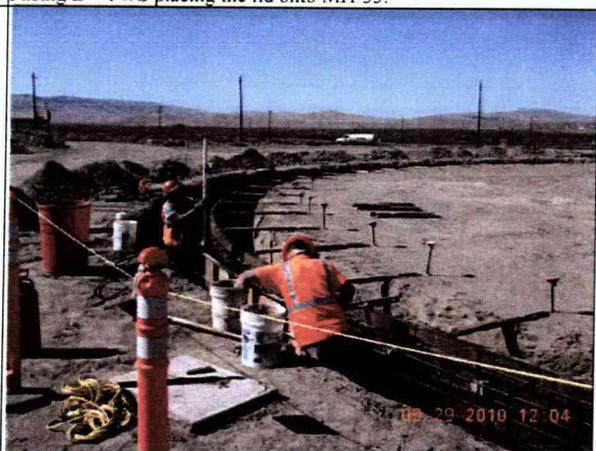
Facing W – TWS construction concrete forms around Tank #4.

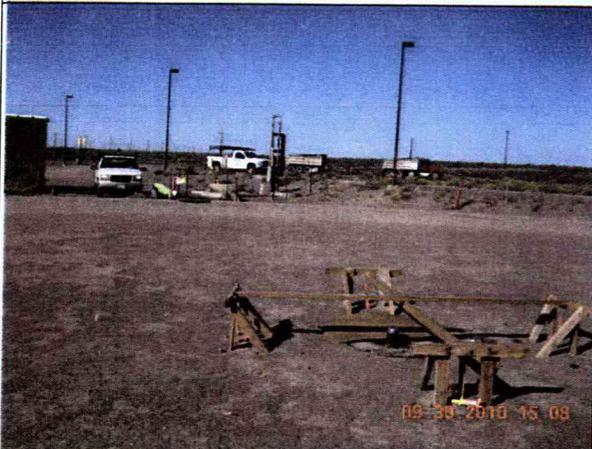
Facing N – BMWC placing the center connections for Tank 3, while installing the drain line manhole.

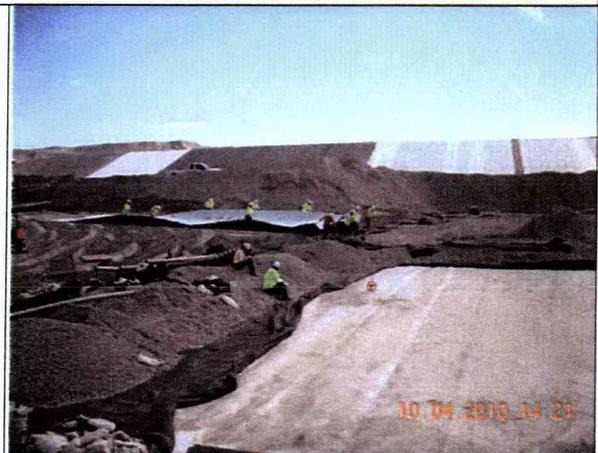
Facing S – ESI placing the 100-mill rub sheet in the Cell 9 sump.

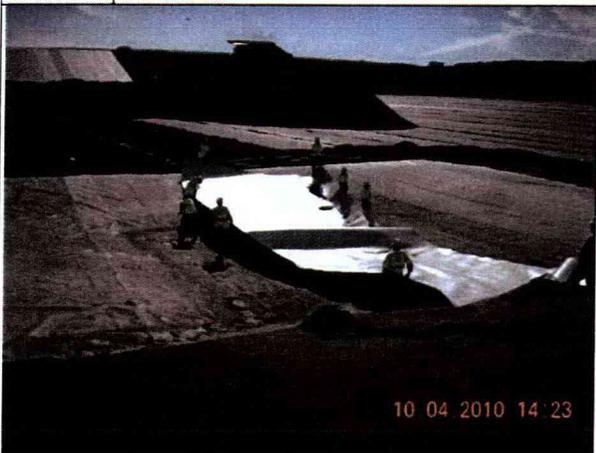
Facing SW – ESI placing the 100-mill rub sheet in the Cell 9 sump.

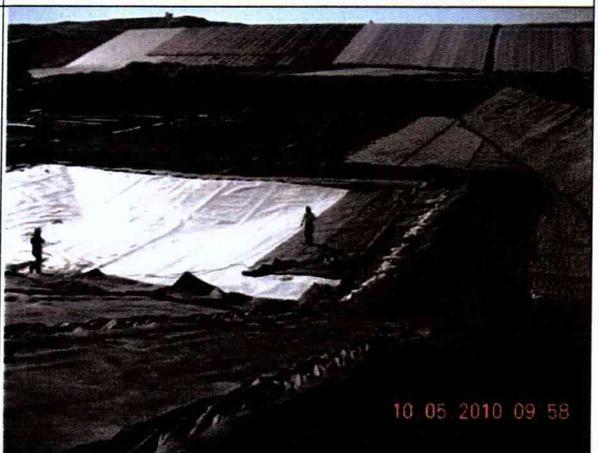
Facing SE – ESI placing the primary geotextile in the Cell 9 sump.

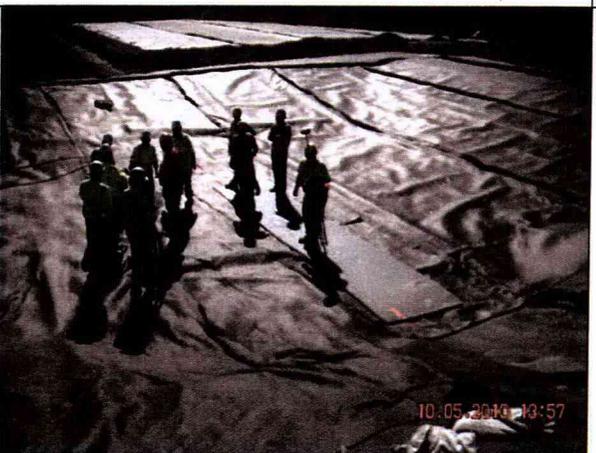
Facing SE – ESI and TWS placing the HDPE flat stock in the Cell 9 sump.

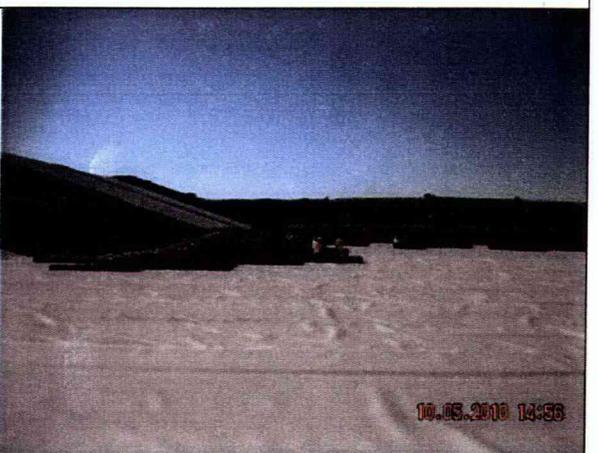
Facing W – ESI deploying secondary geocomposite on the north side of the Cell 10 floor.
