TANK 4 AND LEACHATE TRANSMISSION SYSTEM REPORT
CONSTRUCTION QUALITY ASSURANCE (CQA)

PHOTOLOG

ERDF CONSTRUCTION CELLS 9-10

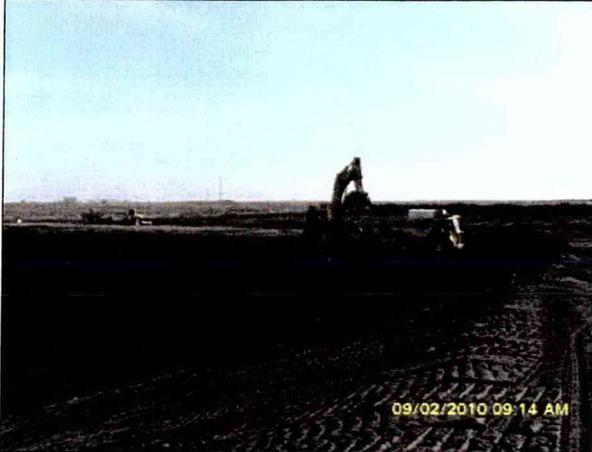
Facing E (2/10/10) – TWS excavating base soil from the Cell 10 footprint.

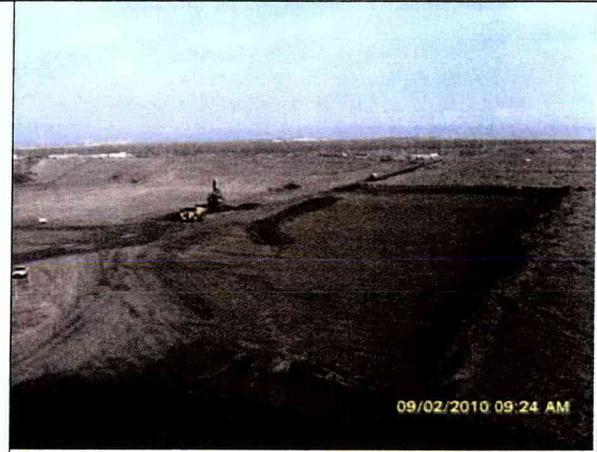
Facing NW (2/10/10) – TWS excavating base soil from the Cell 10 footprint.

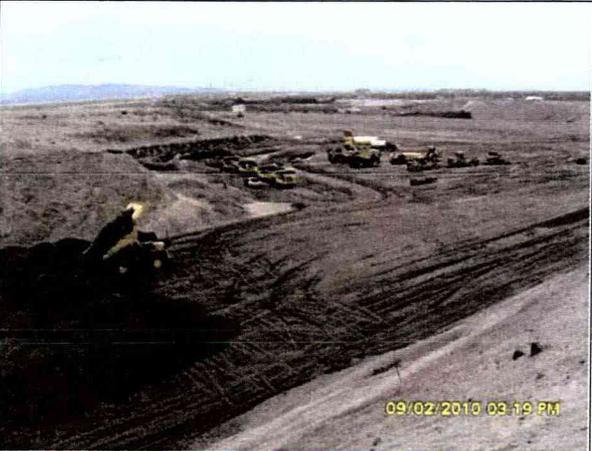
Facing NW (2/10/10) – TWS stockpiling base soil south of Cell 10.

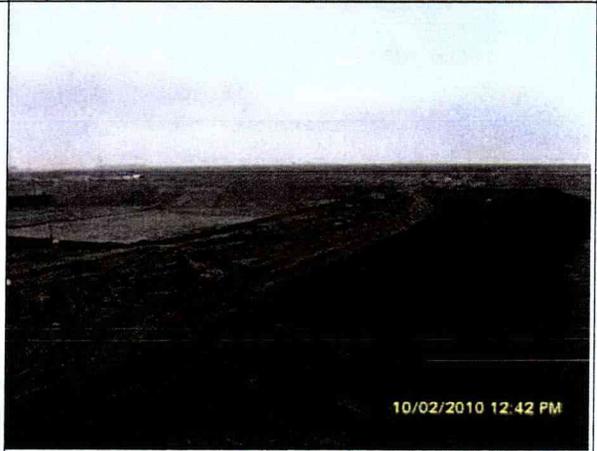
Facing NW (2/11/10) – TWS excavating base soil from the Cell 10 footprint.

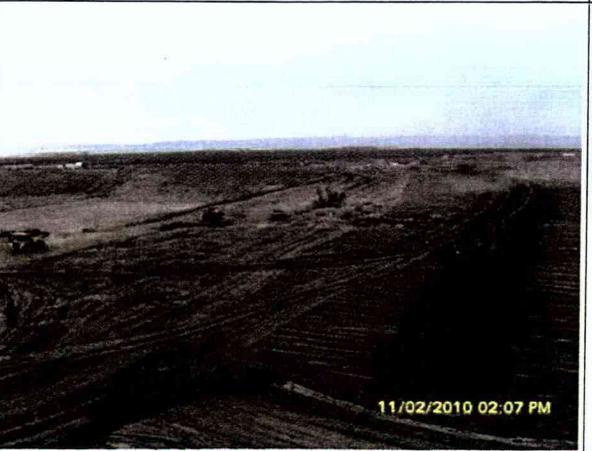
Facing NE (2/12/10) – TWS excavating base soil from the Cell 10 footprint.

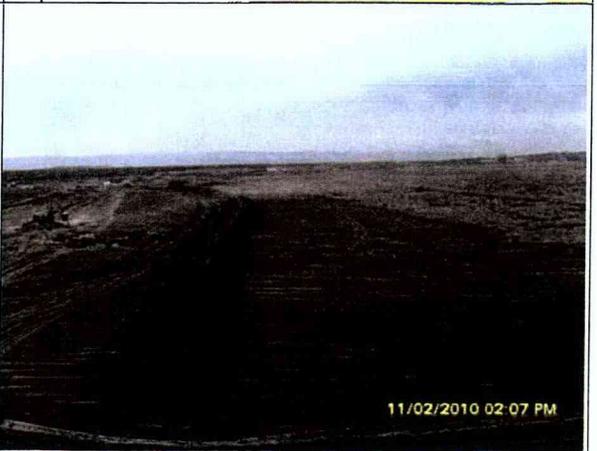
Facing NE (2/12/10) – TWS excavating base soil from the Cell 10 footprint.

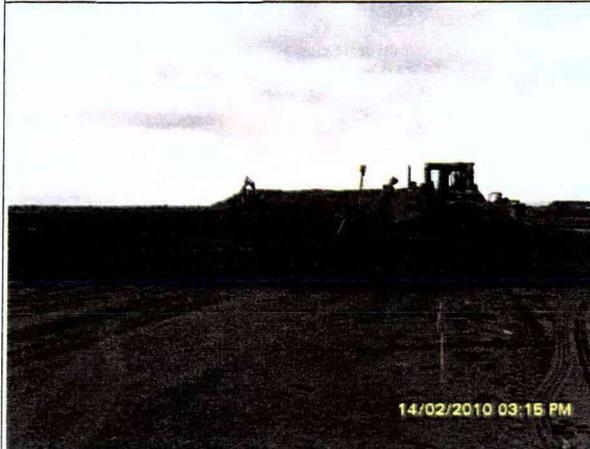
Facing S (2/15/10) – TWS scarifying the subgrade on the north berm with a CAT D6R.

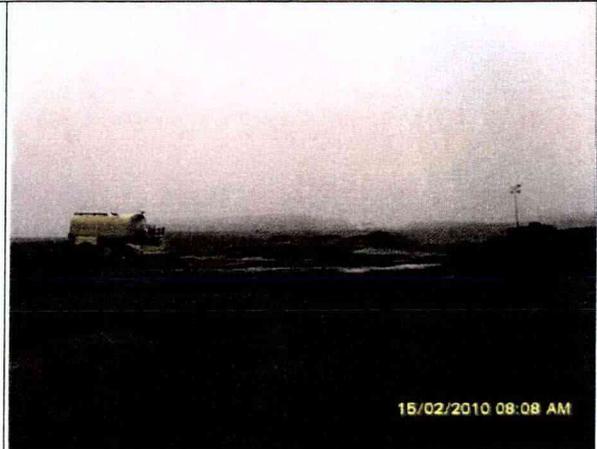
Facing E (2/16/10) – TWS recompacting the subgrade on the north berm with the payhauler water truck.

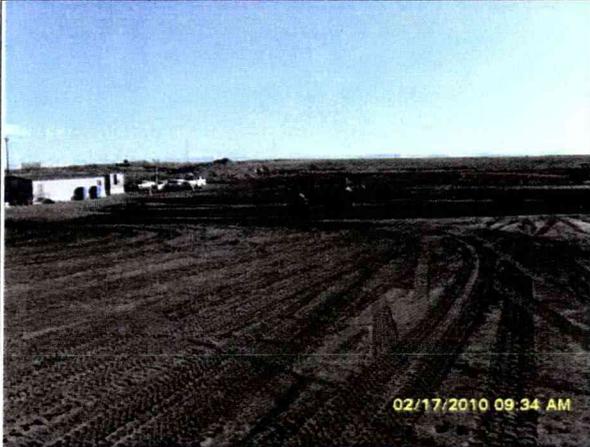
Facing E – TWS placing lift 1 of the Cell 10 north embankment.

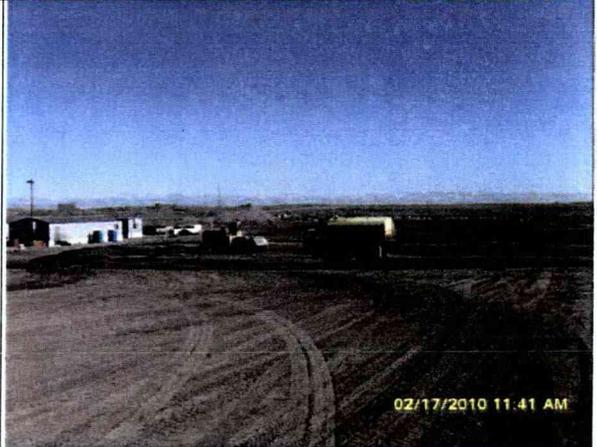
Facing E – TWS compacting the first lift on the north embankment with the payhauler water truck.

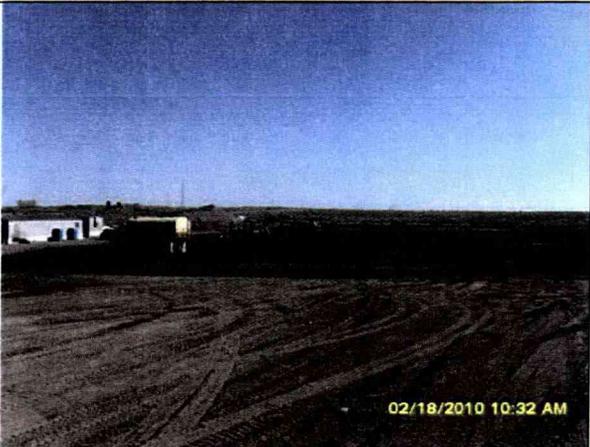
Facing E – TWS moisture conditioning and placing lift 2 on the north embankment.

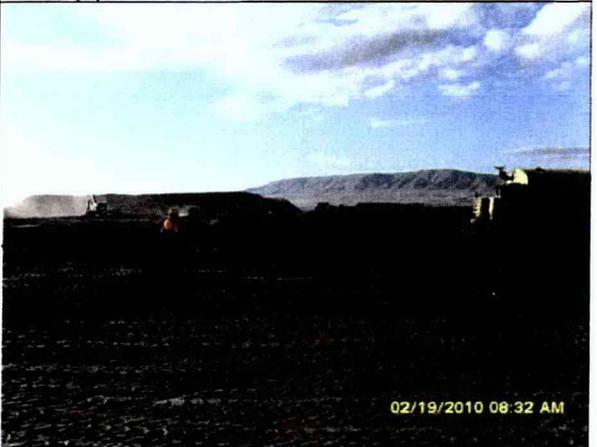
Facing S – TWS moisture conditioning and compacting lift 2 on the north berm.

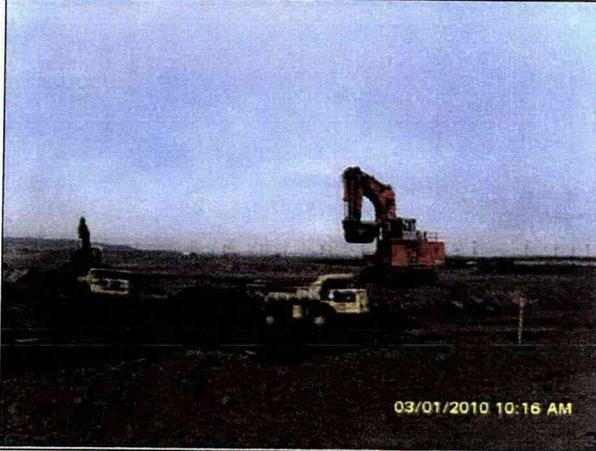
Facing NW – TWS utilizing the CAT 5110 and the Hitachi 1800 to excavate from Cell 10.

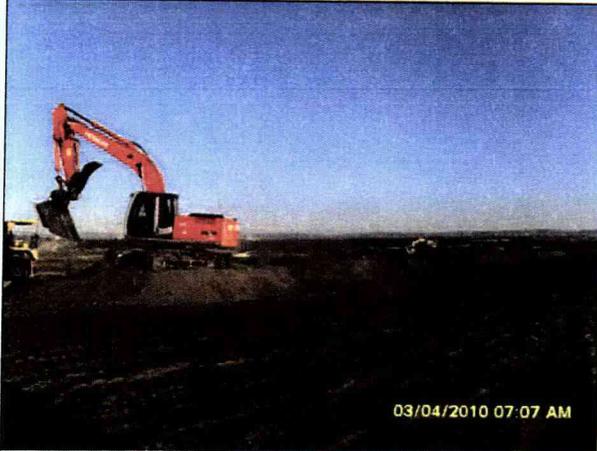
Facing NW – TWS utilizing a Hitachi 200 to build the Run on Control Berm along the east side of Cell 10

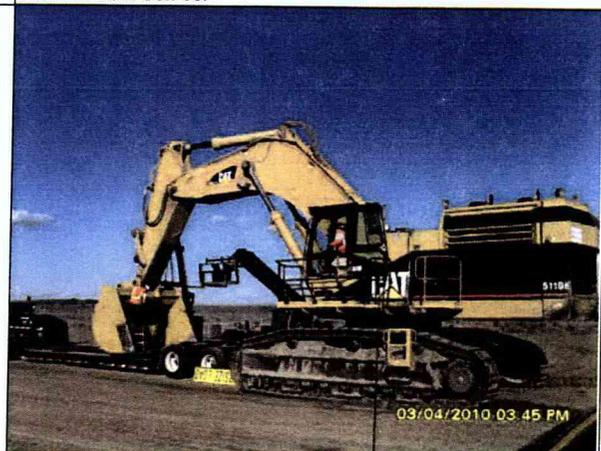
Facing NE – TWS replacing the bucket on the CAT 5110 with a 13-cy bucket.

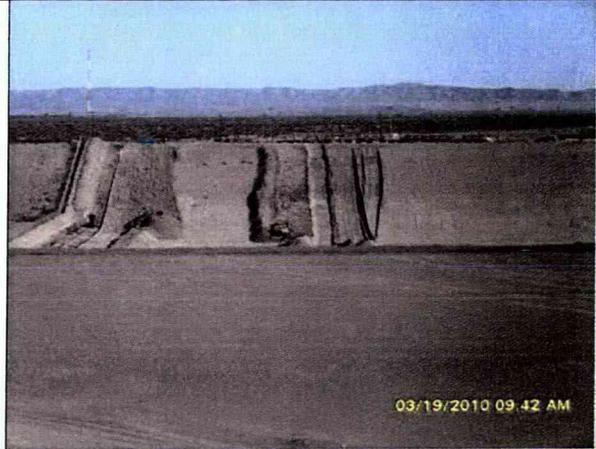
Facing N – TWS cutting the Cell 9 north embankment to grade.

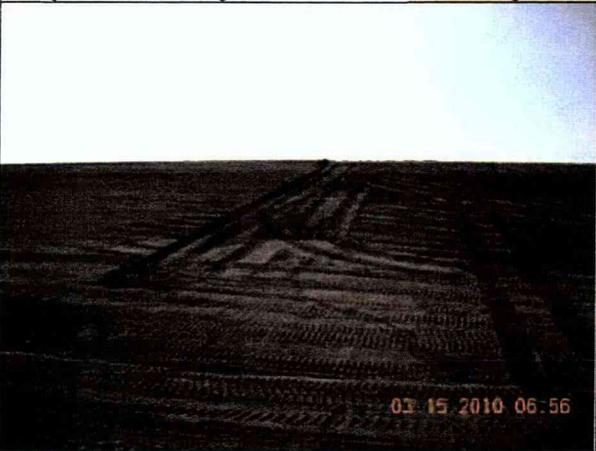
Facing S – A portion of the Cell 9 south embankment has been cut to grade.

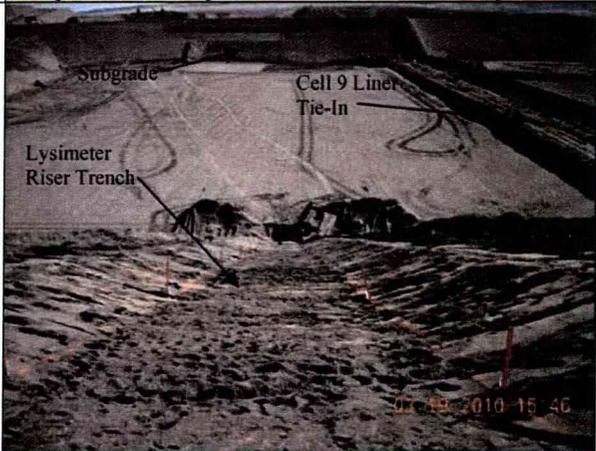
Facing S – Overview of Cell 9.

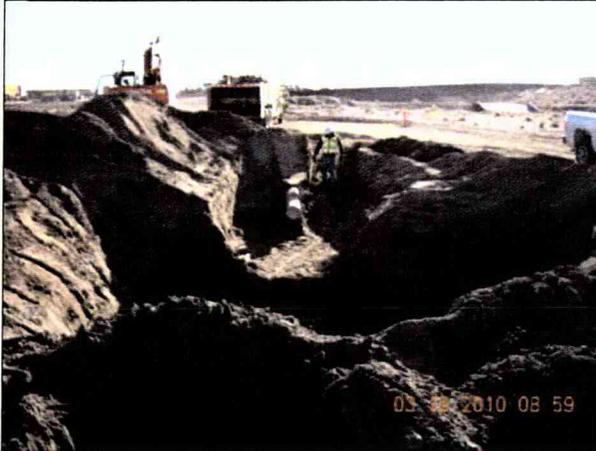
Facing SE - CQA inspecting the excavation for MH-21

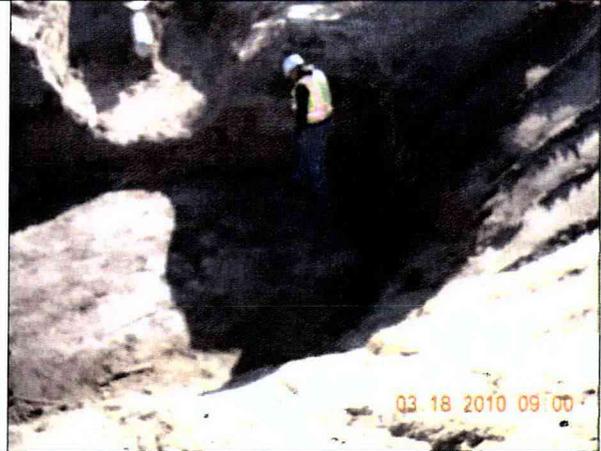
Facing SE - CQA inspecting the excavation for MH-21

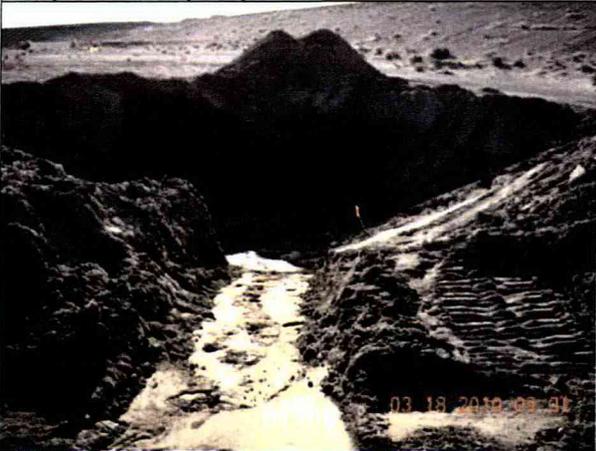
Facing SE - CQA inspecting the excavation for MH-39

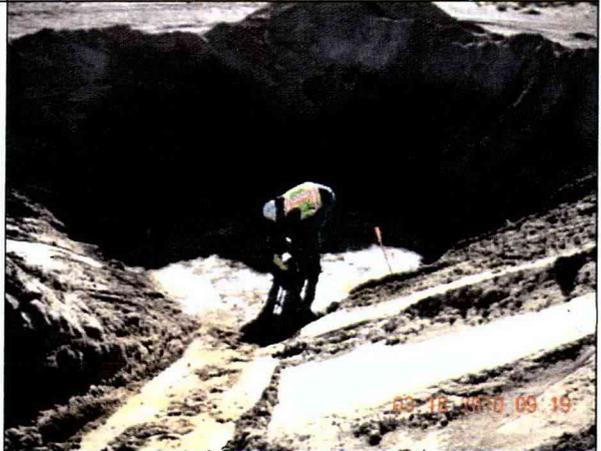
Facing SE - CQA inspecting the excavation for MH-39

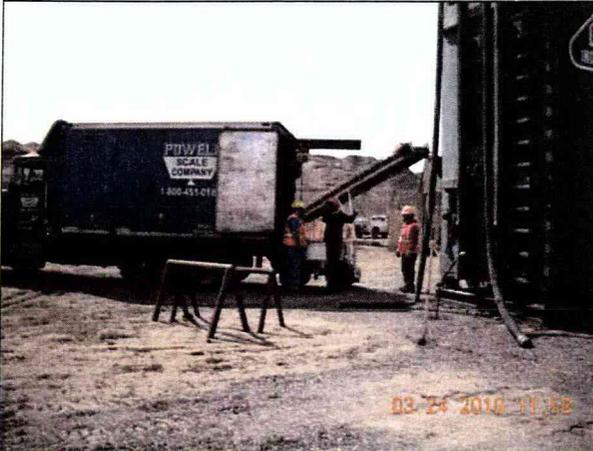
Powell Scale Co. calibrating the P19 (east) bentonite silo.

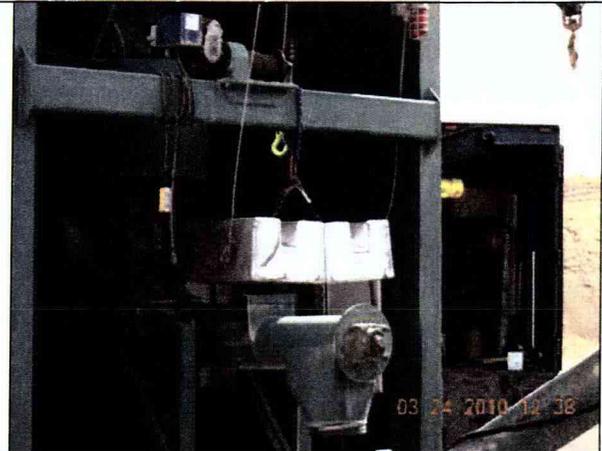
Calibration weights hanging from the P19 (east) silo

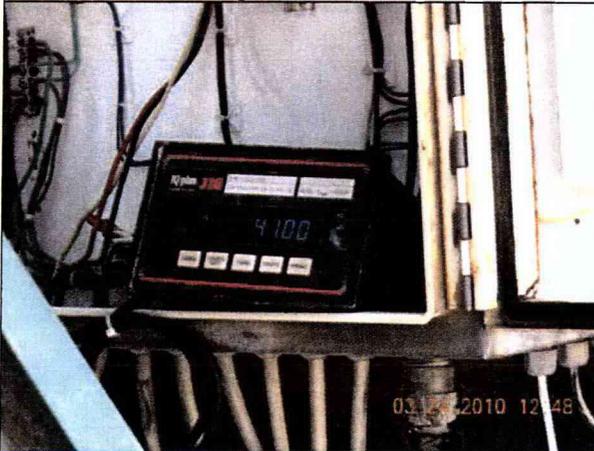
Bentonite silo P19 (east) scale calibration readout..

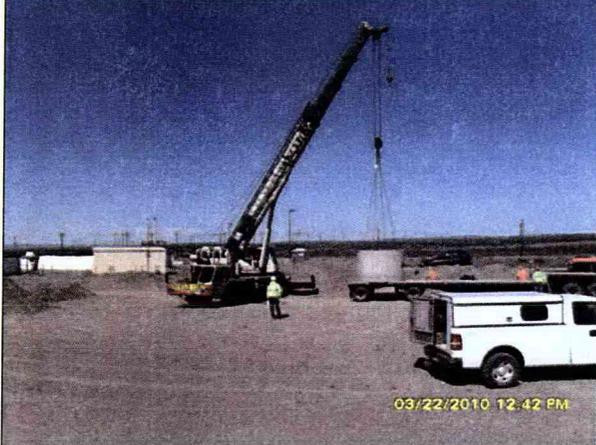
Facing NW – TWS preparing to set MH-21.

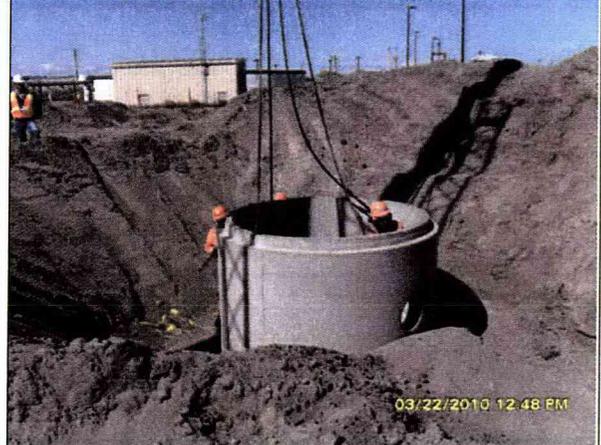
Facing NW – TWS placing MH-21.

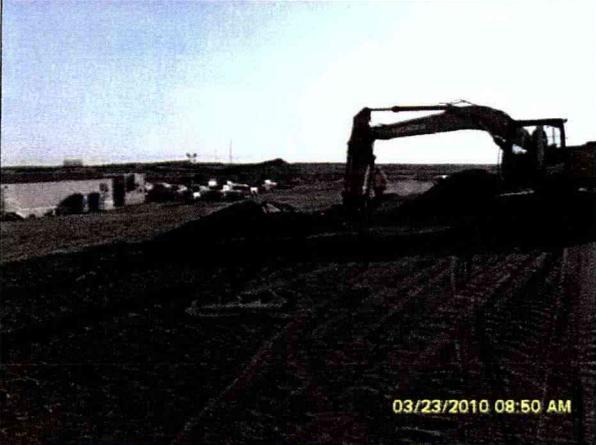
Facing E – TWS excavating MH-33

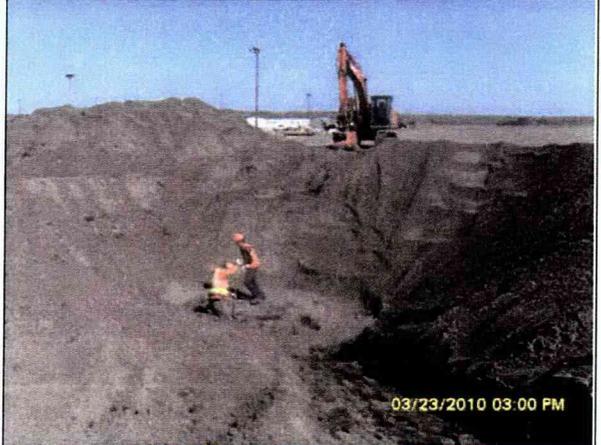
Facing E – TWS preparing the subgrade for MH-32

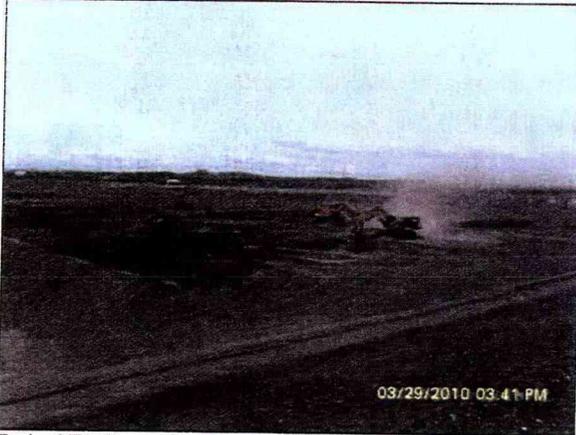
Facing NE - Excavation from Cell 10.

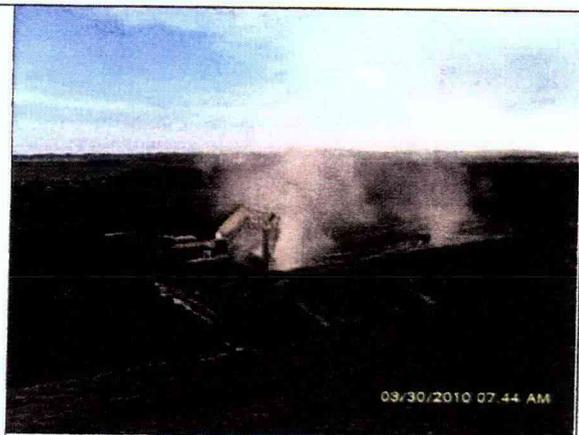
Facing NE - Excavation from Cell 10.

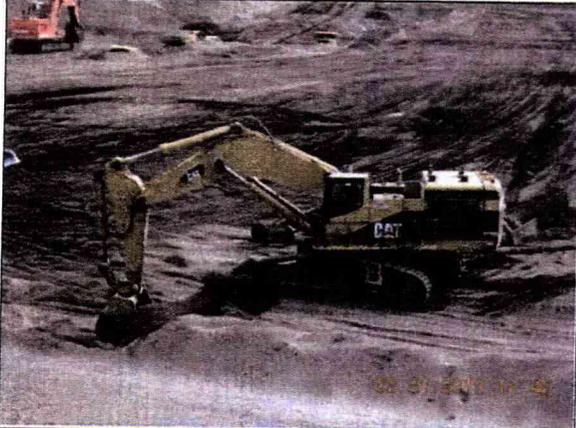
Facing S - The CAT 5110 excavating from Cell 10

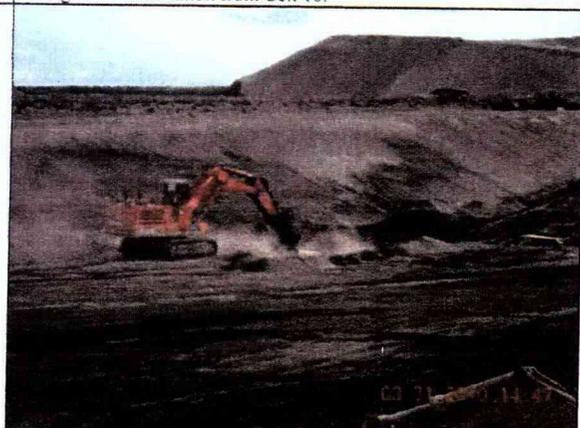
Facing SE - The Hitachi 1800 excavating from Cell 10.

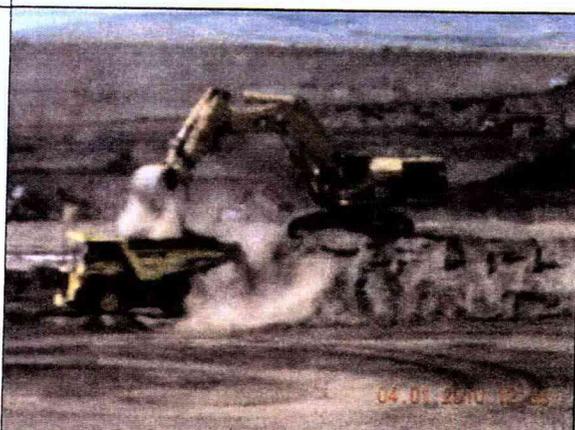
Facing W - The CAT 5110 excavating from Cell 10.

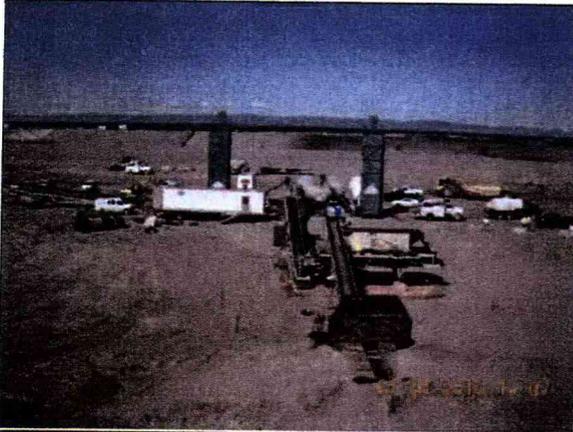
Facing N - Pugmill Setup

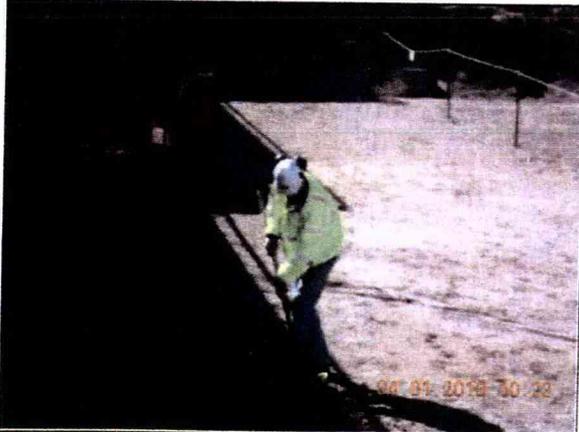
Facing S - TWS sampling the base soil for moisture content verification.

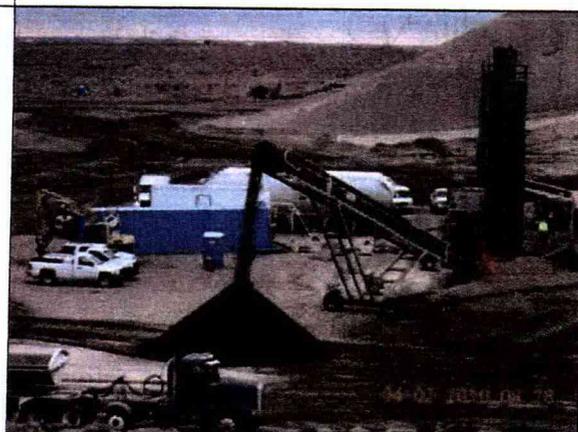
Facing E - TWS beginning admix production.

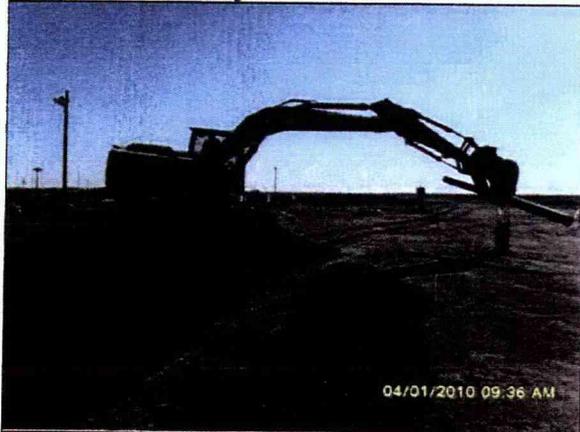
Facing E - TWS excavating for MH-34.

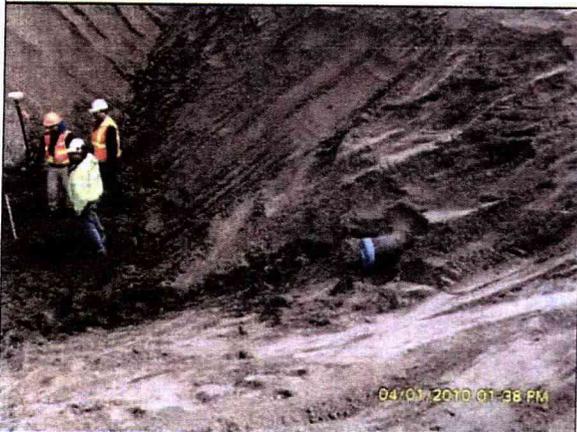
Excavation of MH-34. The fresh water discharge line from Cell 7 has been cut and capped.

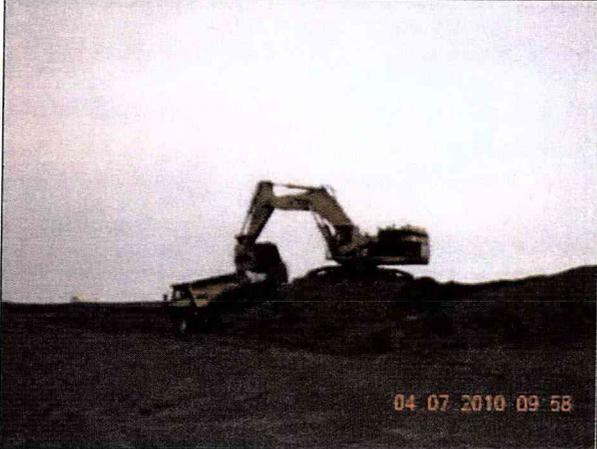
Facing E – TWS utilizing the CAT 5110 to excavate from Cell 10.

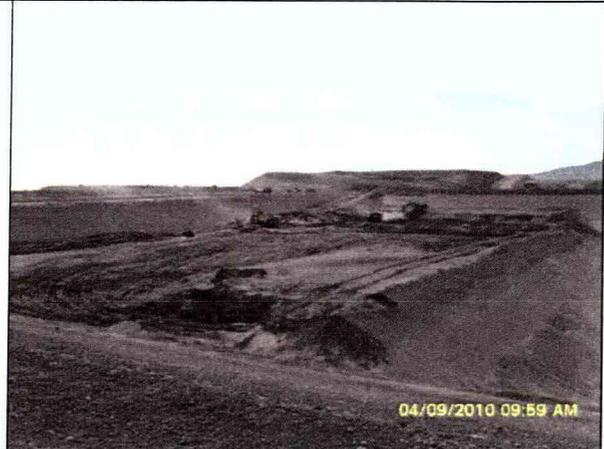
Facing SE – TWS excavating from Cell 10

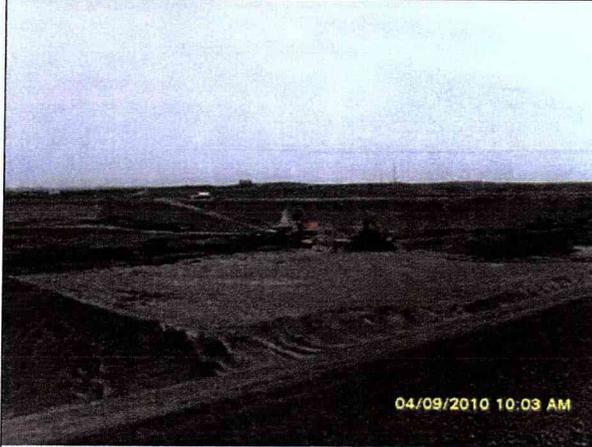
Facing NE – TWS excavating from Cell 10

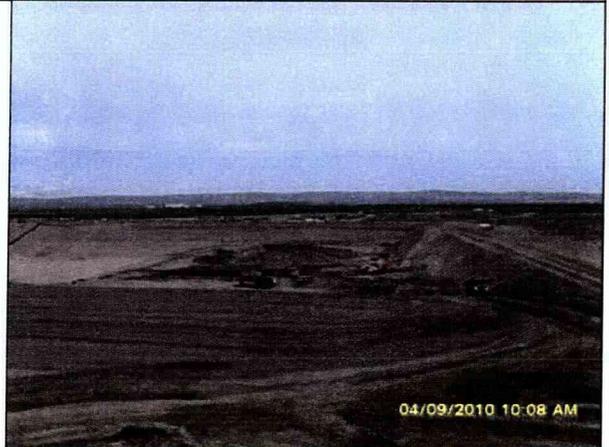
Facing N – TWS excavating from Cell 10

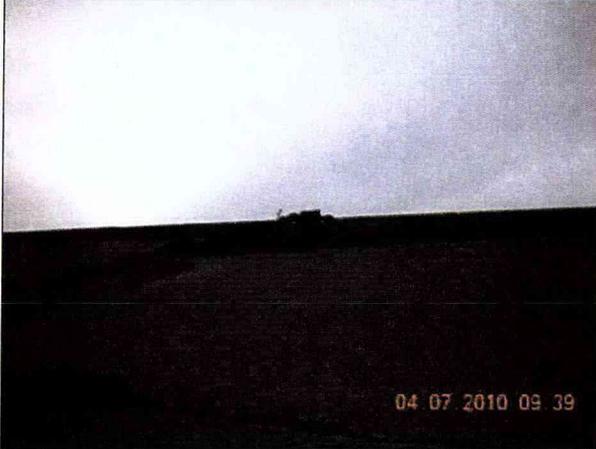
Facing S – TWS using the CAT D6 GPS dozer to cut the south interior slope of Cell 9 to grade.

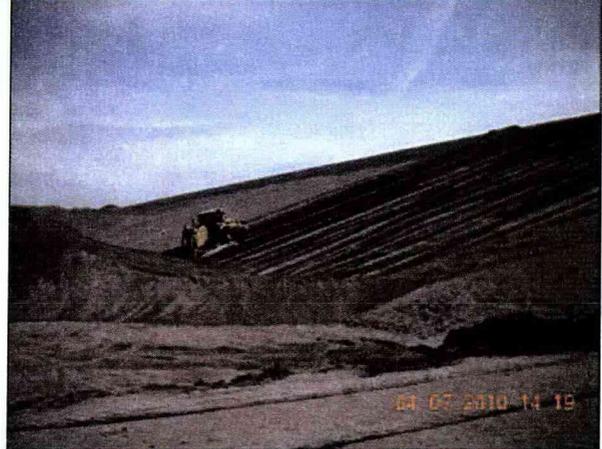
Facing SE – TWS using the CAT D6 GPS dozer to cut the south interior slope of Cell 9 to grade.

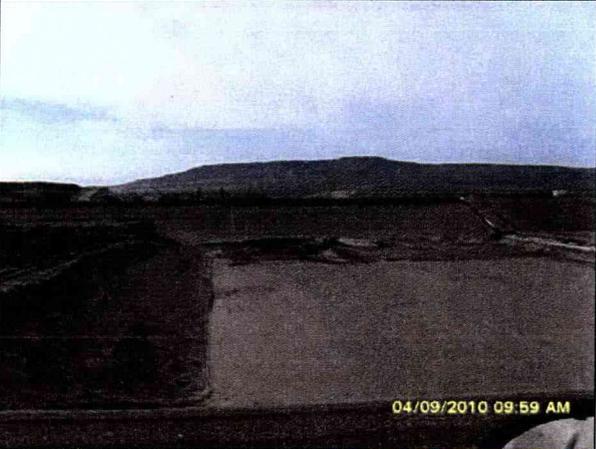
Facing S – TWS mucking out the clippings from Cell 9.

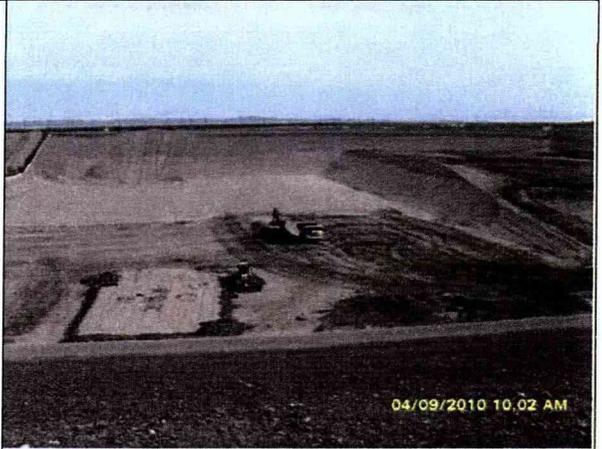
Facing N – TWS mucking out the clippings from Cell 9.

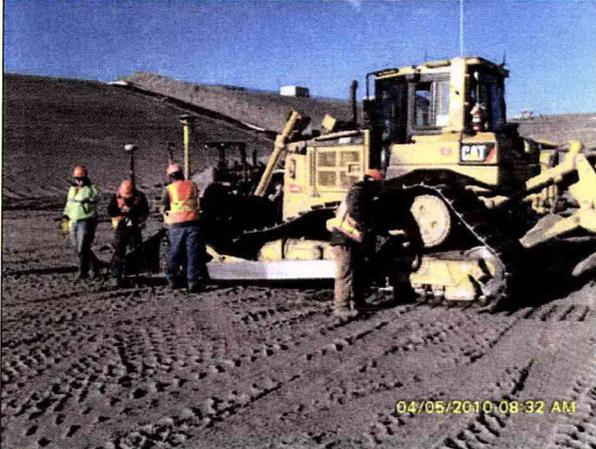
Facing W – TWS and CQA surveyors checking the GPS on the CAT D6 GPS dozer.

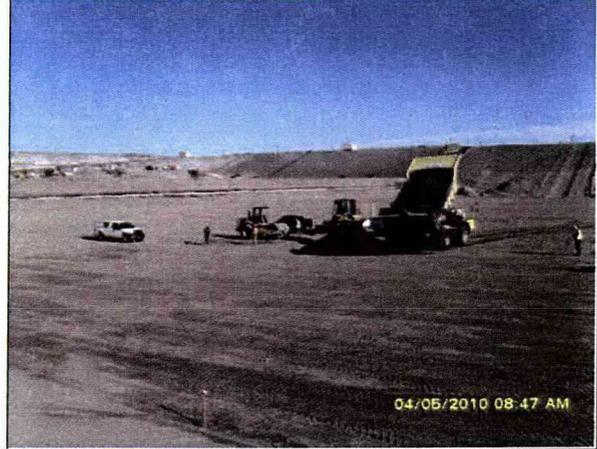
Facing NW – TWS placing the first of the admix for the testpad.

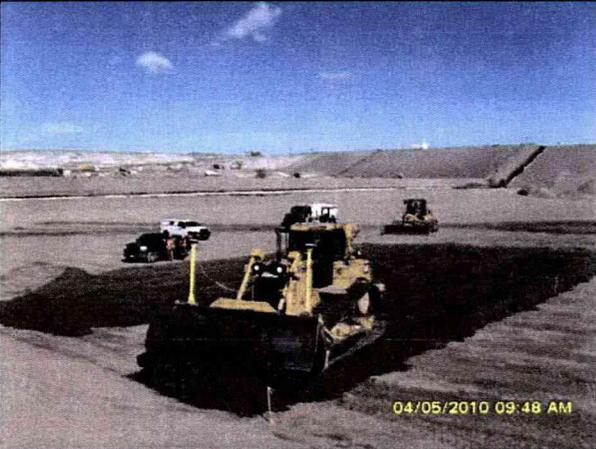
Facing NW – TWS using the CAT D6 GPS dozer to spread the first lift of admix for the test pad.

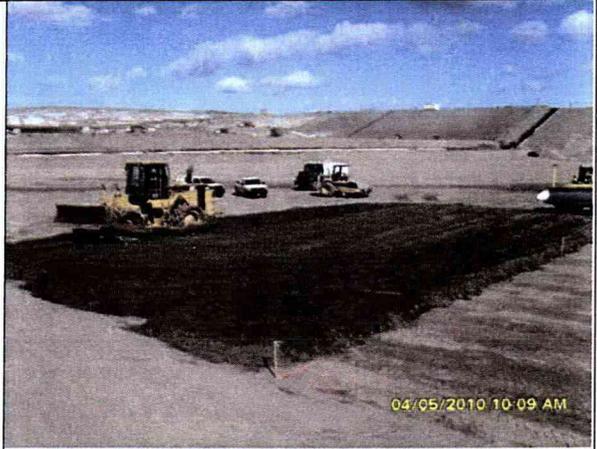
Facing NW – TWS using the CAT 825 compactor to compact the first lift of the test pad..

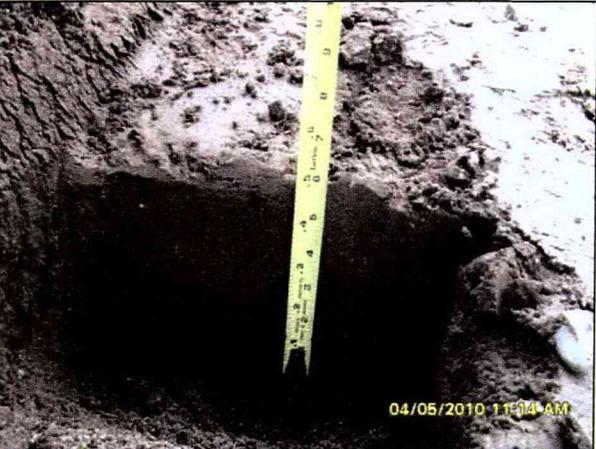
TWS measuring the thickness of the first lift.

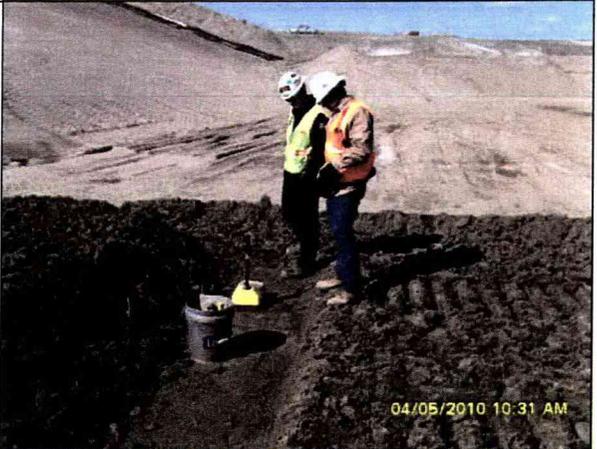
Facing W – CQA testing the density and moisture of the first lift..

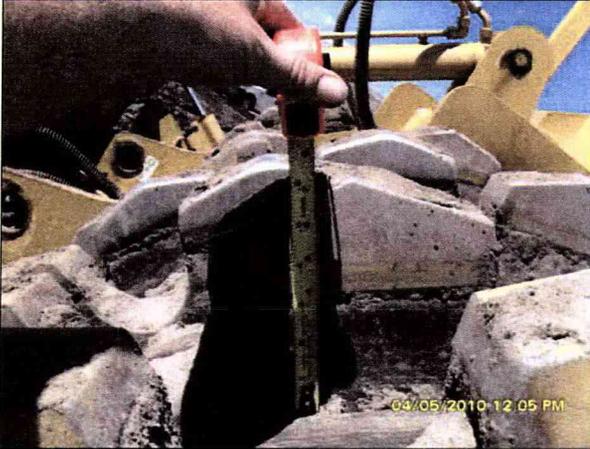
CQA measuring the pegs on the CAT 825 compactor.

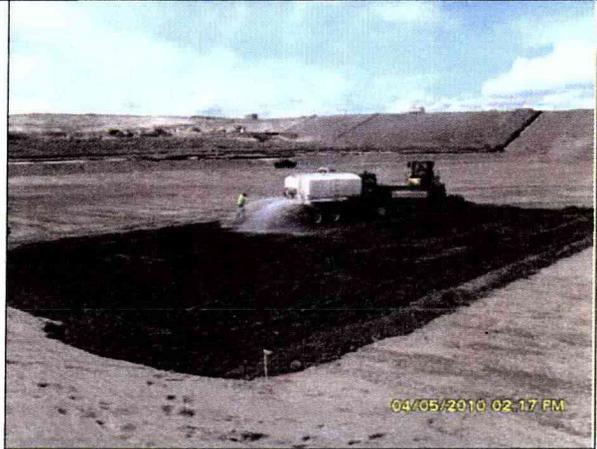
Facing NW - TWS moisture conditioning the test pad.

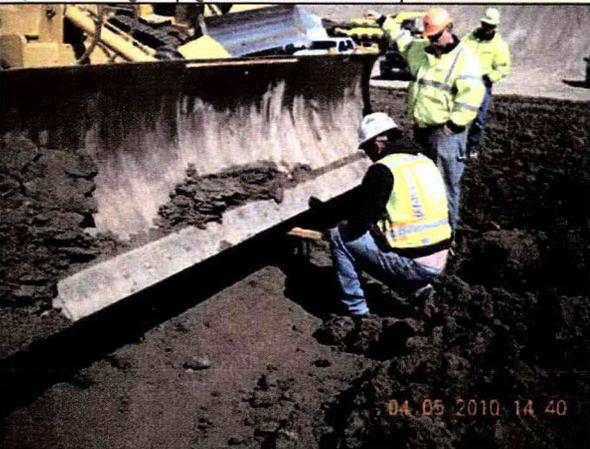
CQA collecting a Shelby tube sample for permeability testing.

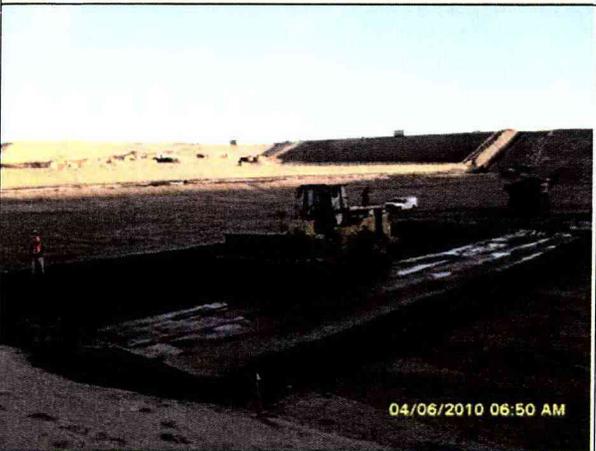
Facing NW - TWS scarifying the test pad in preparation for placing the 4th lift.

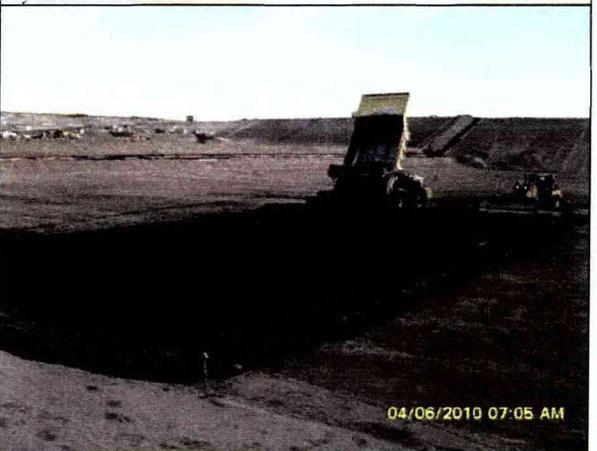
Facing NW - TWS placing the 4th lift on the test pad using the Payhauler trucks.

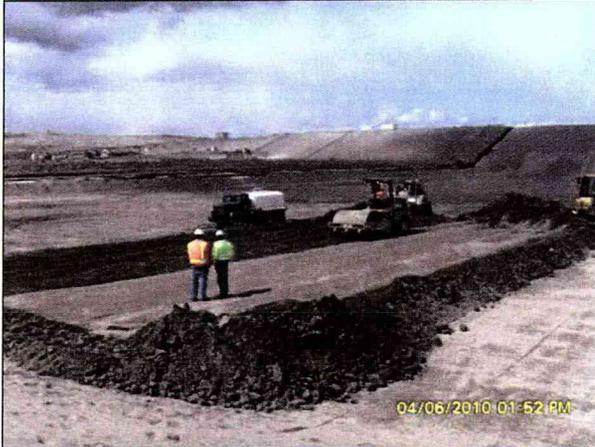
Facing NW – TWS static rolling the final lift of the test pad to demonstrate finishing of the admix liner layer.

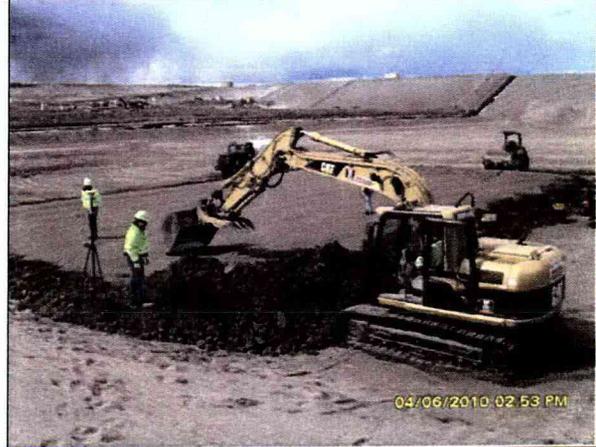
Facing E – TWS excavating one of two test pits to demonstrate that all six lifts are bonded together seamlessly.

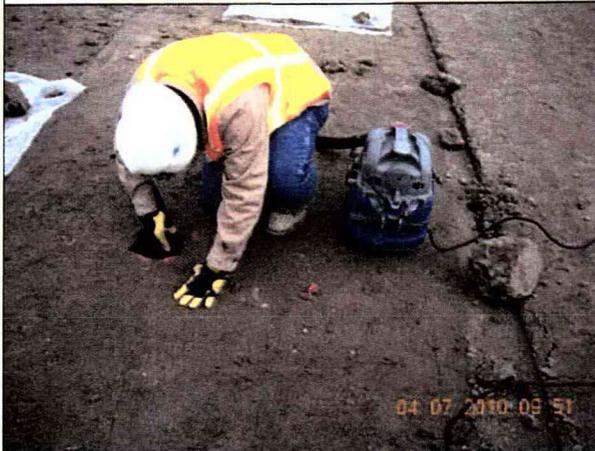
04 07 2010 09 51

Facing NE – CQA preparing Boutwell testing boreholes using a Shop-Vac to clean excess debris from the bottom of the hole.

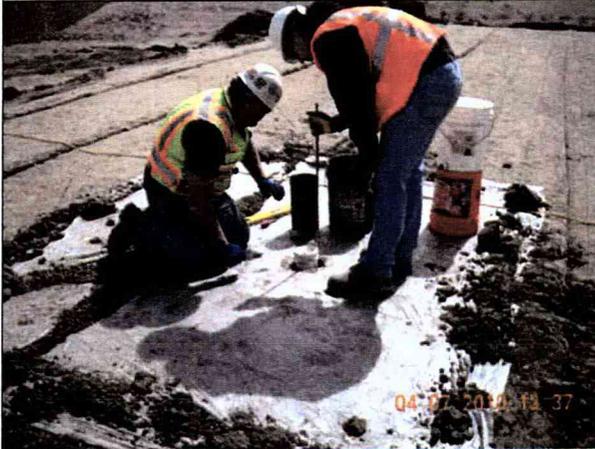
04 07 2010 13 37

Facing S – CQA setting the East Boutwell by tamping bentonite and water around the casing.

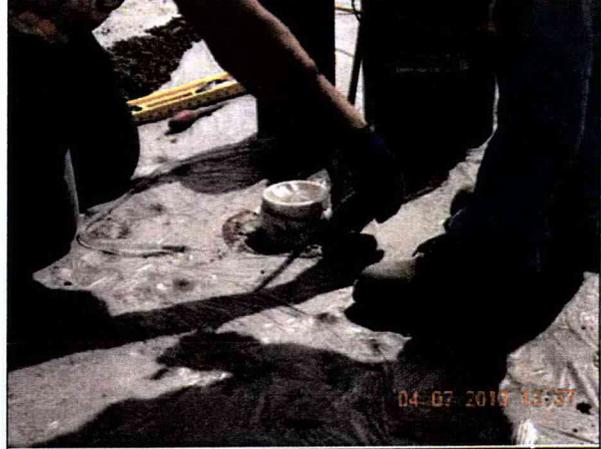
04 07 2010 13 37

CQA placing bentonite around Boutwell casings and tamping into place to seal the Boutwell.

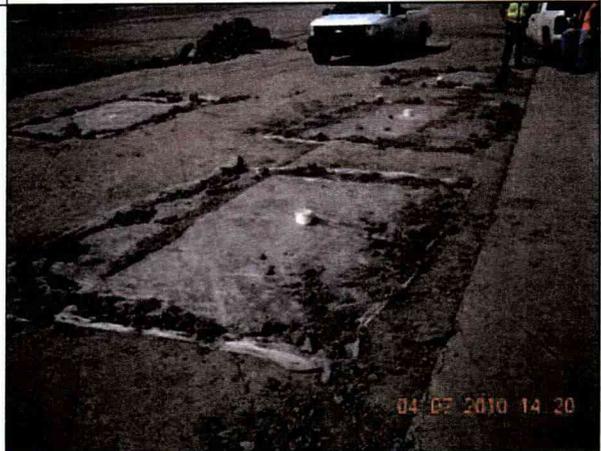
04 07 2010 14 20

Facing NW – Boutwell casing installation complete.

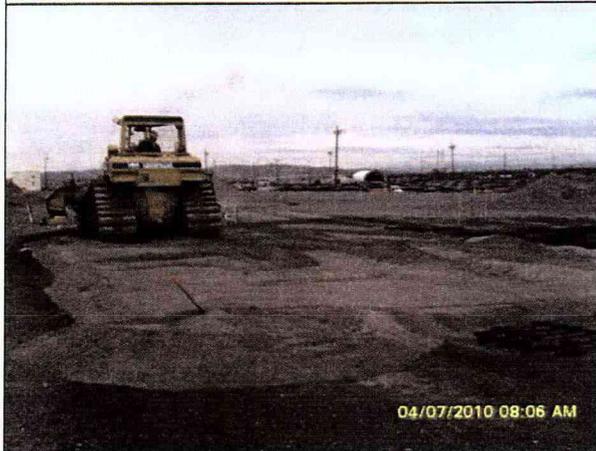
Facing W - TWS placing structural fill on Cell 9 Crest pad.

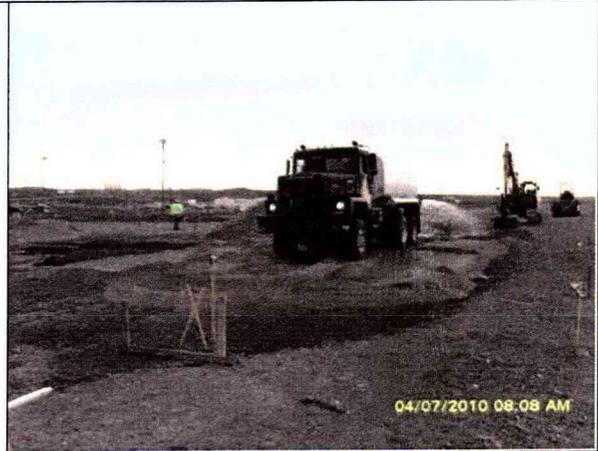
Facing E - TWS moisture conditioning the lifts placed on the Cell 9 Crest Pad.

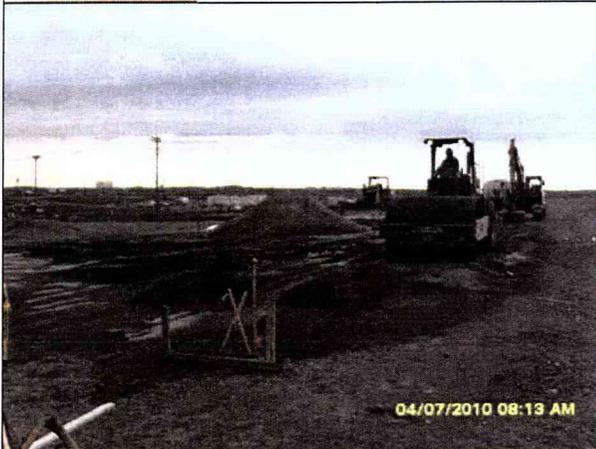
Facing E - TWS using the CAT CS 563 smooth drum roller to compact the lifts placed on the Cell 9 Crest Pad.

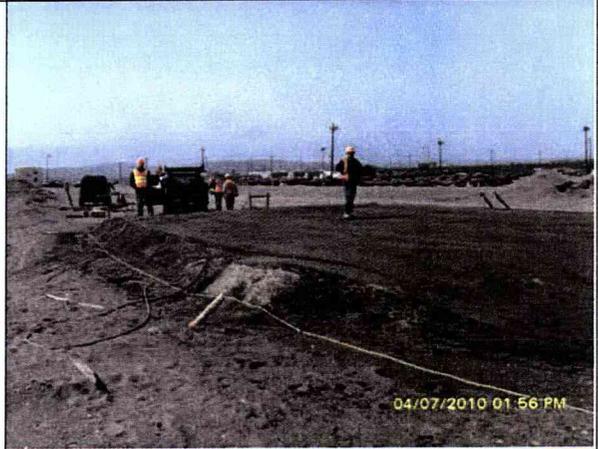
Facing W - The completed Cell 9 Crest Pad.

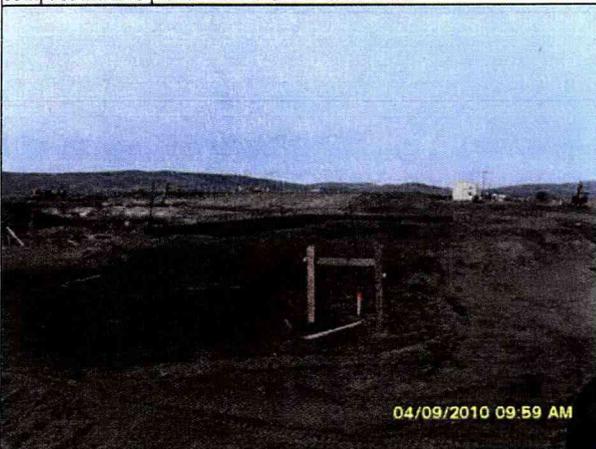
Facing W - TWS has begun to place wooden form along the south and west side of the Crest Pad.

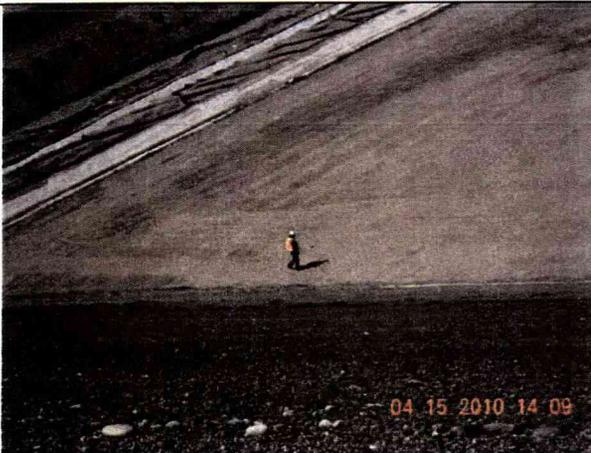
Facing N - Rogers Surveying shooting the elevation of the Cell 9.

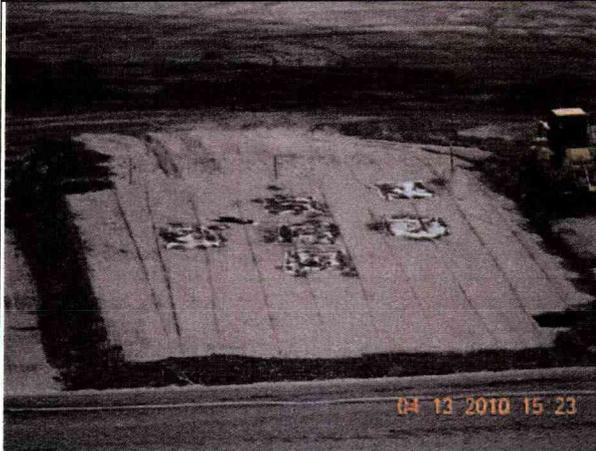
Facing N - Test pad Boutwell locations.

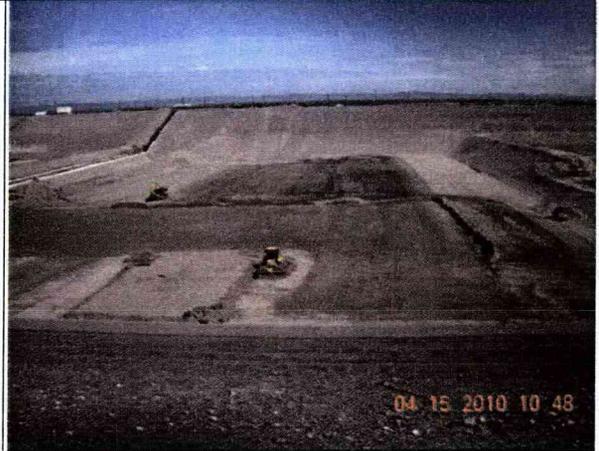
Facing N - Test Pad location in Cell 9.

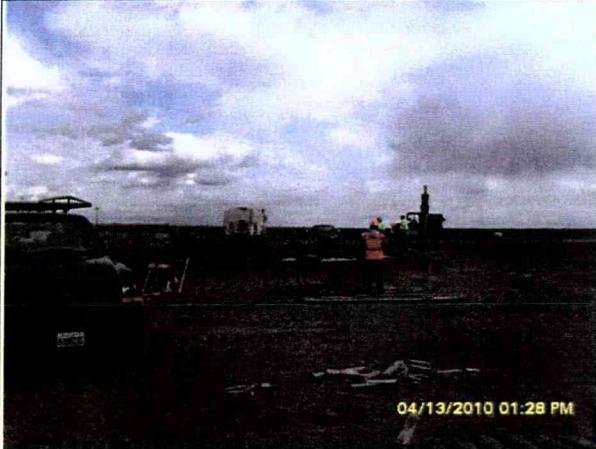
Facing E – TWS building concrete forms for Cell 9 Crest Pad.

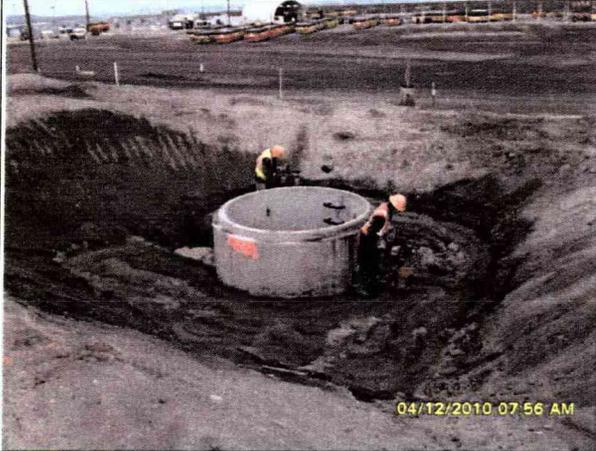
04/12/2010 07:56 AM

Facing N – TWS compacting the backfill around MH-34.

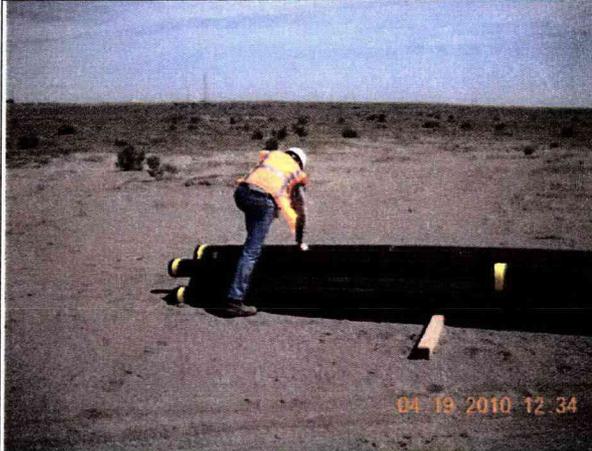
Facing E – CQA inspecting the HDPE double containment pipe.

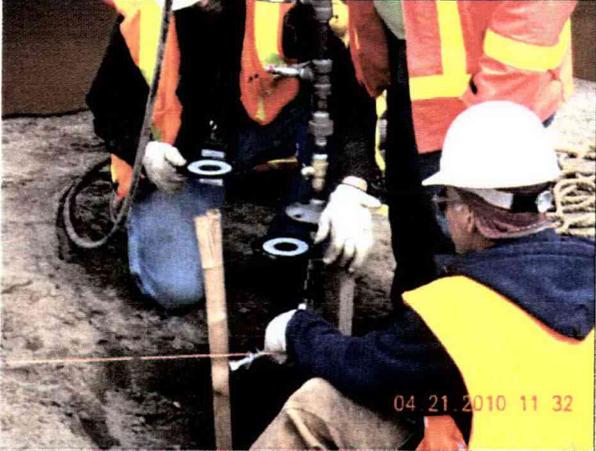
Facing W – After hydrostatic testing failed, BMWC discovered a faulty O-ring, which was replaced.

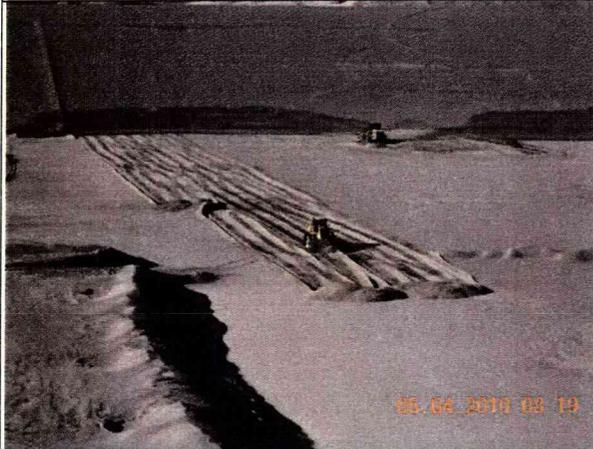
05.04.2010 08.19

Facing S – TWS Re-grading Cell 9 after the wind storm on 5-3-2010

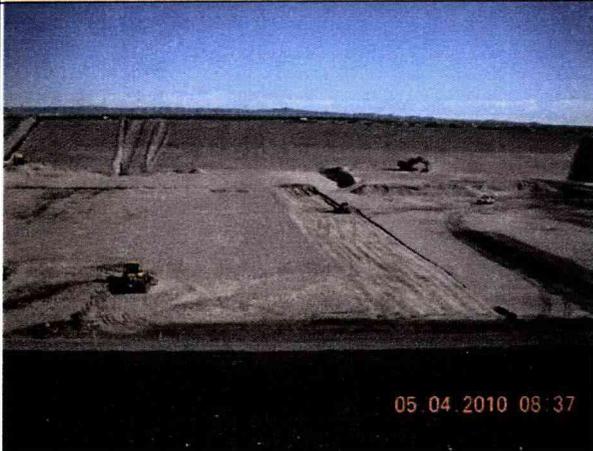
05.04.2010 08.37

Facing N – TWS Re-grading Cell 9 after the wind storm on 5-3-2010

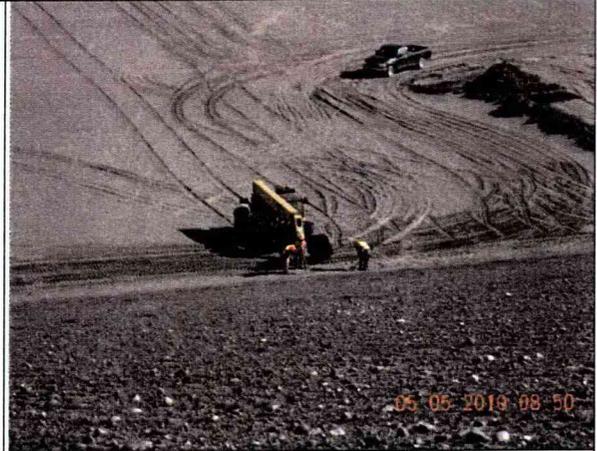
05.05.2010 08.50

Facing N – TWS using hand shovels to remove windblown sand from the south toe of Cell 9.

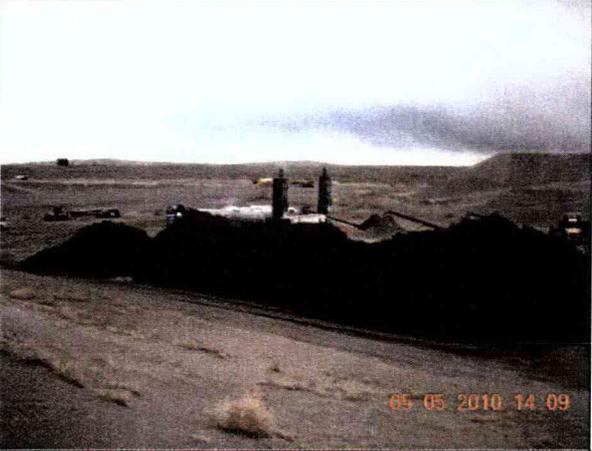
Facing NE – Pug mil set up and stockpiled Admix.

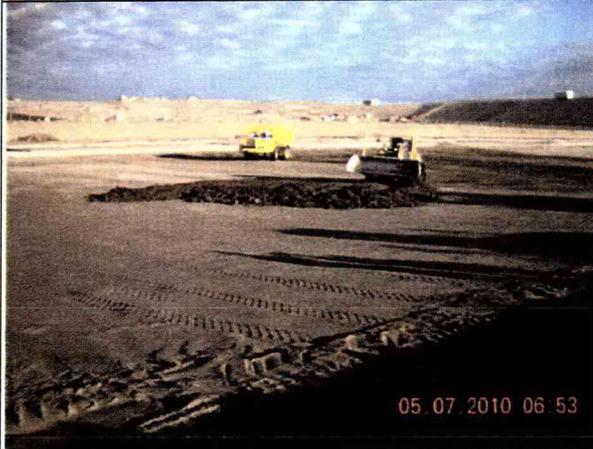
05.07.2010 06:53

Facing NW – TWS beginning the placement of admix in Cell 9.
