TANK 4 AND LEACHATE TRANSMISSION SYSTEM REPORT
CONSTRUCTION QUALITY ASSURANCE (CQA)

PHOTOLOG

ERDF CONSTRUCTION CELLS 9-10

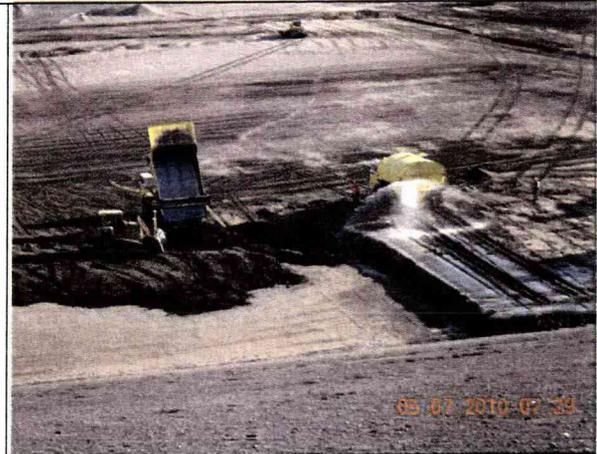
05.07.2010 07:33

Facing N – TWS moisture conditioning the admix as it is placed.

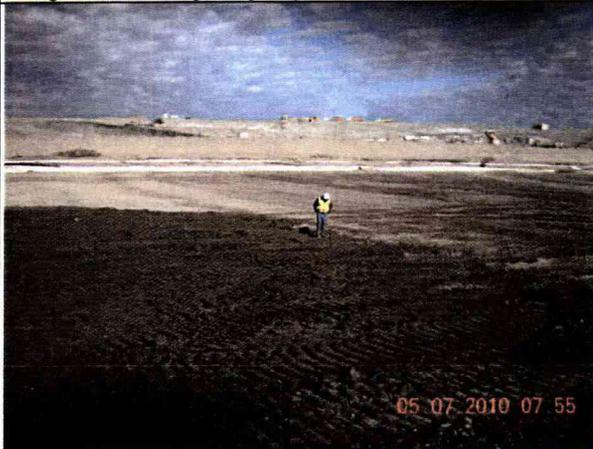
05.07.2010 07:55

Facing NW – CQA inspecting the first lift of the admix during placement.

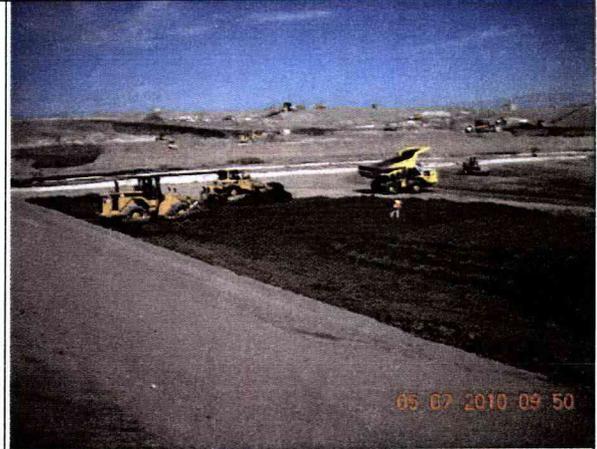
05.07.2010 09:50

Facing NE – TWS compacting the admix with the CAT 825, while the CAT D6 GPS dozer continues to place admix..

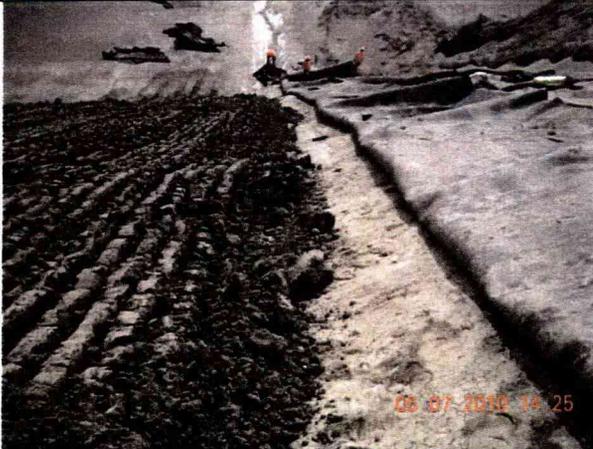
05.07.2010 14:25

Facing S – Cell 9/ Cell 8 Admix tie in.

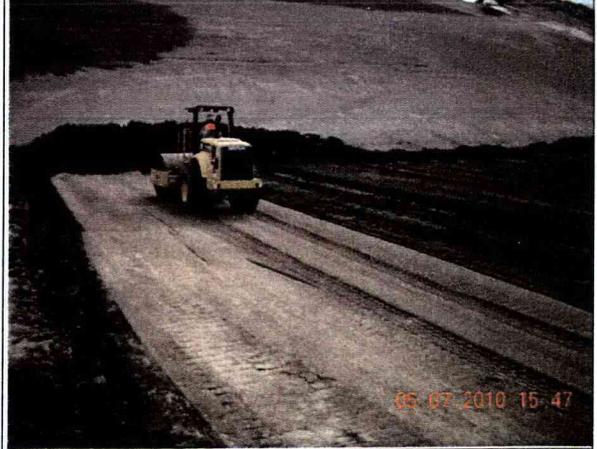
05.07.2010 15:47

Facing S – TWS using the CAT 563 smooth drum vibratory roller to seal the admix to prevent moisture loss at the end of the day.

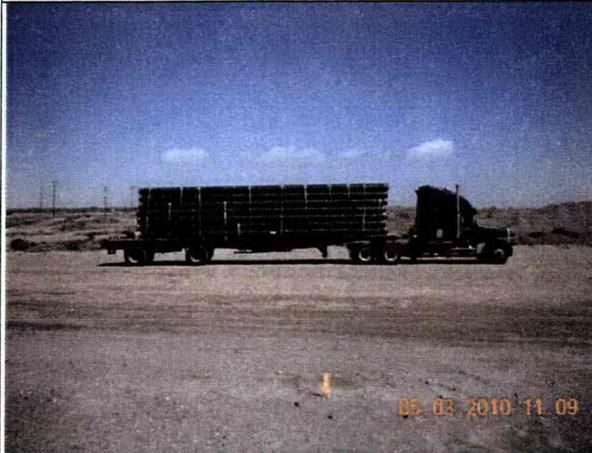
Facing N – A truckload of 12-in HDPE pipe arriving on-site..

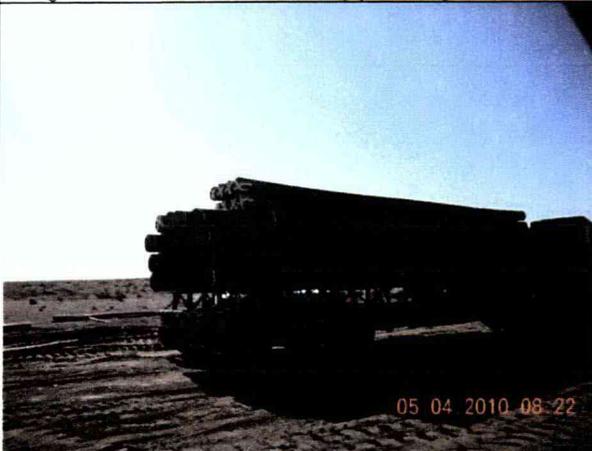
Facing E – A truckload of 10x16-in HDPE and 12-in HDPE piping arriving on-site.

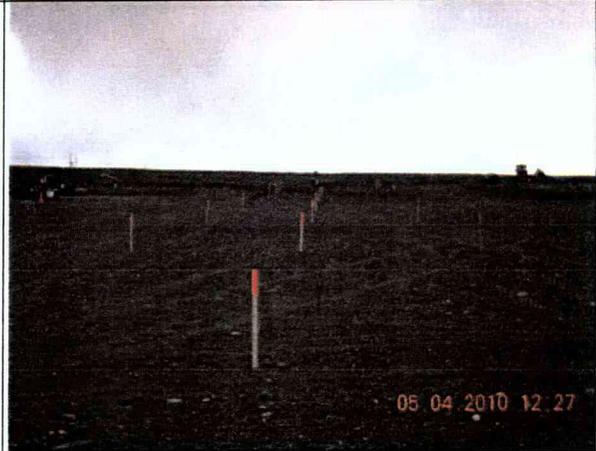
Facing E – TWS has staked the limits of excavation for the leachate transmission line from MH-33 to MH-32.

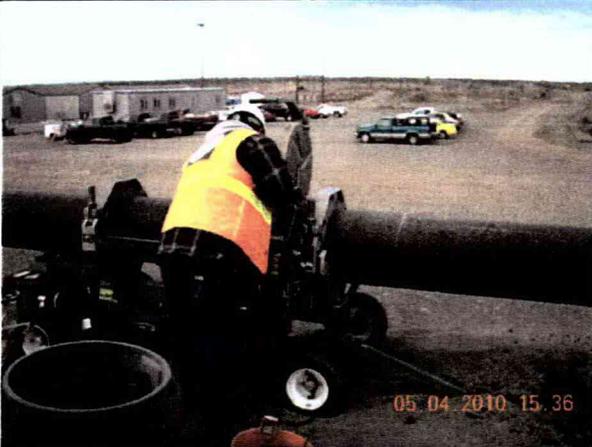
Facing N – BMWC welding 10x16-in HDPE pipe to be placed between MH-32 and MH-33

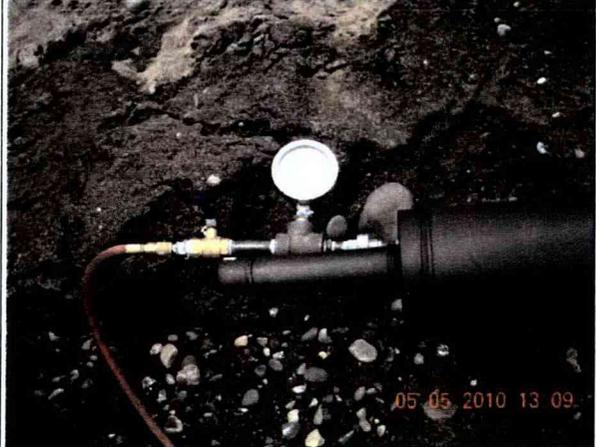
Facing Down – BMWC pneumatically testing the outer containment for the 4x8-in HDPE drain line in the Cell 10 Crest Pad.

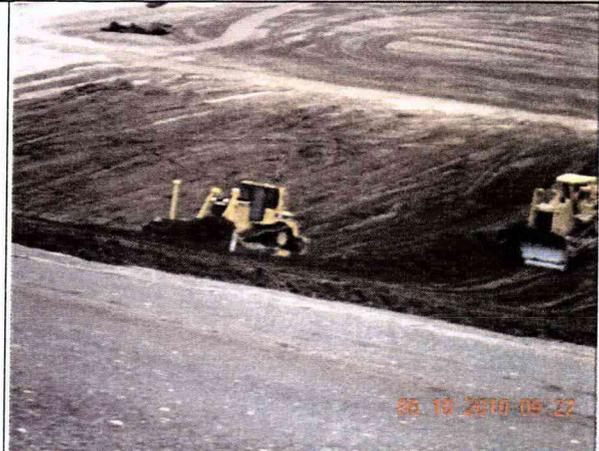
Facing NW – TWS using the CAT D6 GPS dozer to push admix up the south embankment of Cell 9.

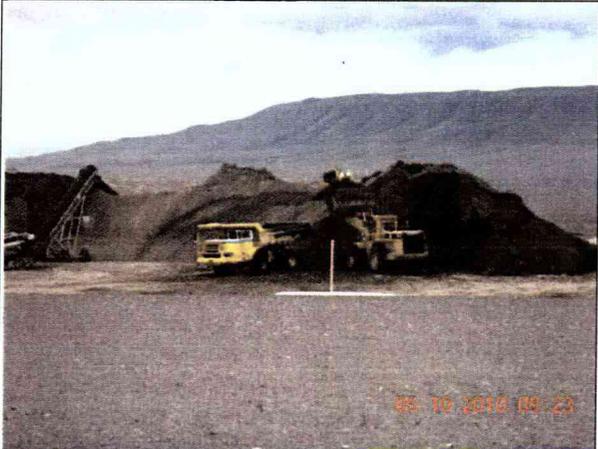
Facing S – TWS using the CAT 988 to load the Payhauler trucks with admix.

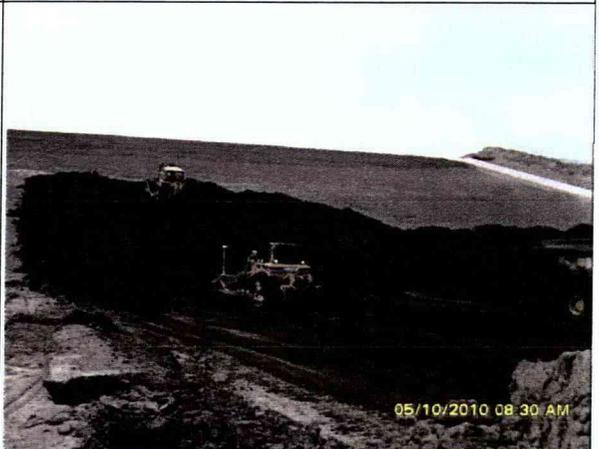
Facing S - TWS using the CAT D6 GPS dozer to push admix up the south embankment of Cell 9

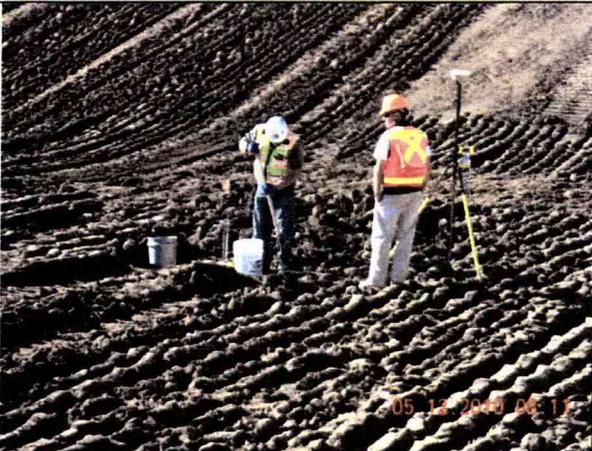
Facing S – CQA collecting a Shelby tube sample.

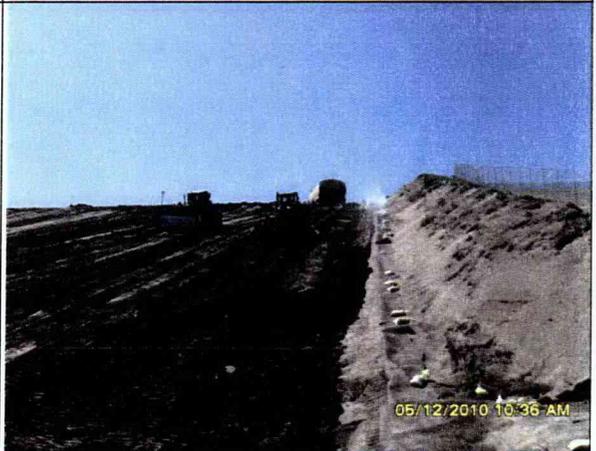
Facing S – TWS using the two CAT D6 dozers to push admix down the south embankment near the Cell9/Cell8 tie in.

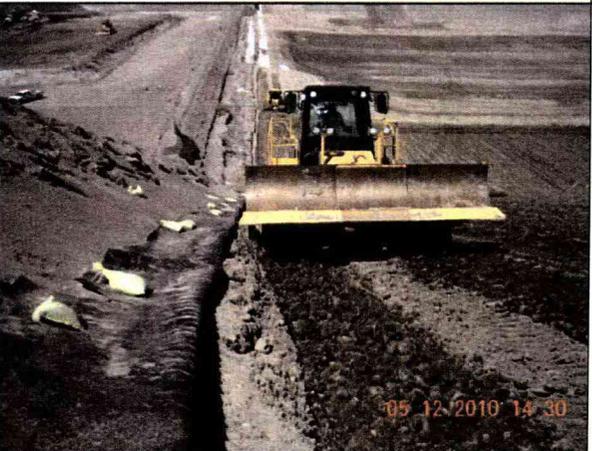
Facing N – TWS using the CAT 825 compactor to compact the admix near the Cell 9/Cell 8 tie in.

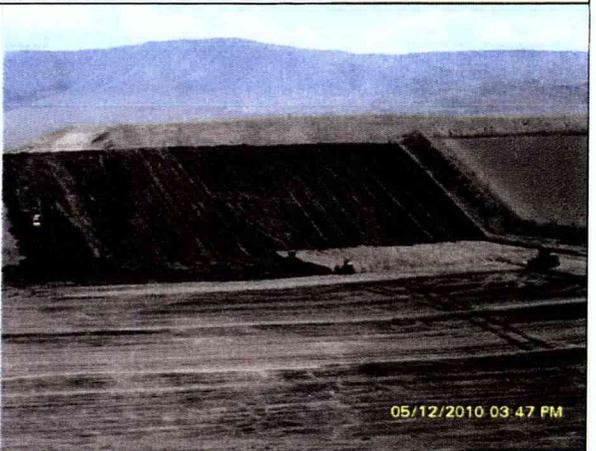
Facing SW – TWS placing admix along the south embankment of Cell 9.

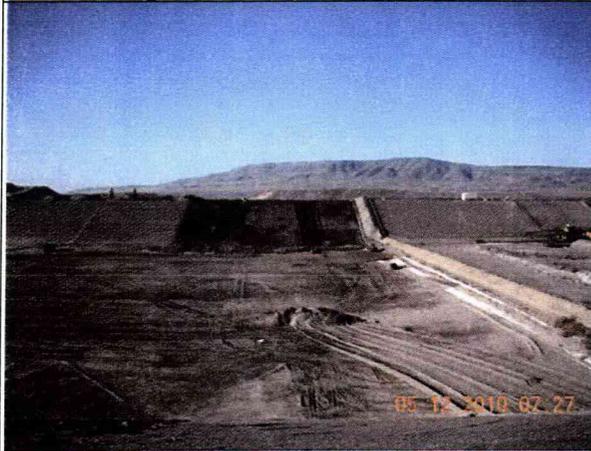
Facing S – Cell 9 subgrade partially complete.

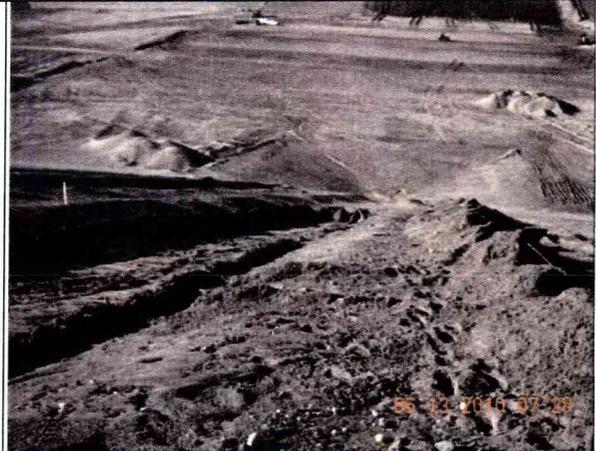
Facing S – Cell 9 riser trench needs to be re-excavated after the wind storm on May 3, 2010.

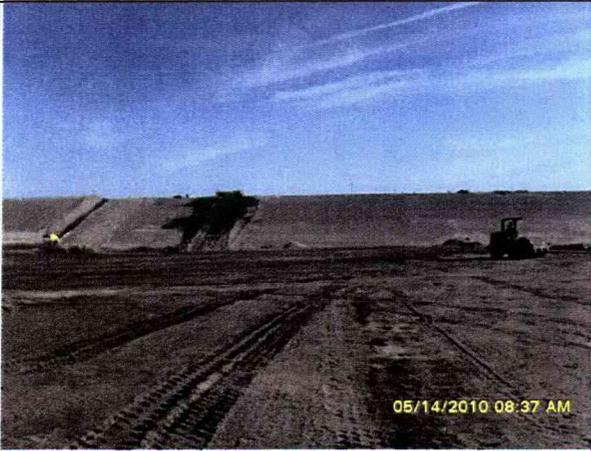
Facing N – Cell 9 subgrade.

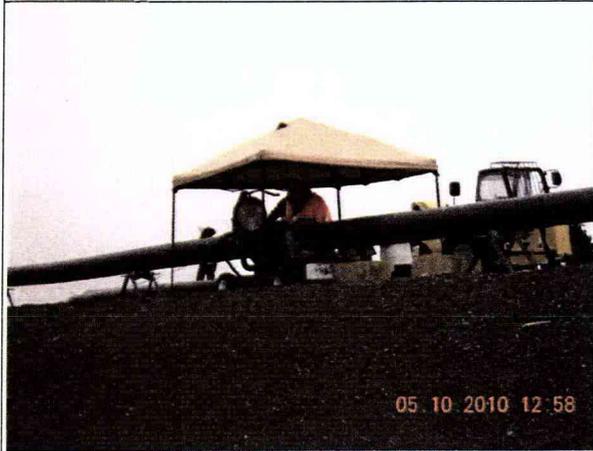
Facing SE – BMWC welding HDPE pipe.

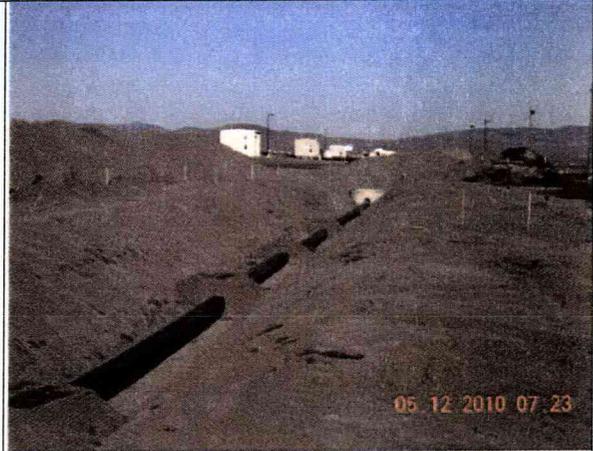
Facing W – 10x16-in HDPE between MH-33 and MH-32.

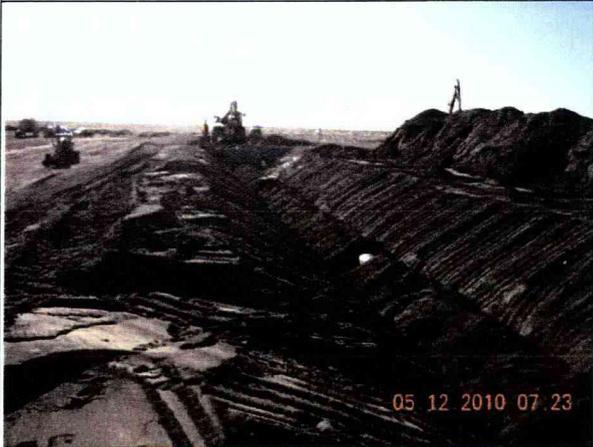
Facing W – 10x16-in HDPE between MH-33 and MH-32 partially cover to control temperature.

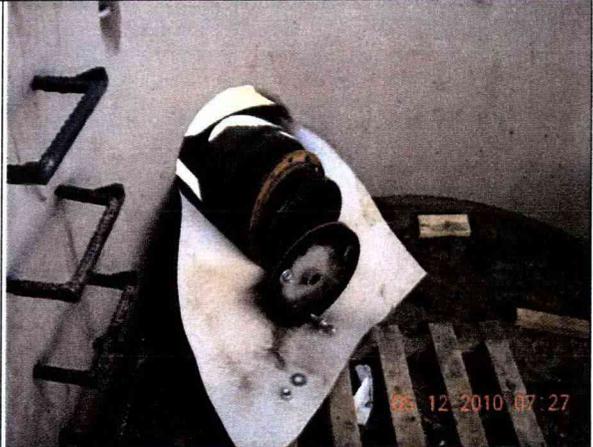
Facing Down – 10x16-in pipe penetration into MH-32.

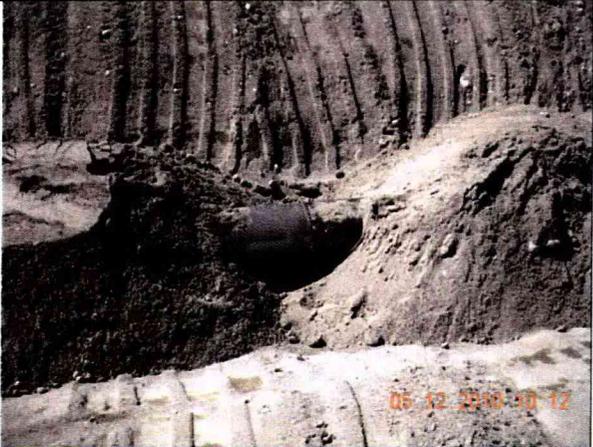
Facing Down – 10x16-in transmission line between MH-33 and MH-32 covered with soil with the joints exposed for inspection.

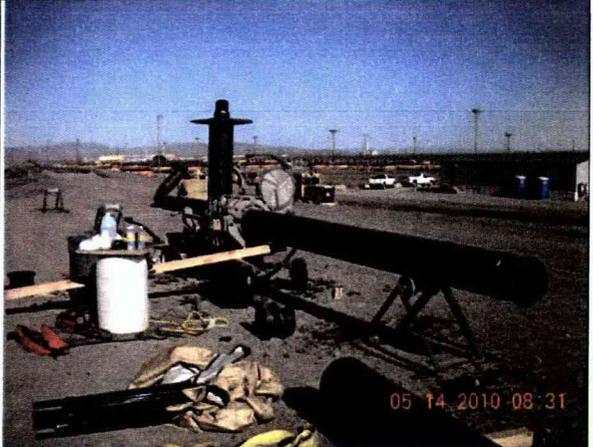
Facing W – BMWC welding 8x12-in HDPE for the tank penetration from MH-21.

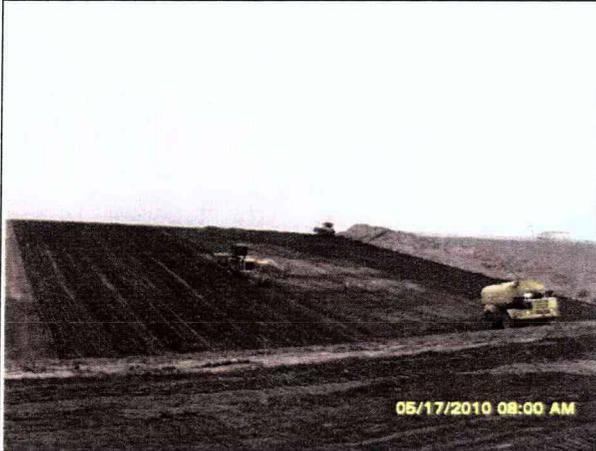
Facing SW – TWS watering and compacting the admix soil placed on the south slope of Cell 9.

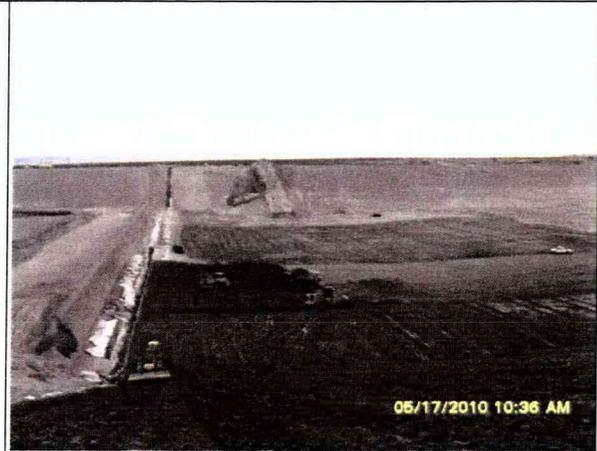
Facing N – TWS placing and compacting the admix soil near the southwest corner of Cell 9.

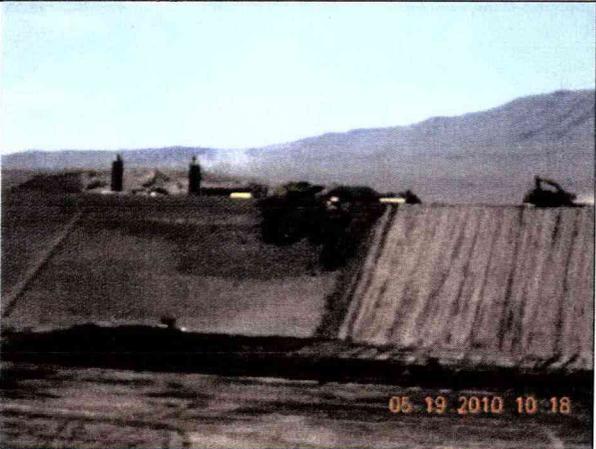
Facing S – TWS placing admix soil on the eastern edge of the south slope in Cell 9.

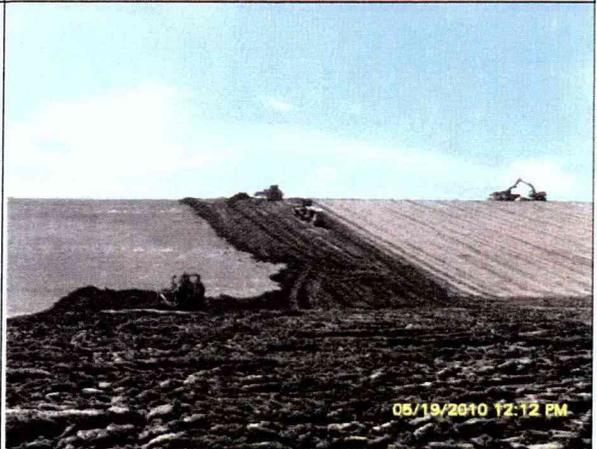
Facing S – TWS placing and compacting admix on the south slope of Cell 9.

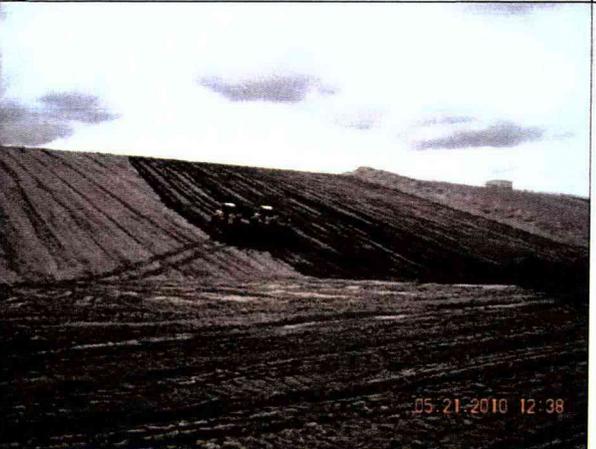
Facing SW – TWS using two CAT D6 dozers to “clip” the 6th lift to grade on the south slope of Cell 9.

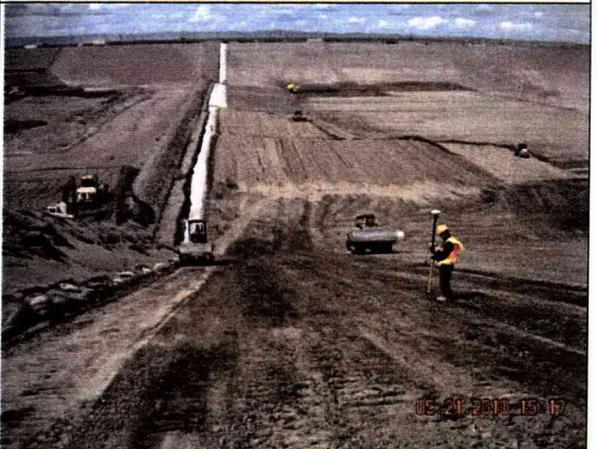
Facing N – TWS static rolling the 6th and final lift on the south slope of Cell 9.

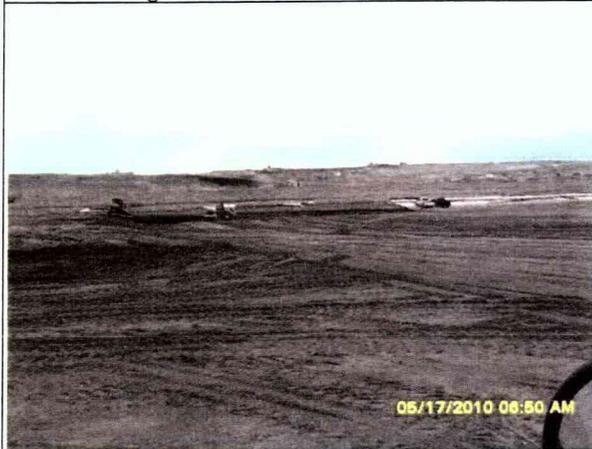
Facing W – TWS preparing the subgrade for admix placement.

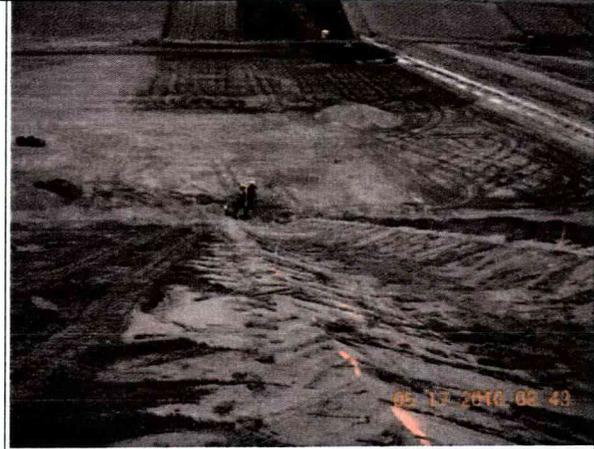
Facing S – TWS excavating the lysimeter sump in Cell 9 with the CAT 312 excavator.

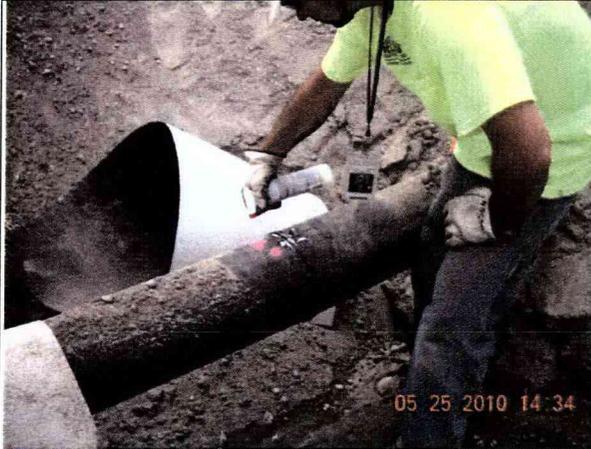
Facing Down – BMWC soap testing the welds on the 4x8-in HDPE discharge line from Tank #3 to MH-22.

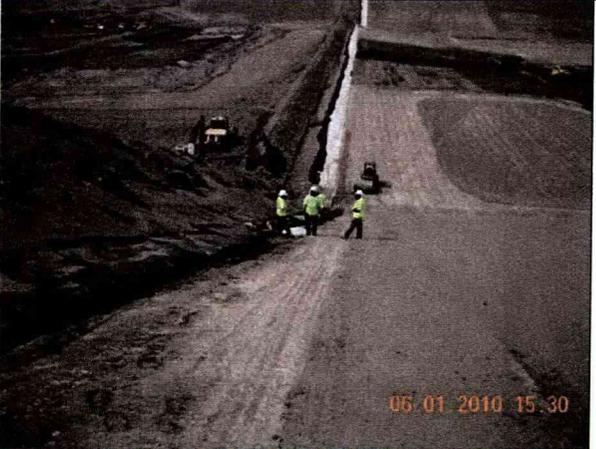
Facing N – ESI exposing the secondary geomembrane tie-in. Subgrade requires additional preparation.

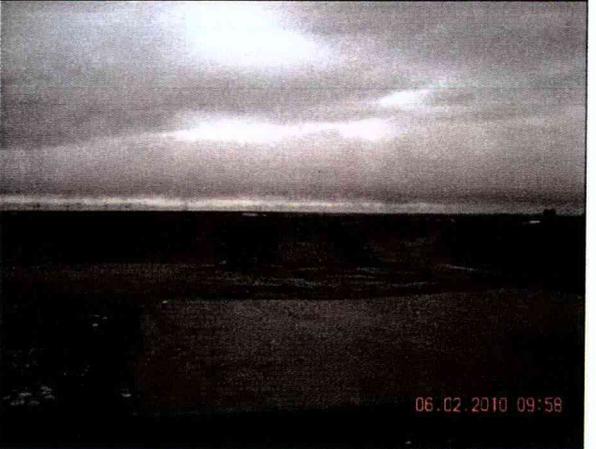
Facing N – Rain showers on 6/2/10 halted admix placement.

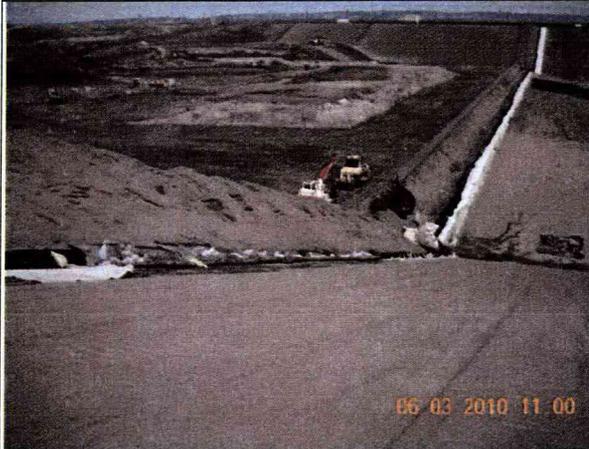
Facing SW – Rain showers on 6/2/10 eroded the admix surface.

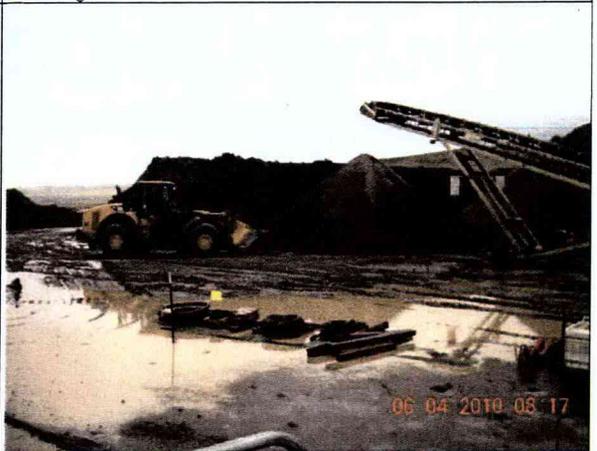
Facing S – TWS removing the non-conforming admix material produced on 6/4/10.

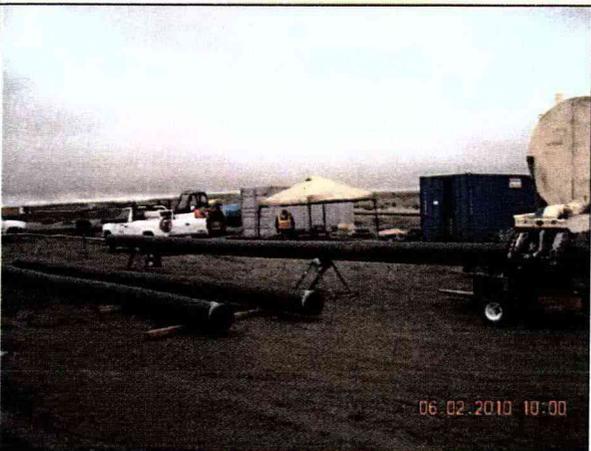
Facing NE – BMWC cutting the weld bead out from inside the 12-in leachate riser pipe.

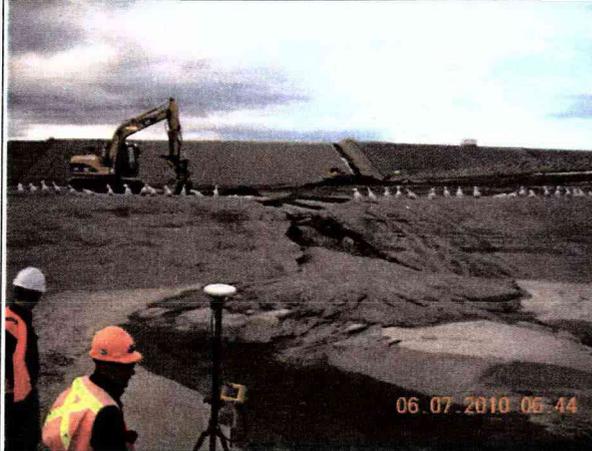
Facing SW – TWS repairing the lysimeter sump in Cell 9

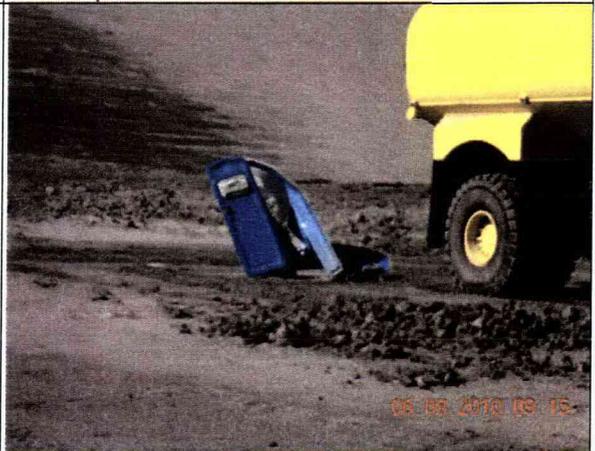
Facing SW – On Tuesday, a water truck backed into a port-a-john, resulting in a Stop Work for earthwork and admix activities.

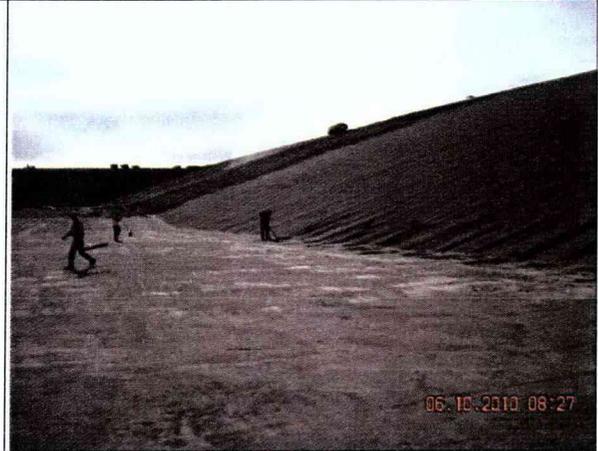
Facing E – TWS removing runnels and other irregularities with hand tools prior to secondary geomembrane deployment.

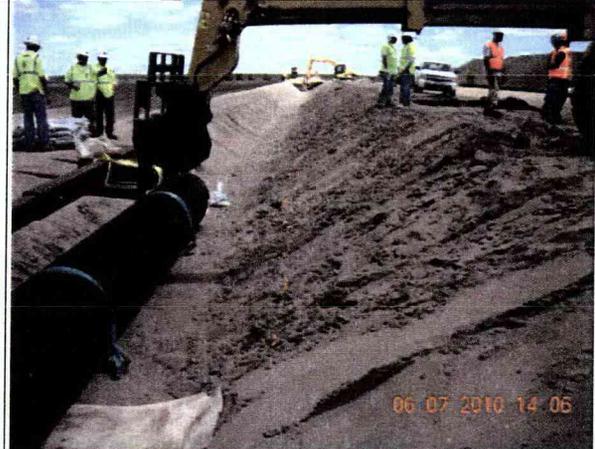
Facing E – The forklift began to tip over during deployment of the secondary geomembrane. The roll was set in the anchor trench.

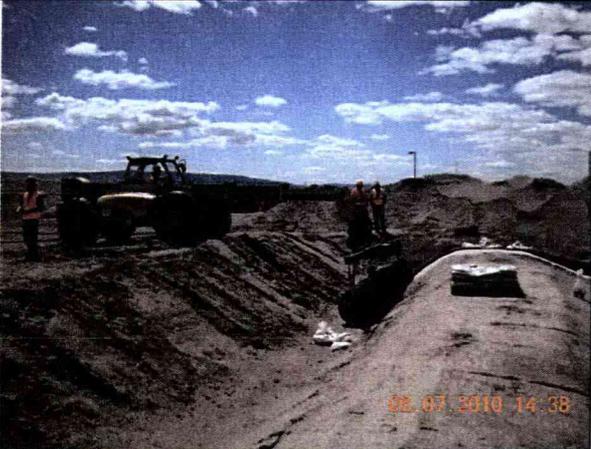
Facing W – All liner activities were halted until the picking incident could be assessed.

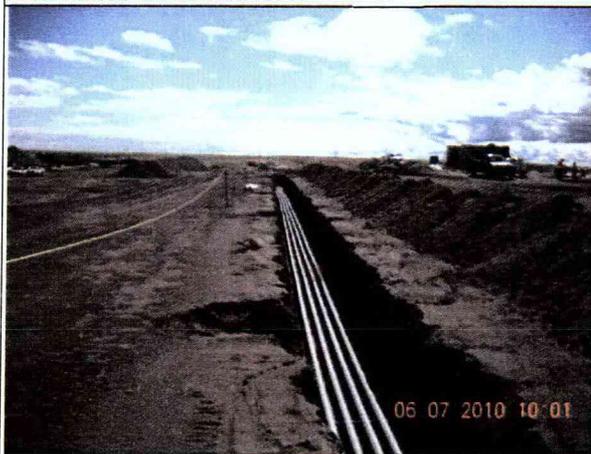
Facing E – Electrical conduit placement between Crest Pads 9 and 10.

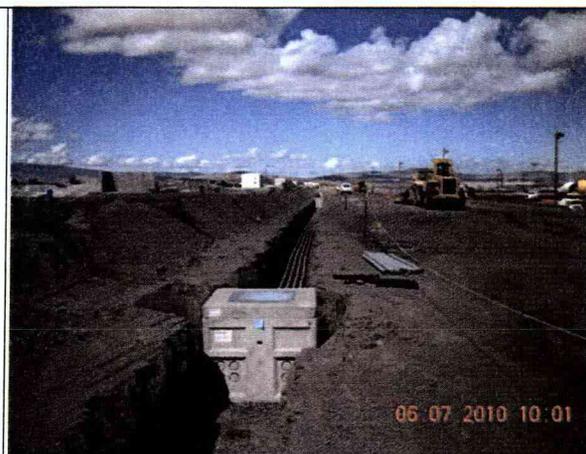
Facing W – Electrical conduit placement from Crest Pad 9 to Crest Pad 8.

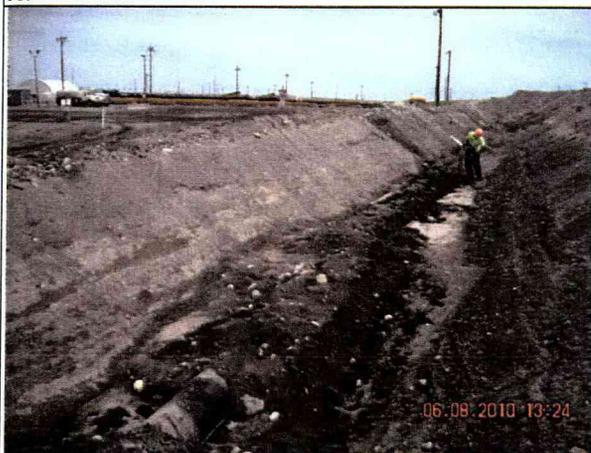
Facing E – TWS compacting the backfill over the leachate transmission line between MH-35 and MH-36.

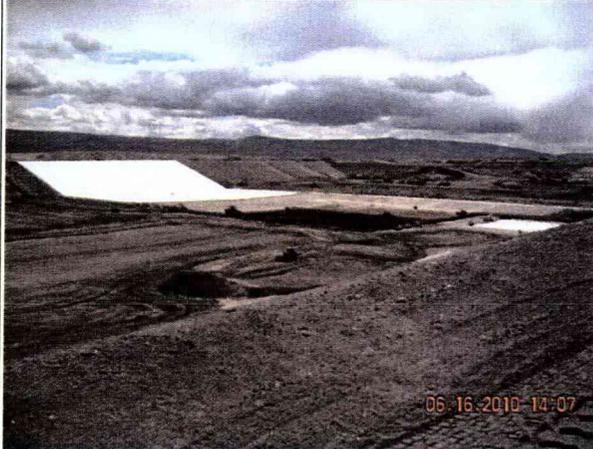
Facing SW – TWS using the CAT D6 to cut the Cell 10 Lysimeter sump to grade.

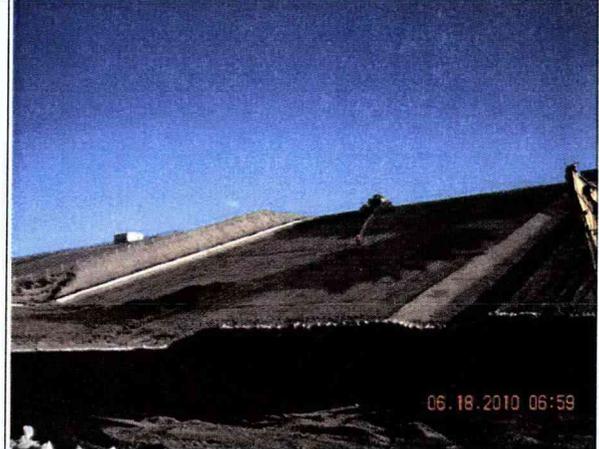
Facing NW – TWS moisture conditioning the Cell 9 subgrade on the north embankment prior to admix placement.

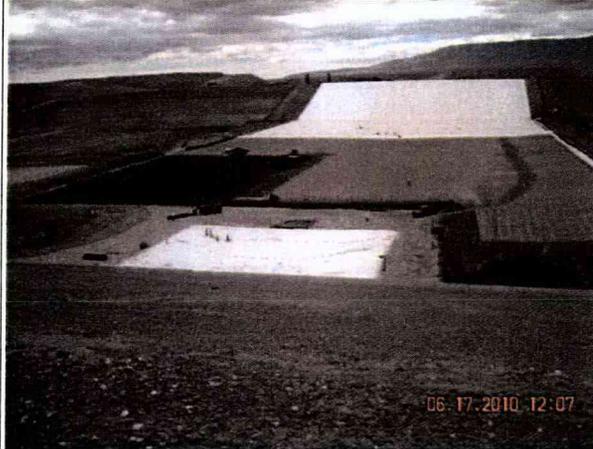
Facing S – TWS placing admix on the floor of Cell 9.

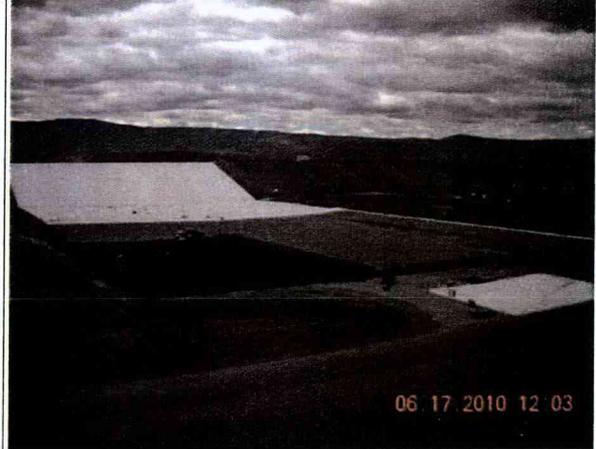
Facing SW – TWS placing admix on the floor of Cell 9.

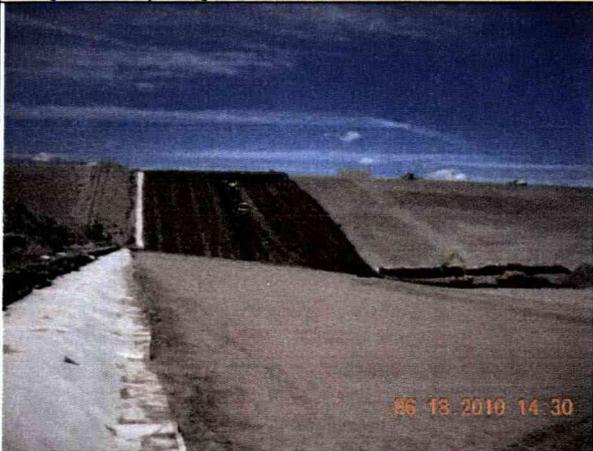
Facing N – TWS placing admix on the north slope of Cell 9.

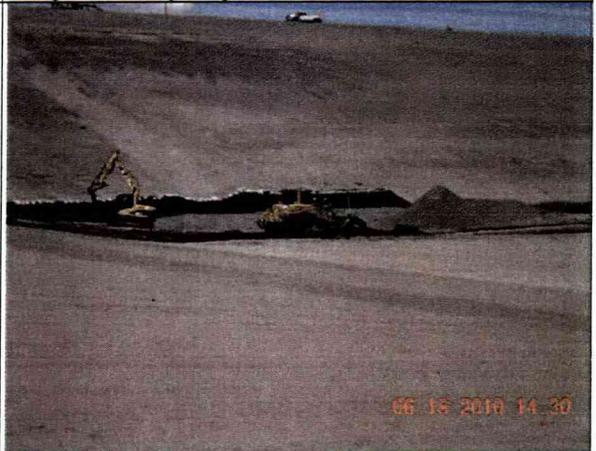
Facing N – TWS preparing to place admix in the Cell 9 Lysimeter sump.

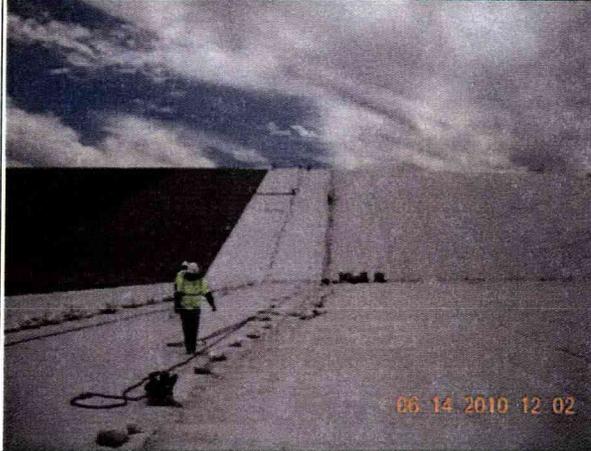
Facing S – ESI seaming secondary geomembrane together in Cell 9.

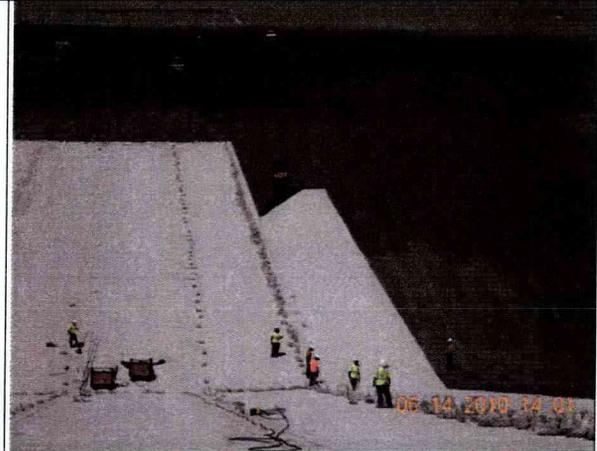
Facing N – ESI using the Kabota RTV to deploy secondary geomembrane on the south half of Cell 9.

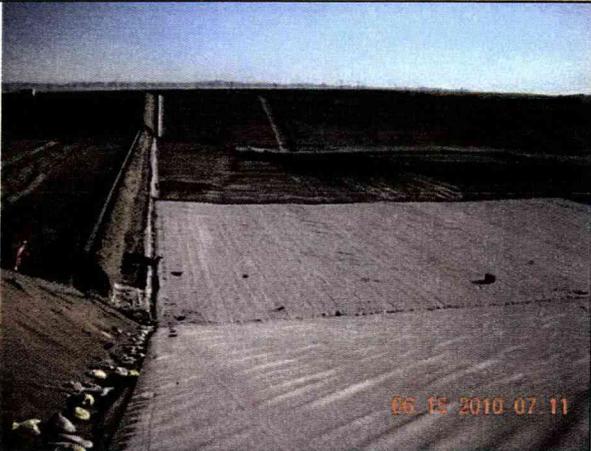
Facing N – Secondary geomembrane has been placed and welded on the south half of Cell 9

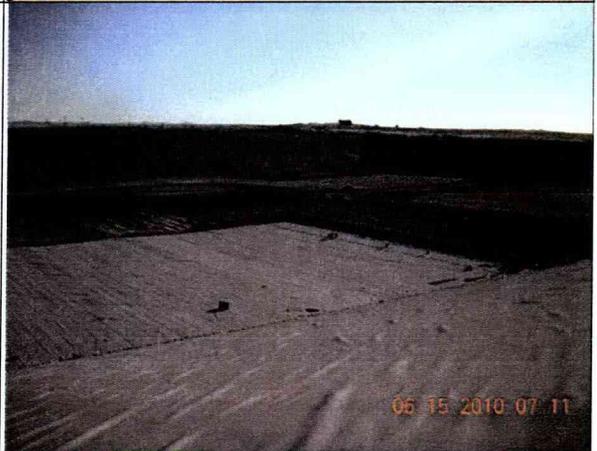
Facing NE – Secondary geomembrane has been placed and welded on the south half of Cell 9

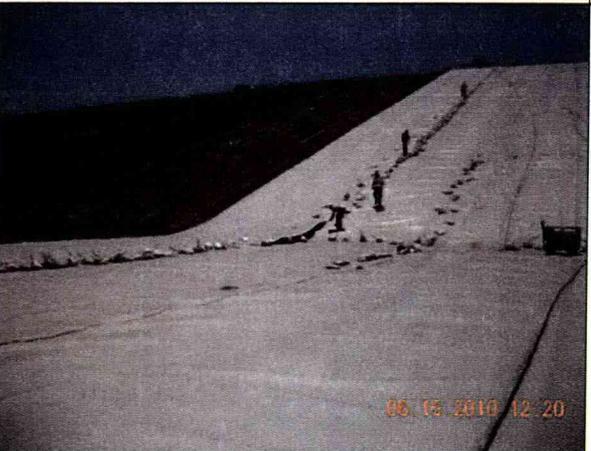
Facing S – ESI utilizing sand bags to weigh down the secondary geomembrane prior to seaming the panels..

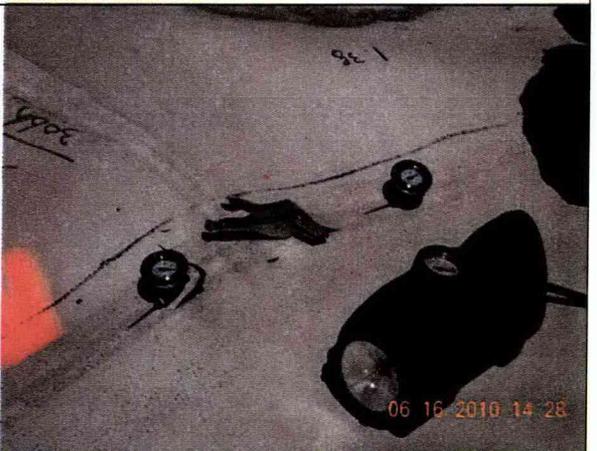
Facing Down – ESI using pressure gauges to perform the non-destructive air test on fusion welded seams.

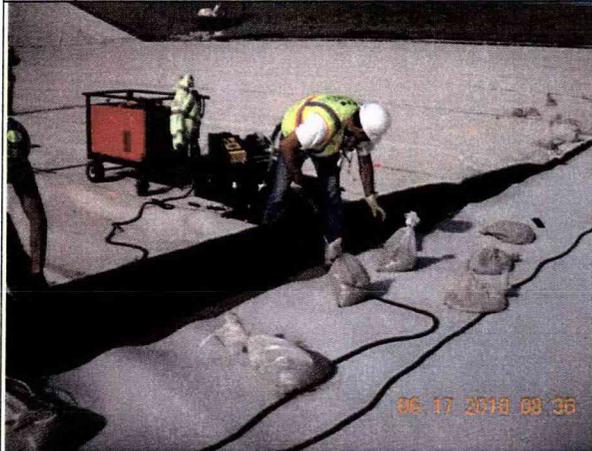
Facing SW – ESI cleaning the underside of the secondary liner prior to welding.

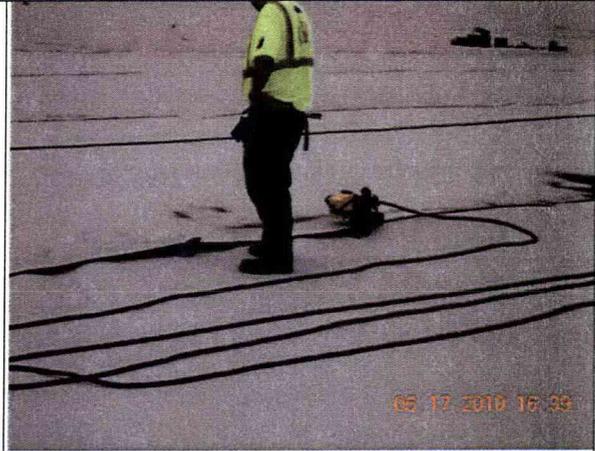
Facing S – ESI welding secondary geomembrane with a DEMTECH pro-wedge fusion welder.

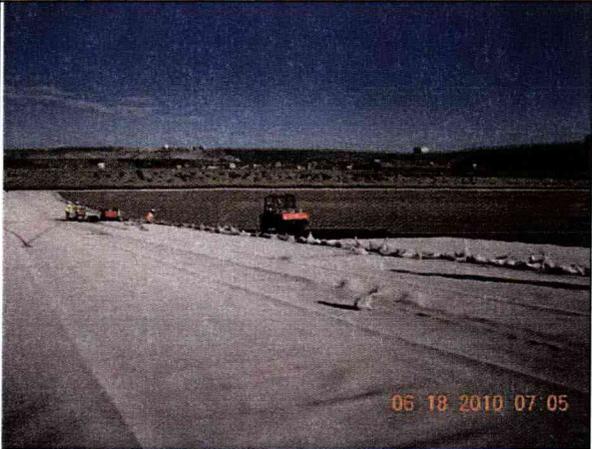
Facing W – ESI using the Kabota RTV to deploy secondary geomembrane on the south half of Cell 9.

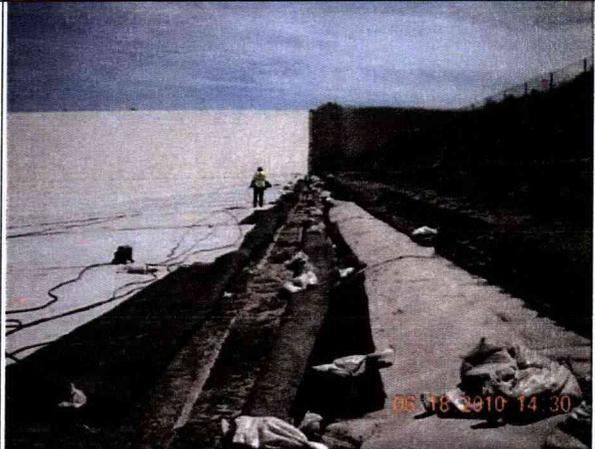
Facing S – ESI preparing to weld the secondary geomembrane to the tie in along the floor of Cell 9.

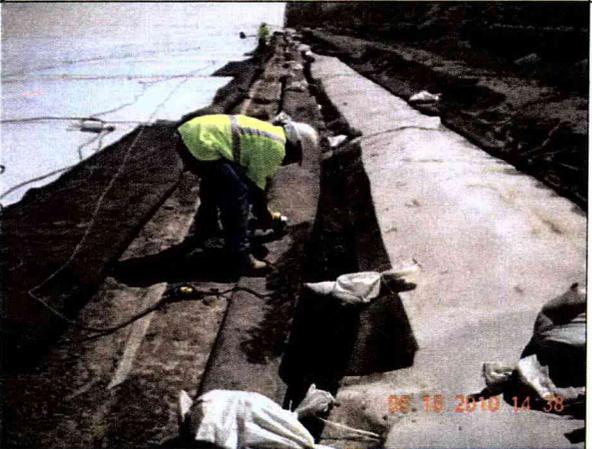
Facing S – ESI preparing to weld the secondary geomembrane to the tie in along the floor of Cell 9.

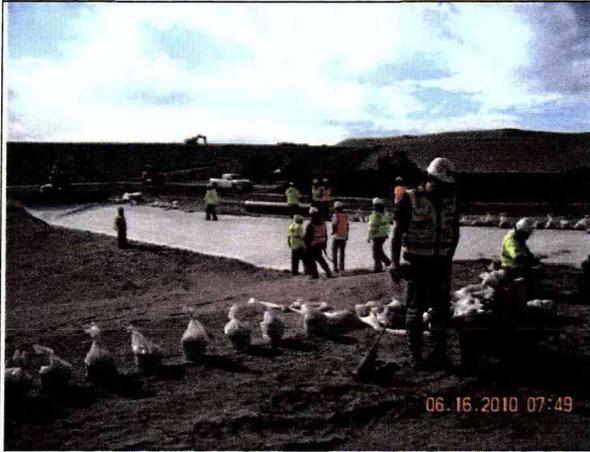
Facing SE – ESI deploying tertiary liner in the Cell 9 lysimeter sump.

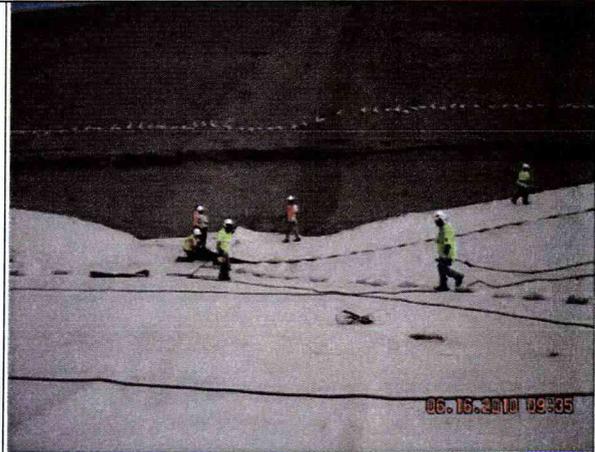
Facing N – ESI placing tertiary liner in the Cell 9 lysimeter sump.

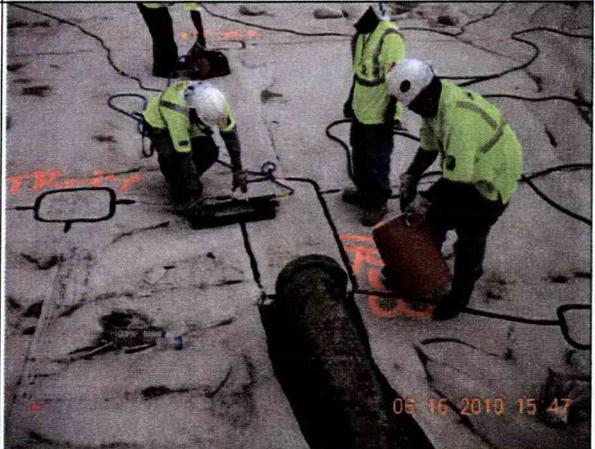
Facing S – ESI performing vacuum testing on all extrusion welds in the tertiary liner system.

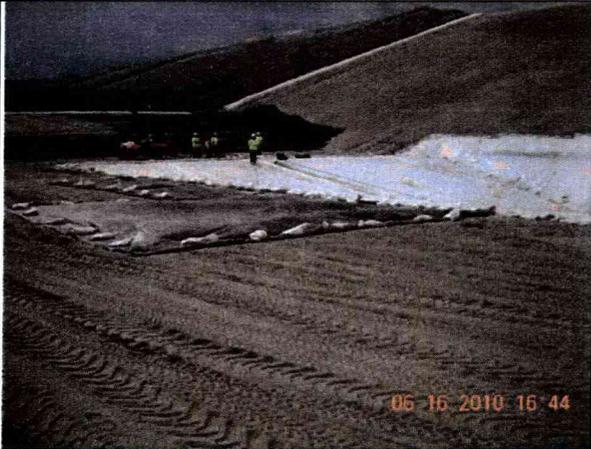
Facing NW – Tertiary liner in the Cell 9 lysimeter sump is complete.

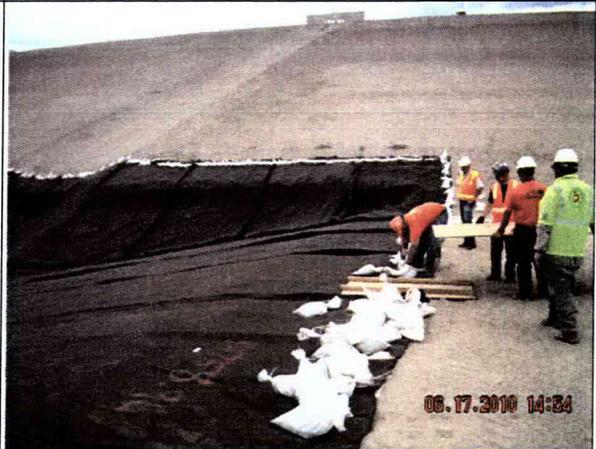
Facing N – ESI has completed placing the geotextile in the Cell 9 lysimeter sump.

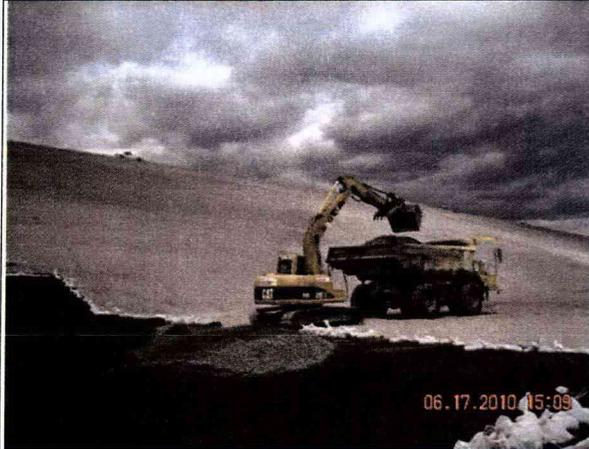
Facing NE – TWS beginning to place drainage gravel in the Cell 9 lysimeter sump.

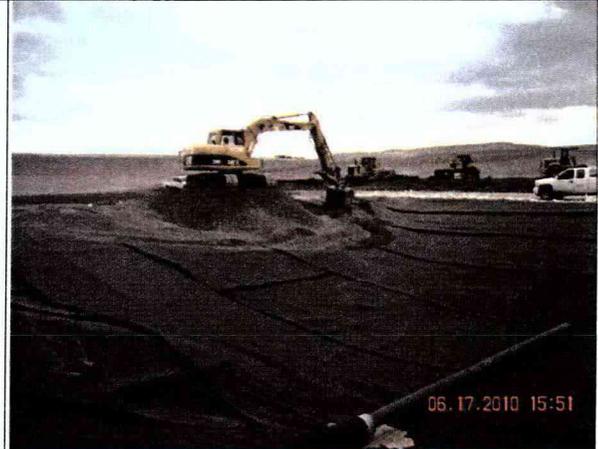
Facing SE – TWS placing drainage gravel in the Cell 9 lysimeter sump.

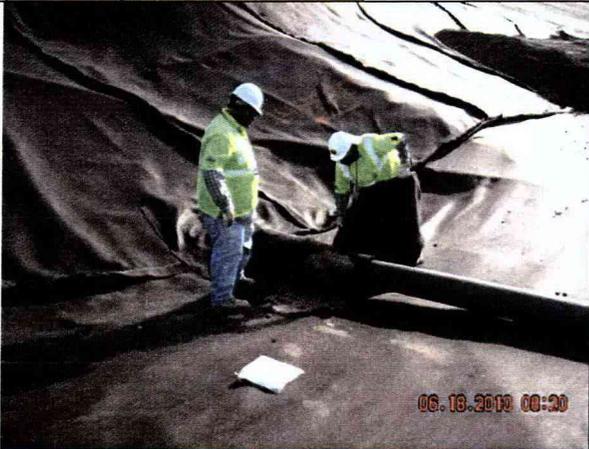
Facing NE – ESI wrapping the Cell 9 lysimeter pipe in geotextile.

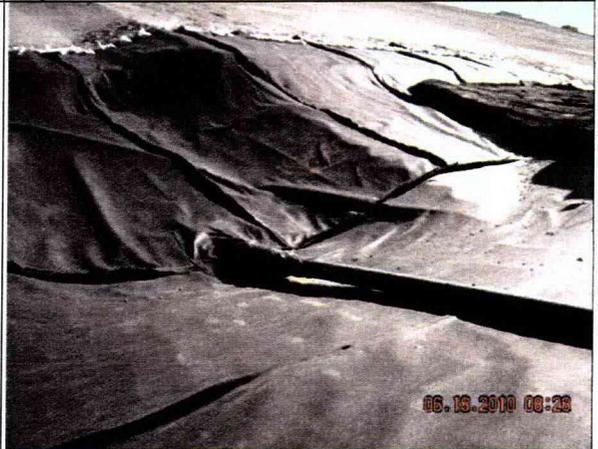
Facing NE – ESI wrapping the Cell 9 lysimeter pipe in geotextile.

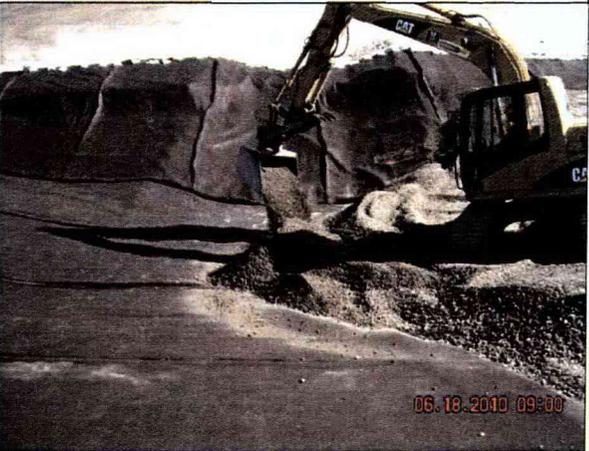
Facing N – TWS placing drainage gravel in the Cell 9 lysimeter sump.

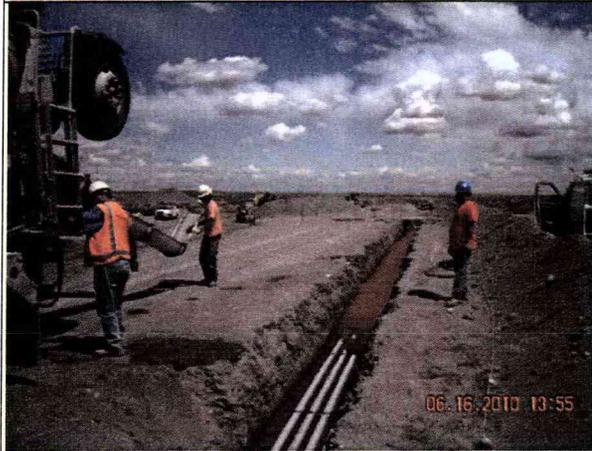
Facing E - TWS placing concrete in the electrical duct bank along the north embankment of Cell 9 and 10.

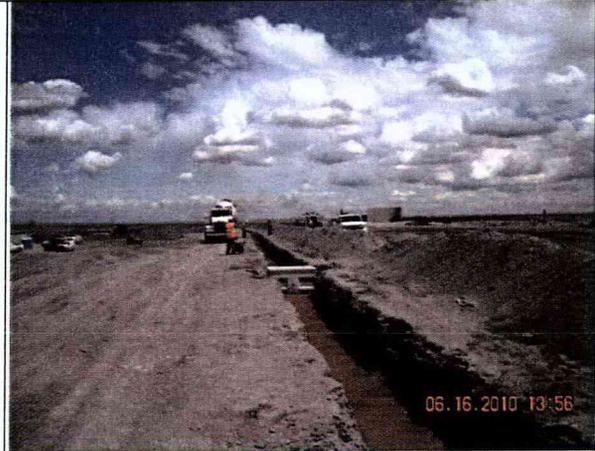
Facing E - TWS placing concrete in the electrical duct bank along the north embankment of Cell 9 and 10.

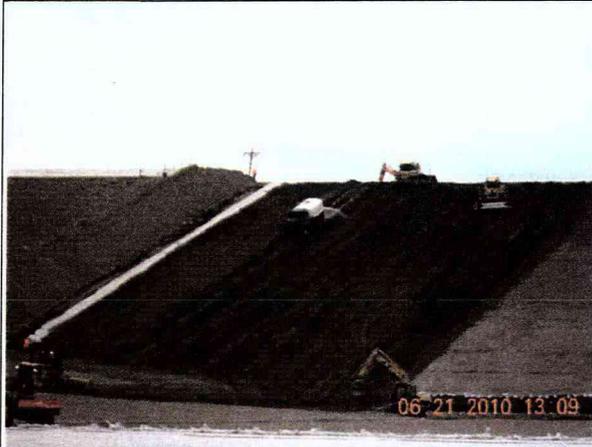
Facing N – TWS using the international water truck to moisture condition the admix on the north embankment.

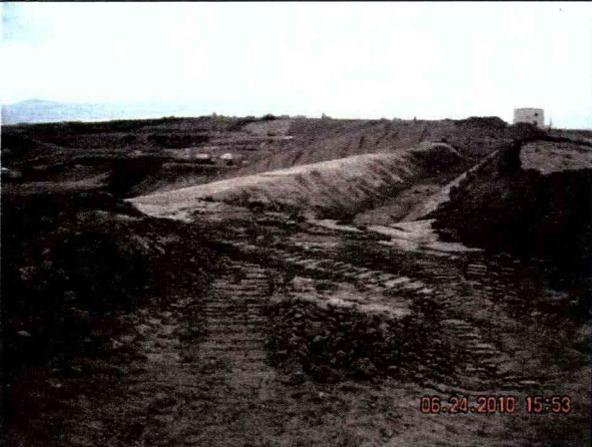
Facing W – TWS has partially completed the liner anchor trench along the north embankment on the west side of Cell 9.
