TANK 4 AND LEACHATE TRANSMISSION SYSTEM REPORT
CONSTRUCTION QUALITY ASSURANCE (CQA)

PHOTOLOG

ERDF CONSTRUCTION CELLS 9-10

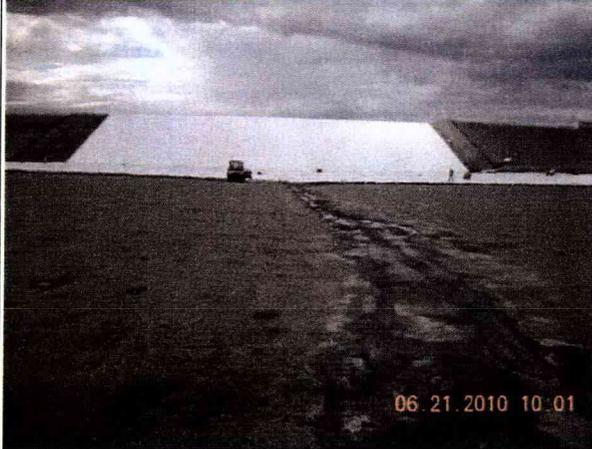
Facing S – Secondary liner activities on hold due to unacceptable subgrade in the trough of Cell 9..

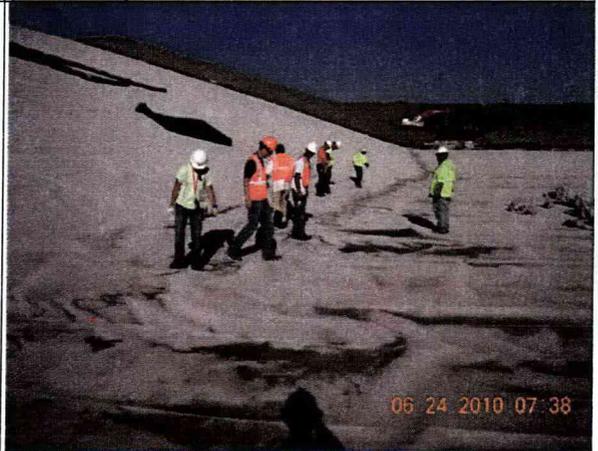
Facing W – Due to heat a large wrinkle formed near the south toe of Cell 9. ESI was instructed to cut the liner, remove the wrinkle and patch the area.

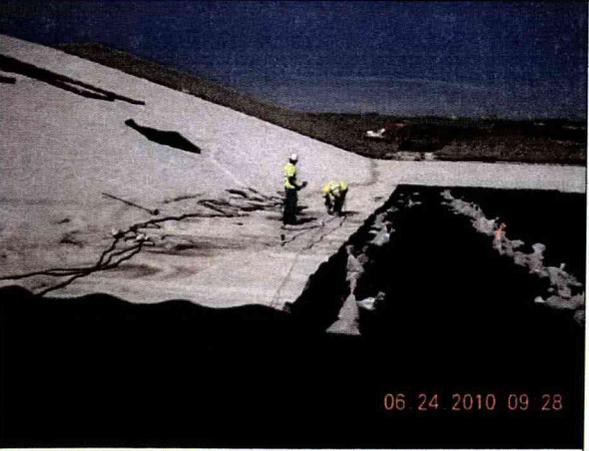
Facing W – ESI welding a patch in the south toe of Cell 9 that was used to remove a large wrinkle.

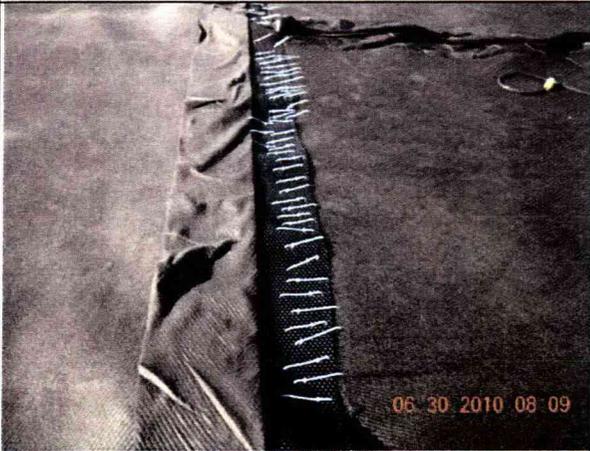
Facing Down – End-to-End seams of geocomposite zip tied together.

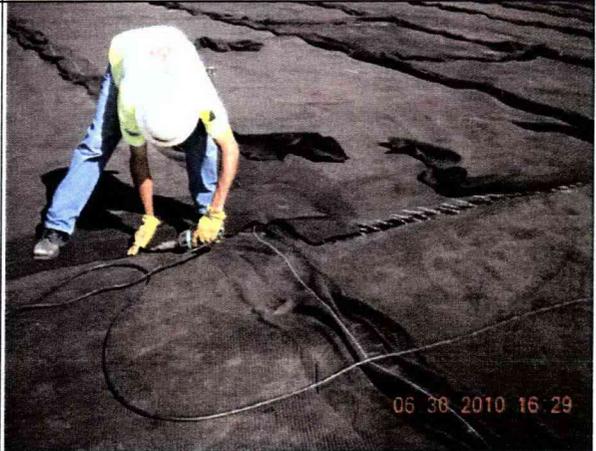
Facing Down – ESI capping End-to-End seam with geotextile to seal out sand or debris.

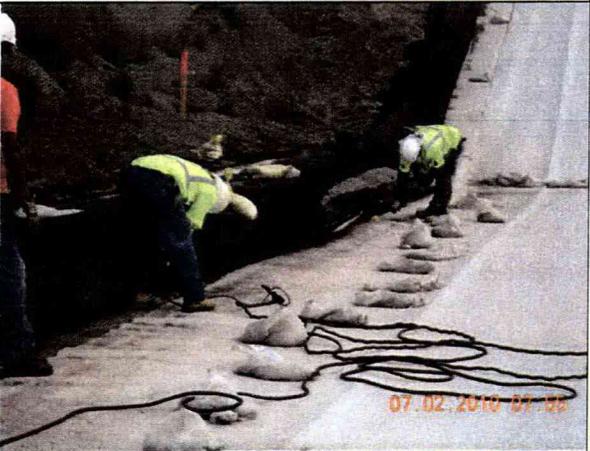
Facing N – ESI preparing to weld the Cell 9 tie-in along the north slope and toe.

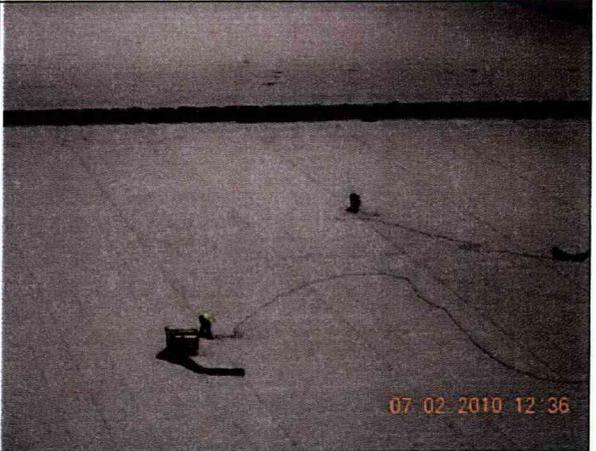
Facing N – ESI making primary repairs on the south half of the floor in Cell 9.

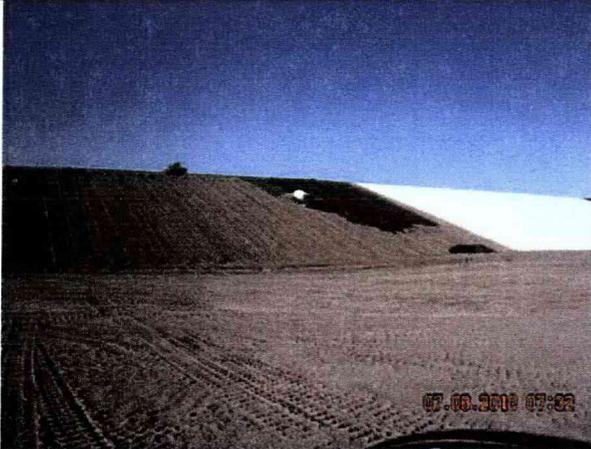
Facing S – TWS watering the admix with the International water truck.

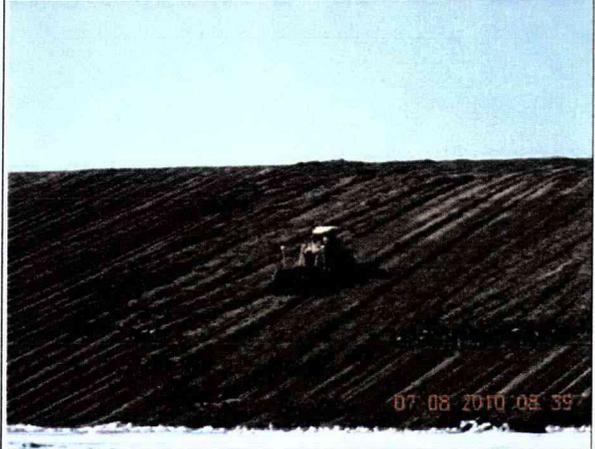
Facing SE – TWS using the CAT D6 GPS dozer to place admix on the south slope of Cell 10.

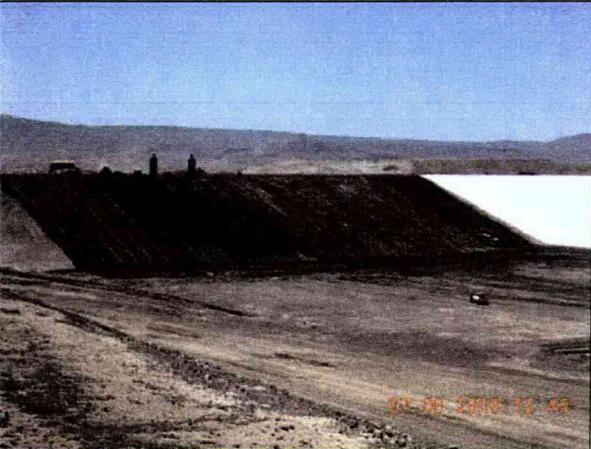
Facing SW – TWS placing and compacting admix on the south slope of Cell 10.

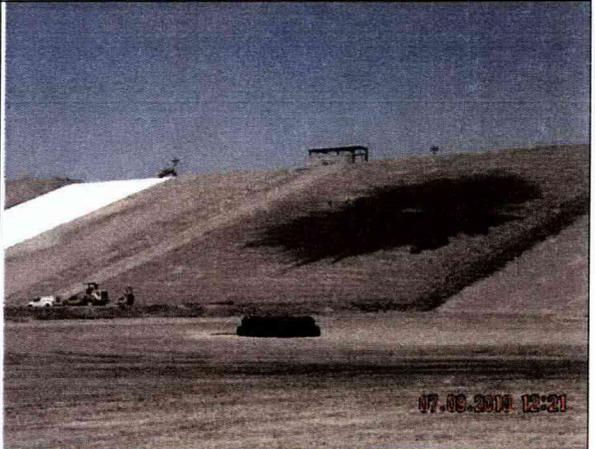
Facing NW – TWS using a laborer and a water hose to moisture condition the admix on the north slope on Cell 9.

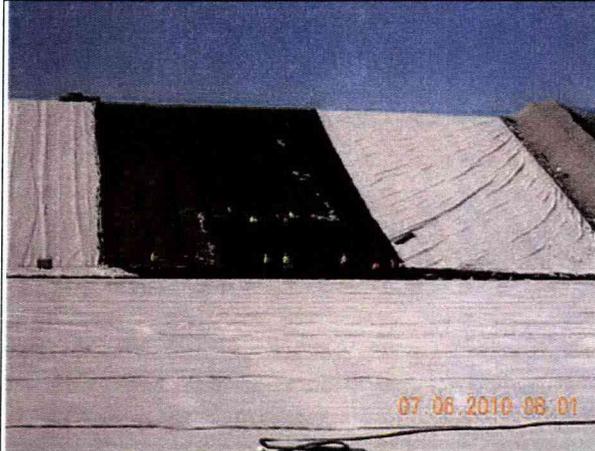
Facing S – ESI placing secondary geocomposite on the south slope of Cell 9.

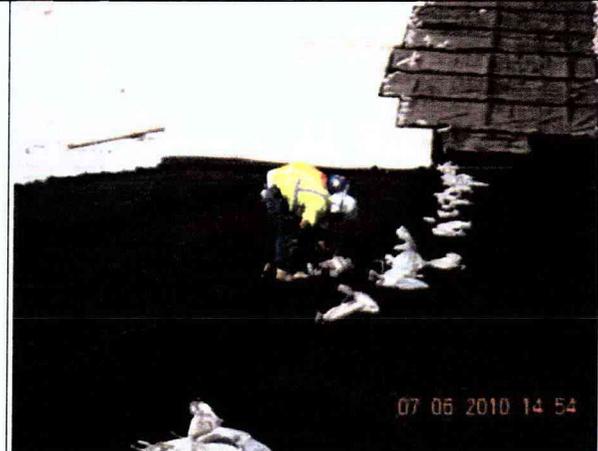
Facing N – ESI using a sewing machine to sew the fabric on the secondary geocomposite after all ties have been completed and inspected.

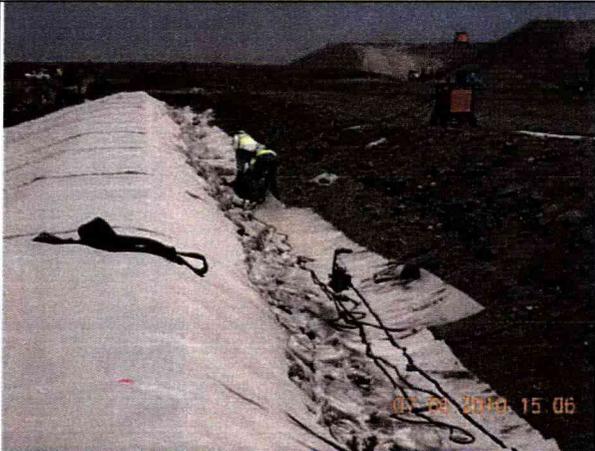
Facing E – ESI welding the secondary liner to the primary liner in the south anchor trench.

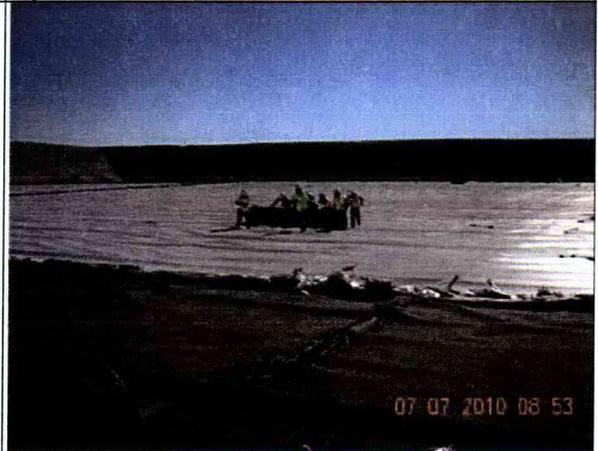
Facing E – ESI rolling secondary geocomposite across Cell 9 in preparation for placement.

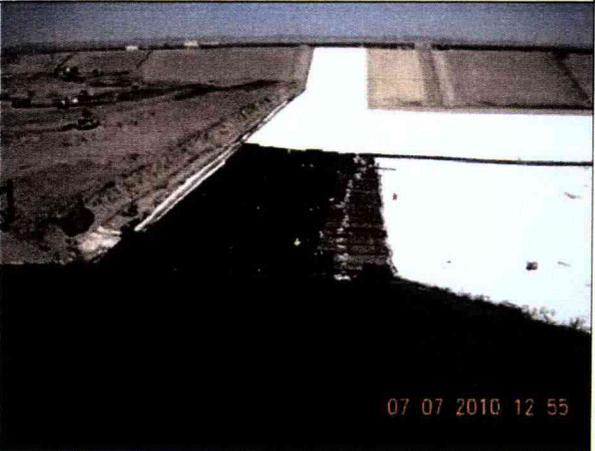
Facing N – ESI deploying secondary geocomposite on the south half of the floor in Cell 9.

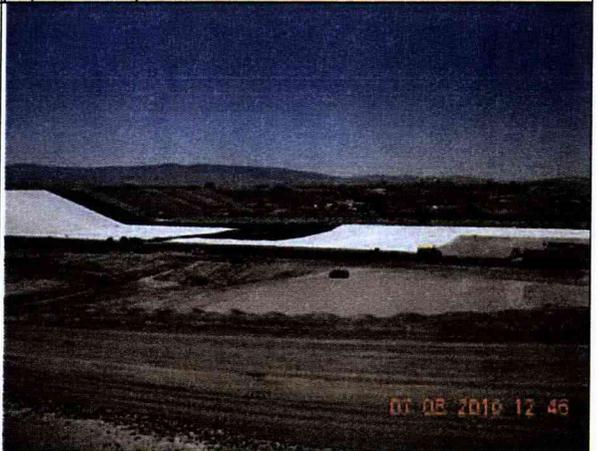
Facing SW – Overall view of liner and geocomposite in Cell 9.
