HNF-59342  
Revision 0

# Five-Year Surveillance Report for the 105-C, 105-D, 105-H, 105-F and 105-N/109-N Safe Storage Enclosures

Date Published  
March 2016

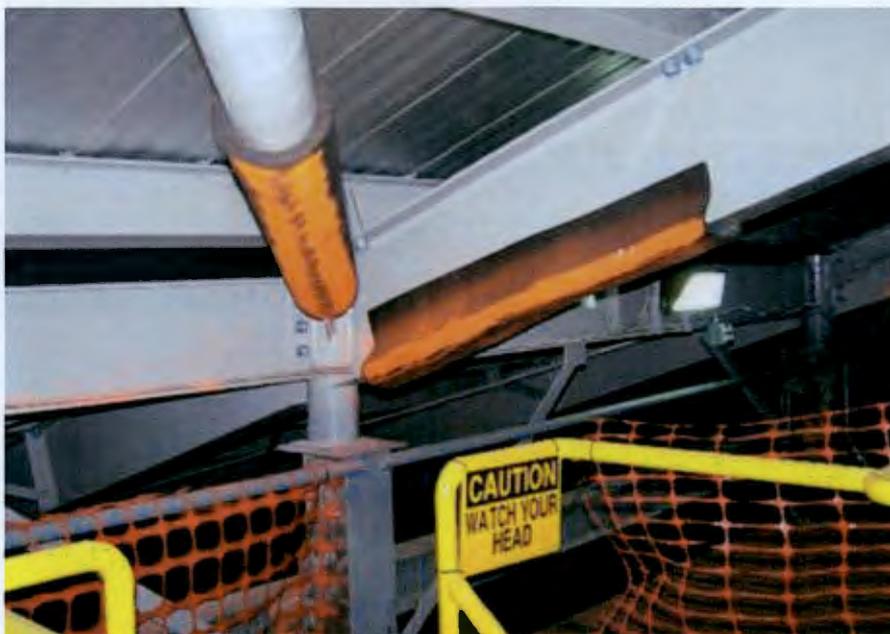
Barriers and postings such as those shown in Figure 3 are used to prevent unwarranted access to hazardous areas within the facility and to inform personnel of potentially hazardous conditions that exist in the SSE.

Figure 3. Barrier and Posting at 105-D SSE.

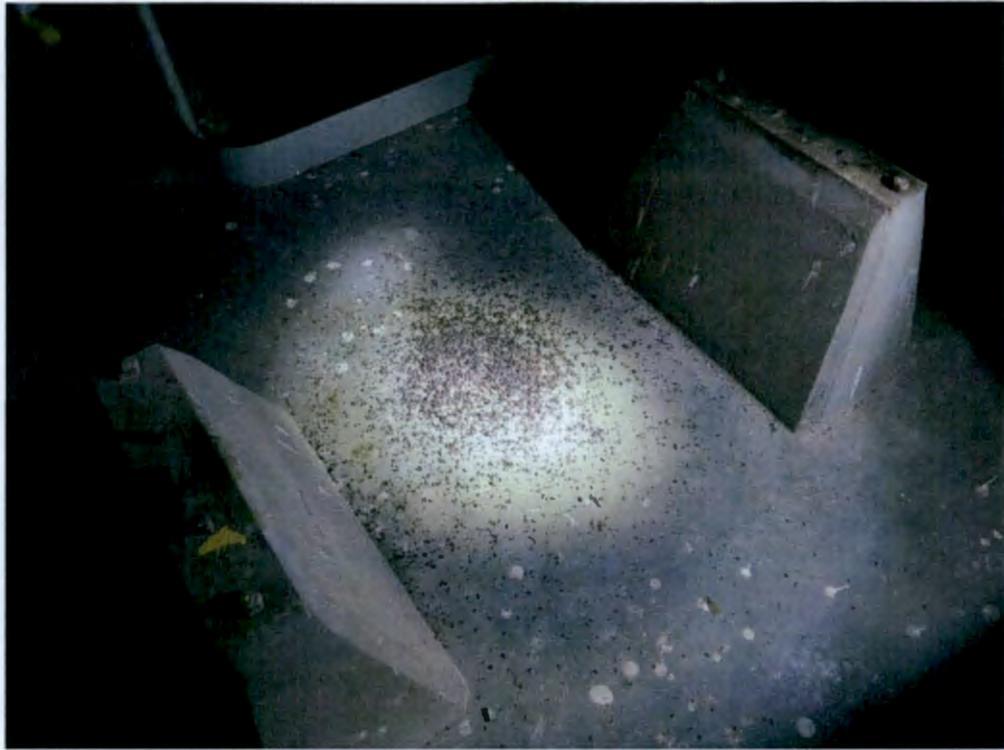
**Figure 1. Accumulation of Bat Guano on floors during reactor entry**

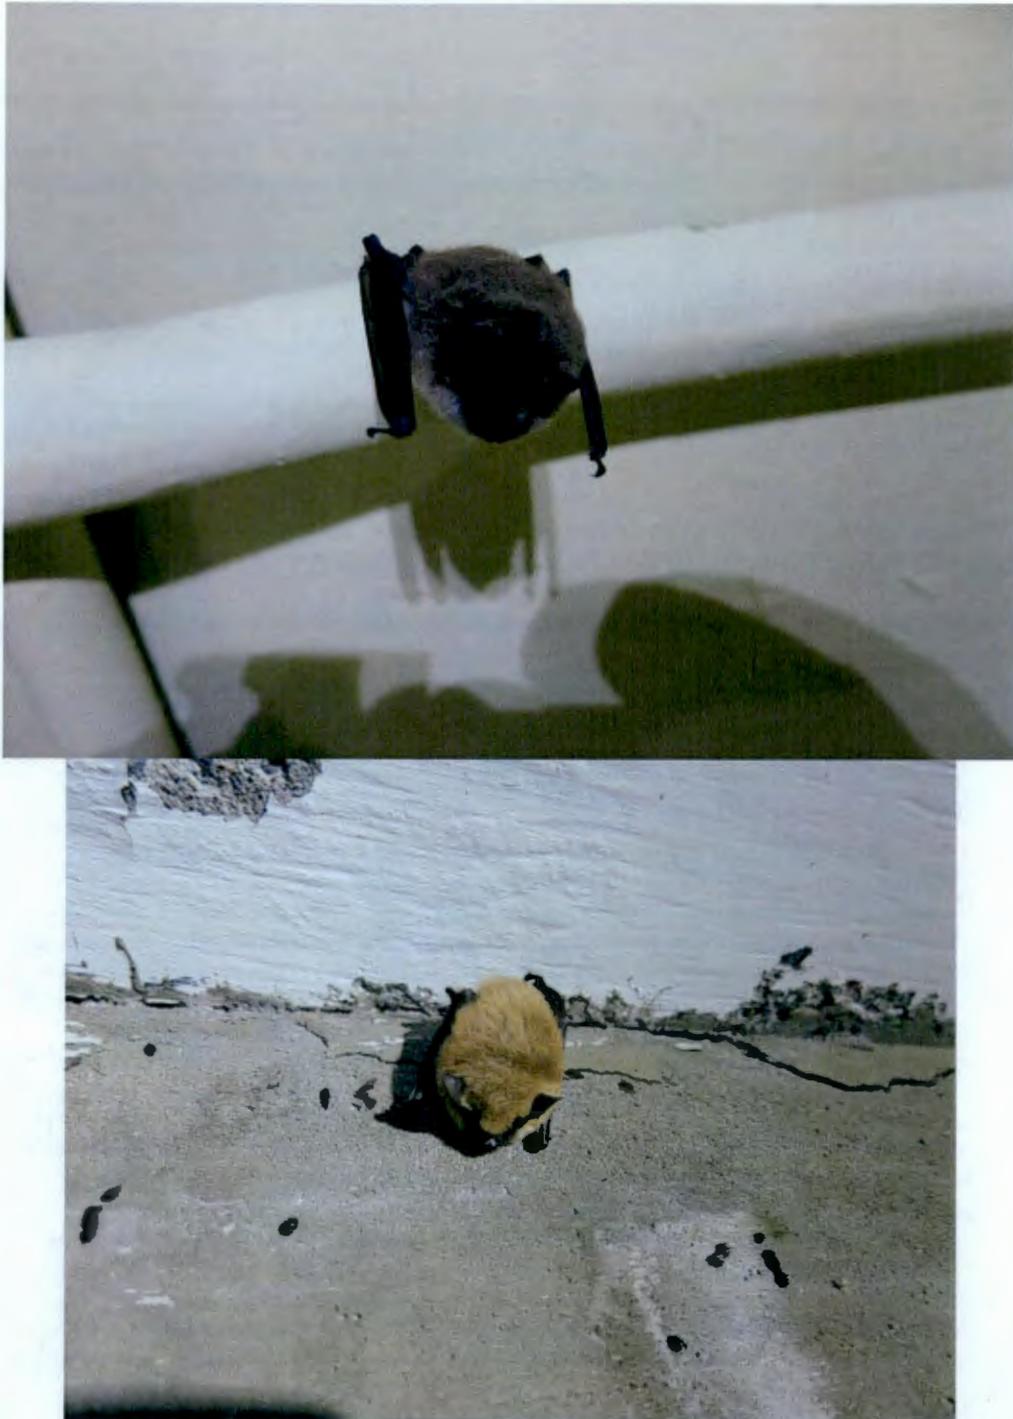
**Figure 2. Bats located inside the 100C reactor**

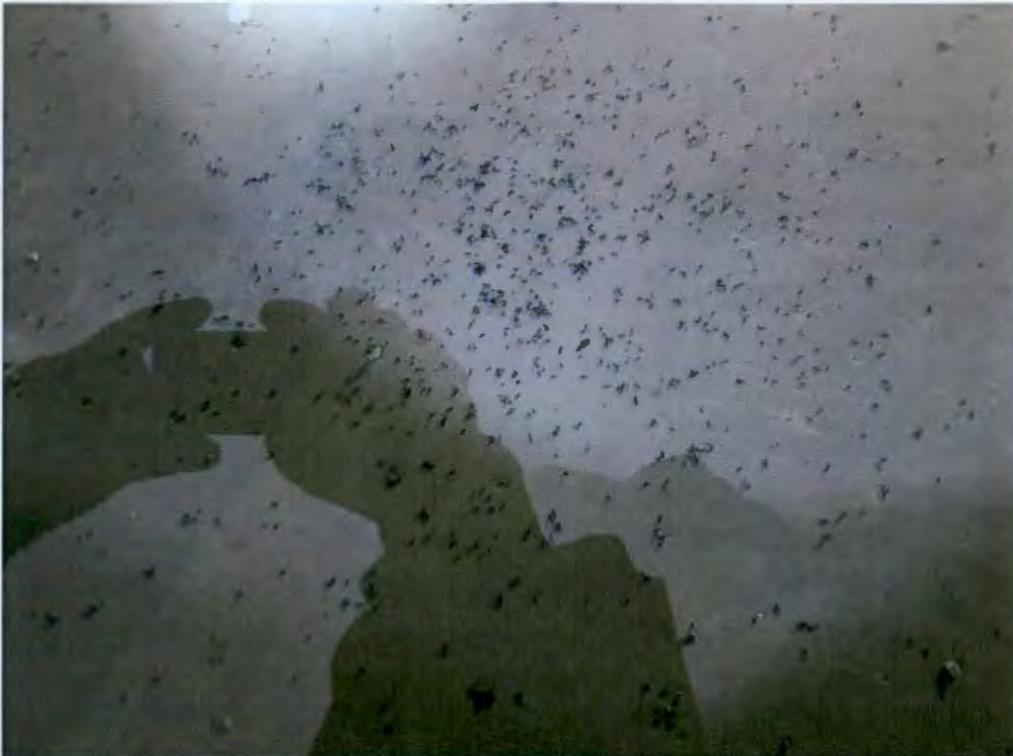
**Figure 1. Accumulation of Bat Guano below a Light Fixture in the 105-F Reactor SSE**

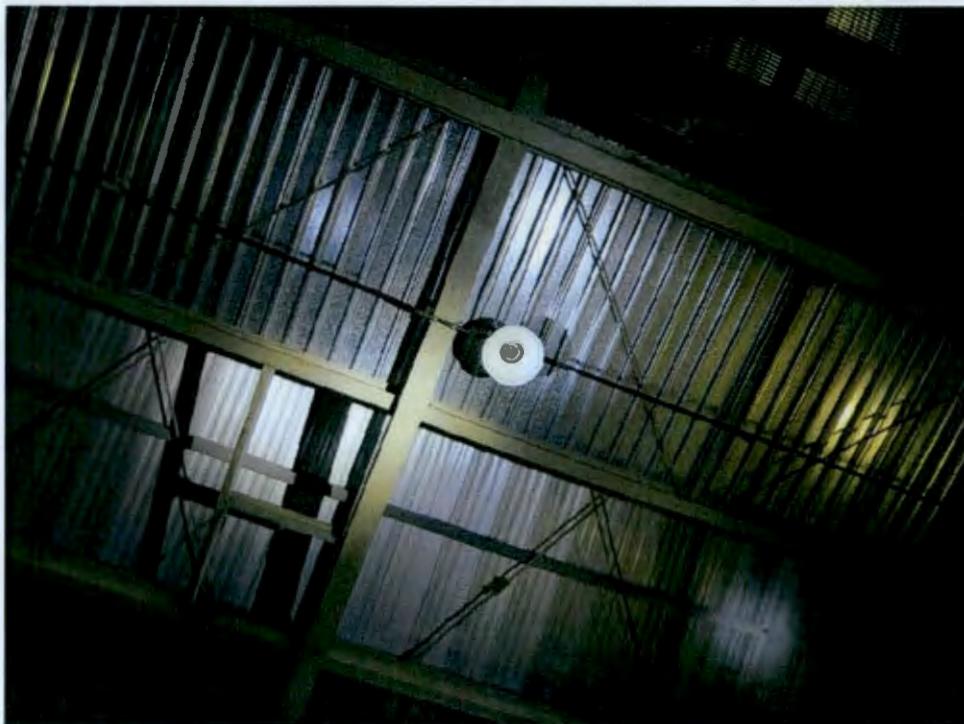
**Figure 2. Light Fixture in the 105-F Reactor SSE, a Probable Bat Roost Structure**

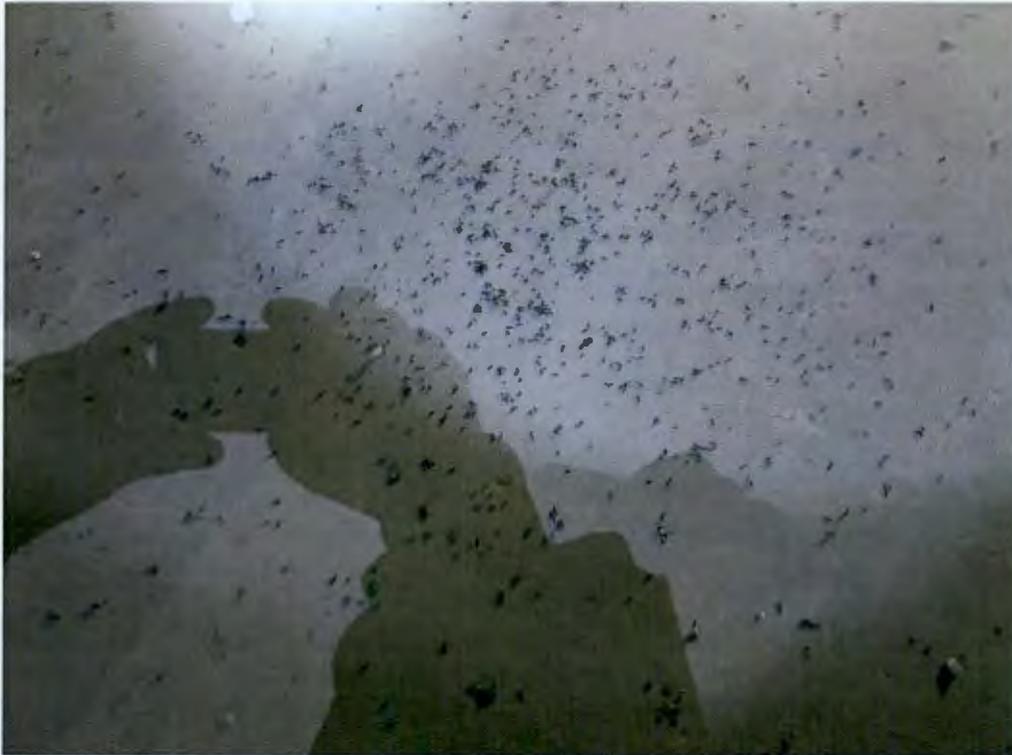
**Figure 1. Accumulation of Bat Guano below a Light Fixture in the 105-F Reactor SSE**

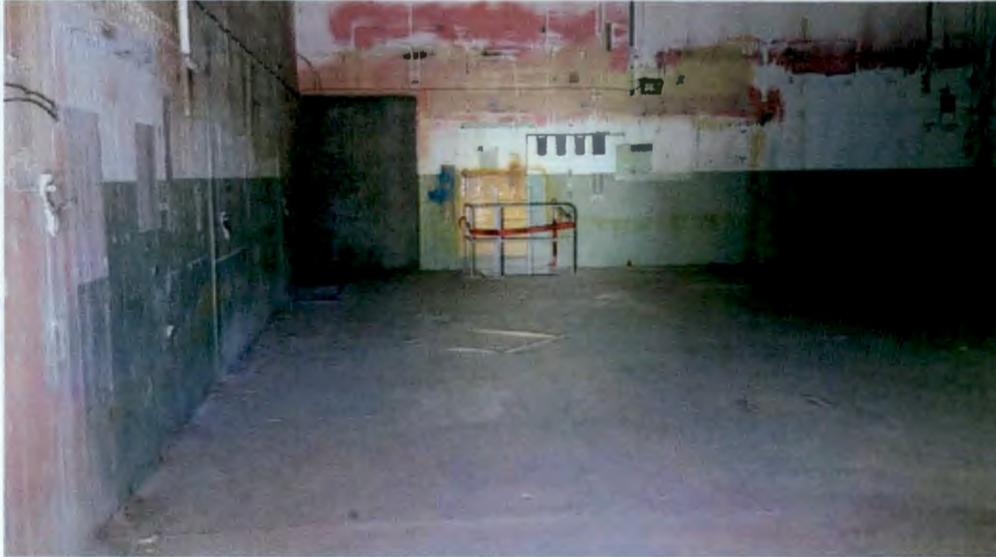
*Figure 1 Looking at guard rails around floor hole from 105 C door.*

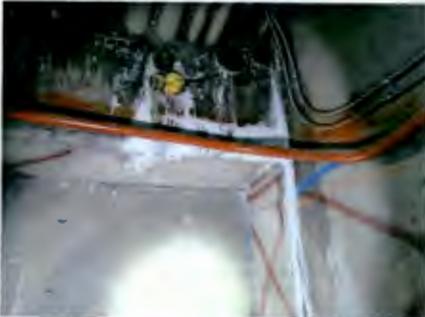
3581 When chipped off, a small chunk of this white deposit had a water drop inside. Somehow from recent water (rain). Also found some of this deposit on outside of bldg at same location

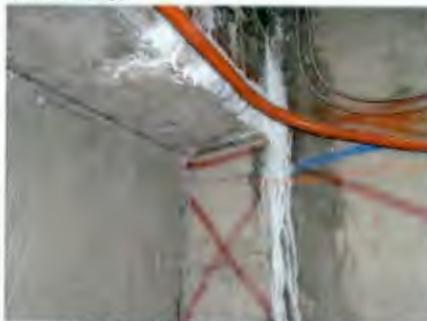
3582 white deposit on building interior

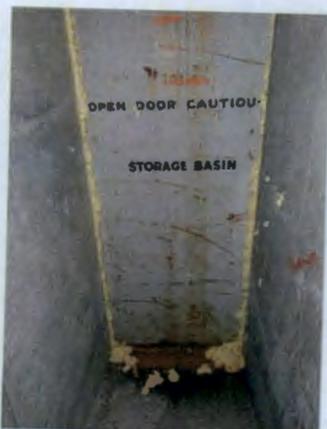
3594 Match THIS PICTURE WITH #3646  
Evidence of water/rust at bottom of door

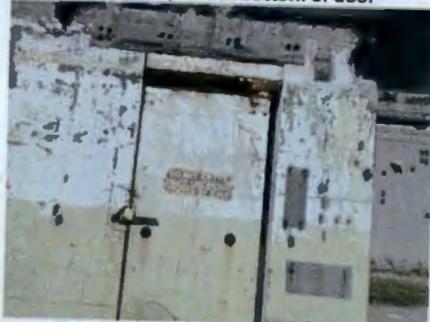
3646 Rear face shield door.. Evidence of rusting inside Possible weather protection issue

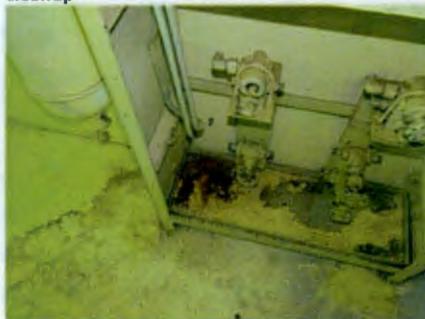
7. Hydraulic fluid is present in the equipment pan and on the floor (Appendix B, Photos 3601 and 3605).

#	New Photo #	Description	Area / Location	Recommendation	Notes
Item # 58	3605	Unknown Liquid at a Mechanical System Component	Elev. 30'-0"	Recommend continuing observation and clean up / removal when possible	Hydraulic fluid is staying well within the equipment pan. Entire area 2' x 3x fluid is from op sys for shield door in pic 3607
	3601	Fluid on floor from overhead winch	Elev.. 30'-0"		
	3602	Overhead winch	Elev.. 30'-0"		
	3607	Shield door with hydraulic operating system	Elev.. 30'-0"		Slow drip releasing hydraulic fluid in pic 3605

3605 Hydraulic fluid is staying well within the equipment pan. Entire area 2' x 3'

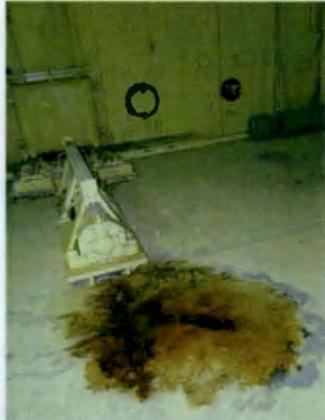
3601 Fluid on floor from overhead winch

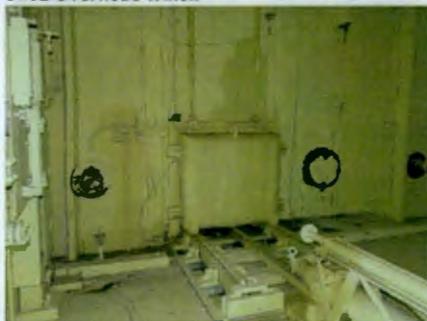
3607 Hydraulic fluid from this op system for this shield door dripping in pic 3605

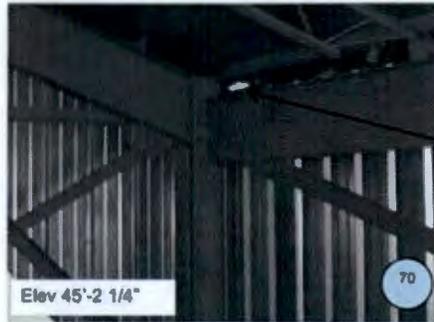
Area where light can be seen from the interior

Item 70 – 2008 Detail SS Details, Soffit area between wall and roof, Elev. 45'-2 1/4", visible light thru gaps,

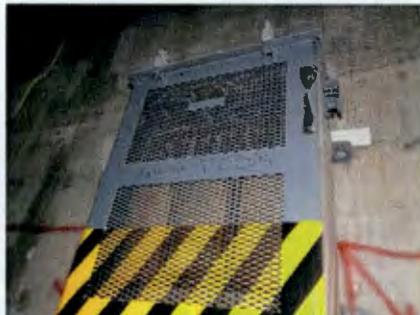
8. Two dry transformers observed at 45 ft 2¼ in. (Appendix B, Photos 3628 and 3629)

3628 Possible PCB in transformer

Two dry transformers were observed in 105-C SSE. A work package will be prepared to remove the transformers. The removal work will be completed in FY 2016.

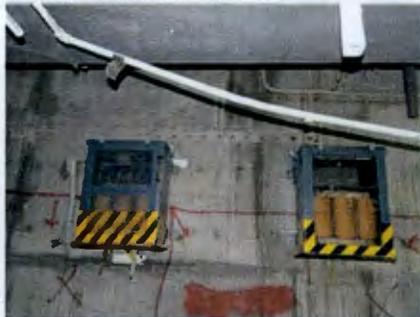
3629 Possible PCB in transformer

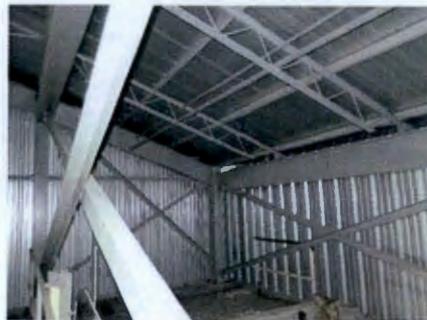
#	New Photo #	Description	Area / Location	Recommendation	Notes
	3622	General ISS Roofing structure	Elev. 59'-4"	Close corner openings. Continued observation to assure no change	Other than openings at corners, structure in very good condition. See pic# 70 on Elev. 45' for another example

3622 Other than openings at corners—structure in very good condition.

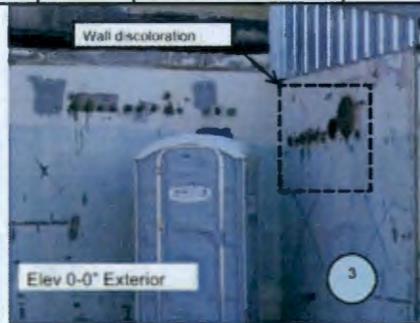
Item 3 -2008 Detail Exposed ISS Closure Details SW Wall of Building Exterior minor corrosion

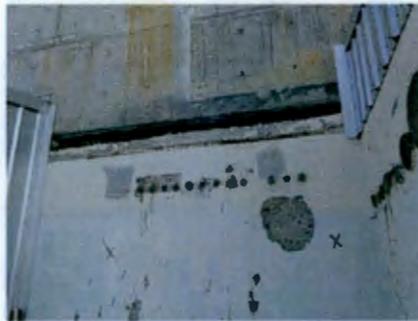
#	New Photo #	Description	Area / Location	Recommendation	Notes
Item # 3	3655	Exposed ISS Closure Details SW Wall of Building	Exterior, Elev. 0'-0"	Recommend plugging conduit opening on exterior	Open conduit

3655 Open Conduit

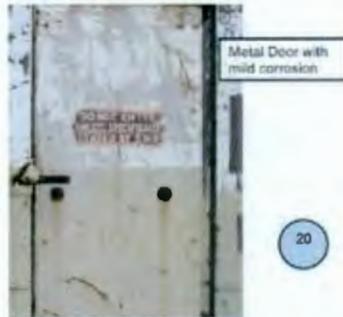
Item # 20 2008 Detail – Existing Metal door @ SE of Exterior building Elevation 0'0"

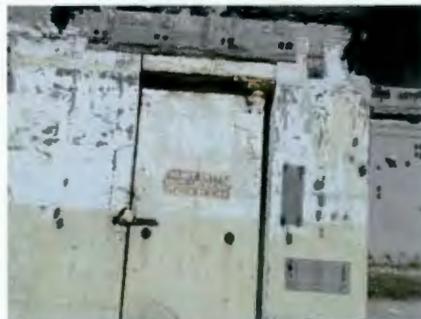
4. Attachment C-1; photo 3594 and 3646, and item 21 from 2008, show the interior and exterior of a steel door on the rear face that exhibit a good deal of corrosion on the outside at its base and some dampness and corrosion on the inside at this location.

3646 Rear face shield door. See picture # 3594. Possible WEATHER Protection issue  
See pic # 3594 @ 0' level interior

Item # 20	3646 3647	Existing Metal Door at SE of Exterior Building, Rear face shield door	Exterior, Elev. 0'-0"	Continue to observe, repair or replace with a pourback or plate if significant corrosion continues	See #3594 at 0" interior, minor corrosion

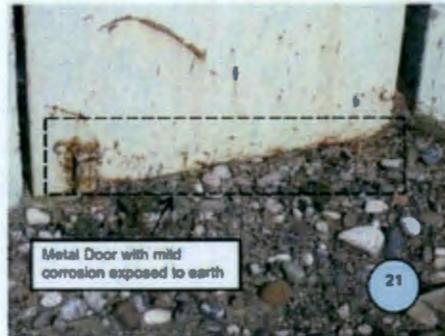
Item 21 – 2008 Detail Existing Reactor Metal Door at SE of Exterior Building Area , Elev. 0'-0",  
minor corrosion, soil removal recommended

Item # 21	No new picture	Existing Reactor Metal Door at SE of Exterior Building Area	Exterior, Elev. 0'-0"	Soil removal recommended	Minor corrosion
Item # 27	3642	Exposed Aggregate at E Corner Wall of Building	Exterior, Elev. 0'-0"	Periodically remove dirt from ledge to reduce likelihood of growing grass	Grass growing on ledge provides an attractive habitat

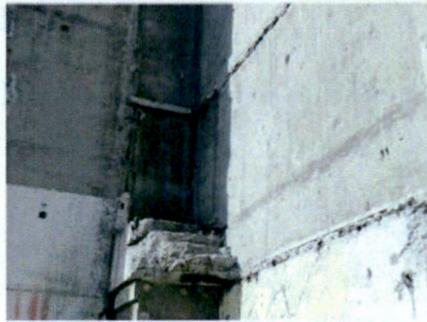
3642 Grass growing on ledge

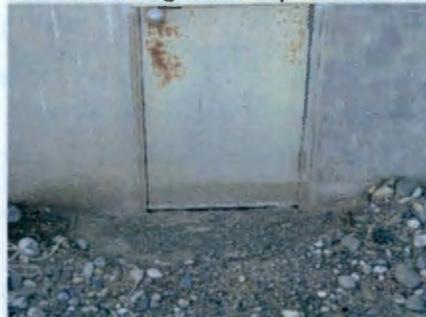
3641 Area of soil removal needs to be more of a gradual slope rather than a hole funneling rain water to the bottom of door jam.

Item # 33	3640 3641	Metal Door at N Wall of Building Exterior	Exterior, Elev. 0'-0"	Area of soil removal needs to be more of a gradual slope rather than a hole funneling right to the bottom of the door jam	Mild corrosion

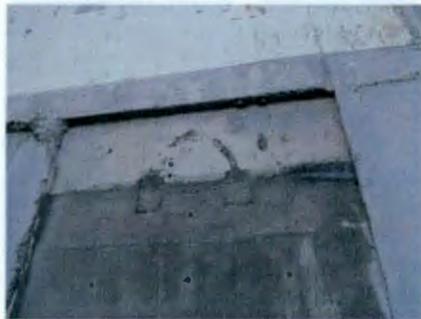
3631 Concrete pourback has cracks across top...Not an issue but should be watched for changes.

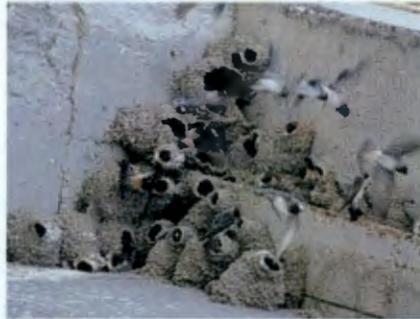
3638 swallows nesting

3638	Swallows nesting	Exterior, Elev. 0'-0"	Recommend continued observation	
	3656	Main Vestibule Entrance	Exterior, Elev. 0'-0"	Update posting	Postings on main vestibule entrance outdated

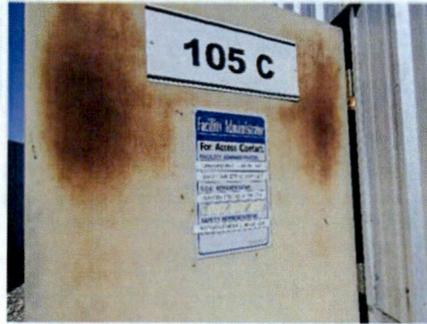
3656 Postings on main vestibule entrance outdated

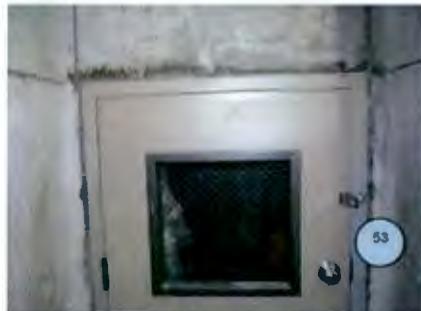
Item # 53 2008 Detail ISS Door Detail, Elev. -17'-6", no visible structural degradation

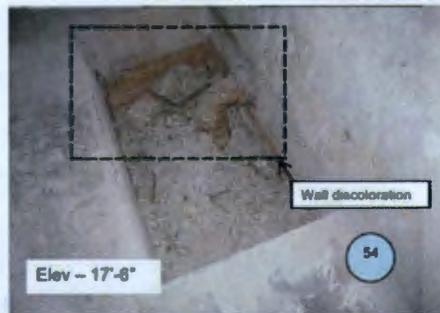
Item # 54 2008 Original Building Structure Floor Detail, Elev. -17'-6", moderate corrosion

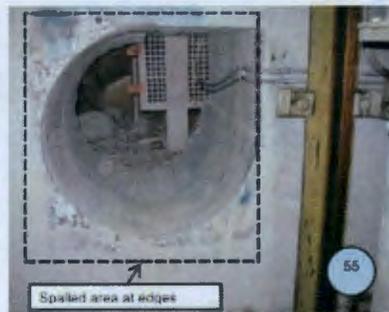
Item # 55 2008 detail spalling

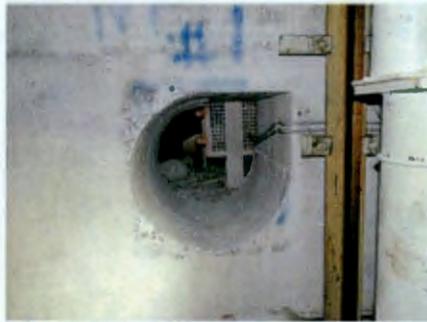
3584 View into water tunnel... Dry

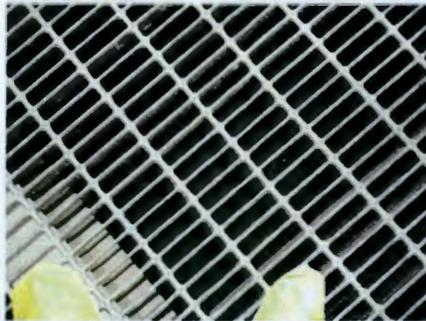
3590 -10' level Dried mud several feet below grating floor (@ -17' grade). Mud dried like tile pattern...cracked mud floor..very dry for a long time.

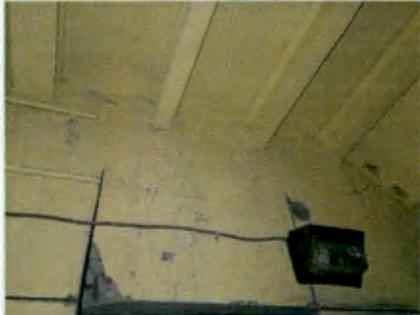
3591 No spalling—piece came out during saw cut of doorway

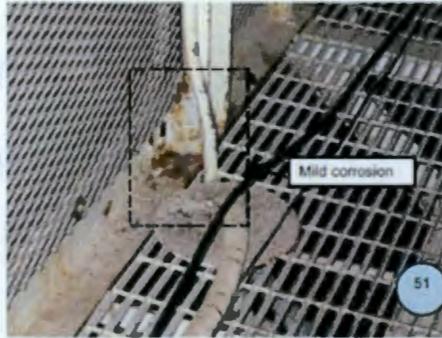
Item # 51 2008 Original Building Structural details @ building interior moderate corrosion

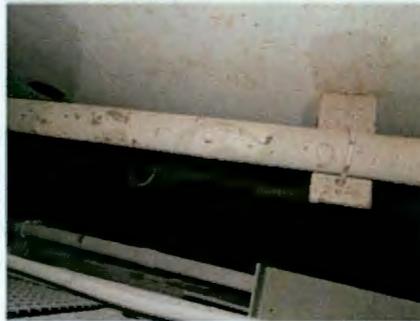
3596 D elevator pit Dry

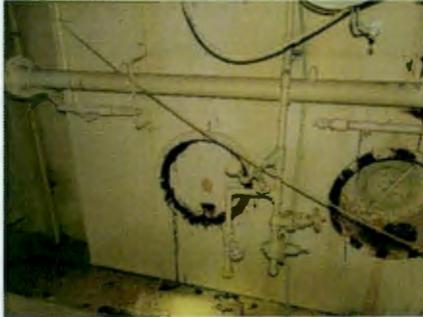
3598 No visible change

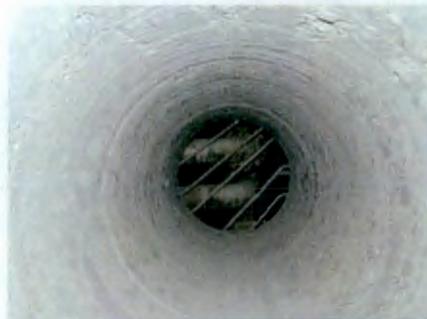
3599 Cutout to rear face

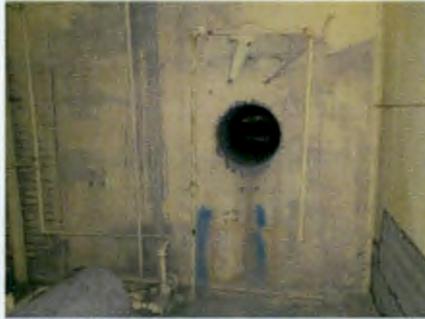
3600 Cutout to rear face

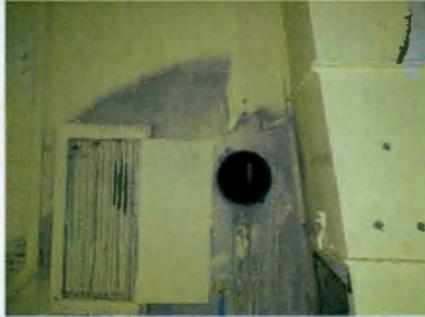
3603 Cut out to rear face

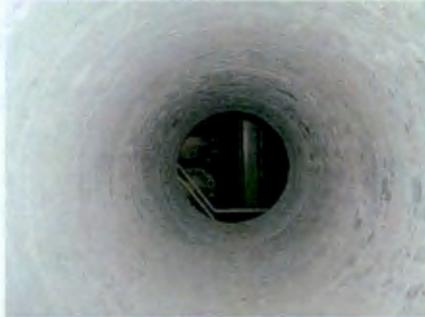
3604 Cut out to rear face

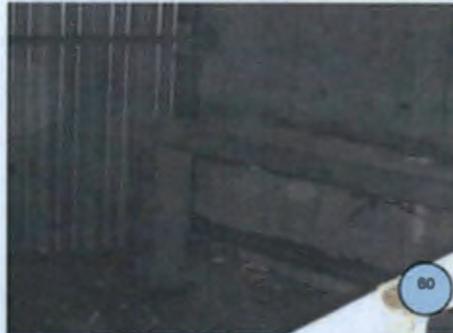
Item 60 –2008 Detail ISS Details, walls & girts, Elev. 45'-2 1/4", no visible structural defects

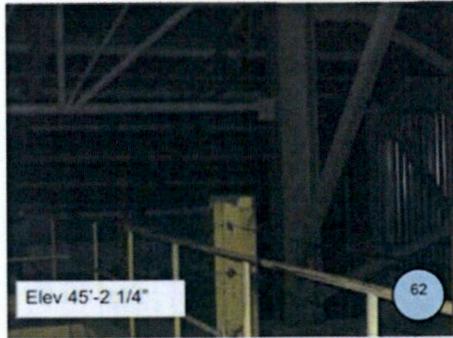
Item 62 2008 Detail – ISS Details, Columns & Beams, Elev. 45'-2 1/4", no visible structural defects

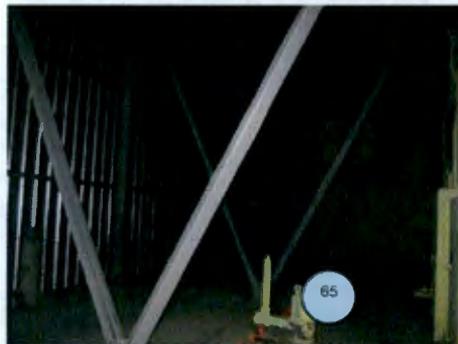
Item 65 – 2008 Detail ISS Details, trusses, Elev. 45'-2 1/4", no visible structural defects

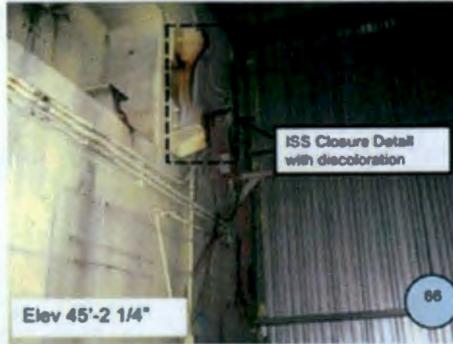
Item 66 – 2008 Detail ISS Details, Original Beam, Elev. 45'-2 1/4", no further structural degradation

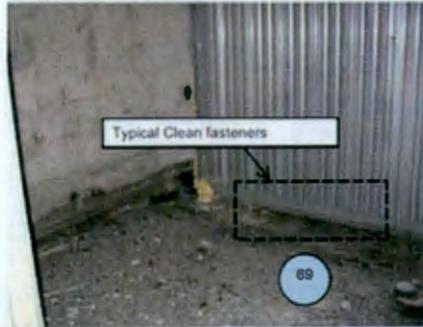
Item 69 – 2008 Detail ISS Details, fasteners, Elev. 45'- 2 1/4", no visible structural defects

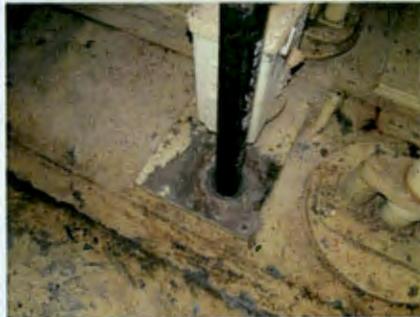
3611 vent penetration to top of reactor block / below HEPA filter housing

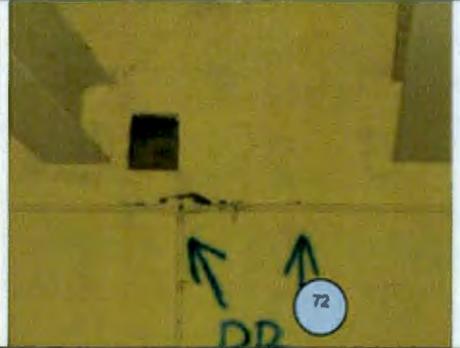
<p>72</p>	
<p>Item 72 – 2008 Detail ISS Details, pourbacks, Elev. 59'- 4", no visible structural defects</p>

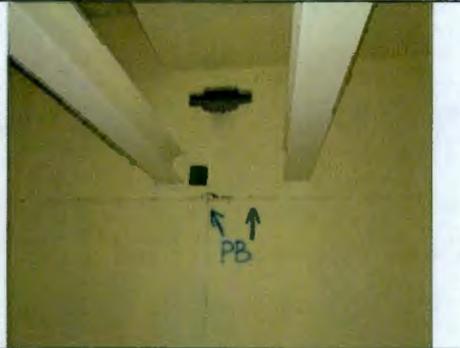
<p>PB</p>	
<p>3624 No change to condition</p>

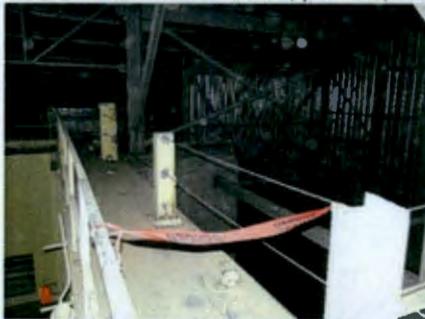
3619 Demolition beyond access boundary

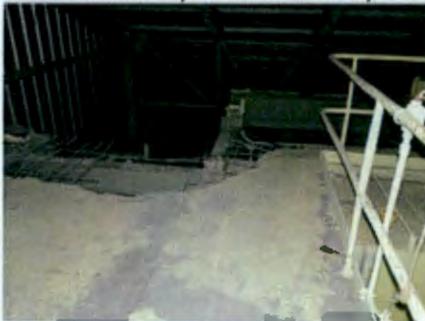
3620 Demolition beyond access boundary

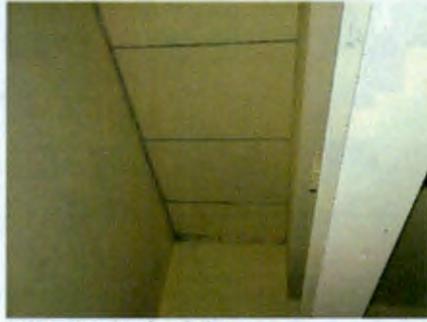
3625 old ceiling/roof plugs

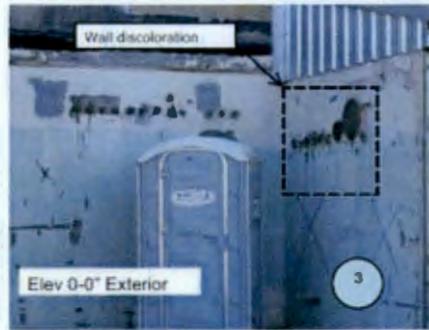
Item 3 -2008 Detail Exposed ISS Closure Details SW Wall of Building Exterior minor corrosion

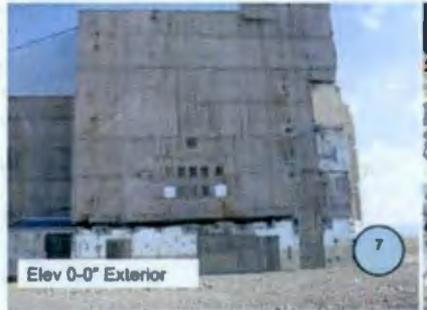
Item 7 – 2008 Detail View of South Wall, Elevation 0'-0"

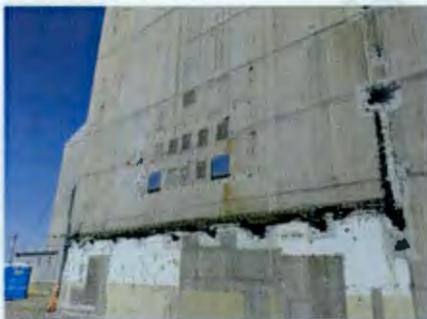
3652 HEPA Filter covers on south side of building, HEPA filter noted on interior +15' Experimental Room

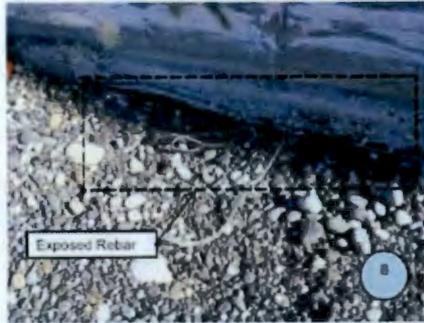
Item 8 –2008 Detail Exposed Foundation/Floor Rebar at S Wall of Building Exterior, Elev 0'-0", recommend soil removal

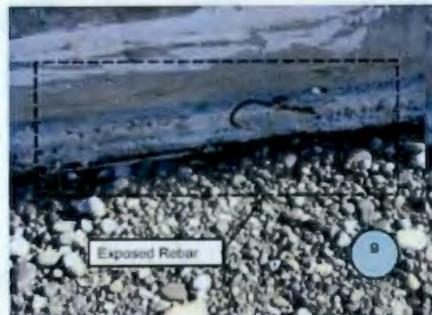
Item 9 2008 Detail– Exposed Foundation/Floor Rebar at S Wall of Building Exterior, Elev 0'-0", recommend soil removal

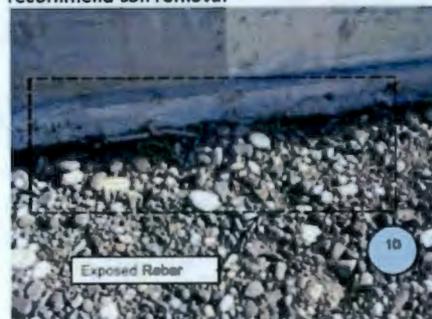
Item 10 –2008 Detail Exposed Foundation/Floor Rebar at S Wall of Building Exterior, Elev. 0'-0", recommend soil removal

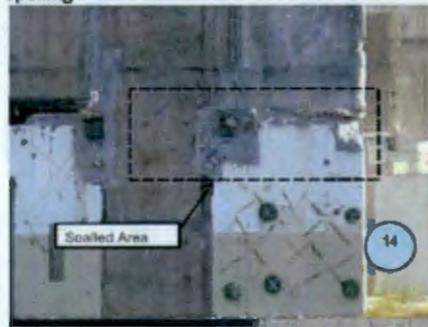
Item 14 2008 Detail– Exposed Aggregate at SE Wall Corner of Building Exterior, Elev. 0'-0", spalling

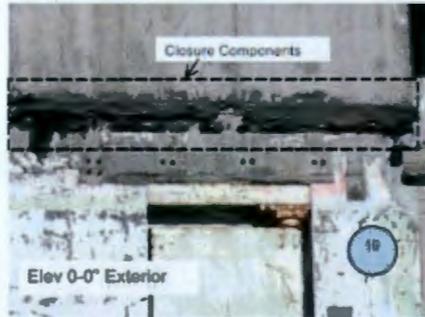
Item 19 – 2008 Detail Exposed ISS Detail at SE Wall of Exterior Building, Elev. 0'-0",  
discoloration item

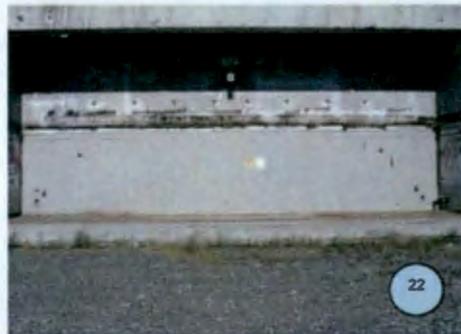
Item 22 – 2008 Detail ISS Closure Detail, Elev. 0'-0", no visible defect

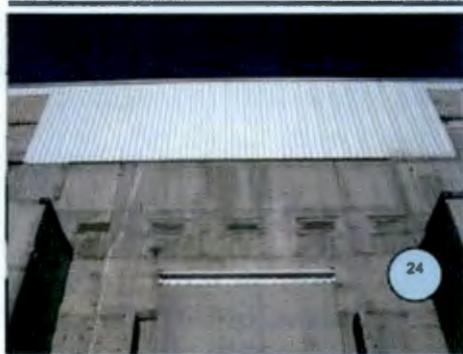
Item 24 2008 Detail – ISS Closure Detail, as seen from Elev. 0'-0", no visible defect

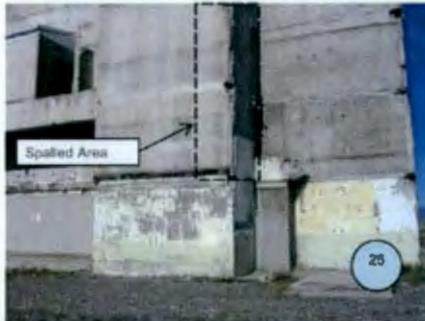
Item 25 –2008 Detail Exposed Aggregate at E Corner Wall of Building Area , Elev. 0'-0", spalling

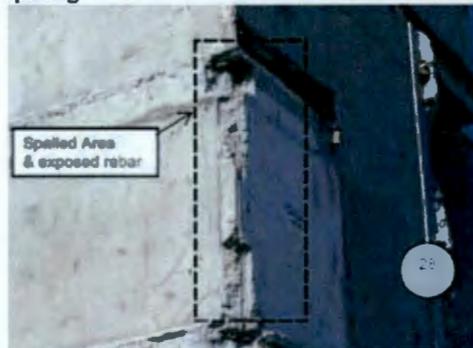
Item 28 –2008 Detail Exposed Aggregate at E Corner Wall of Building Area , Elev. 0'-0" , spalling

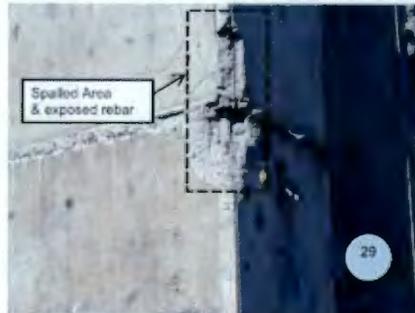
Item 29 –2008 Detail Exposed Aggregate at NE Corner Wall of Building Exterior, Elev. 0'-0", spalling

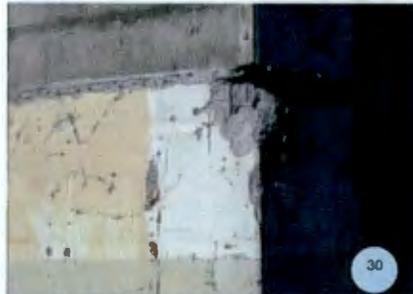
Item 30 –2008 Detail Exposed Aggregate at NE Corner Wall of Building Exterior, Elev. 0'-0", spalling

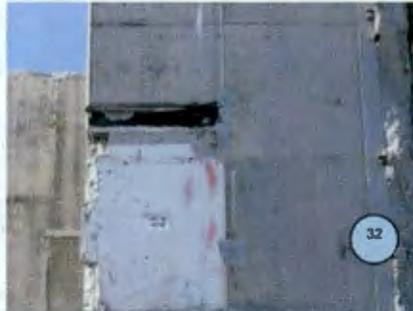
Item 32 2008 Detail Exposed Aggregate from ISS detail at Wall of Building Exterior, as seen from Elev. 0'-0", no further visible defect

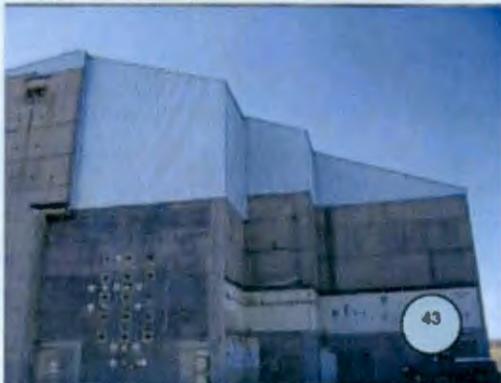
Item # 43 2008 Details Pourback ISS details @ NW wall of bldg. exterior

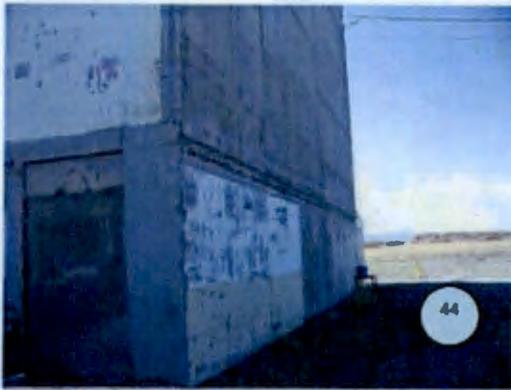
Item 44 – 2008 detail View of NW Wall of Building Exterior, from Elev. 0'-0"

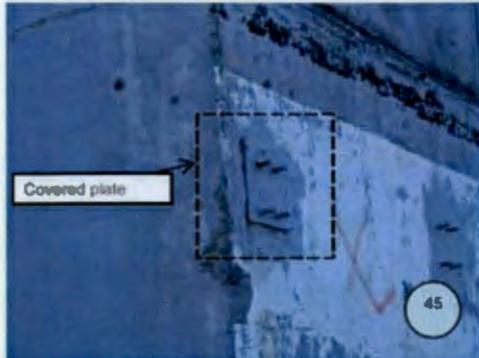
Item 45 -2008 detail Exposed ISS detail at NW Wall of Exterior Building, from Elev. 0'-0", no visible

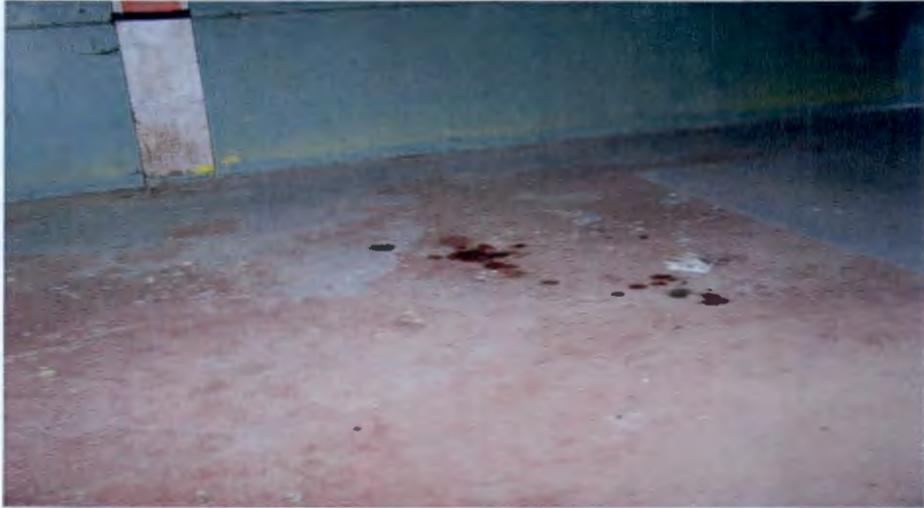
Photo 2

- The ground level was found to be clear. There was a small hydraulic puddle in the north end of the room that appears to be caused by the over head hoist. (Photo 2)

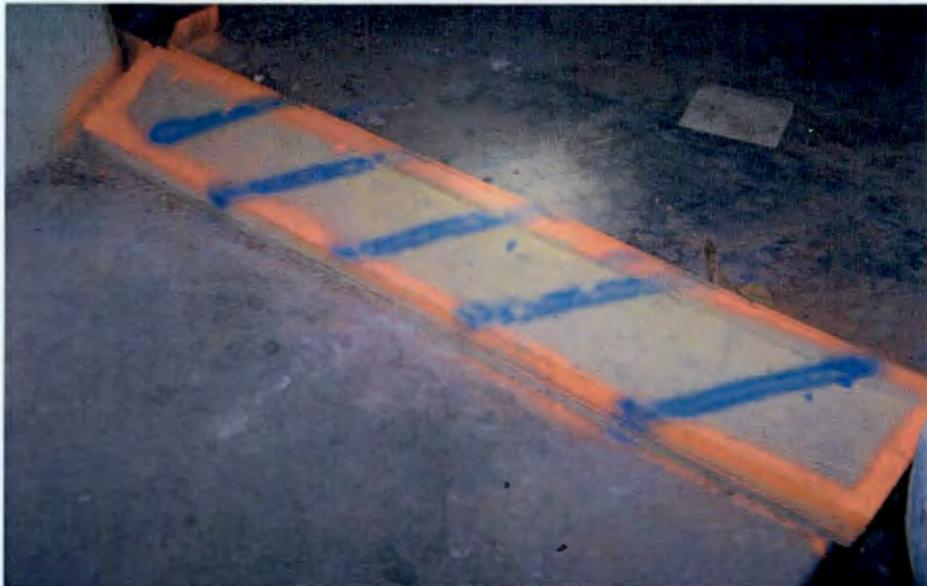
Photo 3

- Trip hazard at the top of the stairs leading into the room (Painted Orange). (Photo 3)
- Tray protruding into walk way (Painted Orange). (Photo 4)
- Metal floor seam pulling apart and curling up posing a trip hazard, this is not painted orange but can be avoided by staying on the walk path.
- Trip hazard at bottom of stairs leading up to the 42' level. This is the metal flooring turns up like a "drip pan" (Painted Orange). (Photo 5)

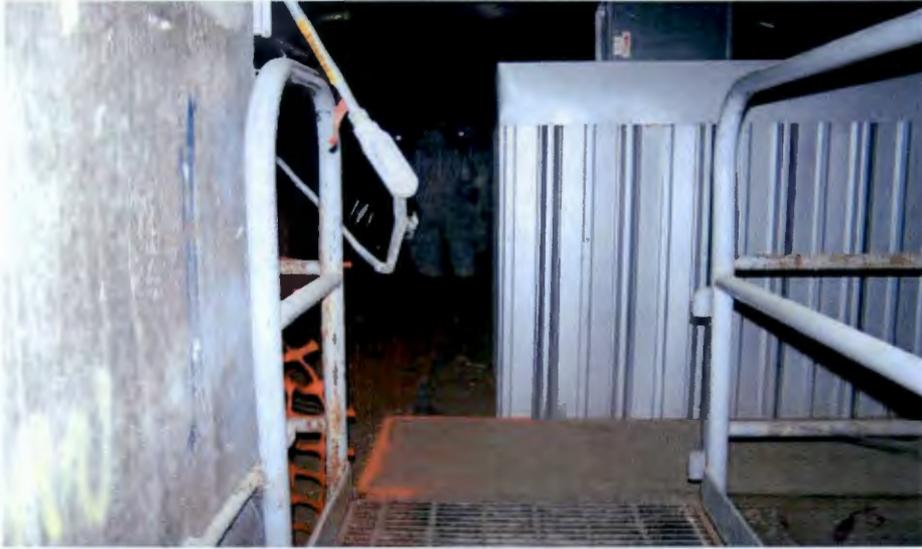
Photo 6

- Rise on top steps of bridge are taller than normal making this small stair case ununiformed.
- Conduit protruding into walkway while crossing the bridge between the stairs and "top hat" floor. (Photo 6)
- Wooden platform covering "top hat" floor has step down on west end of "top hat" posing tripping hazard (Painted Orange). (Photo 7)

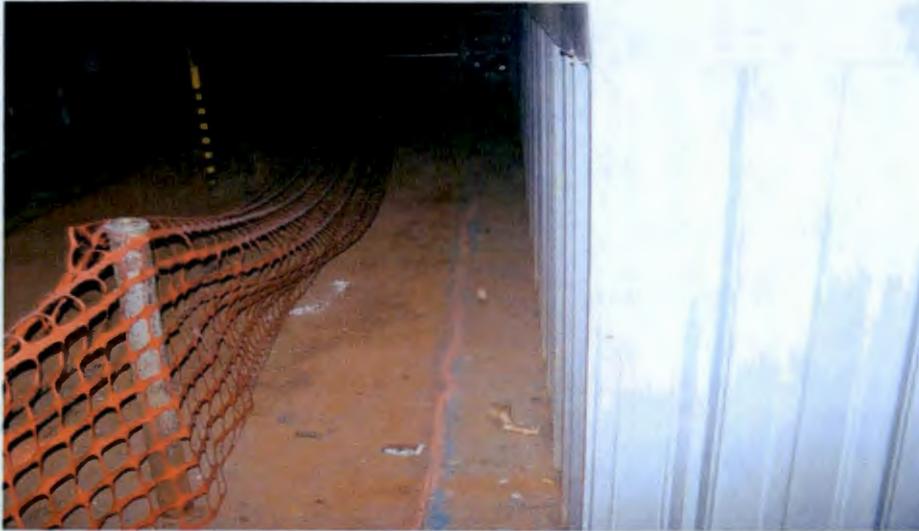
Photo 8

- “Top hat” floor has approx. 1” rib at seam posing a tripping hazard (Painted Orange). (Photo 8)
- Back side of tank on SE corner of top hat has a picking eye protruding into the walkway posing a struck against hazard (Painted Orange). (Photo 9)

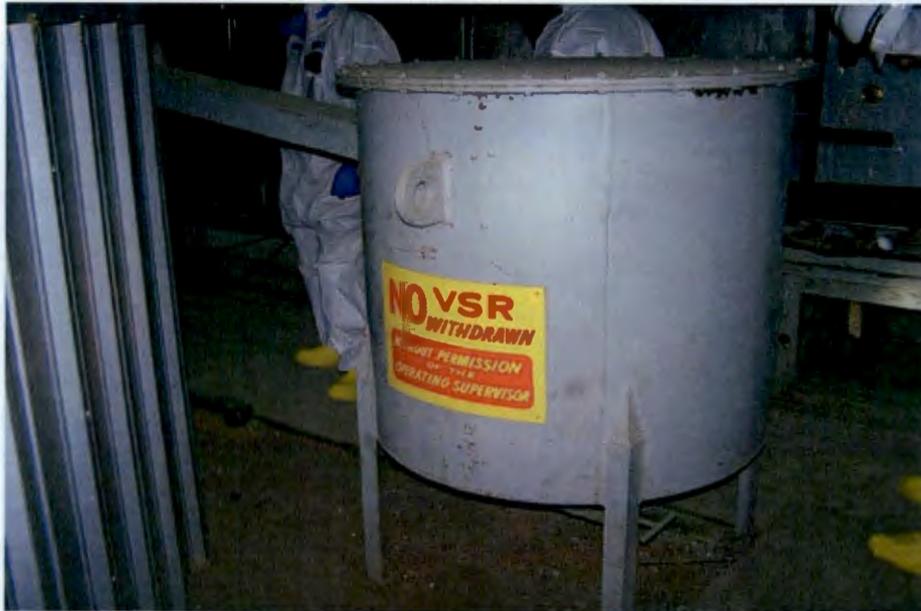
Photo 9 (Struck by hazard is actually on the back side of this tank, painted orange)

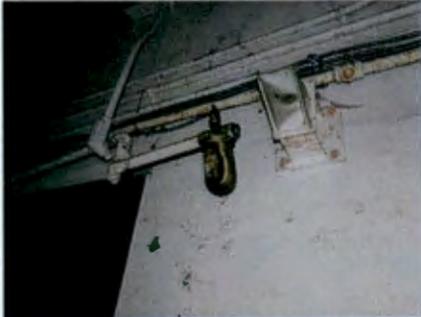
3538 Air line filter has residual fluid dripping from it

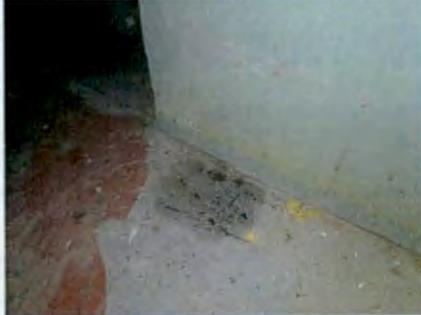
3539 floor below air line filter

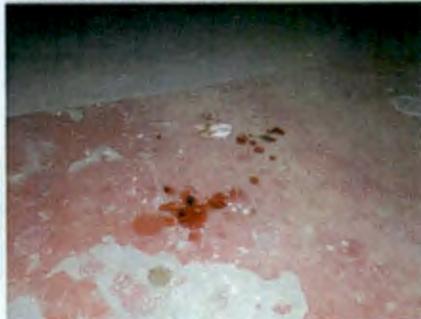
3540 under dripping winch from 40' level

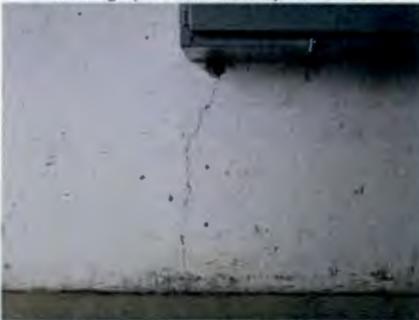
3543 inside vestibule crack on wall under electrical box

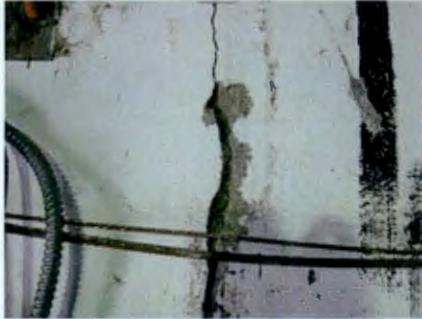
3544	Wall crack	0' level Outer vestibule	Recommend continuing observation
	3545	Wall crack	0' level Outer vestibule	Recommend continuing observation
	3546	Wall crack	0' level Outer vestibule	Recommend continuing observation
	3561	Wall crack with monitor installed	0' level Outer vestibule	Crack monitor installed in vestibule on concrete wall crack Recommend continuing observation
	3562	Wall crack with monitor installed	0' level Outer vestibule	Crack monitor installed in vestibule on concrete wall crack. Same as picture 3561
	3659	Wall crack showing on interior wall	0' level inside— opposite side of vestibule wall	Recommend continuing observation
	3669	Wall crack w monitor installed	0' level inside— opposite side of vestibule wall	Recommend continuing observation

3545 vestibule crack

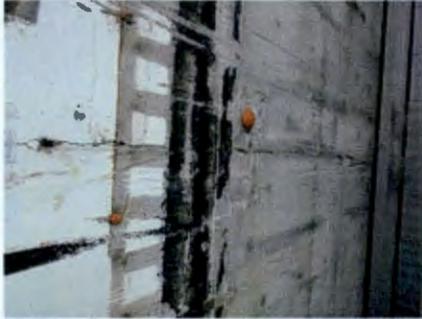
3546 vestibule crack

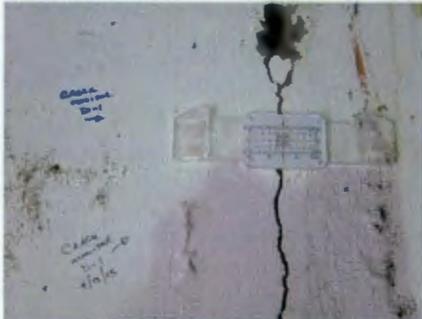
3561 crack monitor installed in vestibule on concrete wall crack

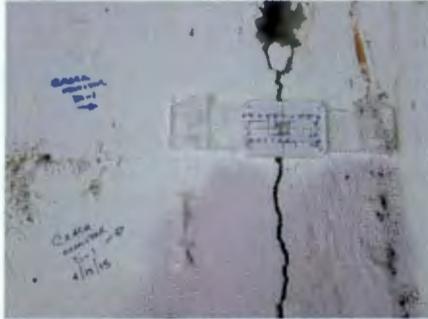
3562 Crack monitor installed in vestibule on concrete wall crack

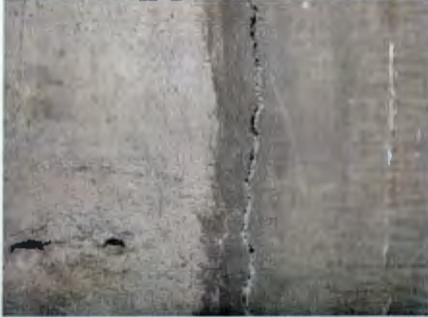
3659 Wall crack inside facility other side of vestibule wall

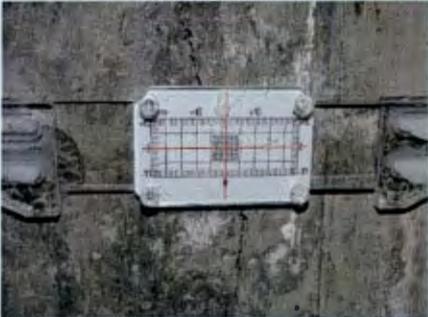
3669 Wall crack with crack monitor installed. Other side of vestibule wall

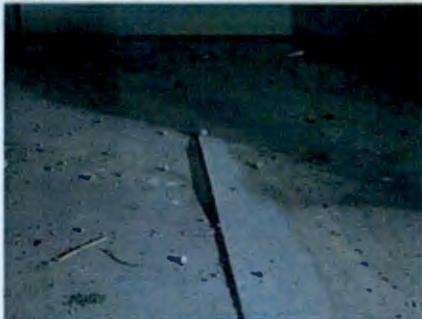
Item #	New Photo #	Description	Area / Location	Future Inspection/Maintenance Recommendations
14, 14A	3505 3506 3507	Floor	Interior – Elev. 13'-0"	Floor panel previously just discolored, now seems to be lifting at edge Recommend continuing observation

3507 floor panel lifting at edge

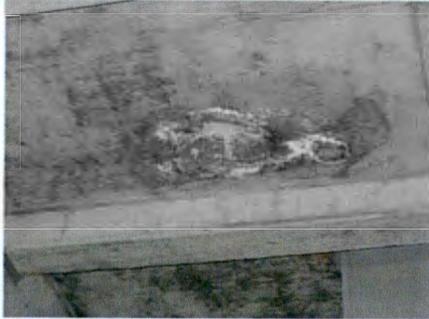
3509 White discoloration on surface of concrete looking up at ceiling in multiple locations

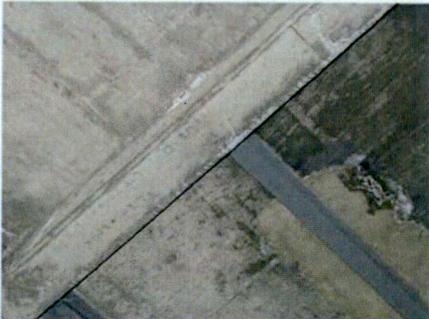
3508 White discoloration on surface of concrete looking up at ceiling in multiple locations

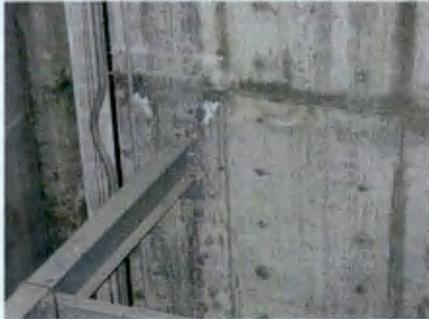
3510 White discoloration on surface of concrete looking up at ceiling in multiple locations

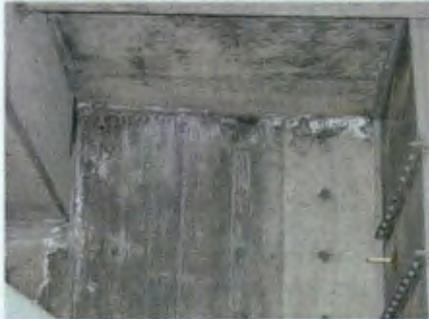
3511 White discoloration on surface of concrete looking up at ceiling in multiple locations

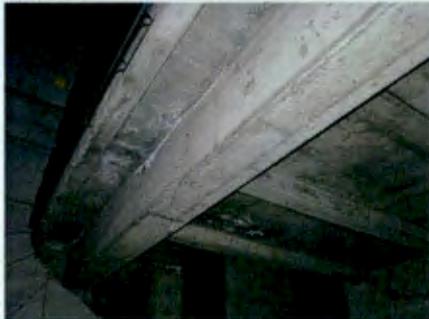
3512 White discoloration on surface of concrete looking up at ceiling in multiple locations

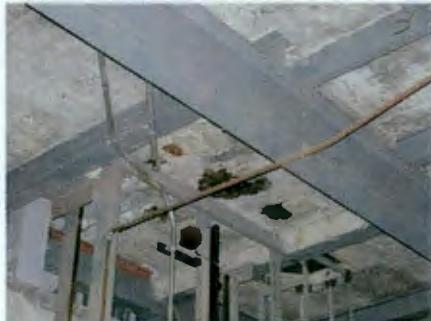
Item #	New Photo #	Description	Area / Location	Future Inspection/Maintenance Recommendations
19, 19A	3513	Guard Rails	42' 4 5/8"	Fall Hazard
	3516	Mechanical equipment blocking Surveillance path	42' 4 5/8"	S & M plan needs to be revised to show proper path. Unable to get all around top hat
	3530	Under side of floor above	42' 4 5/8"	42' elevation looking up under 56' elevation...several "holes" in floor with darkness around them... Same type of "holes" on other side of bldg. at exact same place....previous equipment used these penetrations Recommend continuing observation

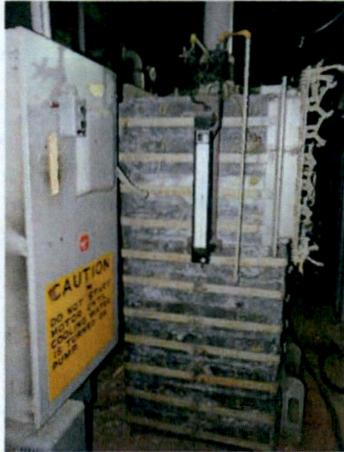
3516 On the current surveillance route behind the top hat on the west side... route should be revised so as not to walk "behind" the top hat. Very narrow area.
