HNF-59342  
Revision 0

# Five-Year Surveillance Report for the 105-C, 105-D, 105-H, 105-F and 105-N/109-N Safe Storage Enclosures

Date Published  
March 2016

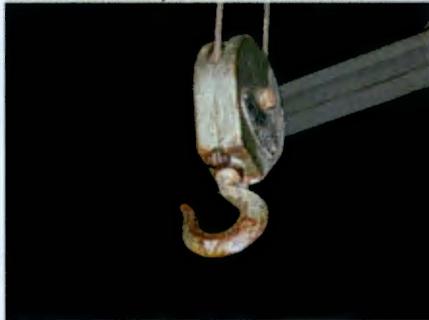
3515 Winch located above the reactor above the 80' elevation is leaking soil/grease. Oil/grease is dripping down chain/hood and floor below chain/hood which can be seen while standing in northwest portion of 56'4" level looking up.

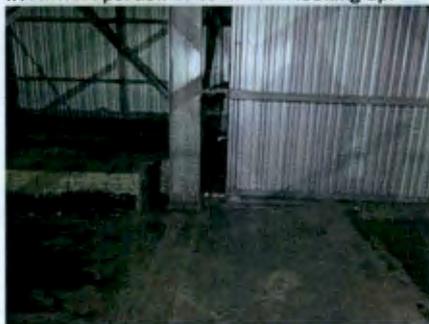
3519 On ease side of structure, various locations were observed in which light from the outside could be seen through gaps

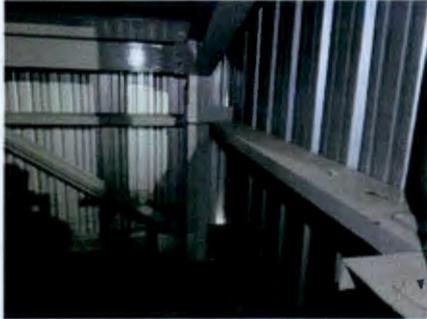
3520 On ease side of structure, various locations were observed in which light from the outside could be seen through gaps

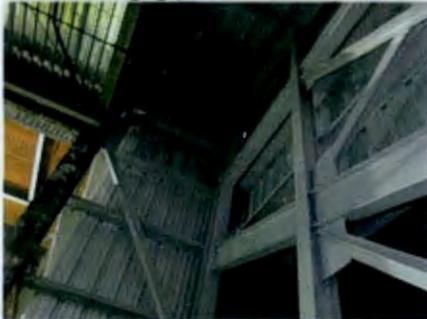
3521 On ease side of structure, various locations were observed in which light from the outside could be seen through gaps

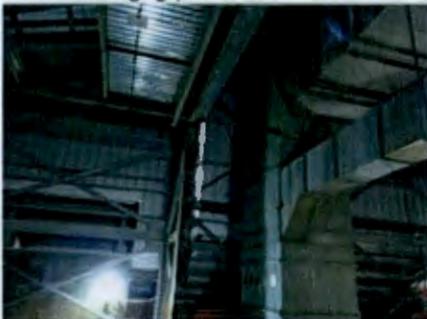
3522 On ease side of structure, various locations were observed in which light from the outside could be seen through gaps

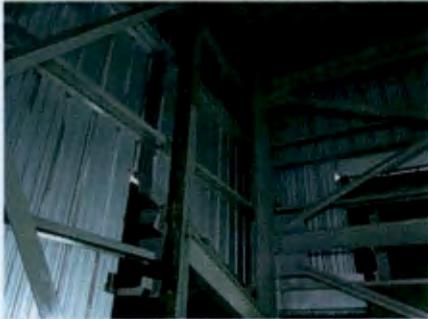
3523 On ease side of structure, various locations were observed in which light from the outside could be seen through gaps

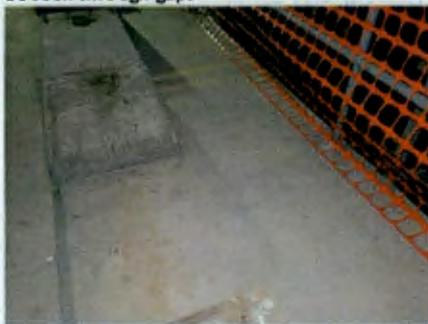
3525 Hairline cracks in concrete across "catwalk" around top hat. Several cracks exist, most across entire width of walkway. No crack visible from underside of concrete from stairway underneath. Vibrations felt on walkway when outside trucks drove by. No way to know if cracks have been there for duration due to past equipment use, or if they are newly appearing.

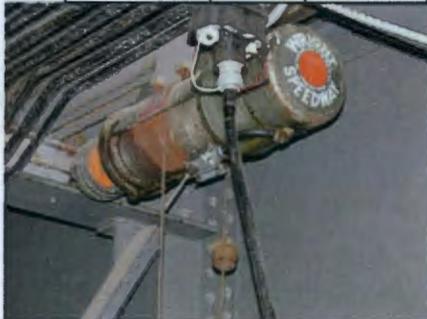
Item #	New Photo #	Description	Area / Location	Future Inspection/Maintenance Recommendations
	3527	Fluid dripping Winch	Elev. 80'-5 1/4"	Recommend continuing observation

3527 Winch located above the reactor above 80' elevation is leaking oil/grease. Oil/grease is dripping down chain/hook and floor below chain/hook which can be seen while standing in northwest portion of 56' elevation looking up

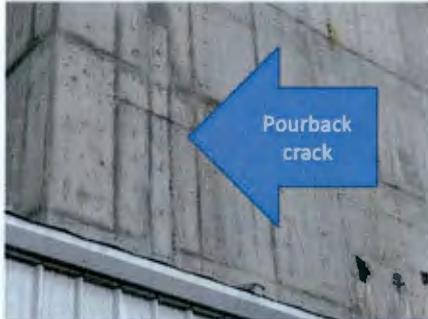
Item #	New Photo #	Description	Area / Location	Future Inspection/Maintenance Recommendations
	3547, 3548	Pourback above vestibule	Exterior Elev. 0'	Pourback appears to have begun to crack. No notations or pictures to show previous condition Recommend continuing observation
	3550, 3551	Metal roofline	Exterior Elev. 0'	Missing foam insert (both pics same location) West side of front face Recommend continuing observation
	3674	Pourback wall crack	Exterior Elev. 0'	See evaluation in Attachment A
	3676	Pourback wall crack	Exterior Elev. 0'	See evaluation in Attachment A

3547 outside above vestibule concrete pourback leading to crack in vestibule wall

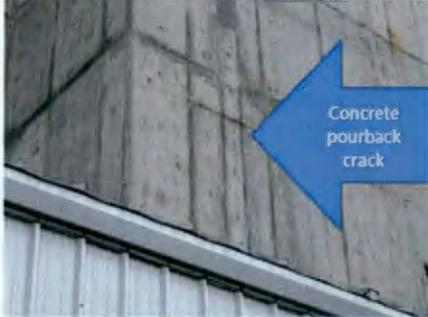
3548 outside above vestibule concrete pourback leading to crack in pourback

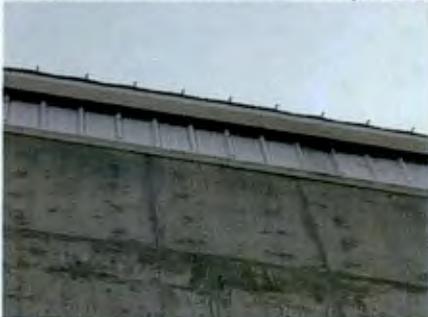
3550 Missing foam insert on west side of front face

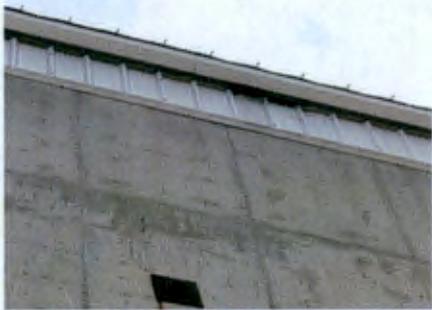
3551 Same spot as pic 3550 Missing foam insert on east side of front face

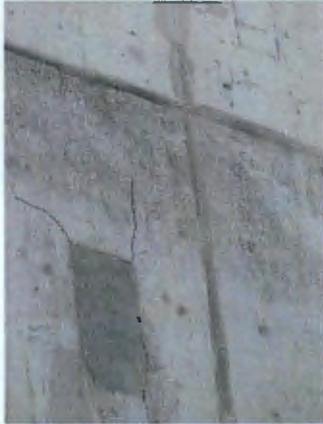
3674 Upper portion of cracked wall at pourback location

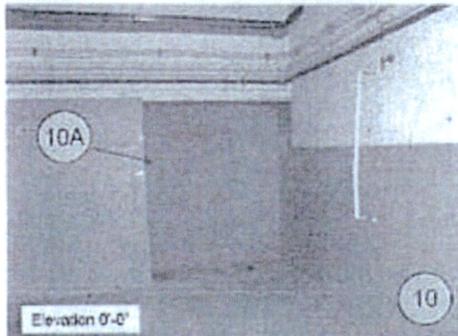
10A 2009 Detail - Elev 01'-0" Pourback. No visibly evident structural degradation. No change to condition. General area good.

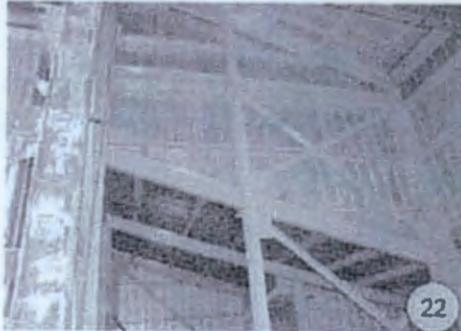
22 2009 Detail - Elev 56'-4", ISS Steel Beams, Girs. Braces & Columns, No Visible Issues No change to condition.

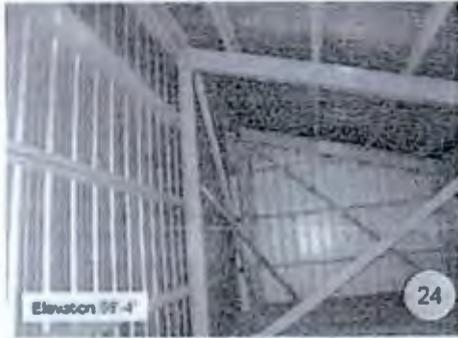
24 – 2009 Detail - Elev 56'-4", ISS Steel Beams, Girts, Braces & Columns, No Visible Issues

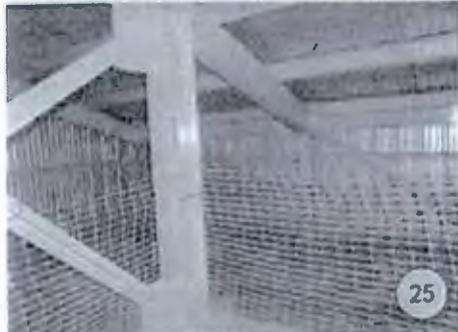
25 2009 Detail - Elev 56'-4", ISS Steel Beams, Girts, Braces & Columns, No Visible Issues

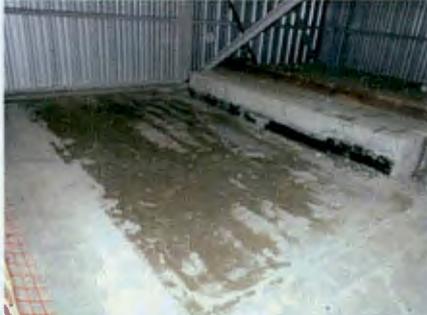
3517 Possible old roofing area with residual adhesive from previous roofing material (asphalt)???

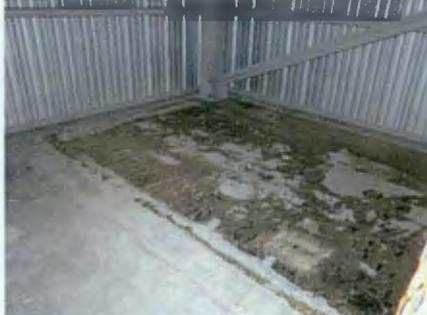
3518 same detail as 3517

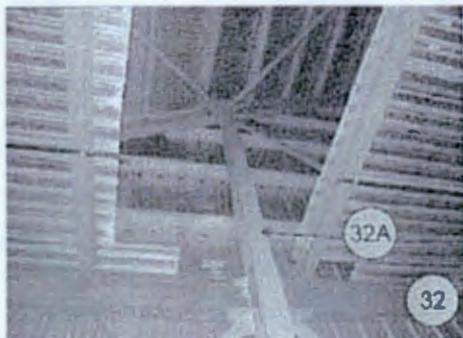
32A 2009 Detail Interior - Elev 56'-4", ISS Steel Column, No Visible Issues No change in condition.

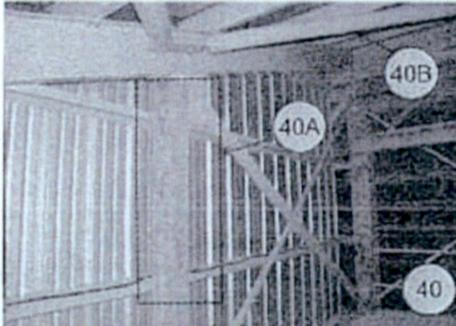
40A 2009 Detail - Elev 801-5 1/4", Column, Discoloration

40B 2009 Detail - Elev 80'-5 1/4", ISS Cross Brace, No Visible Issues No change to area condition

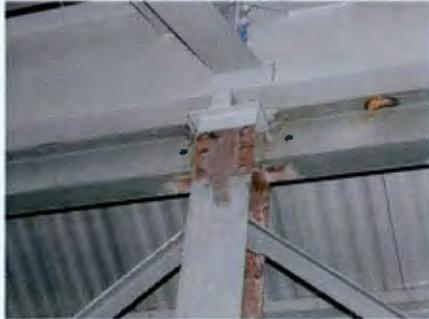
3528 Old pics 41, 41A, 42a 42b 42c Series of beams missing bolts.. appear to be unused structurally. Have been replaced with larger beam above and taken out of service

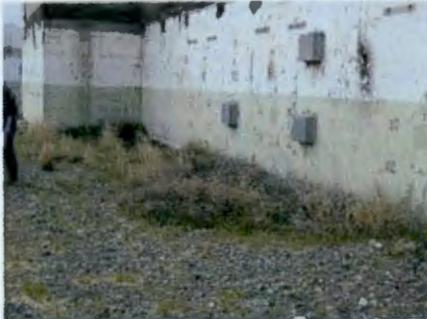
3555 tumbleweed accumulation and exposed rebar at dirt level on east side of SSE Old pic 48

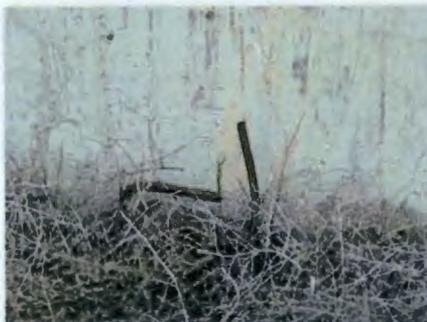
3556 same rebar as pic 3555 on east side of facility.

- i. Swallow nests were noted at various locations on the exterior of the facility. Locations of the nests don't appear to be a current problem. Photos are shown in Attachment D, Photos 3497, 3549, 3552, 3553, 3554, 3558, and 3559. ASSESSMENT / RECOMMENDED ACTION: If recommended actions for Item in Section A, vi, suggest removal of nests.
- ii. Foam insert appeared to be missing on the west side of the SSE (outside of front face) located on the bottom edge of the siding. Photo is shown in Attachment C, Photo 3550. ASSESSMENT / RECOMMENDED ACTION: Same recommended action as Section A, vi.
- iii. Tumbleweed accumulation on east side of SSE. Photos are shown in Attachment D, Photos 3556 and 3557. ASSESSMENT / RECOMMENDED ACTION: Periodic removal of tumbleweeds is suggested.

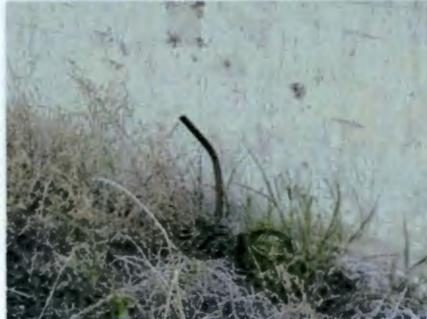
3557 same rebar as pic 3555 on east side of facility

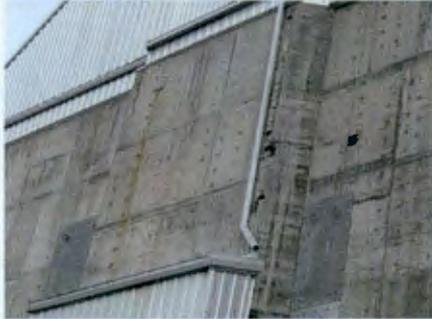
3560 Rust discoloration on south side of SSE

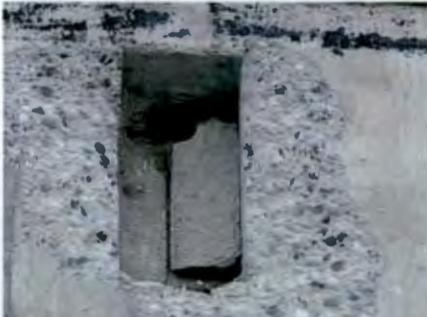
3497 Swallow nest inside beam cavit. On west side of front face wall.

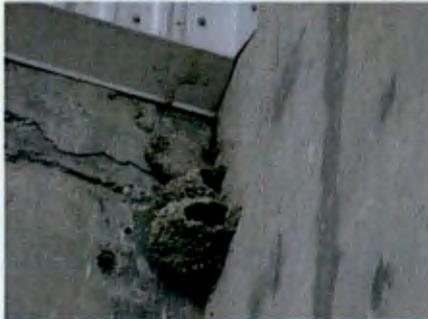
3552 bird nests

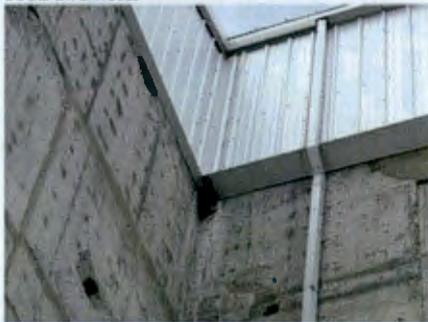
3553 bird nests

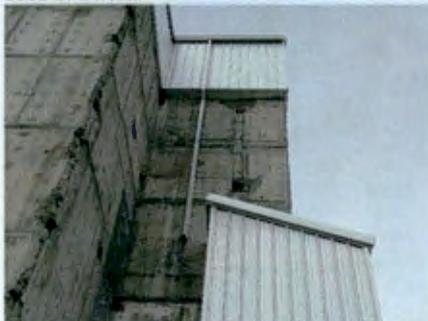
3554 bird nests

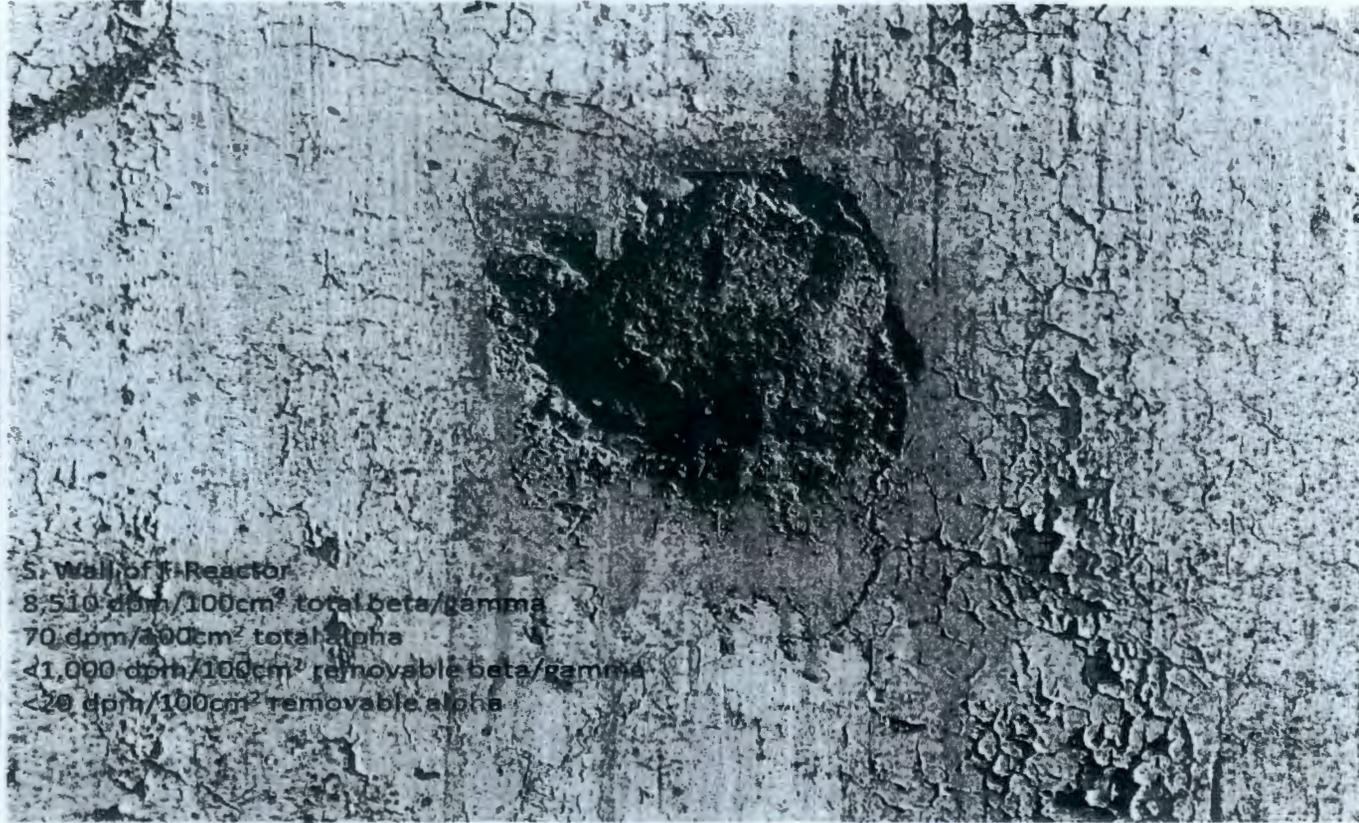
S. Wall of F-Reactor  
 8,510 dpm/100cm<sup>2</sup> total beta/gamma  
 70 dpm/100cm<sup>2</sup> total alpha  
 <1,000 dpm/100cm<sup>2</sup> removable beta/gamma  
 <20 dpm/100cm<sup>2</sup> removable alpha

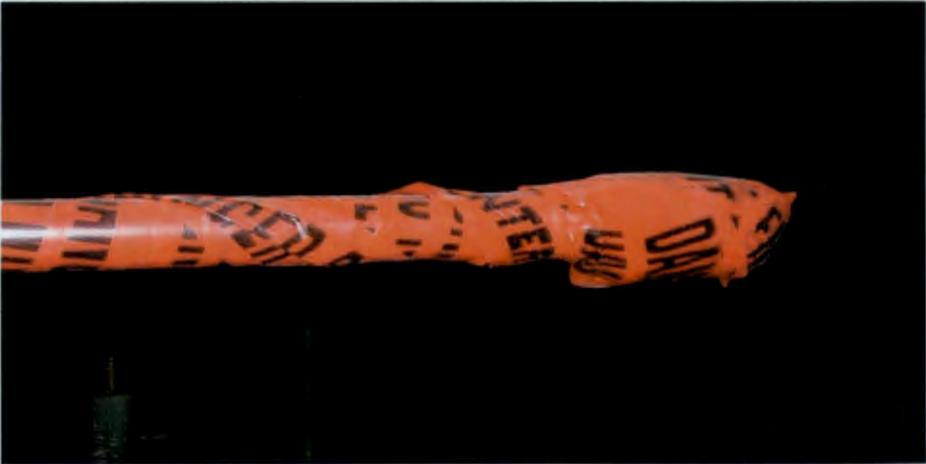
Photo 3

- Rise on top steps of bridge are taller than normal making this small stair case ununiformed.
- Speed rail extends out past bridge when crossing onto the "top hat" area. Rail padded and covered in Red "Danger" tape. (Photo 3)
- "Top hat" floor has approx. 1" rib at seam posing a tripping hazard (Painted Orange). (Photo 4)

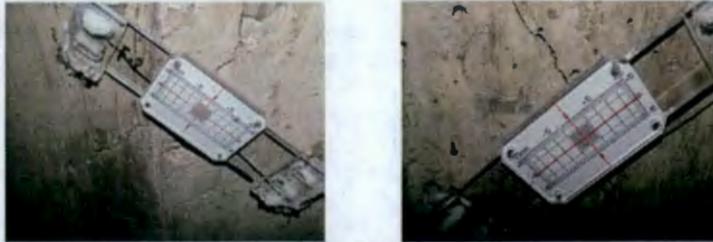
Figure 2 – Affixed Crack Monitors F-2 and F-1 (some parallax is evident in the photos, but straight on flash photos are unusable because of the glare of the flash on smooth plastic surfaces)

1. SSE Structure – address numerous small openings in the steel siding prior to extending the time between inspections.
2. SSE Structure – annually visually monitor the crack above the vestibule and compare to earlier photos.
3. SSE Structure – record crack monitor quantitative information with each SSE entry in the future and evaluate building movement if any reading other than 0 – 0 is observed.
4. Include annual visual monitoring and quantitative record crack monitor readings (items 2 and 3 above) in the S&M Plan requirements when revised.
5. Future use of surveillance routes and S&M Plan revision should be considered to reflect actual conditions / maps in the SSE and to provide guidance when and how Routes 4 and 5 shown in the S&M Plan should be used.

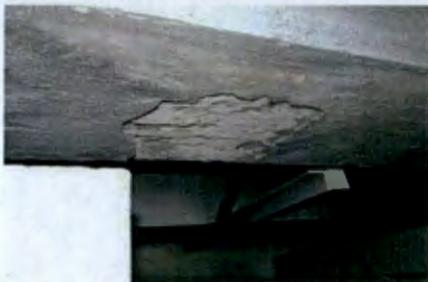
3020 Originally pictured crack in beam unverifiable. Evidence of spalling on underside of beam. Beam to ceiling joint intact. No indication of sagging of beam

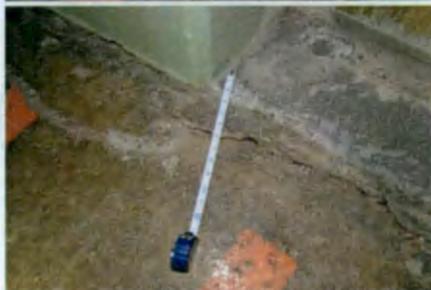
3032 No significant change since 2008

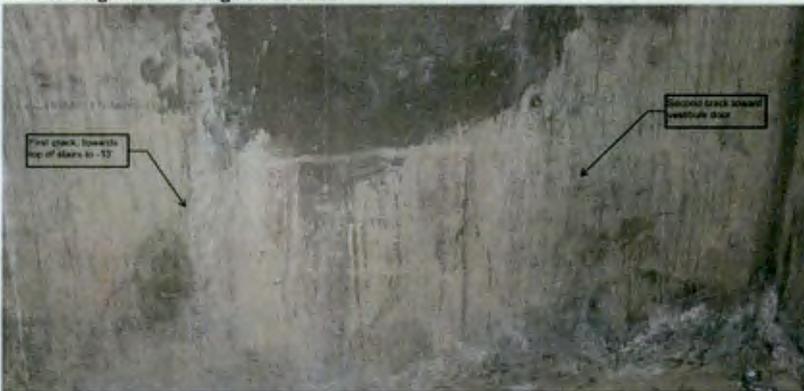
3031 No significant change since 2008.

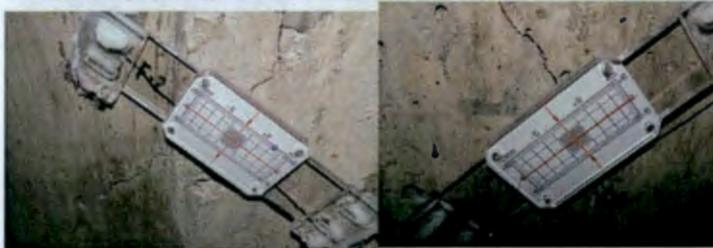
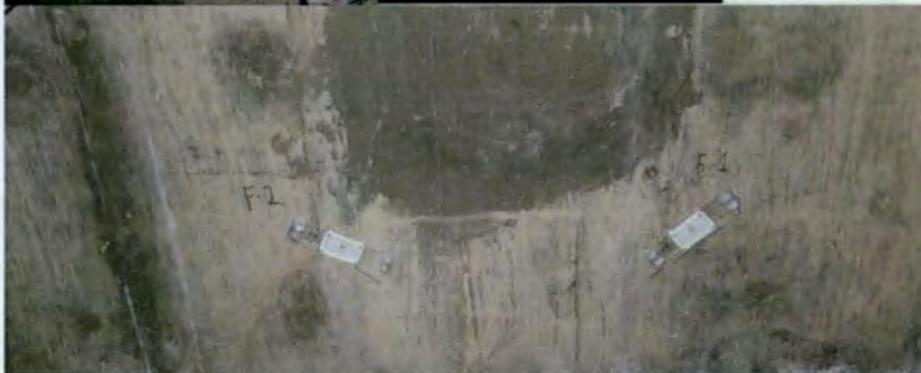
2014 Photo # 2984 Crack about 12 ft off floor

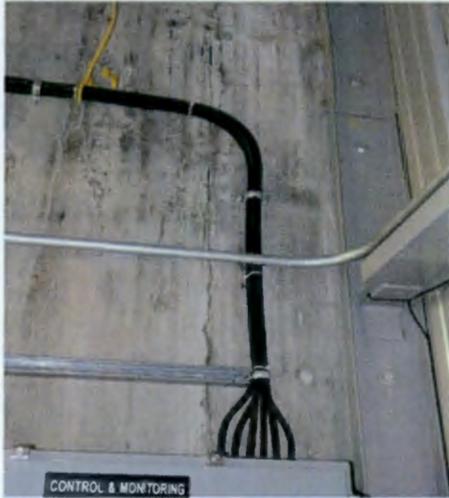
2014 Photos # 3124, 3125, 3119 As installed Crack Monitors at interior bottom corners of the infill

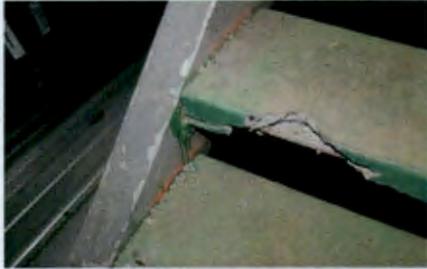
3050 No change since 2008. Safety and structural inspection concur stair is acceptable. Tread measures 10 1/2 x 29 1/2 x 2 1/2 if tread replacement is ever planned.

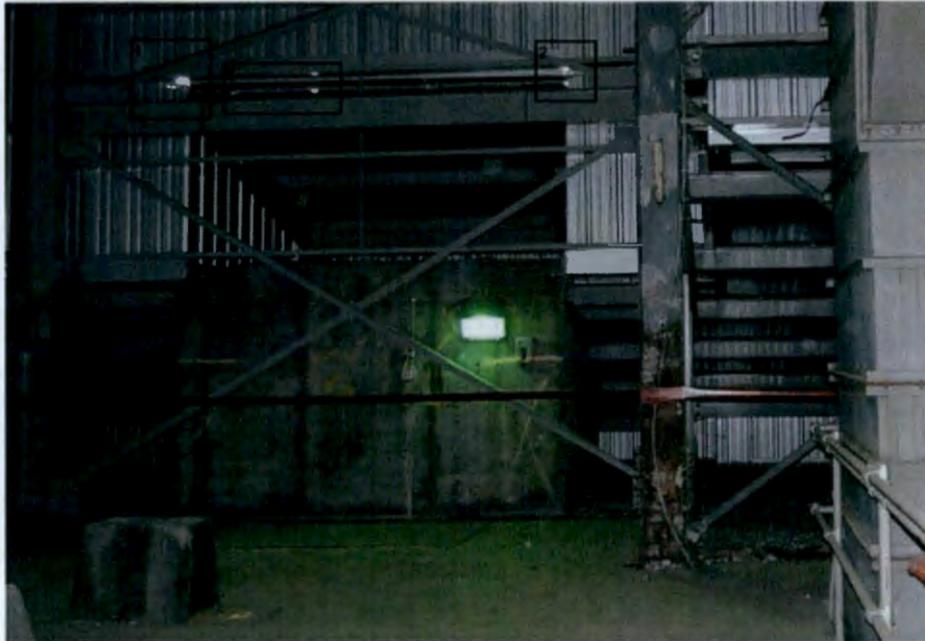
2014 Photo # 3087

2. Observation of SSE metal sheathing at the 56' and 80' levels showed multiple openings at junction points where outside light could be seen – evidence of a possible access point for small birds, bats, insects, spiders, etc. While not every pinpoint of outside light is big enough for bird or bat access, there is ample evidence of some bats being in the structure. If any closure of these openings is considered, timing is an issue with the biological team, but a program of maintenance may be recommended to close off the identifiable openings with a wire mesh or metal fabric from the outside. Adhesive or self-tapping screws with a non-corrosive metal mesh or metal fabric would seem to provide an effective and fast way to inhibit further entries, this approach would presumably use an articulated man-lift of significant size. Additionally, consideration for galvanic corrosion with the galvalum roof / siding materials must be accounted for when selecting a material for closure. The area shown in Attachment C-5, Items 31-34 and photo 3087 are typical instances. Scheduling of any maintenance program should be considered based on the Ref 4 input, and is recommended to be completed prior to extending the SSE surveillance periodicity.

Markup of photo 3087 showing 6 bright spots (outside light in 1 – large, 2- medium and 3-small spots) which are SSE openings to the outside for bat intrusion along one vertical to sloped siding junction. This photo is from the D Elevator area, 56' elevation, and looking west. This particular location shows a bit higher density of openings, but is somewhat typical of various sizes of openings that were observed at the 56' and 80' elevations.

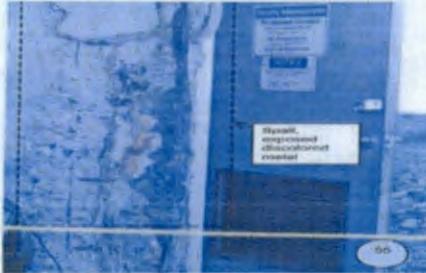
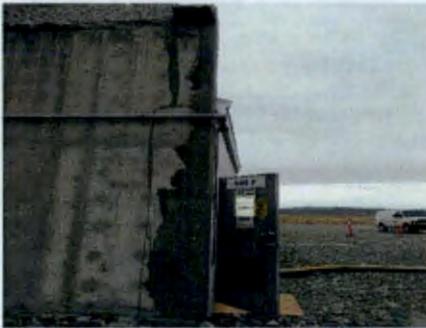
3012 Repair completed between surveillances. Concrete repair not holding up. Patch chipping away in places

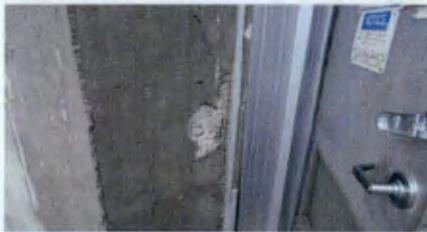
3013 Repair completed between surveillances. Concrete repair not holding up. Patch chipping away in places

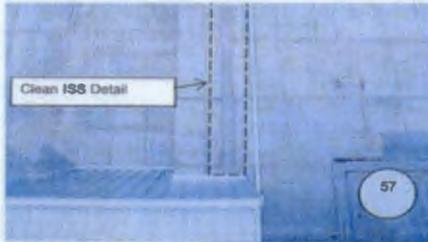
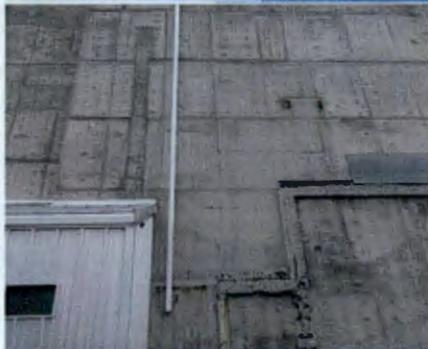
3014 2<sup>nd</sup> example of same patch failing, just above vestibule door.

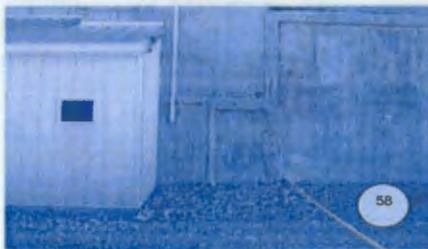
3015 Almost full length crack of south side of pourback. Next to downspout at vestibule. Concrete infill doesn't seem to be adhering to old wall. Crack goes all the way to interior. Refer back to 20A for further information.

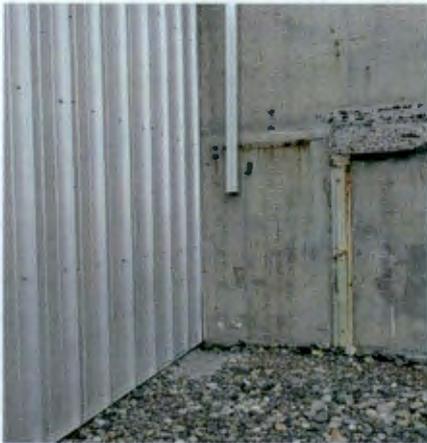
3016 Downspout at corner of building. Interior is dry.

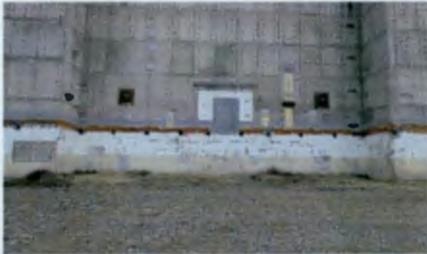
2996 No changes to building condition. Downspouts drain immediately adjacent to building from approx. 75'. Wildlife nests not included in assessments.

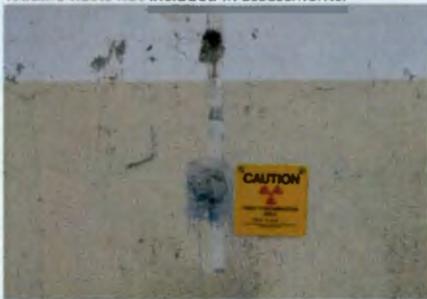
3019 Contamination spot (FCA-F-0001) on south wall. E of fuel discharge area.

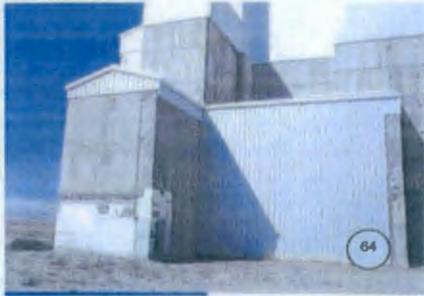
2991 Structural Steel around Route 4 access point was inspected for pattern suggest that "Man Door Knock Out" shown on 0105FDCC0005 / H187254 SHT01

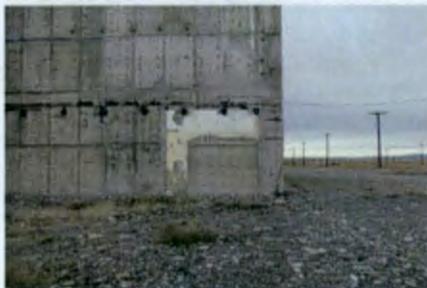
66	3004	Exterior wall detail - existing crack	0'0"	No change since 2008. Verified corner inside front face was dry. Beam pockets. Recommend continuing observation

3004 Verified corner inside front face dry inside . Beam pockets no change

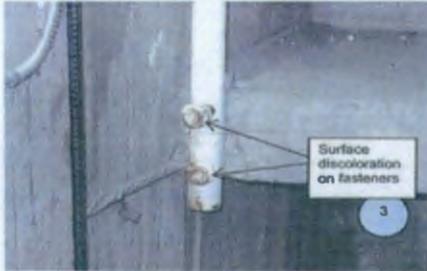
3023 Crack from 2008 was not obvious. No water stains on floor.

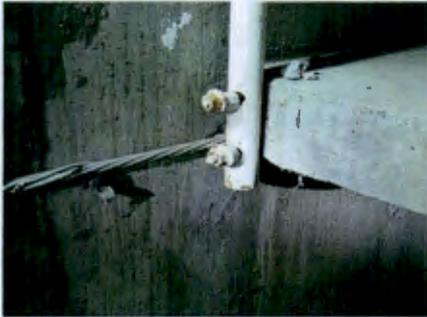
3025 No change. Remove from surveillance.

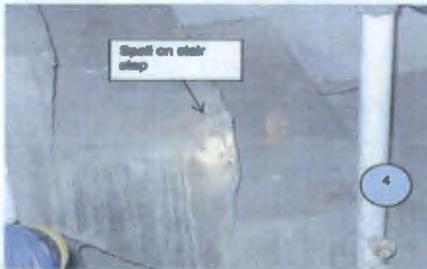
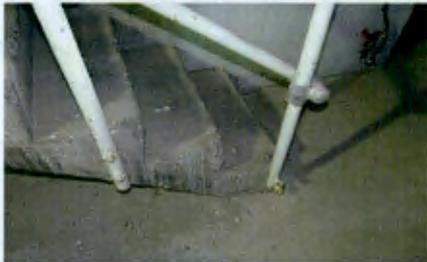
3026 No change since 2008. Remove from surveillance.

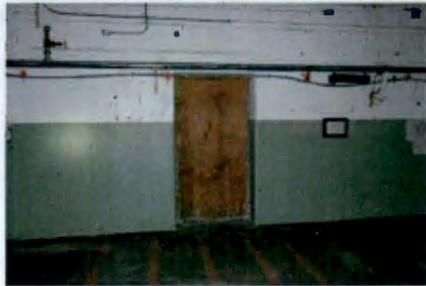
3029 No change since 2008.

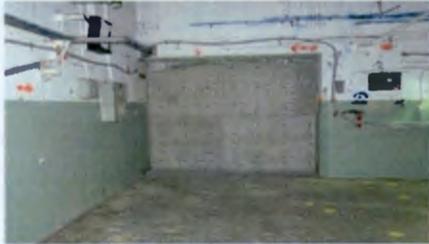
3035 No change since 2008. Dry all around and in corner.

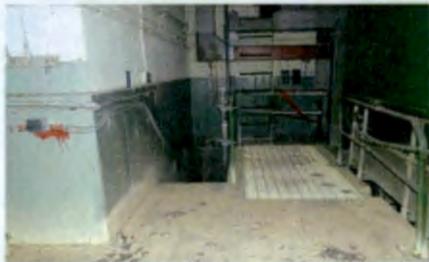
3037 No changes since 2008.

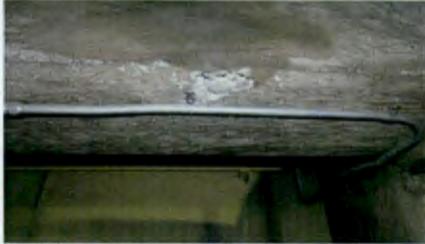
**New Item 11A**

3038 New spalling location to add to surveillance. No evidence this is new condition. Was not on surveillance route prior to 2014.

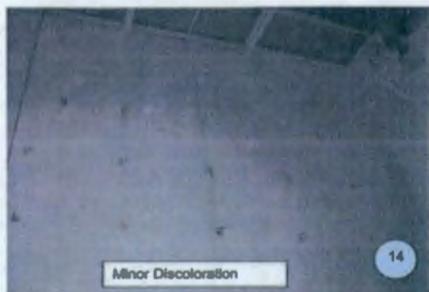
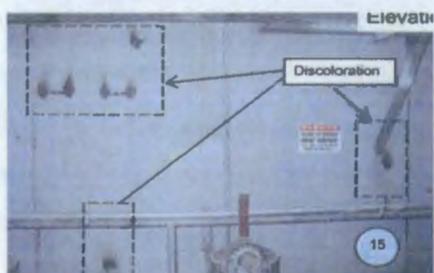
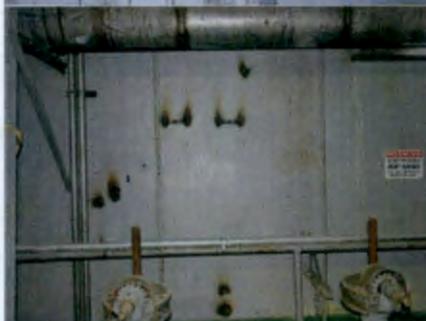
3040 No change since 2008.

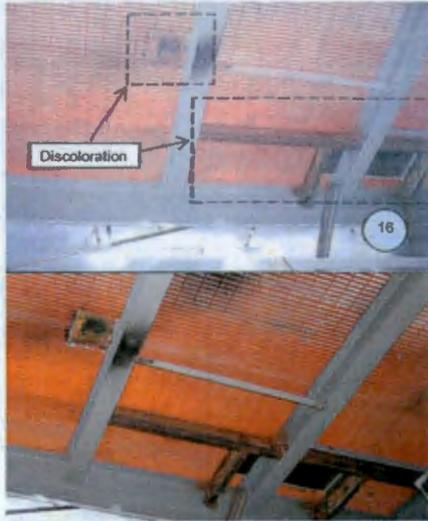
3031 No change since 2008

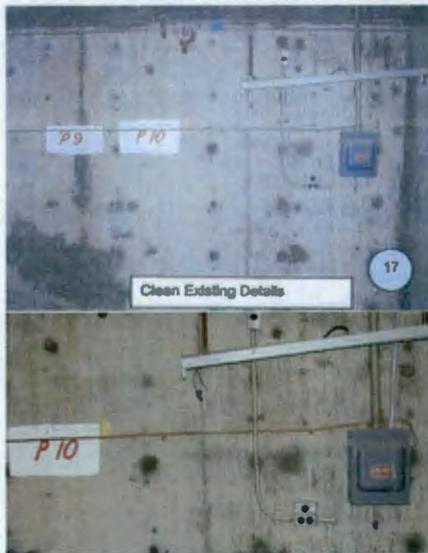
3042 No change since 2008.

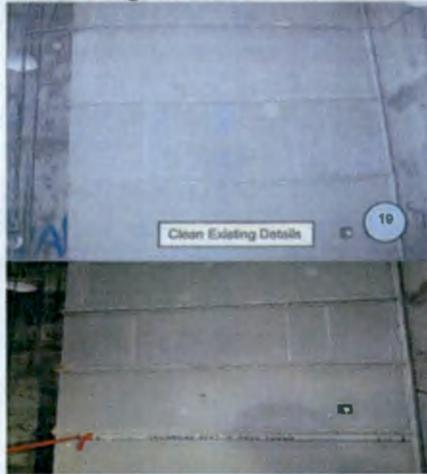
3044 No changes since 2008. Remove from surveillance.

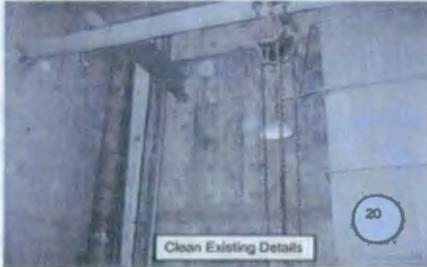
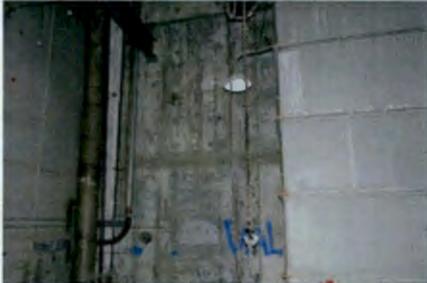
3045 No changes since 2008. Remove from surveillance.

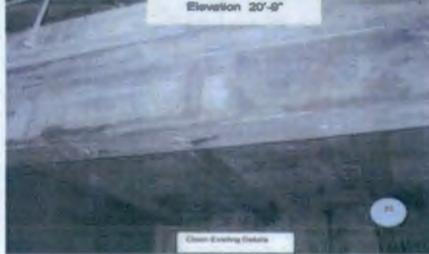
No new photo. No change since 2008. Remove from surveillance.

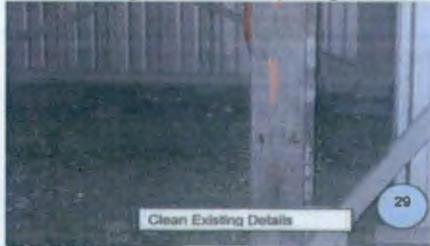
No change since 2008. No new photo. Remove from surveillance.

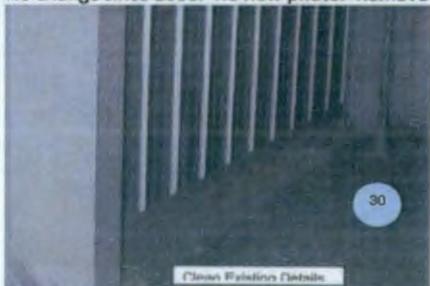
No change since 2008. No new photo. Remove from surveillance.

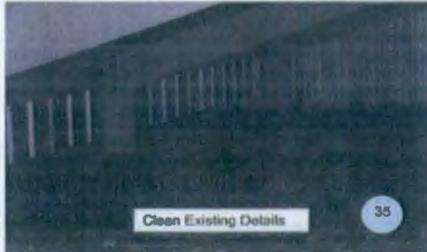
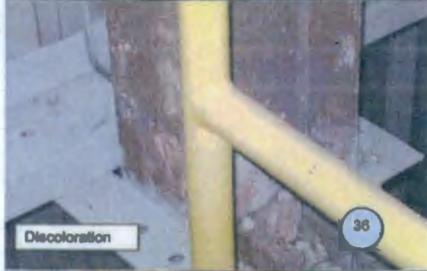
3058 Discoloration is determined to be grout stains from CMU infills. No change since 2008. Remove from surveillance.

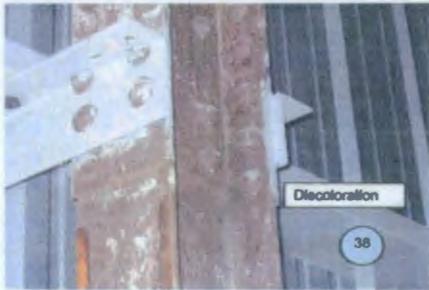
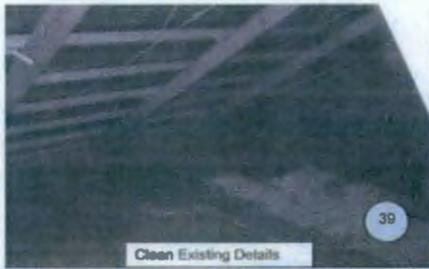
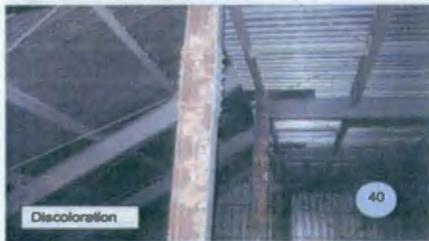
3066 Discoloration is determined to be grout stains from CMU infills or Aged Red Lead coating. No change since 2008

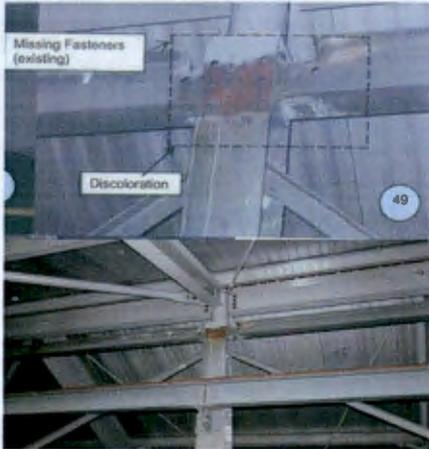
3067 Rivets removed as part of SSE Construction. No change since 2008

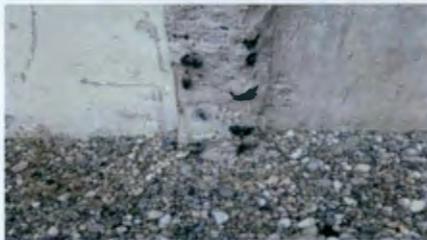
3008 Sometime between surveillances work was completed to cut rebar ends and paint the ends

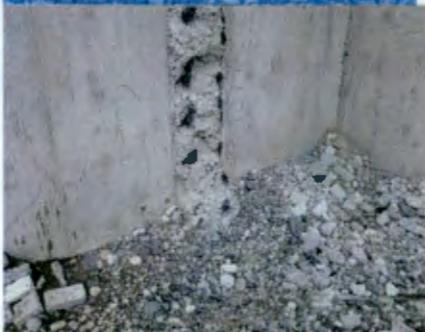
3009 Sometime between surveillances work was completed to cut rebar ends and paint the ends

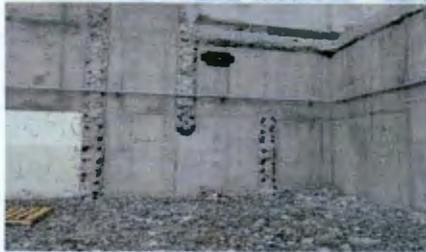
3010 Picture shows location better than previous... Work completed between surveillances buried rebar under concrete debris and guano from bat habitat.

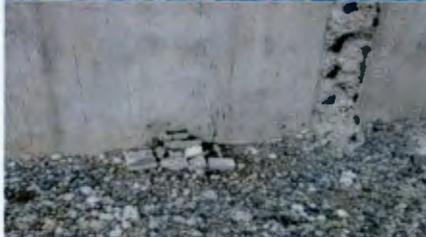
3011 Picture shows location better than previous... Work completed between surveillances buried rebar under concrete debris and guano from bat habitat.

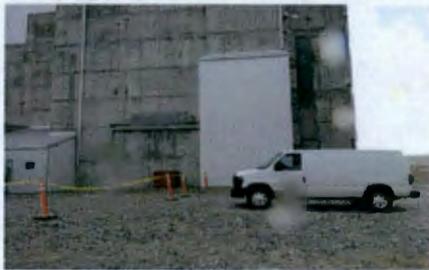
2993 No change in building condition. No reason to continue future surveillance. Birds nest on SW corner of building.

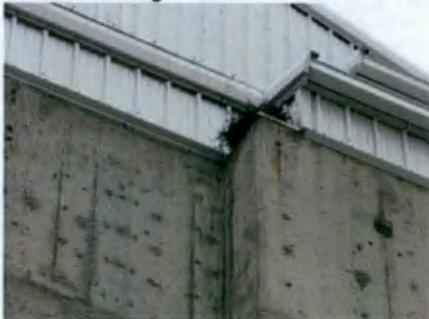
3018 No change in building condition. No reason to continue future surveillance. Birds nest on SW corner of building.

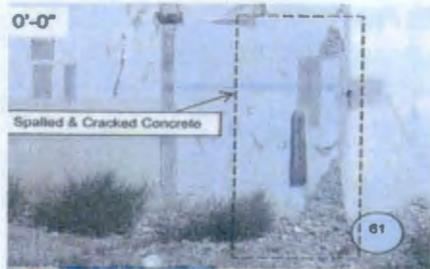
2997 No change since 2008

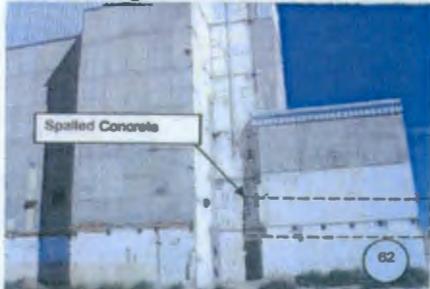
2998 No change to spalling at beam pockets. Rebar exposed at corner in very good condition painted black.

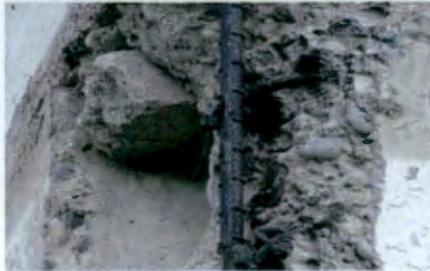
3008 No change to spalling at beam pockets. Rebar exposed at corner in very good condition painted black.

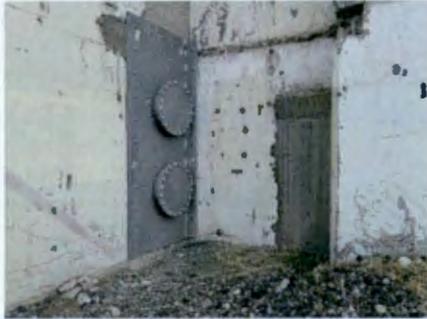
3001 Rt 5 Access very good shape.

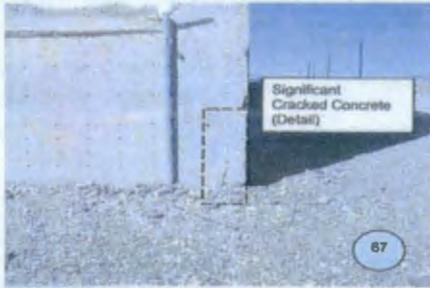
3005 No change since 2008. Verified corner inside front face was dry. Beam pockets.

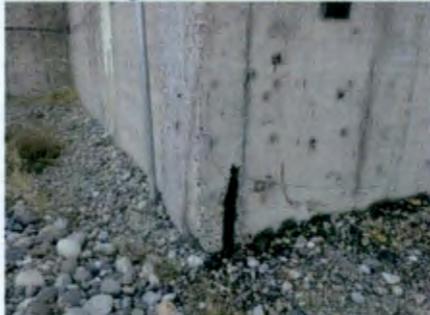
3006 No change since 2008. Verified corner inside front face was dry. Beam pockets.

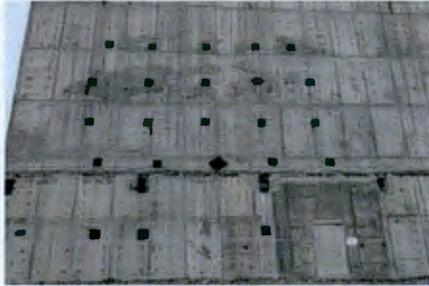
3007 No changes since 2008

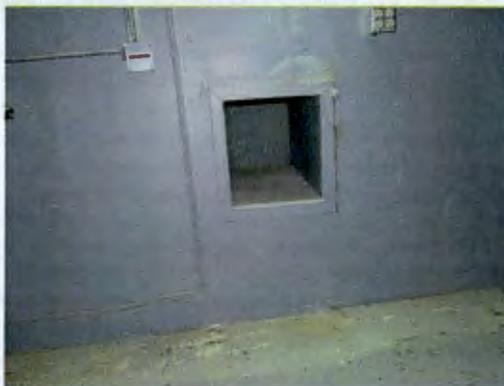
Figure A-1 – Front Face opening interior

- Attachment A Figure A-1 and Attachment C-1 photo 3464 shows a 24" by 24" opening in the concrete west wall of the front face that is only closed by a bolted plate (just N of the vestibule). With a wrench or ratchet, the plate could be removed in a very short time and access to the interior of the SSE could be gained. Per Section 2.1.5 of Ref 4, any remaining entrances will be welded shut. It is recommended that this item be addressed in the near term.

construction did not remember any reason for or approval of a deviation to plate this opening versus a pour-back that would have met the SSE design criteria listed in Ref 4 for an opening of that size within 10' of outside grade elevation. This area was photographed in the previous WCH inspection report – with no record of concern for this item. It may be that the previous inspection team had good reactor and structural knowledge, they lacked the historic background and security basis for the pourback versus plate decision making used during design and construction of the SSE.

**ASSESSMENT / RECOMMENDED ACTION** – While there is a risk of unauthorized access introduced by this item, and regulator and public confidence issues would result from an authorized entry, significant public safety risk (real health and industrial / radiological safety harm) is minimal given the very good conditions inside the SSE. However, there are easy actions to remove the risk completely short of installing a concrete pourback per the original design. Polestar recommends that when the SSE is closed, the same weld material used for the doors in

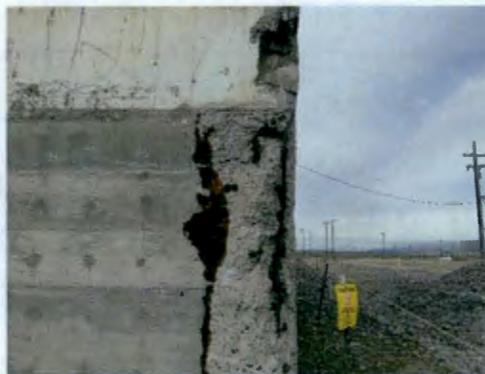
Figure A-3 – Foam Entrained in Pourback at Northeast Corner of SSE

- 1. The pourback at the front face on the NE corner of the building (shown in Figure A-3 and included in Attachment C-5 Item # 68 and new photo 3491) includes a portion that is polyurethane foam and is badly weathered. This is not a structural issue since the inside of this pourback was observed to be dry and well-sealed. Rather it only begs a question since it is so obvious and upon close inspection is weathered so badly. At some point, scraping out the old foam and painting this area may be a prudent action just to preclude future questions.

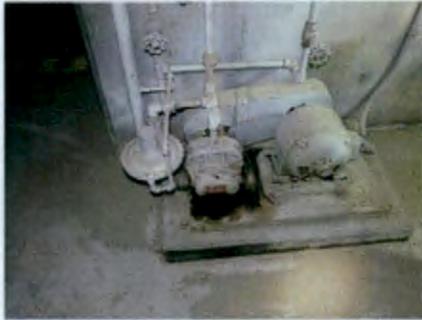
3405 Decon Room @ 0' - Minor oil weeping into tray

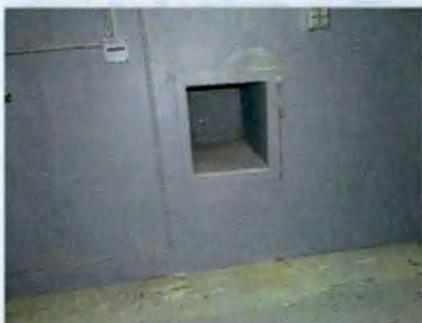
3464 Possible unauthorized personnel access point to front face.

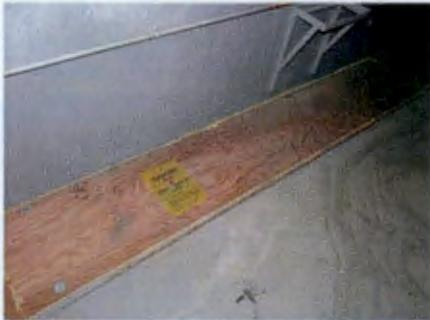
3467 Plywood glued and bolted to ground to cover CA  
Note\*\*\* no picture but dry at bottom of C elevator shaft

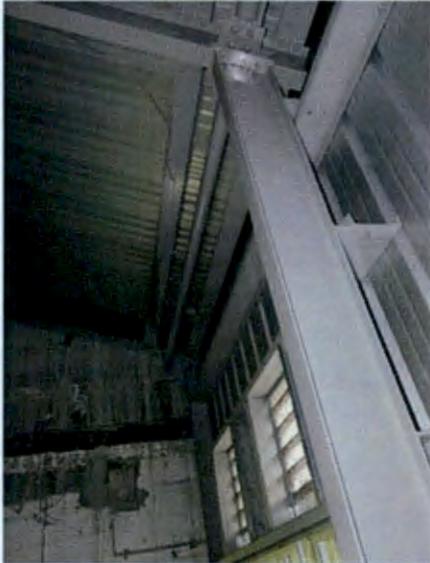
3468 wall vent and ceiling structure in vestibule—previous evidence of water intrusion but no entry point seen.

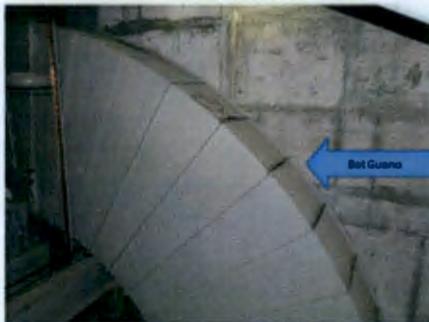
#	New Photo #	Description	Area / Location	Future Inspection/Maintenance Recommendations
	3422	Bat Guano accumulating on vent duct flange from stairs on way up to 42' level	Elev. 42' 5"	As seen from stairway to 42' elevation Recommend continuing observations.

3422 Bat guano accumulating on vent duct flanges.

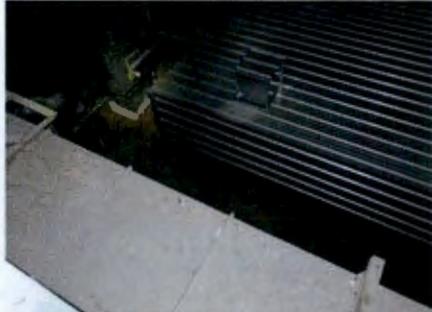
3441 wet spot @ 42' from dripping winch @ 80' level as seen from 56' walkway

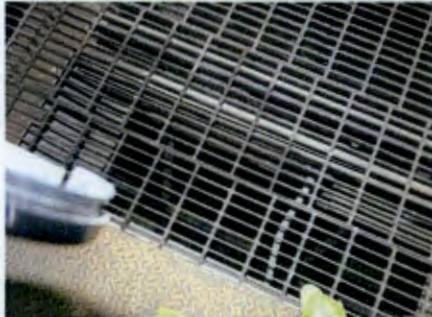
3456 Leaking winch @ +79 elevation below NE corner of diamond decking @ 80' elevation

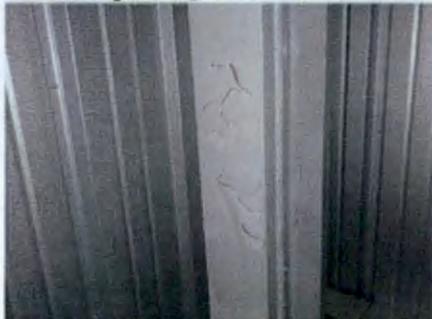
3445 Peeling paint on beam along east wall.

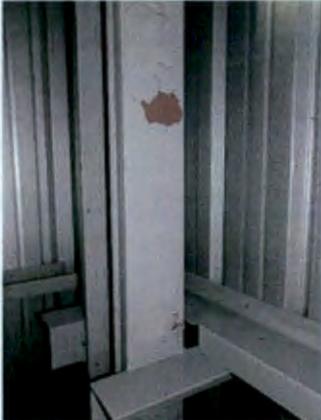
3446 Red undercoat in good condition after large blister picked off.

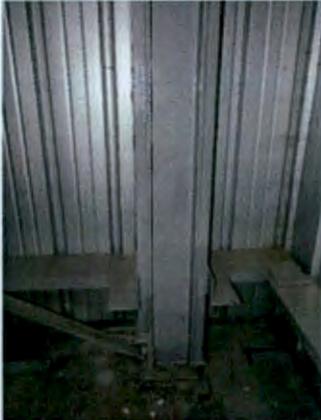
3447 Blistering/peeling grey paint. Detail of original column with modifications as part of SSE.

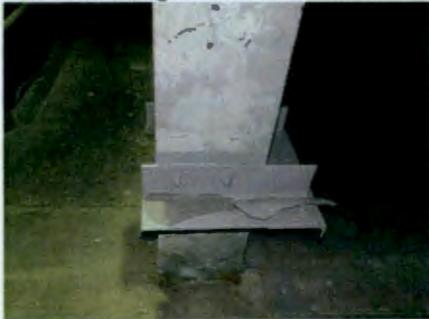
3450	Peeling paint on beam. along east wall	Elev. 56'4"	No structural issue
--	------	--	-------------	---------------------

3450 Peeling paint on support. Red undercoat in good condition.

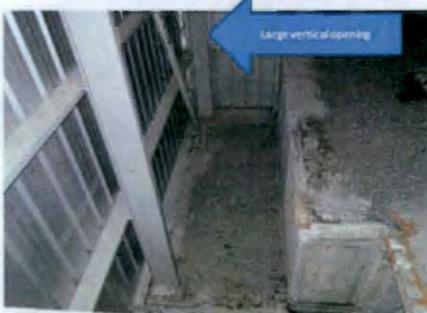
3454 Prior Roof sections east side from 80' elevation. Space is clean and dry with no visible issues other than siding issue.

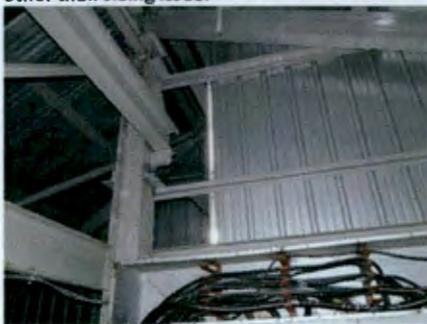
3455 10-12 feet long x 1" open gap at interior corner of structure. Animal/bird/pest intrusion point

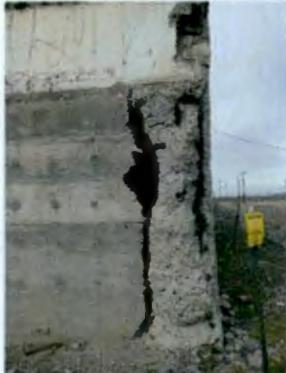
3491 - No visible change to condition. Suspected existing foam joint material. No evidence inside of deteriorating condition.

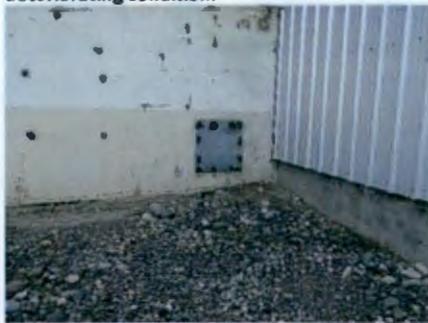
3476 exterior of view 3464 not sealed properly. At least 2 opposing bolts need to be welded shut.

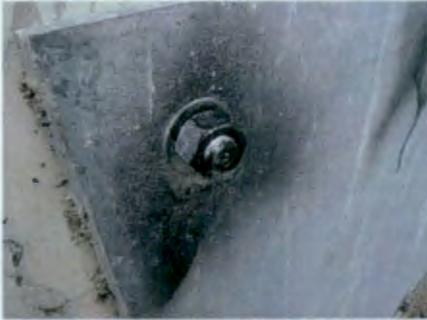
3477 bolt on metal cover plate. Recommend welding.

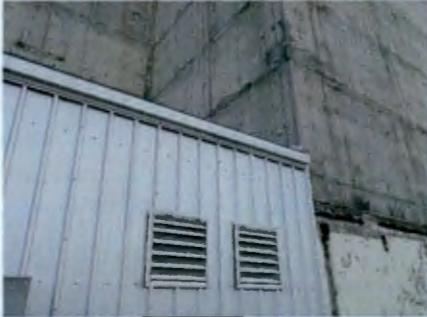
3478 exterior view of 3468  
Reported water entry—no defects seen.

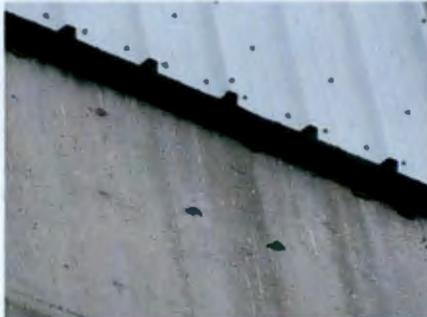
3481 100's of birds building mud nests under ledge at seam locations around entire bldg.

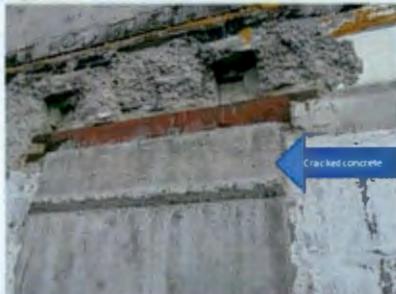
3484 cracked concrete on pour back does not appear to be an issue but should be watched.

3484 Blow-up of crack on pour back near SW corner of building.

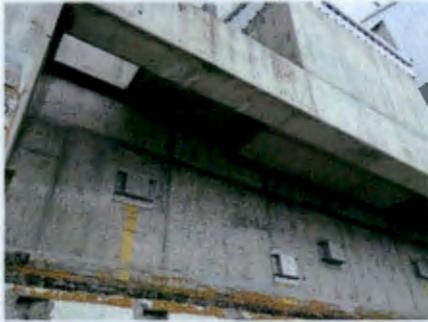
3485 Lots of bird feces on metal cap covering.

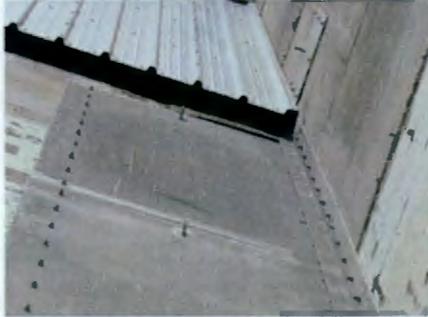
3489 Metal cover plate with birds nesting above.

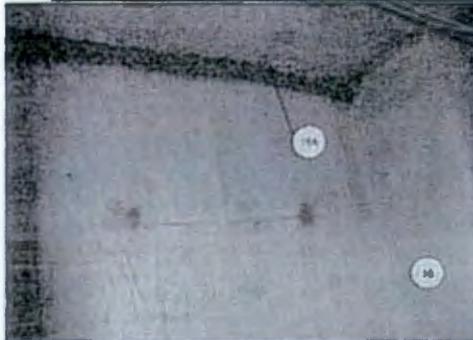
Item # 16 2010 Detail Below Grade 2 -30" Pourback. Spalling

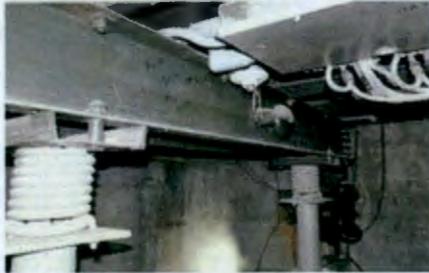
3400 No visible issues

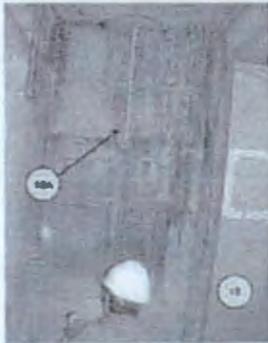
Item # 18 2010 Detail Below Grade 2 -30' Concrete Wall, Discoloration

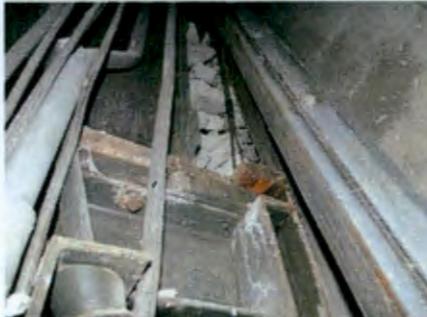
3401 Rubble at bottom of elevator shaft. Looking up shaft

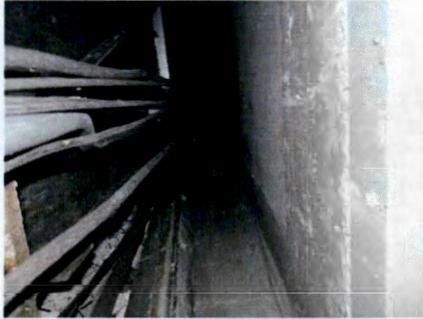
3402 Looking up Elevator shaft. No visible issues.
