HNF-59342  
Revision 0

# Five-Year Surveillance Report for the 105-C, 105-D, 105-H, 105-F and 105-N/109-N Safe Storage Enclosures

Date Published  
March 2016

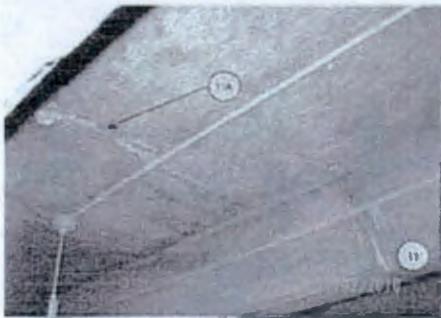
Item # 11 2010 Detail Below Grade 1 15' Ceiling, Discoloration and Corrosion

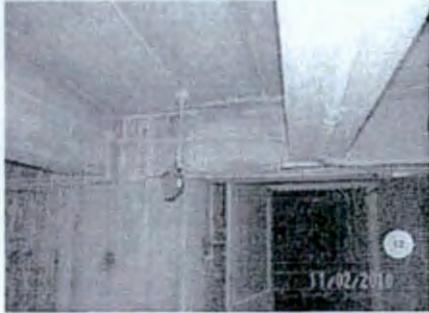
Item # 12 2010 Detail Below Grade 1 -15' Ceiling Beams and Wall, Discoloration and Corrosion

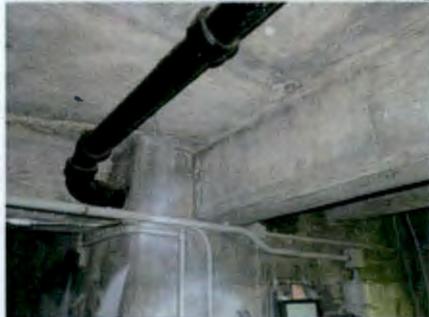
3403 No visible issues.

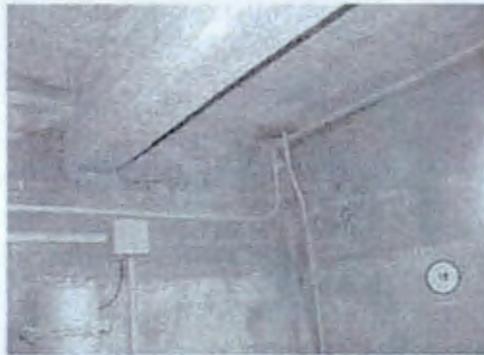
Item # 15 2010 Detail, Below Grade 1 -15' Ceiling Beam and wall, no visible issues

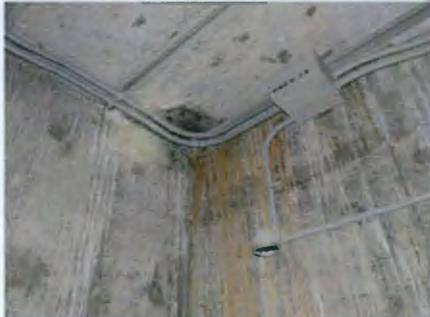
3404 Interior very dry. No visible issues.

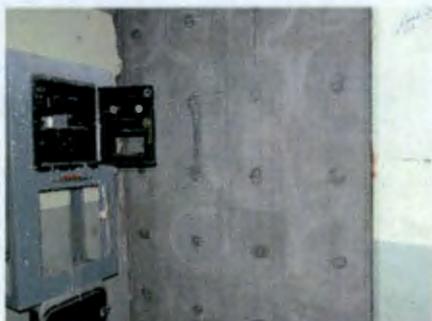
3406 Pour back in good condition

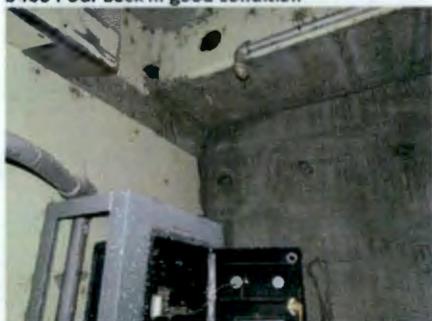
3407 Interior very dry

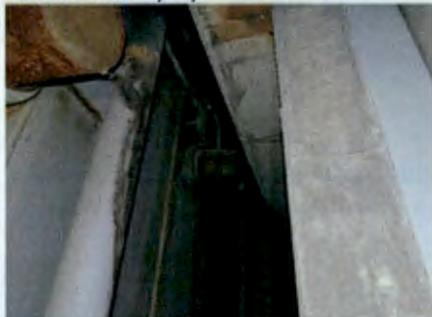
3409 Block isolation Reactor to rear face. No visible issues.

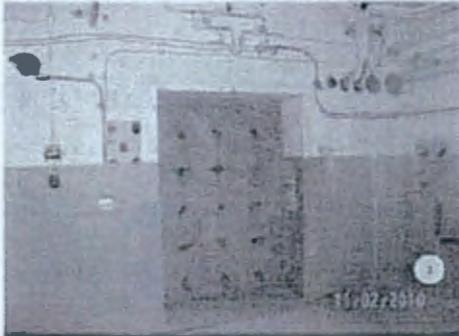
Item # 3 2010 Detail Elev. 0' Wall, No visible issues

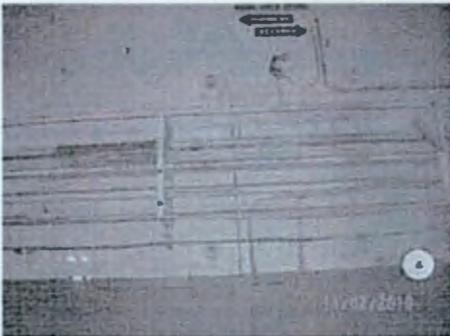
Item # 4 2010 Detail Elev. 0' Wall No visible issues

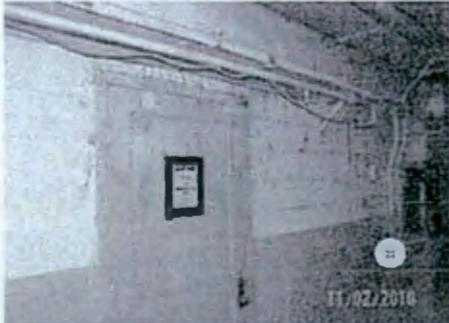
Item # 19 2010 Detail elev. 0, Ceiling Beam and Wall, No visible issues

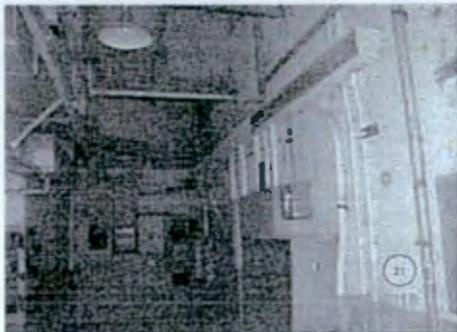
Item # 21 2010 Detail Elev. 0 Masonry Wall, No visible issues

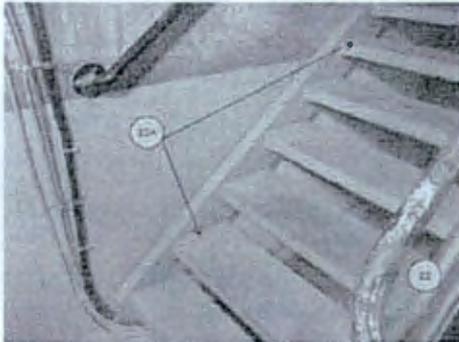
Item # 22 2010 Detail Elev 12'0", Stairs, Loose steps

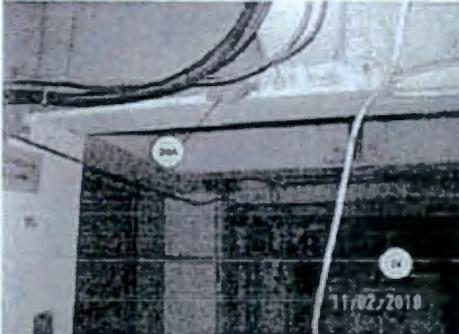
Item # 24 2010 Detail Ceiling beam, spalling

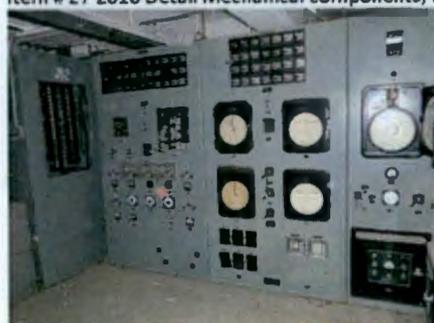
3414 12' Elevation. No visible issues.

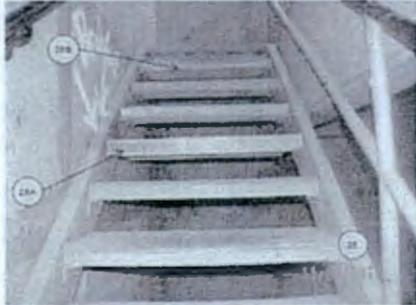
Item # 28 2010 Detail Stair, Repaired step, loose step

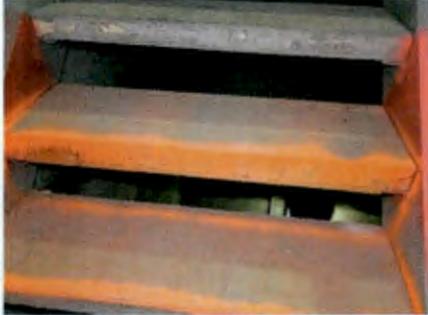
3415 on way up to 22 foot level. Wood stair in good condition

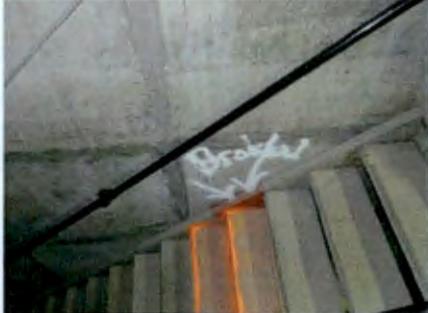
3417 Historic mark on wall. Stair has been replaced and is in good condition

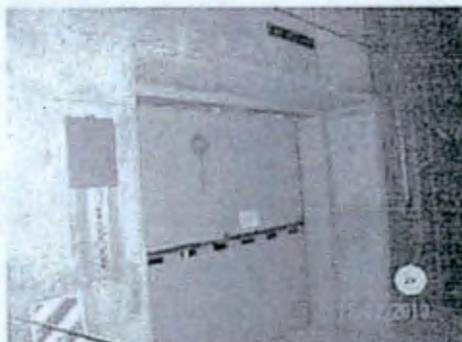
Item # 29 2010 detail Elevator No visible issues

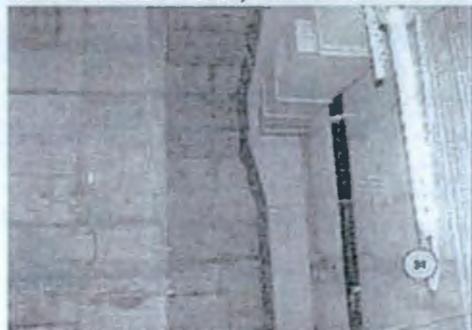
Item # 31 2010 details wall, no visible issues

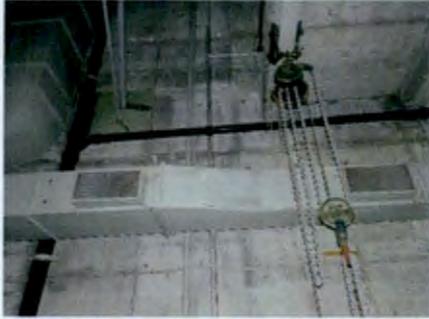
3419 Dry/Clean with no visible issues.

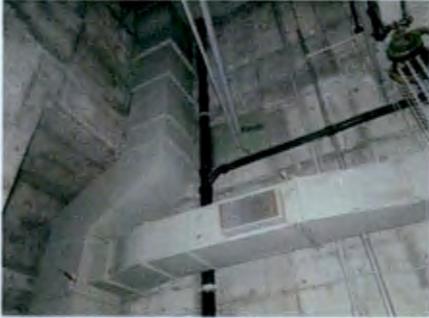
3420 Dry/Clean with no visible issues.

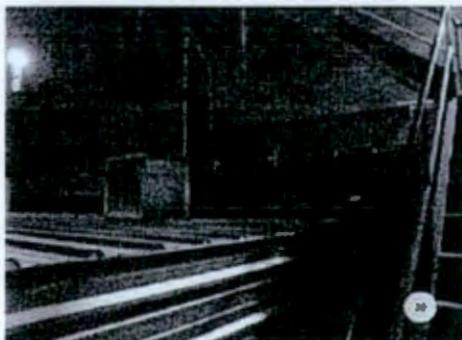
Item # 39 2010 Details Top of Unit, Wall and Stair Details, No visible issues

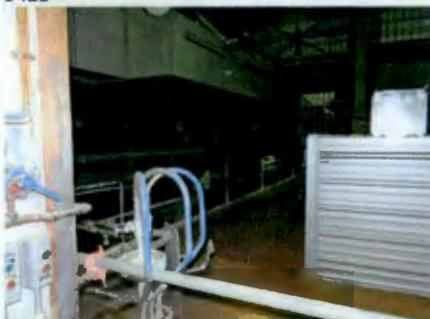
3425 42' level detail No visible issues.

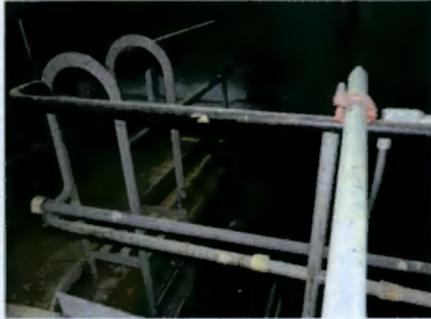
3426 42' level detail No visible issue.

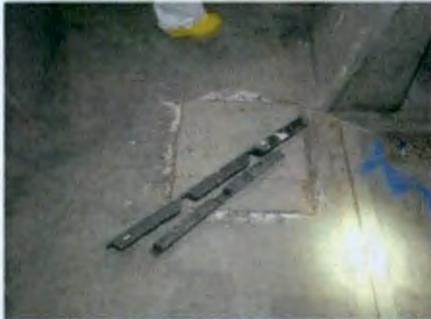
3428 Foam pieces on floor from roofing project.

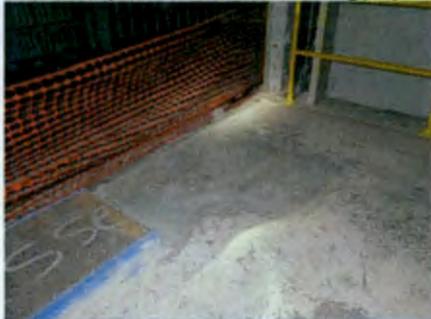
3429 Detail of roofing/floor construction. No visible issues. Comparable condition in a number of SSE Structures.

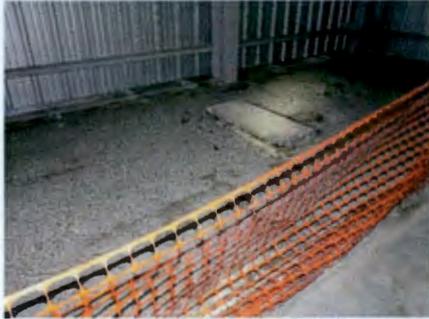
3430 detail of roofing/floor construction. No visible issues. Comparable condition of a number of SSE Structures

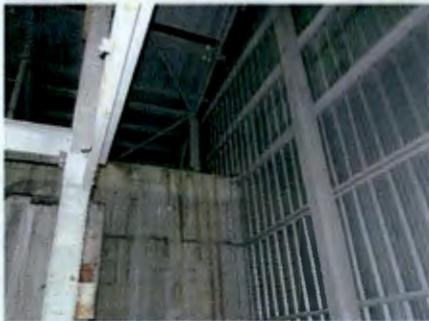
3432 Clean and Dry. No visible issues.

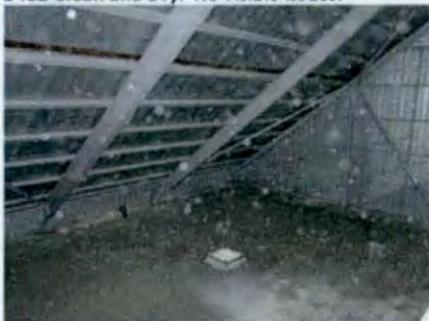
3433 Looking down onto old roofing structure—dirt in the air. No visible issues.

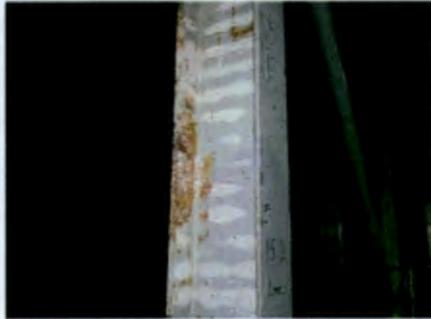
3440 Beam detail with mortar stains from masonry infills. No visible issues.

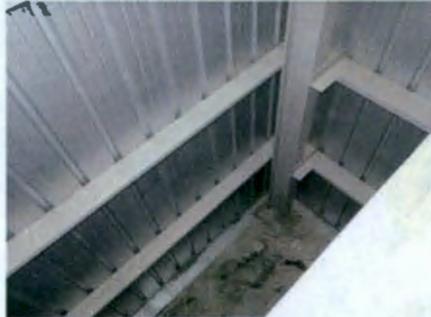
3444 Clean/Dry interior detail. NE corner along E wall 42" elev. As seen from 56'

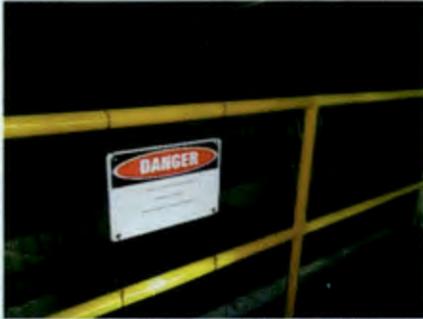
3451 Old pics 52, 53, 54, 55 general area detail. No visible issues

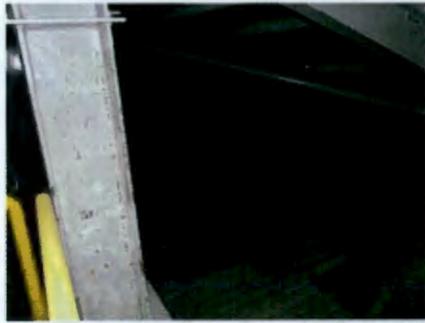
3452 80' elevation. General area detail. No visible issues

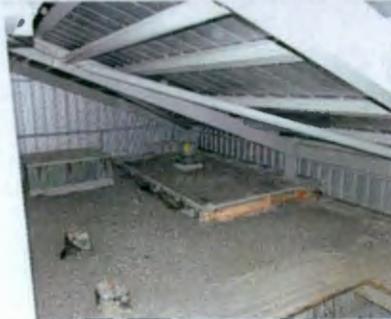
Prior roof SE corner from 80' elevation. Clean/Dry No visible issues.

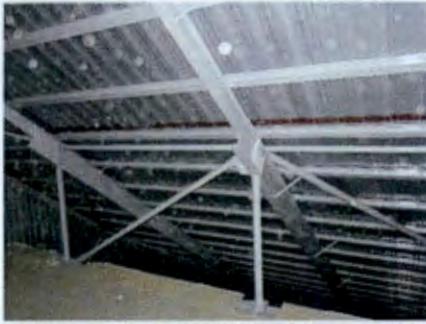
3457 General area detail. Clean/Dry. No visible issues.

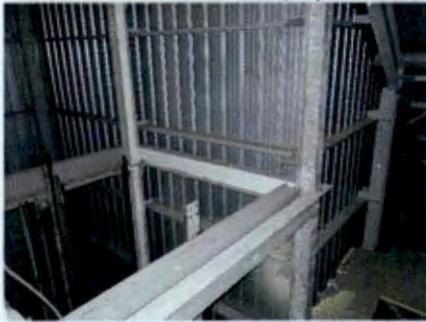
3458 General area detail Clean/Dry. No visible issues.

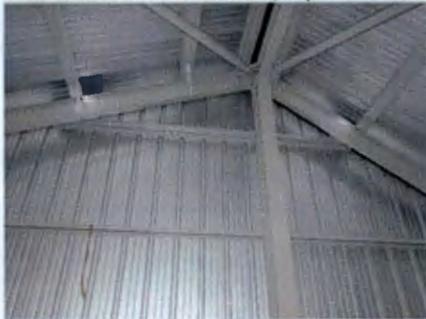
3459. General area structure. Clean and Dry. No visible issues.

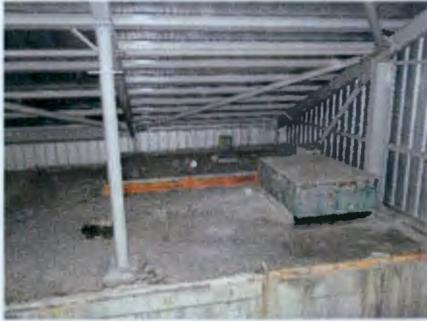
3460 Prior Roof SW corner as seen from +80' elevation. No visible issues.

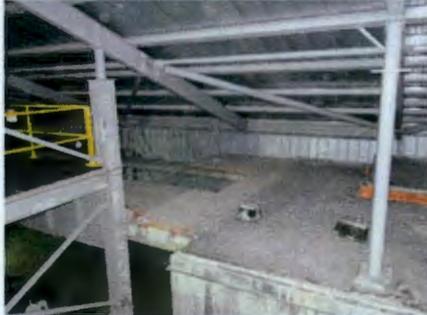
3461. Prior Roof W corner as seen from +80' elevation. No visible issues.

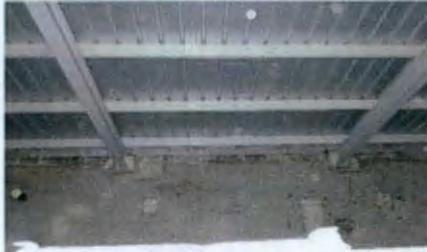
3462 Prior roof W corner as seen from +80' elevation. No visible issues.

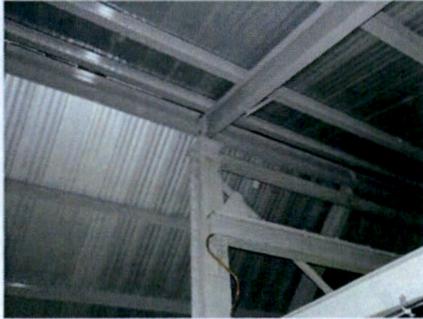
3463 General area structure detail. Clean and Dry. No visible issues.

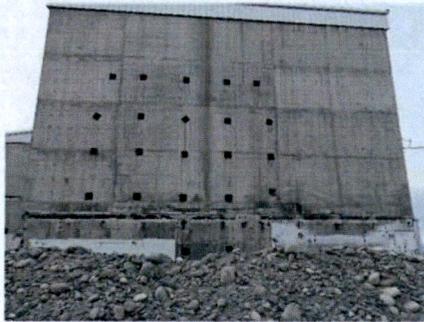
3493 No visible change to condition

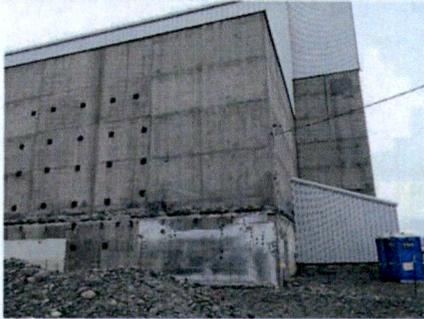
3494 No visible change to condition

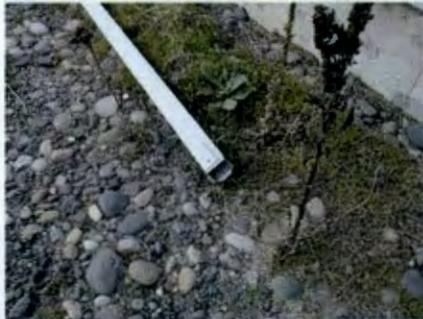
3495 Close up of fallen downspout piece. Connection piece still intact. No visible change

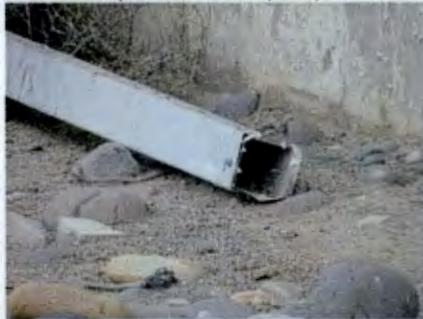
3496 Close up of fallen downspout piece. Connection piece still intact. No visible change

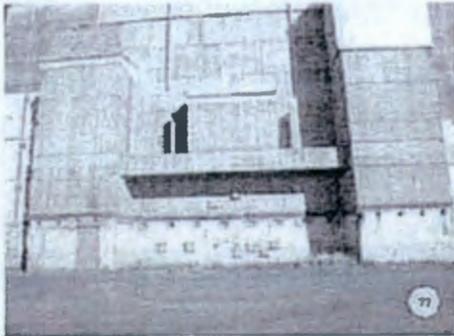
Item # 73 2010 Detail General wall area No visible issues

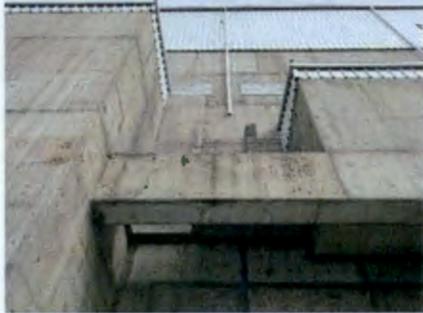
3487 Possible Weather protection issue. Small amount of erosion from downspout runoff

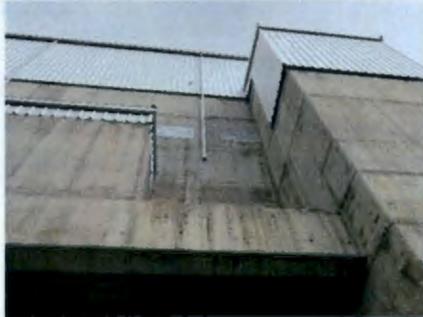
3488 Possible weather protection issue. Small amount of erosion from downspout runoff

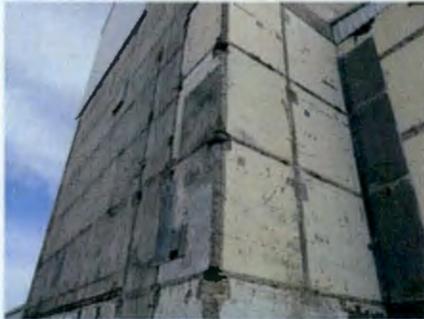
3483 spalled concrete around entire building in very good shape, .no noticeable degradation/excessive rebar corrosion since original project.

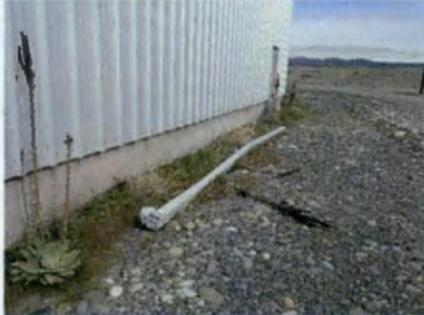
3490 2nd piece of broken downspout from S exterior wall

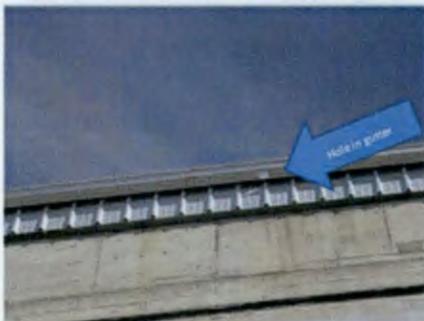
4989 shows hole in gutter where downspout was placed on left side of bldg

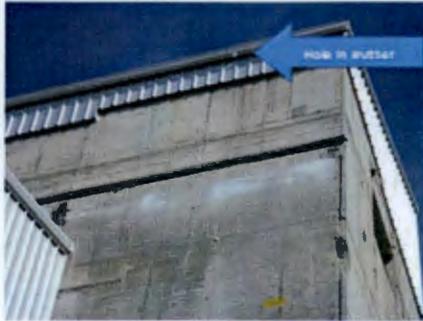
4986 shows hole in gutter where downspout was placed on left side of bldg

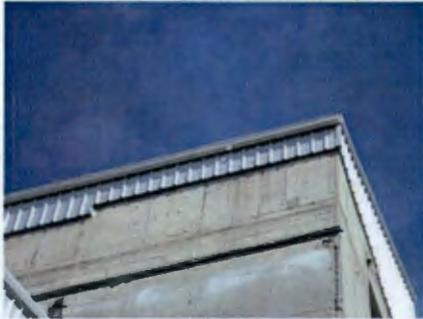
4986 shows where downspout should be returned to left side of bldg.

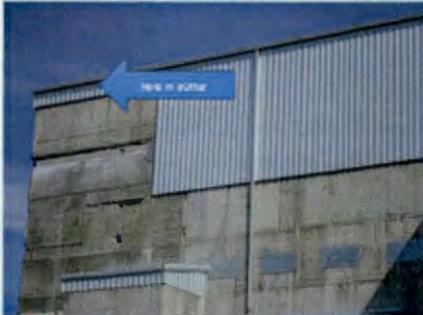
4983 shows hold in gutter where downspout was placed (on right side of bldg)

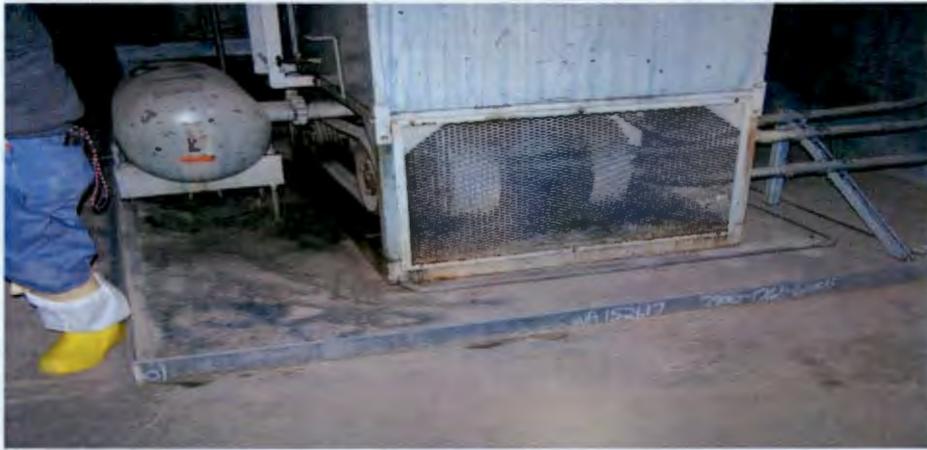
Photo 1

- Trip hazard around equipment caused by drip pan. (Photo 1)
- Trip and struck by hazards around piping. (Photo 2)
- Struck by and sharp object hazards from 2 step platform. (Photo 3)

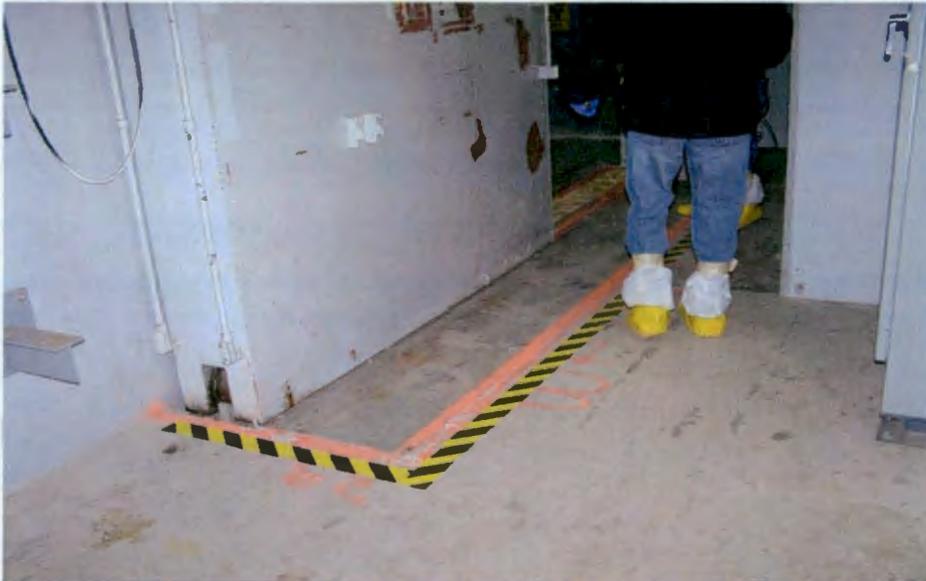
Photo 4

- (Room 401)- Tripping hazard caused by trough for door 403. (Photo 4)
- Overhead hazard caused by piping in stair well between 28' and 40' elevations. (Photo 5)

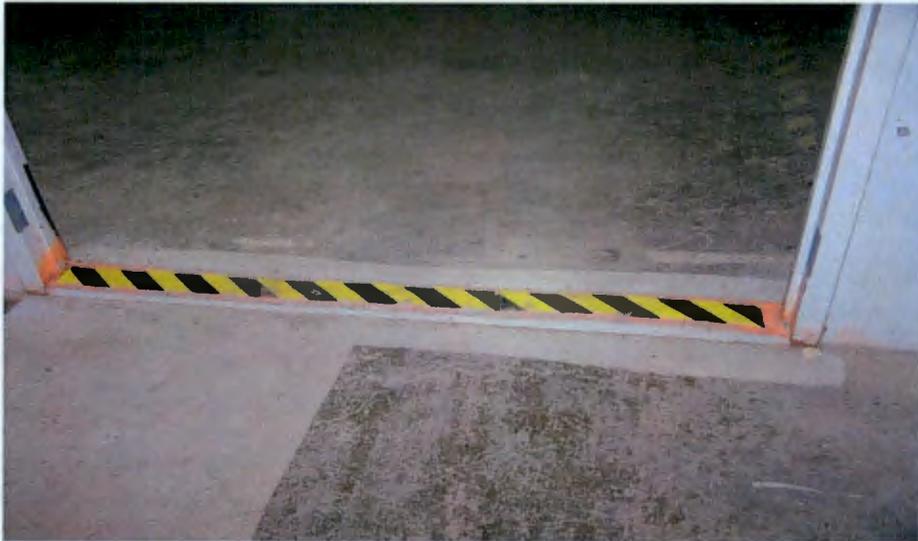
Photo 6

- Trip hazard leading into the room 503 (Painted Orange). (Photo 6)
- Numerous trip hazards and sharp edges on roof area above 109 N (many identified with orange paint, but many are not identified). (Photo 7)

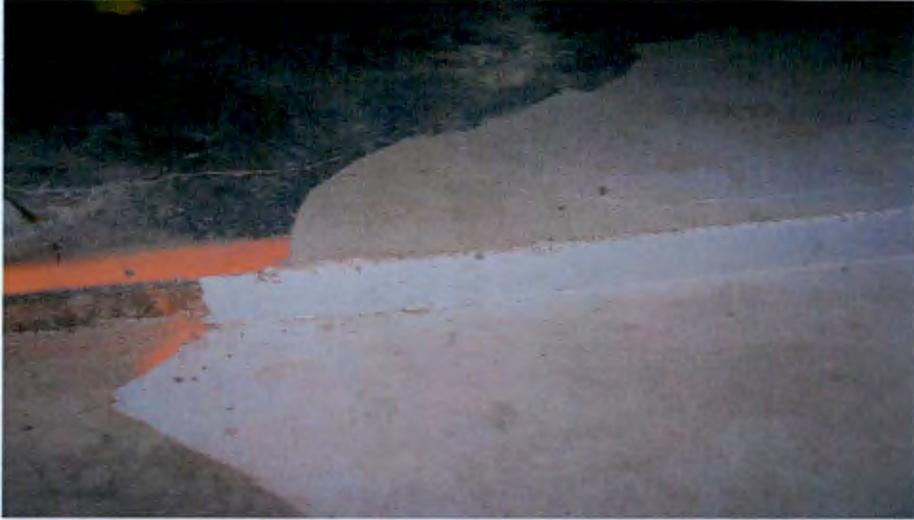
Photo 9

- Lamp burned out in room 610, with mandatory flashlights or head lamps, and other lighting in the area, this does not pose an issue at this time.
- Fire water piping running between rooms 601 and 610 is low hanging causing an overhead hazard.
- Numerous cross bracing throughout room 607 causing struck by and overhead hazards (Identified with Caution Tape). (Photo 8)
- Unexpected step down in room 607 causing a trip hazard (Painted Orange faded). (Photo 9)
- Large cable tray in the path between rooms 607 and 611. (Photo 10)

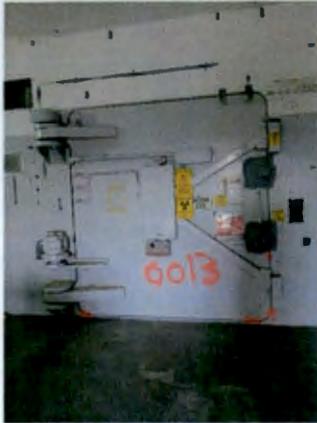
- On a windy day, air flow out of the Zone 1 door into Room 172 was noted (Attachment C, Photo 3737, 3738). While a potential radiological issue - high radiation / high airborne area venting to a buffer area; from an SSE standpoint this indicates that not only is that particular door not sealed, other doors around the SSE structure are not sealed as well allowing wind around the buildings to apply a positive or negative pressure and cause air movements within Zone 1.

3738 Zone 1 door. welded closed yet breeze coming through

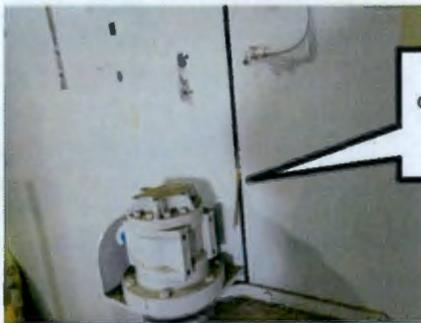
Notice piece of maslin cloth, presumable placed here at some time past to indicate air flow.

3737 Zone 1 door. welded closed yet breeze coming through

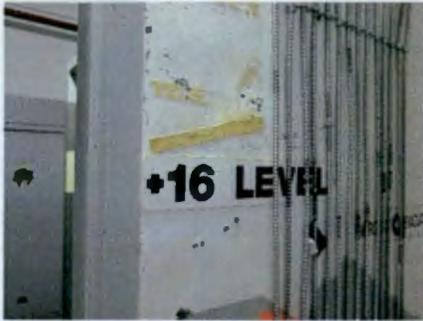
3716 S&M plan labeled 14'6" level. Needs to be changed with next S&M Plan revision

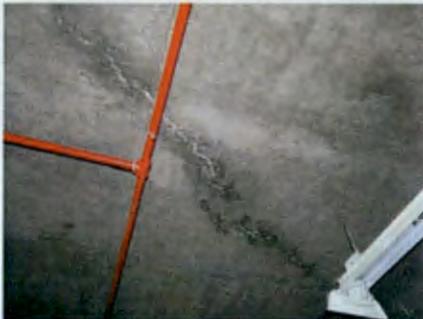
3721 Picture of possible calcium carbonate bleeding on ceiling in room 302

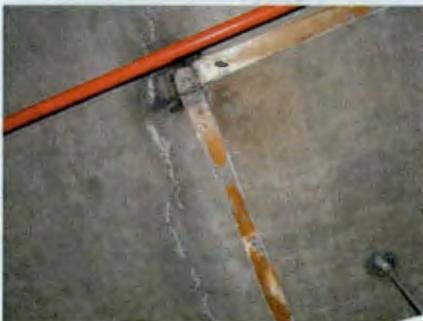
3722 Same as above

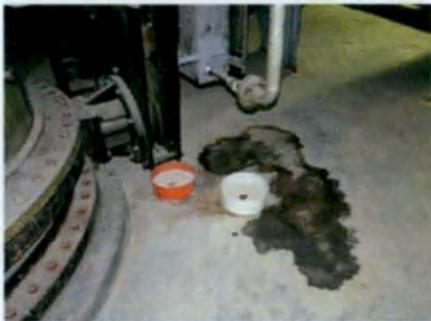
3693 Old fluid stains on floor next to containers of kitty litter. Good practice for weeping hydraulic fluids

Turnover Photo #	New Photo #	Description	Area / Location	Future Inspection/Maintenance Recommendations
422	3693	105N: Rm.#607- NE Corner at El.+60'- 6" dated 02-07-2012	105N +60'	Continue observation, good practice recommended for other weeping hydraulic / oil lines shown in photo 3693.

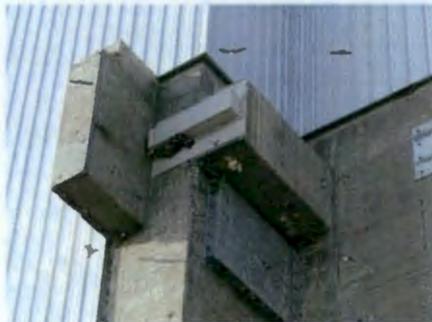
- Swallow nesting at concrete / siding junction point and in some cases (Attachment C, Photo 3682) directly on the steel plate / boxes installed as closures.

3682 Swallow nesting directly on metal caps/closures

Turnover Photo #	New Photo #	Description	Area / Location	Future Inspection/Maintenance Recommendations
	3682	Swallows nesting directly on metal caps/closures	Exterior	Continue observation for damage to any steel surfaces.
	3683	Possible water intrusion/corrosion with backfill @ door	Exterior	Consider moving soil from adjacent to doors and grading away from door sill to ensure no in-leakage and prevent accelerated corrosion of the Zone 1 doors.
	3685	Possible water intrusion/corrosion with backfill @ door	Exterior	
	3686	Possible water intrusion/corrosion with backfill @ door	Exterior

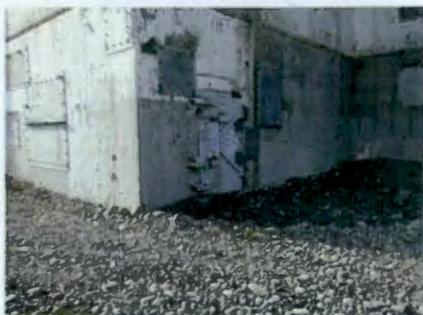
4. Possible water intrusion/corrosion from outside caused by contact with backfill at the door (Appendix F, Photo 3683).

3683 Possible water intrusion/corrosion issue w backfill over bottom sill of door

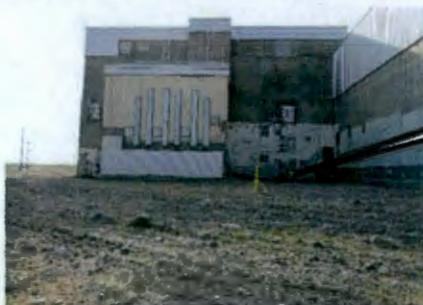
3685 Possible water intrusion/corrosion issue with backfill at door

Same location as photo  
3686 below

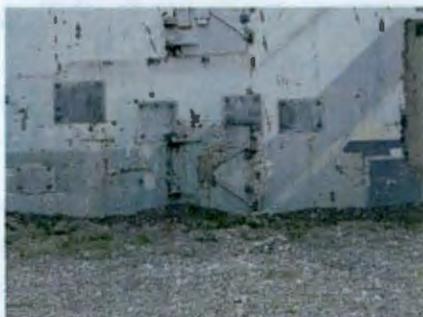
3686 Possible water intrusion/corrosion issue with backfill over the sill at this Zone 1 door

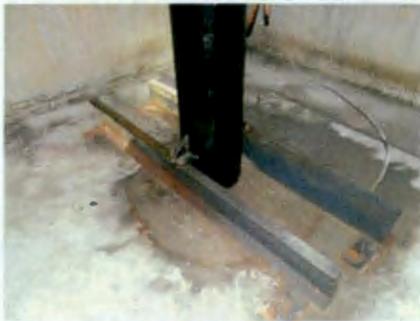
3729 No visible change to condition

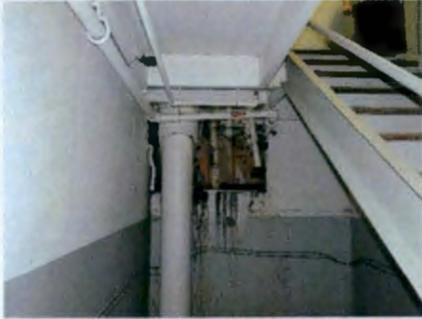
3728 4/15 - Interior pour back framing remains

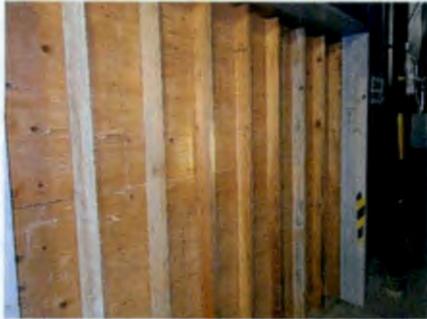
3723 Interior pour back framing remains

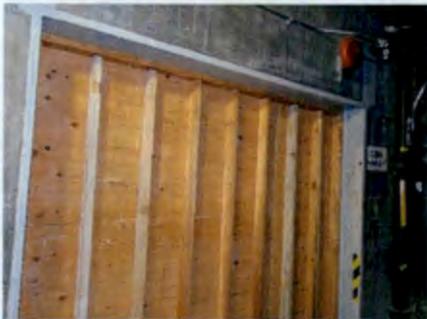
3724 Interior pour back framing remains

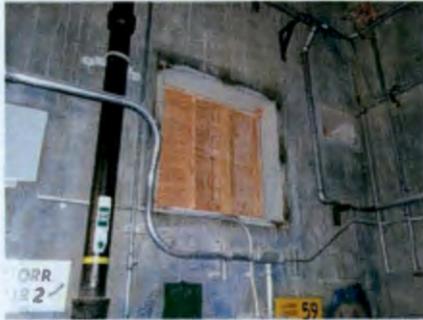
3725 Interior pour back framing remains

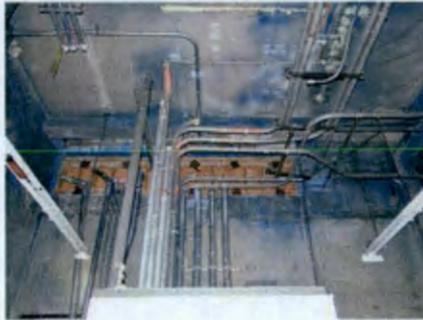
3727 Interior pour back framing remains

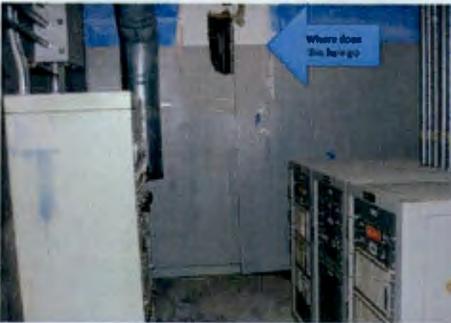
378 - 105N/Rm.#301-Looking West at El.+16'-6" dated 02-15-2012

Confirmed that this "hole" in the photo above is in a drywall partition and goes to an adjacent room on this floor.

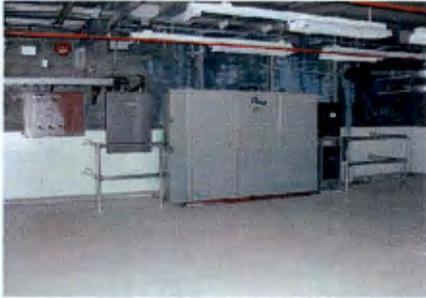
386 -105N/Rm.#401-Looking East at El.+28'-3" dated 02-15-2012

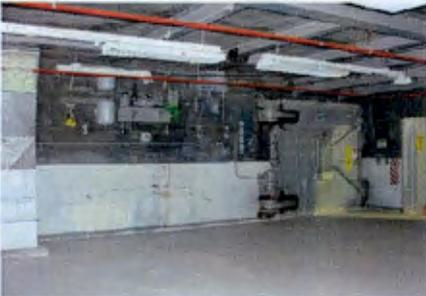
388 - 105N/Rm.#401-Looking West at El.+28'-3" dated 02-15-2012

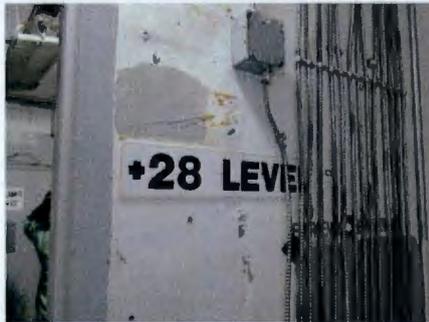
3711 Sign on wall at door entrance from stairwell

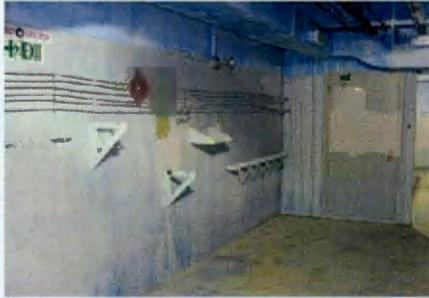
392 - 105N / Rm.502-East Wall Looking South at El.+40' dated 02-07-2011

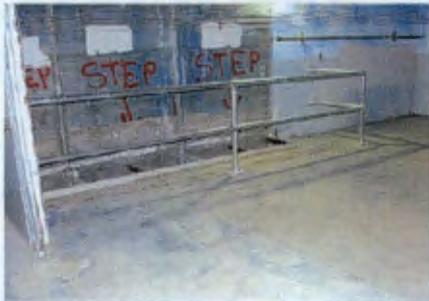
395 - Rm.#501-East Wall at El.+40' dated 02-07-2012

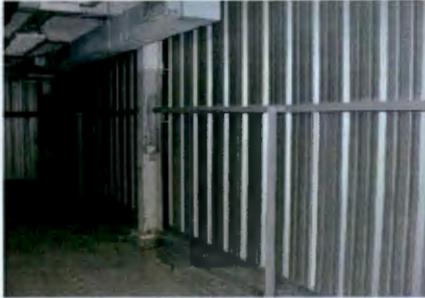
399 - 105N / Rm.#503-East Wall Looking North at El.+40' dated 02-07-2012

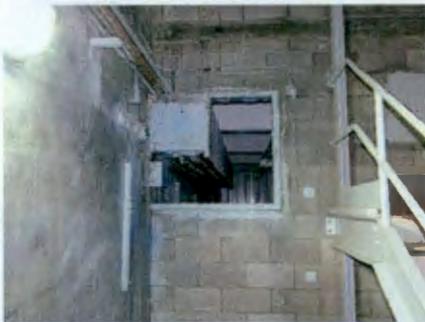
3705 in stairwell to adjacent / accessible room at this elevation

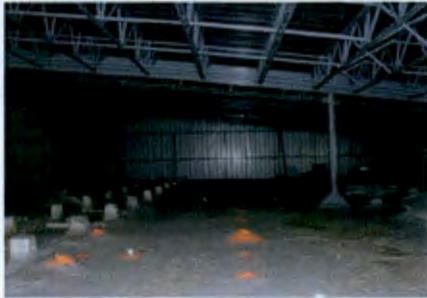
105 - 109N: Area under SSE Roof-East Wall Ctr. At El.40' dated 02-07-2012

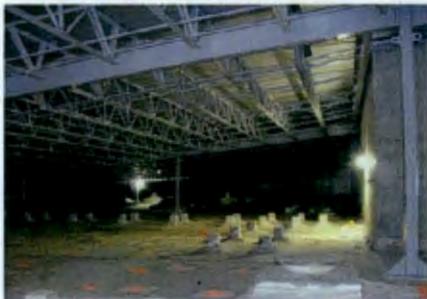
110 - 109N: Area under SSE Roof-West 1/2 Roof at El.40' dated 02-07-2012

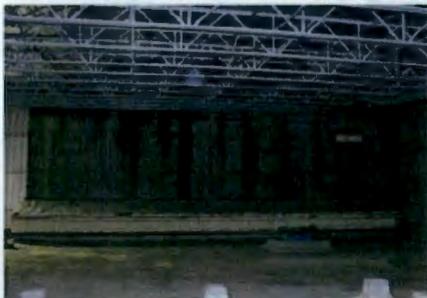
112 - 109N: Area under SSE Roof-North Wall, West of Press. at El.40' dated 02-07-2012

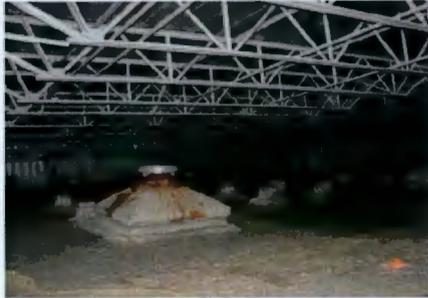
116 - 109N: Area under SSE Roof-South Wall, West End at El.40' dated 02-07-2012

NOTE - No roof leaks were noticed during inspection. It was a dry day and had not rained for several days previous.

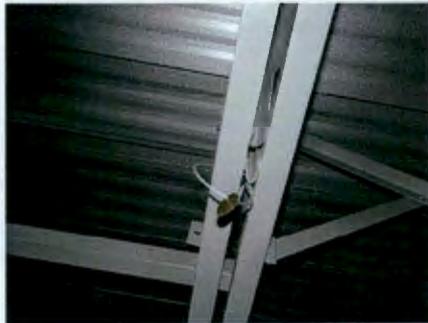
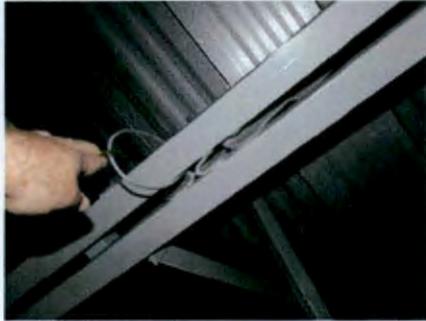
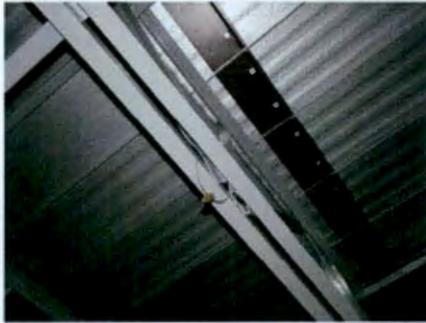
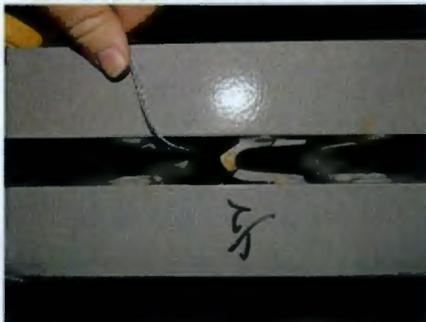
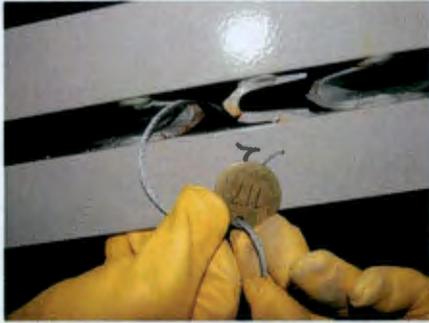
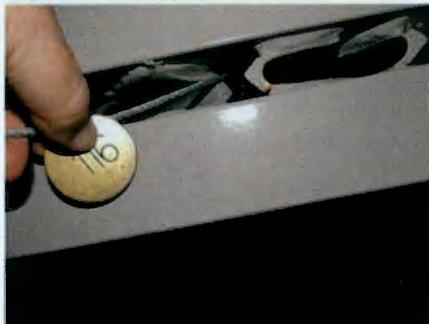
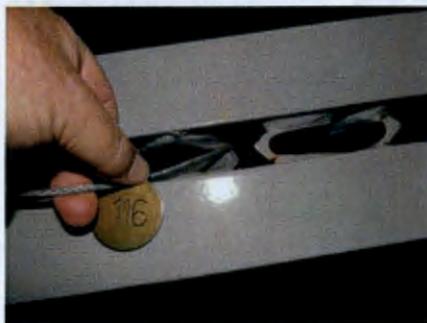
The following several photos were taken during the inspection efforts in the 109-N "attic" space for the joist tears as called out in Ref 1 Section 3 and Appendix A. As noted in Attachment A of this report, structural evaluation of the 2015 as found conditions and with review the previous evaluation documented in Ref 3, recommend this item not be continued for further inspections.

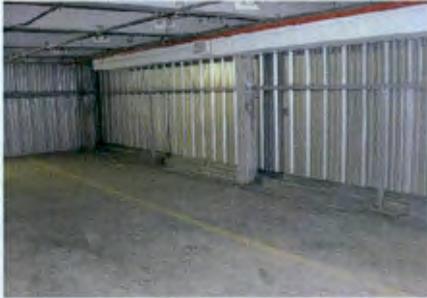
402 -105N: Rm.#520-North End Looking North at El.+51' dated 02-07-2012

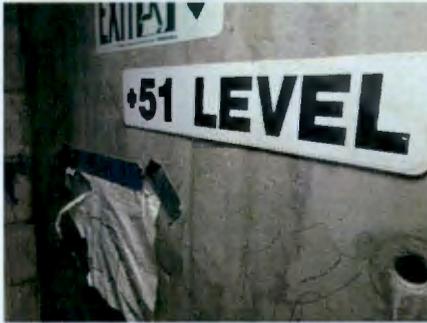
Turnover Photo #	New Photo #	Description
402	No new photo	105N: Rm.#520-North End Looking North at El.+51' dated 02-07-2012
	3700	Elevation sign in stairwell
	3701	Other aspects of the rooms at +51'
	3702	
	3703

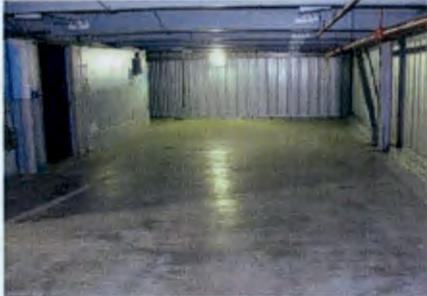
404 - 105N: Rm.#610-Looking North at El.60'-6" dated 02-07-2012

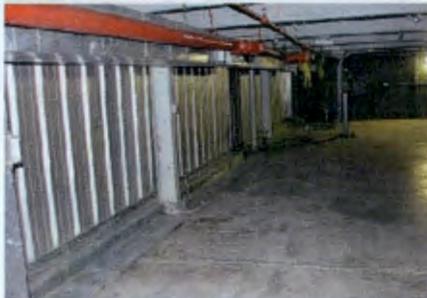
405 - 105N: Rm.#601-Looking South at El.+60'-6" dated 02-07-2012

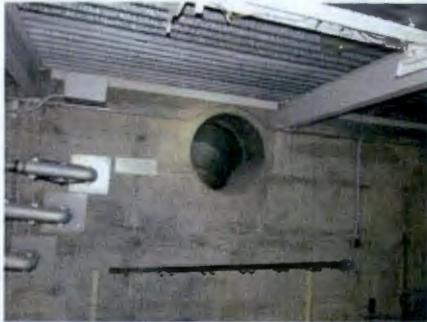
407- 105N: Rm.#802-Looking East at El.+60'-8" dated 02-07-2012

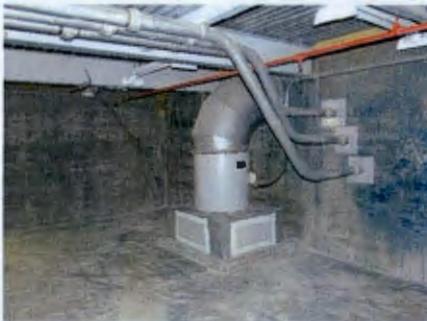
3697 – This photo and the one below shows the "hole" in photo 407 above is actually an open ventilation duct.

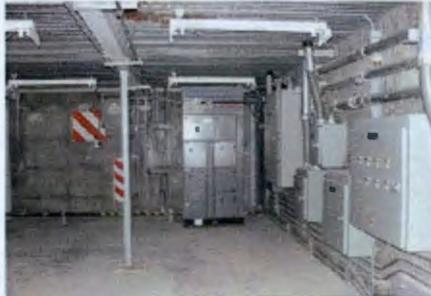
3698 – duct on the opposite side of wall from photo 3697 above

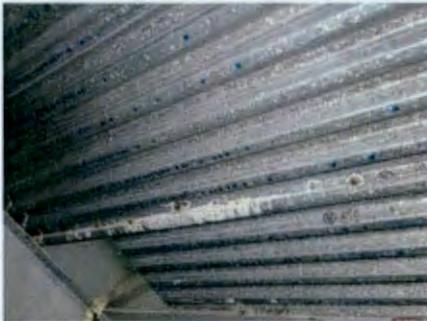
3690 Typical old roof corrosion

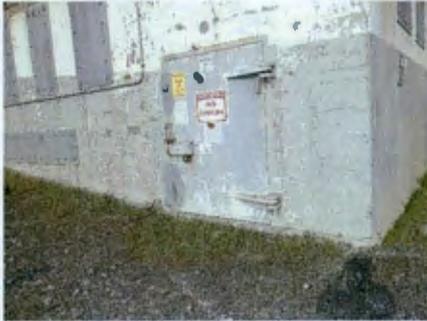
3679 Good clearance at door sill. No concern about water intrusion.

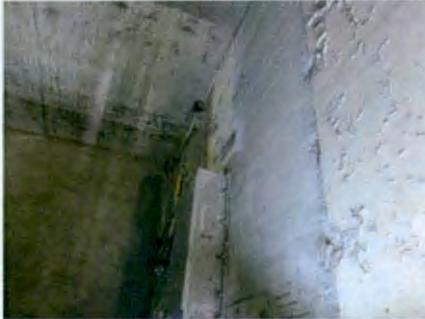
3731 109N Entrance Pit Clean and Dry

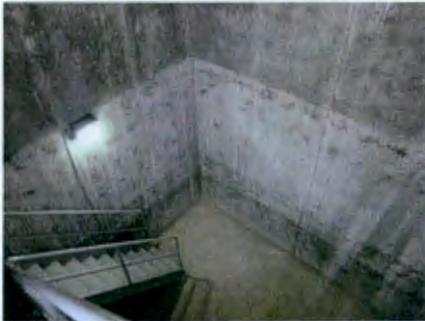
3732 109N Entrance Pit Clean and Dry
